January 28, 2018

Violation Location: 26425 Laureles Grade, Monterey. CA 93940
A.P.N: 416-051-005-000
Zoning: RDR/B-8-VS
Case Number: 17CE00378

Subject: Tree removal impact assessment for property located at 26425 Laureles Grade

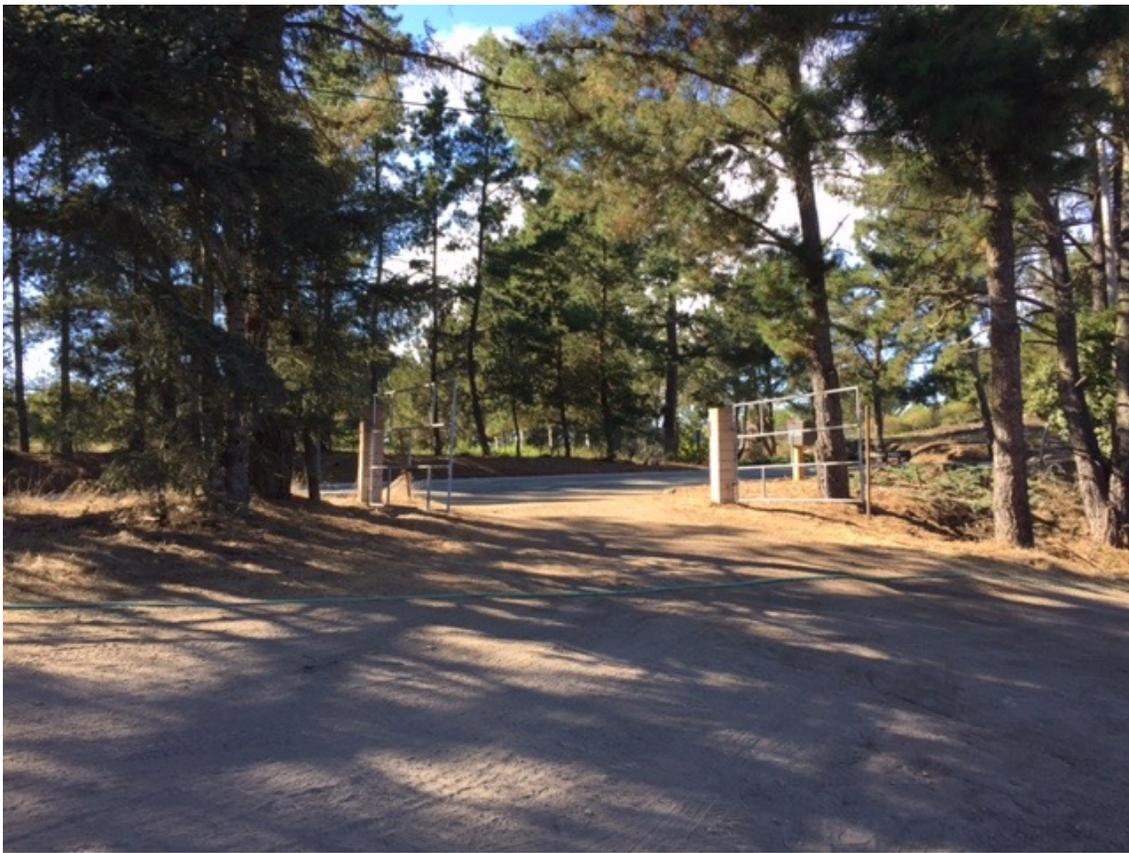
Figure 1. Entrance on west side of property along Laureles Grade is dominated by several mature and introduced Monterey Pine trees that were planted decades ago. Apply all-weather aggregate surface to entrance to prevent sediment tracking onto Laureles Grade roadway.

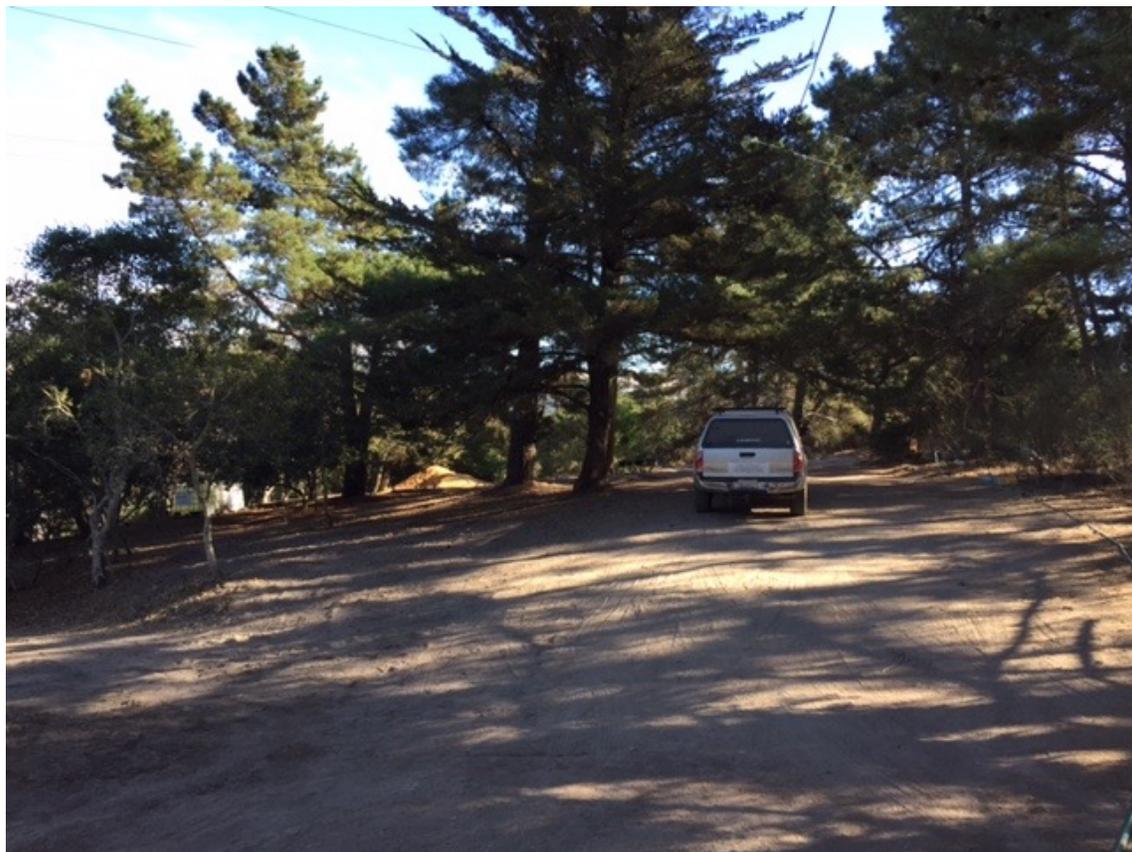
Figure 2. Disturbed area near entrance to property will have mulch applied to exposed areas that are relatively flat. Rice straw mulch and/or woodchip mulch soil protection (i.e., source protection) measures will assist in stabilizing exposed soil surfaces and reducing erosion concerns.

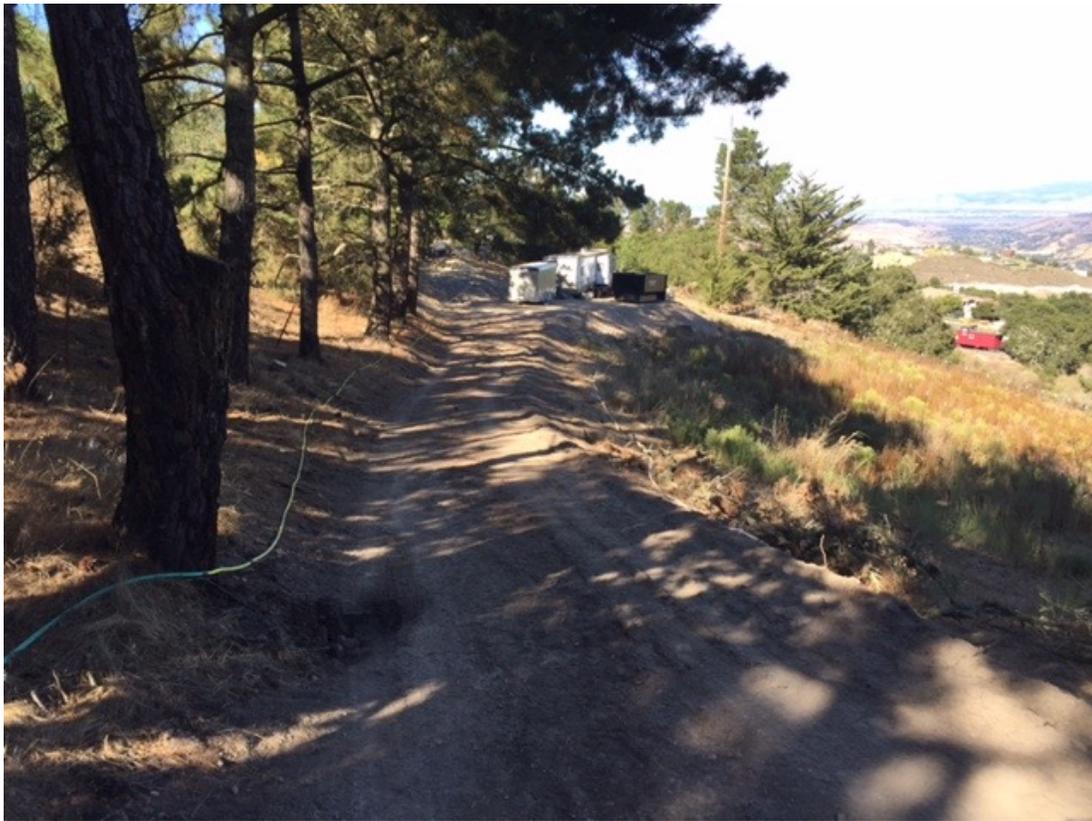
Man-made features on this undeveloped, but previously disturbed property are limited to a few trailers that are owned by the property owner (refer to *Figure 3*). Soils on the parcel appear to be stable and sufficient for supporting slope restoration and stabilization activities that are provided in this report, as well as with property development operations that are proposed for the subject parcel (refer to soils report that was prepared by *Soil Surveys Group, Inc*).

Figure 3. Graded road along upper west part of property provides access to a few trailers. It should be noted that a road existed here prior to the most recent non-permitted grading. Retain and winterize road and install silt fence along downslope perimeter of road and graded pad where trailers are located.

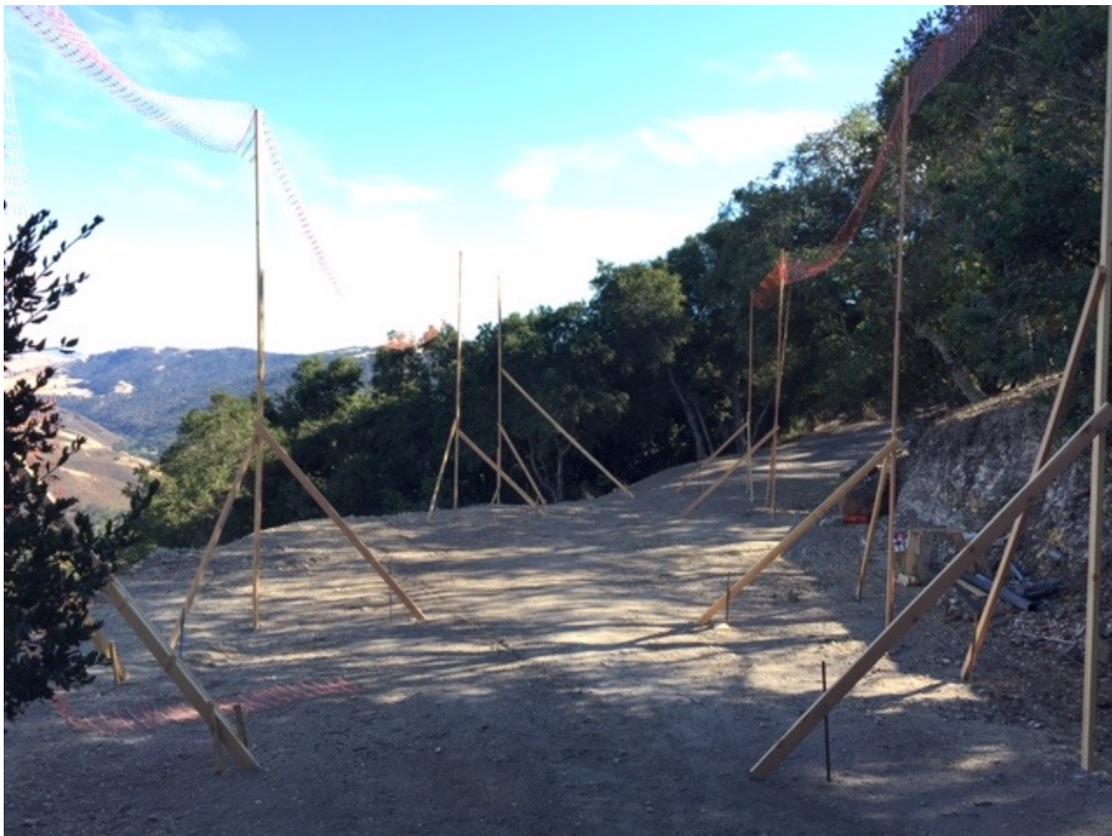
The cut slope that is located along the western edge of the proposed building pad/terrace (refer to *Figures 4 & 13*) was evidently cut into the slope using heavy equipment several years ago by a previous property owner. The roots that are visible are well-weathered and do not appear to be recently cut or impacted, which supports the property owners position that this grading cut occurred several years ago. The immature to mature Coast Live Oak trees that are located on the upslope side of the cut slope have adapted to this grading cut (i.e., lowered grade) within their primary root zone and are currently in fair to good health and condition. Consequently, in my professional opinion no mitigation, preservation or remediation actions are necessary for these relatively immature and smaller size oak trees that are located a short distance above the cut slope, due to the fact there is no evidence of significant stress or decline attributed to the cut slope. In situations where grading operations have resulted in the exposure of roots, it is often advised and advantageous to cleanly cut permanently exposed roots and then cover the exposed soil profile (containing larger primary lateral roots and smaller fibrous roots) with a natural burlap fabric or similar and kept moist until permanently backfilled or covered (refer to *Item 4* under *Tree Protection & Preservation Measures*). However, per the assessment, this root protection and preservation measure is not necessary at this time and will not likely provide any significant benefit to the nearby oak trees.

Figure 4. Building pad/terrace for proposed homesite. Retain, but apply woodchip or rice straw mulch to exposed flatter surfaces. Cut slope developed by previous property owner is located on right side of photo.

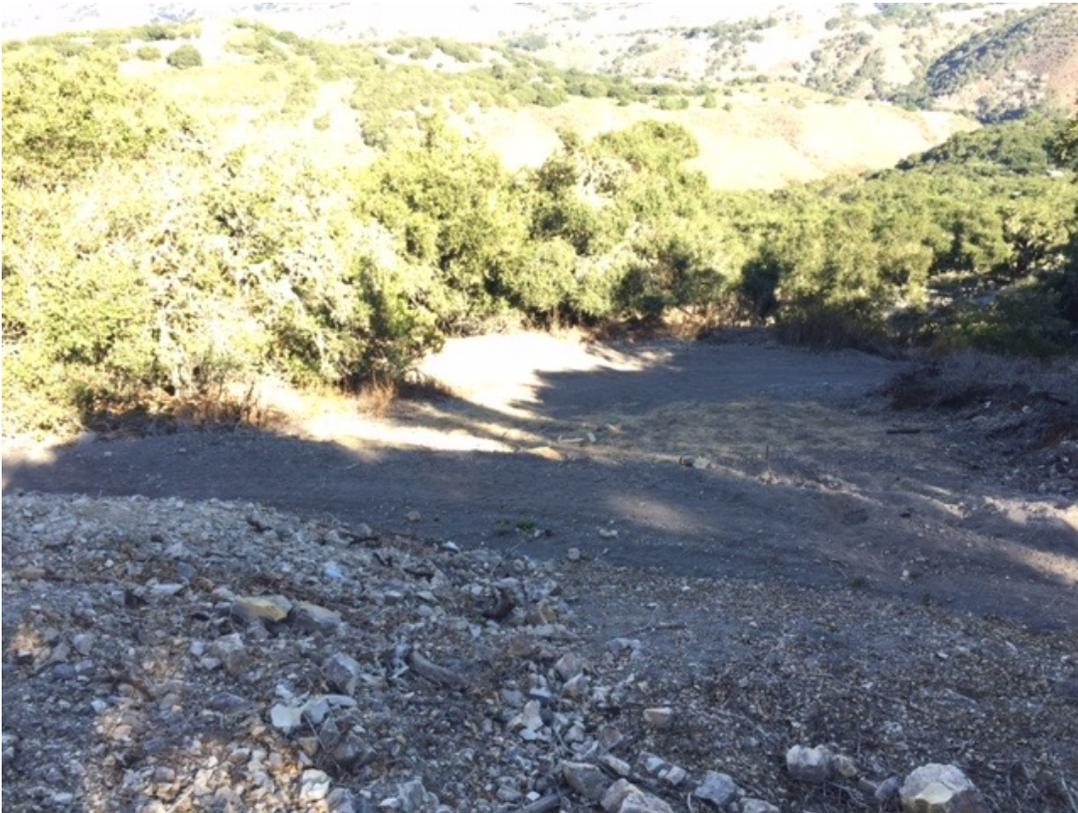
Figure 5. Steep and disturbed slope viewed from building pad seen in last photo is greater than 25% grade. A narrow road/path is located in mid slope and at bottom of slope. Properly shape and track roll slope prior to applying hydromulch and erosion control blankets. Also, install straw wattles (i.e., slope interruption measures) in upper and lower section of slope to assist in stabilizing and protecting impacted slope. The oak tree that was removed was located in foreground in lower center portion of photo.

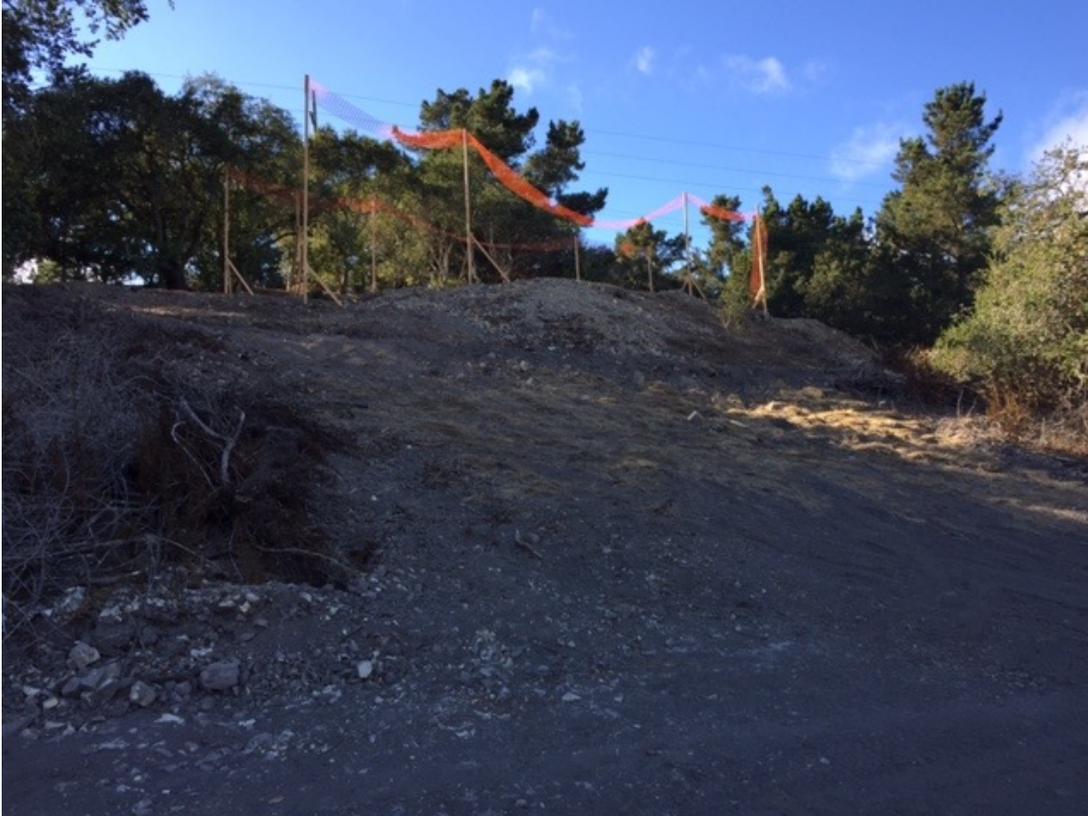
Figure 6. Another view of disturbed and exposed slope below proposed homesite that needs to be stabilized and restored. Oak that was removed was located near top of slope (center portion of photo).

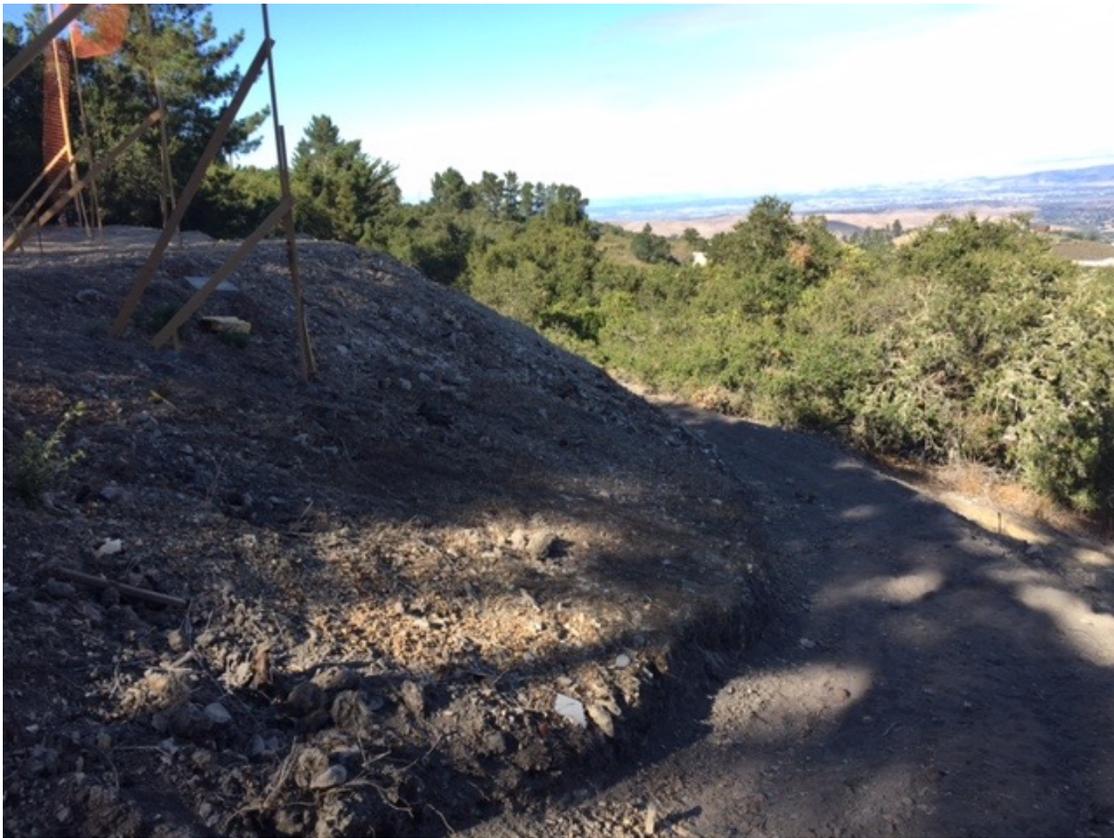
Figure 7. Another view of upper portion of disturbed slope below proposed home building site and narrow road/path that also needs to be restored and/or outsloped. Upon completion of slope shaping and track rolling operations apply native seed mix and erosion control blankets.

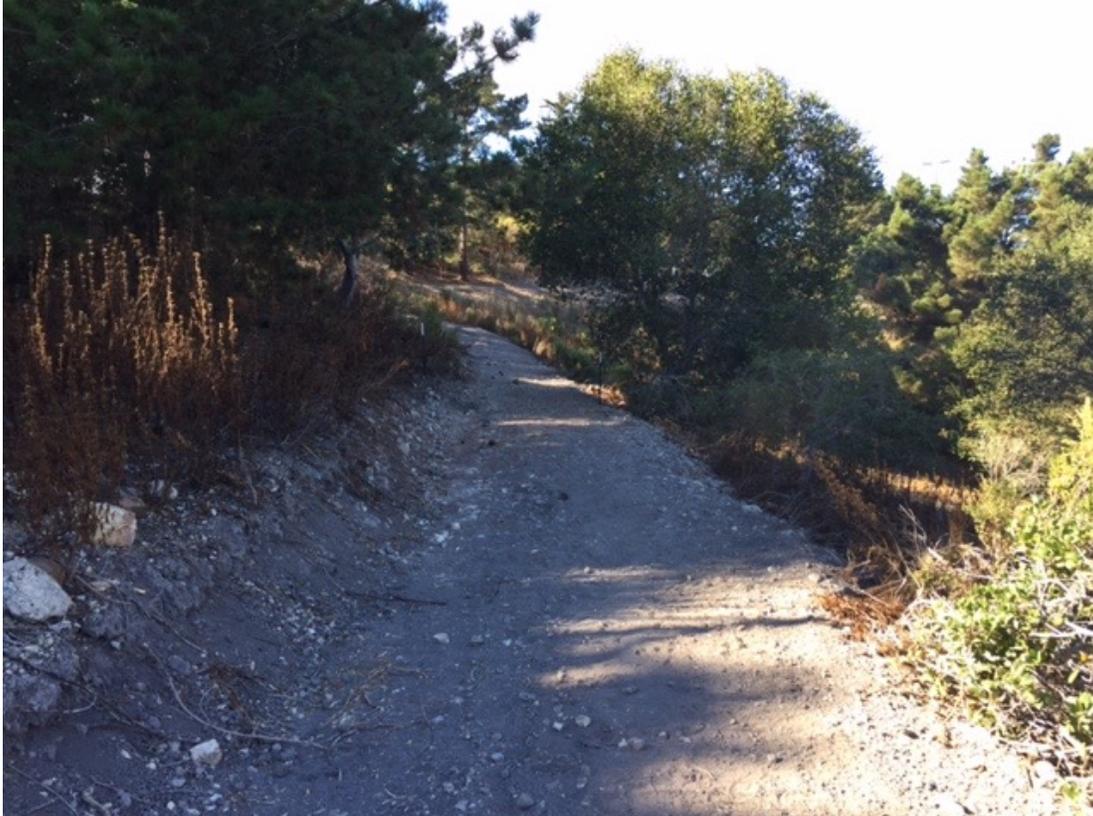
Figure 8. Outslope narrow road/path and install earthen or sand bag water bars every 50 feet to divert concentrated runoff off of exposed soil surfaces. Also apply native seed mix and rice straw or woodchip mulch to protect and stabilize exposed soil surfaces.

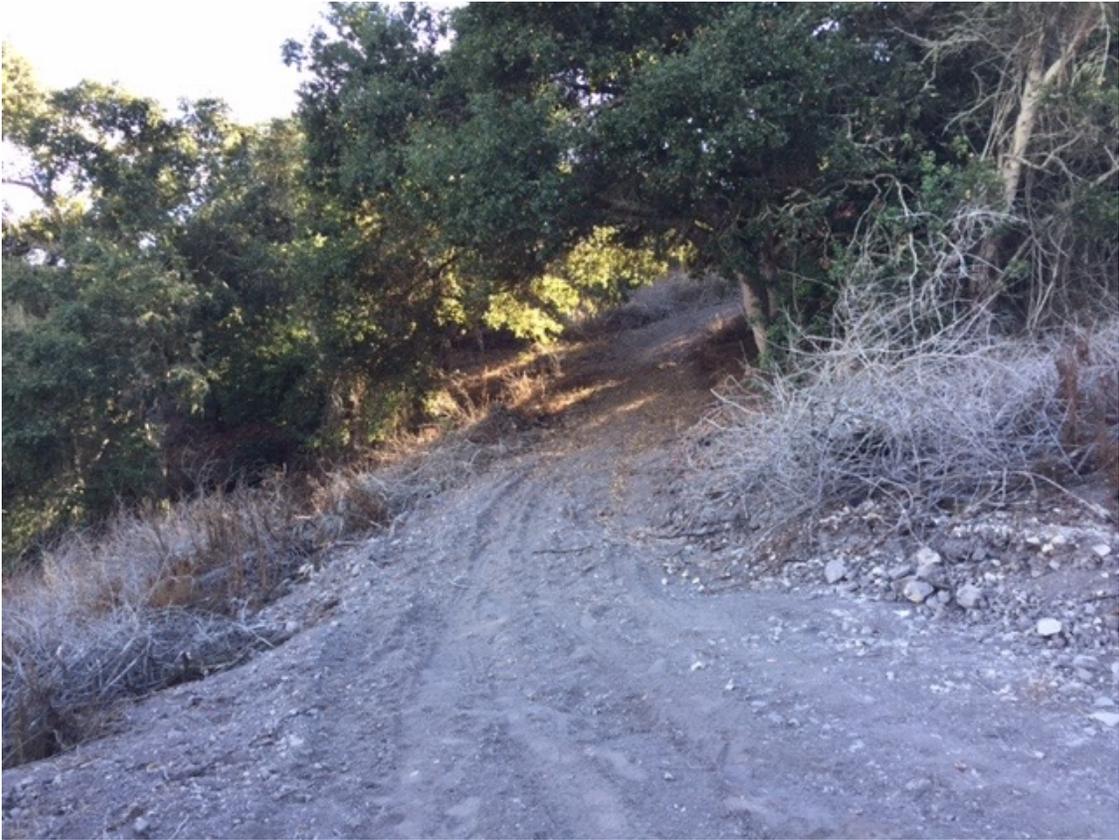
Figure 9. Vertically track roll exposed soil surfaces followed by the application of native seed mix (preferably via hydromulch) and erosion control blankets (e.g., jute net should be sufficient).

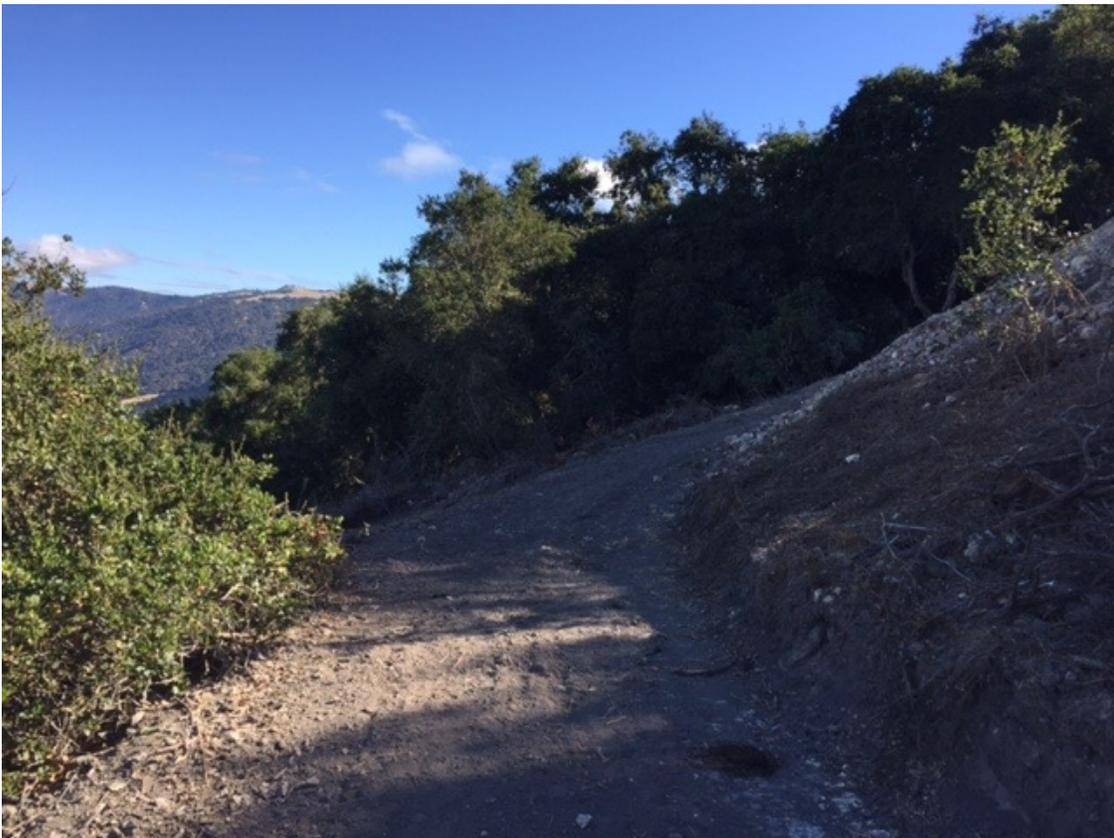
Figure 10. Shape and outslope narrow road/path into surrounding slope prior to applying and installing soil stabilization measures. Retain small oak sapling visible near right edge of photo.

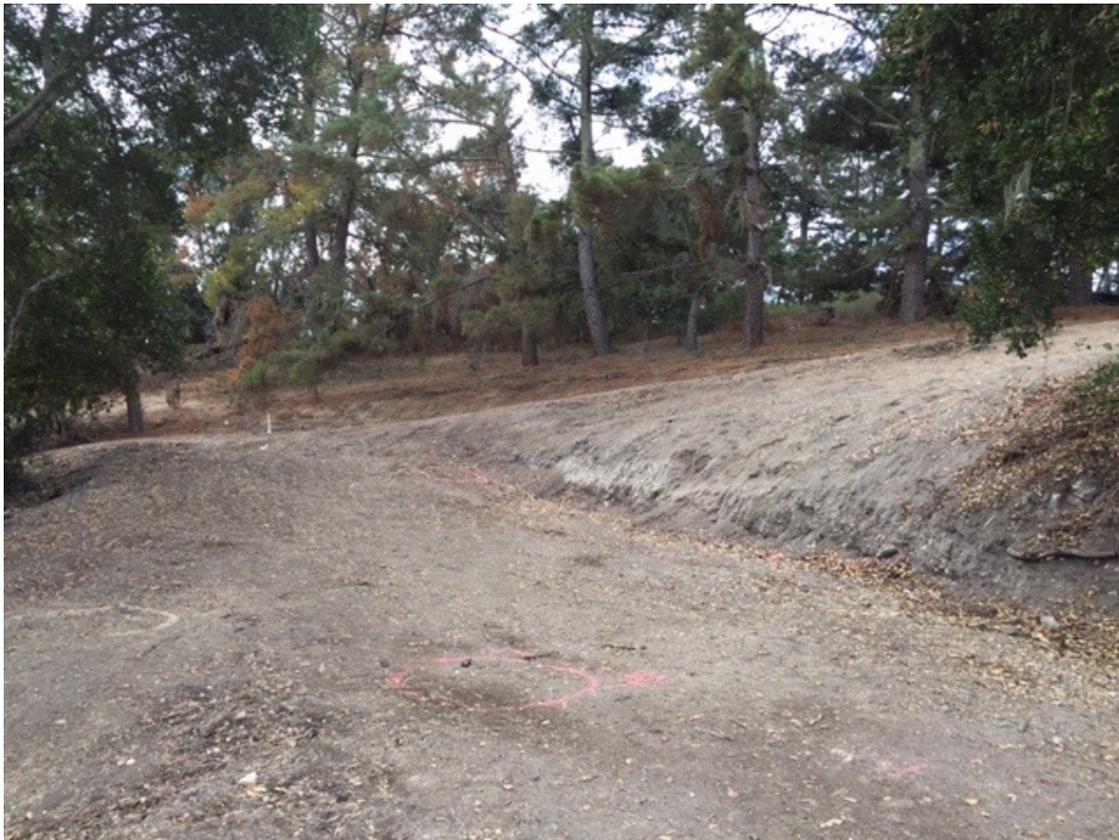
Figure 11. Install rice straw or wood chip mulch in foreground (i.e., flatter areas) and erosion control blankets (e.g., jute net) and straw wattles on steeper slopes (e.g., right of center) to stabilize exposed soil surfaces and prevent erosion problems.

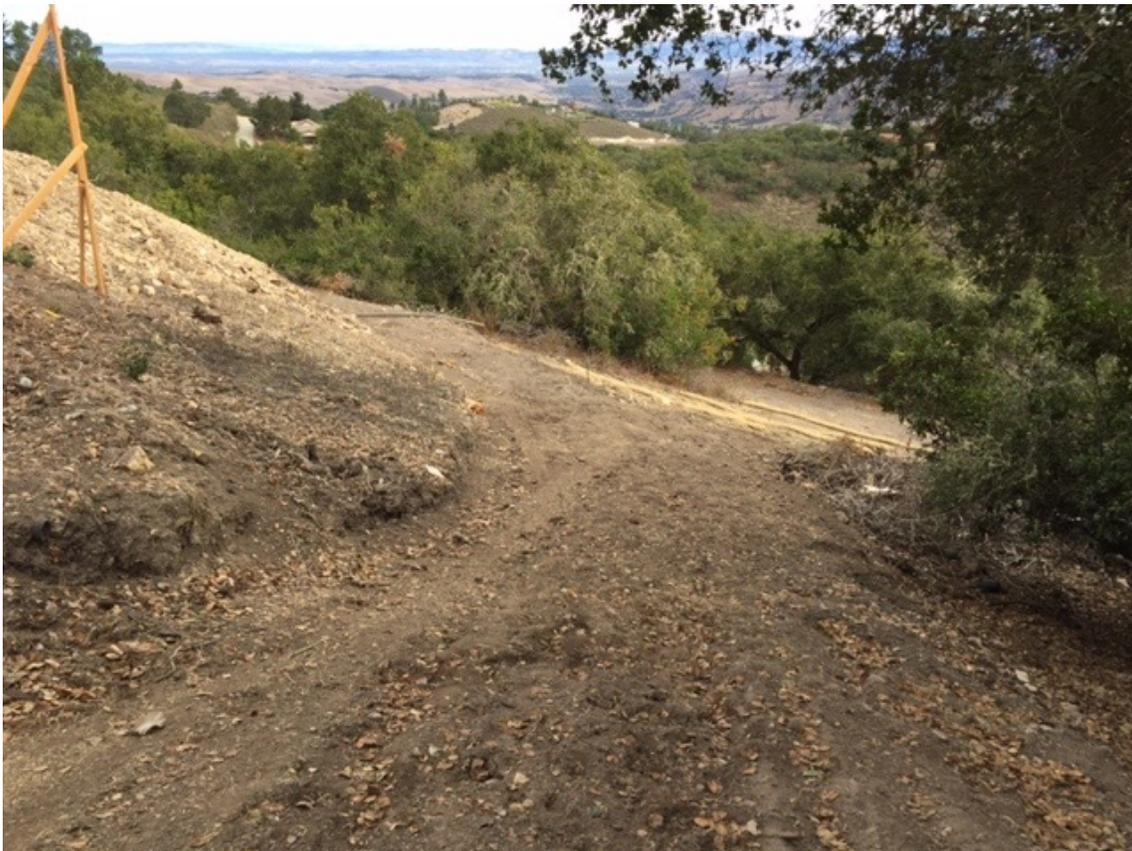
Figure 12. Restore lower road/path and apply native seed mix and soil stabilization measures to exposed slope. As of late, straw wattles have been installed toward lower section of slope (right of center).

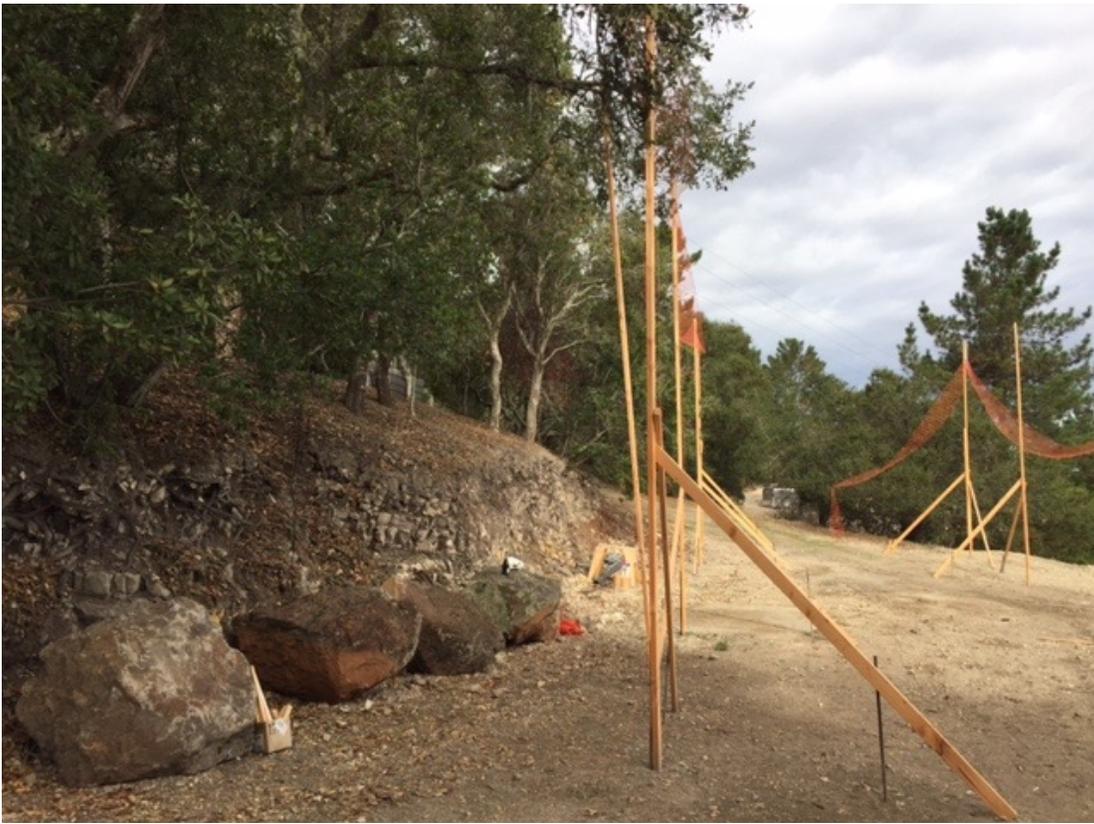
Figure 13. Proposed building pad and site was developed by previous property owner. Relatively immature oak trees located above cut slope are in generally good health and condition and have adapted to the grade change that occurred several years ago. Retain cut slope and building pad/terrace.

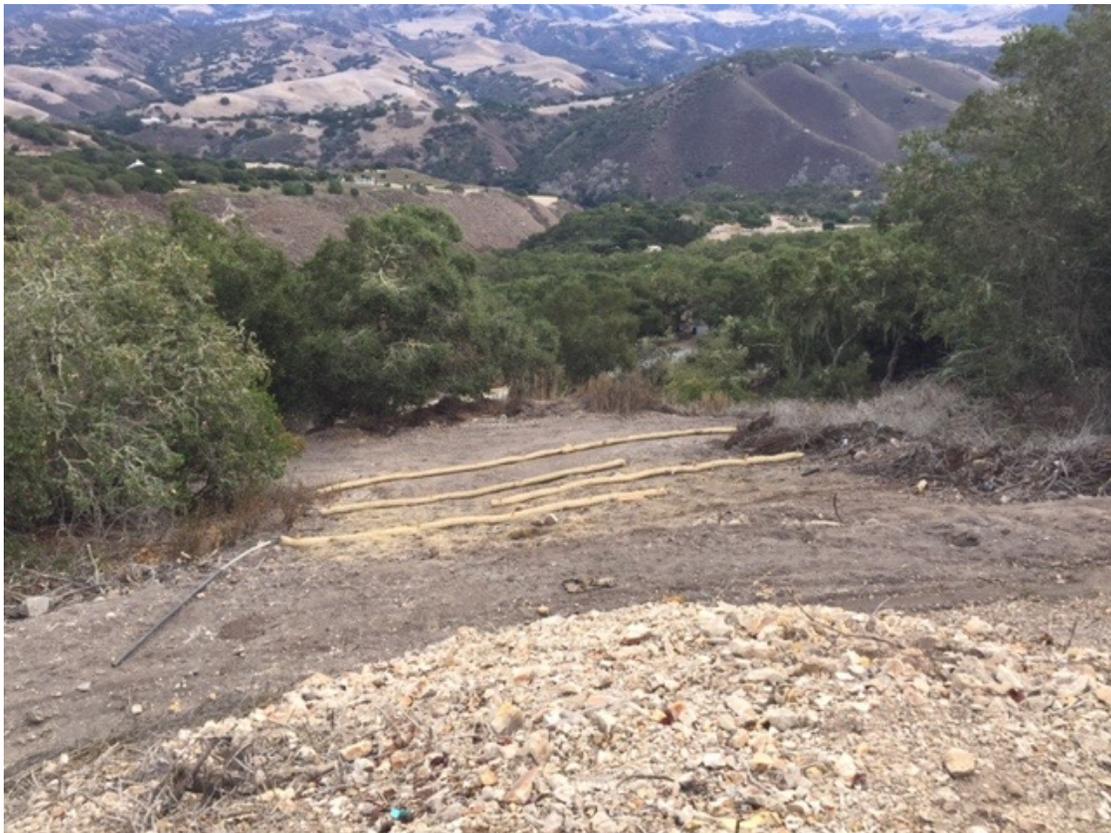
Figure 14. Straw wattles have recently been installed in lower section of slope. Additional erosion and sedimentation control and slope stabilization BMP's provided in this report should be implemented.

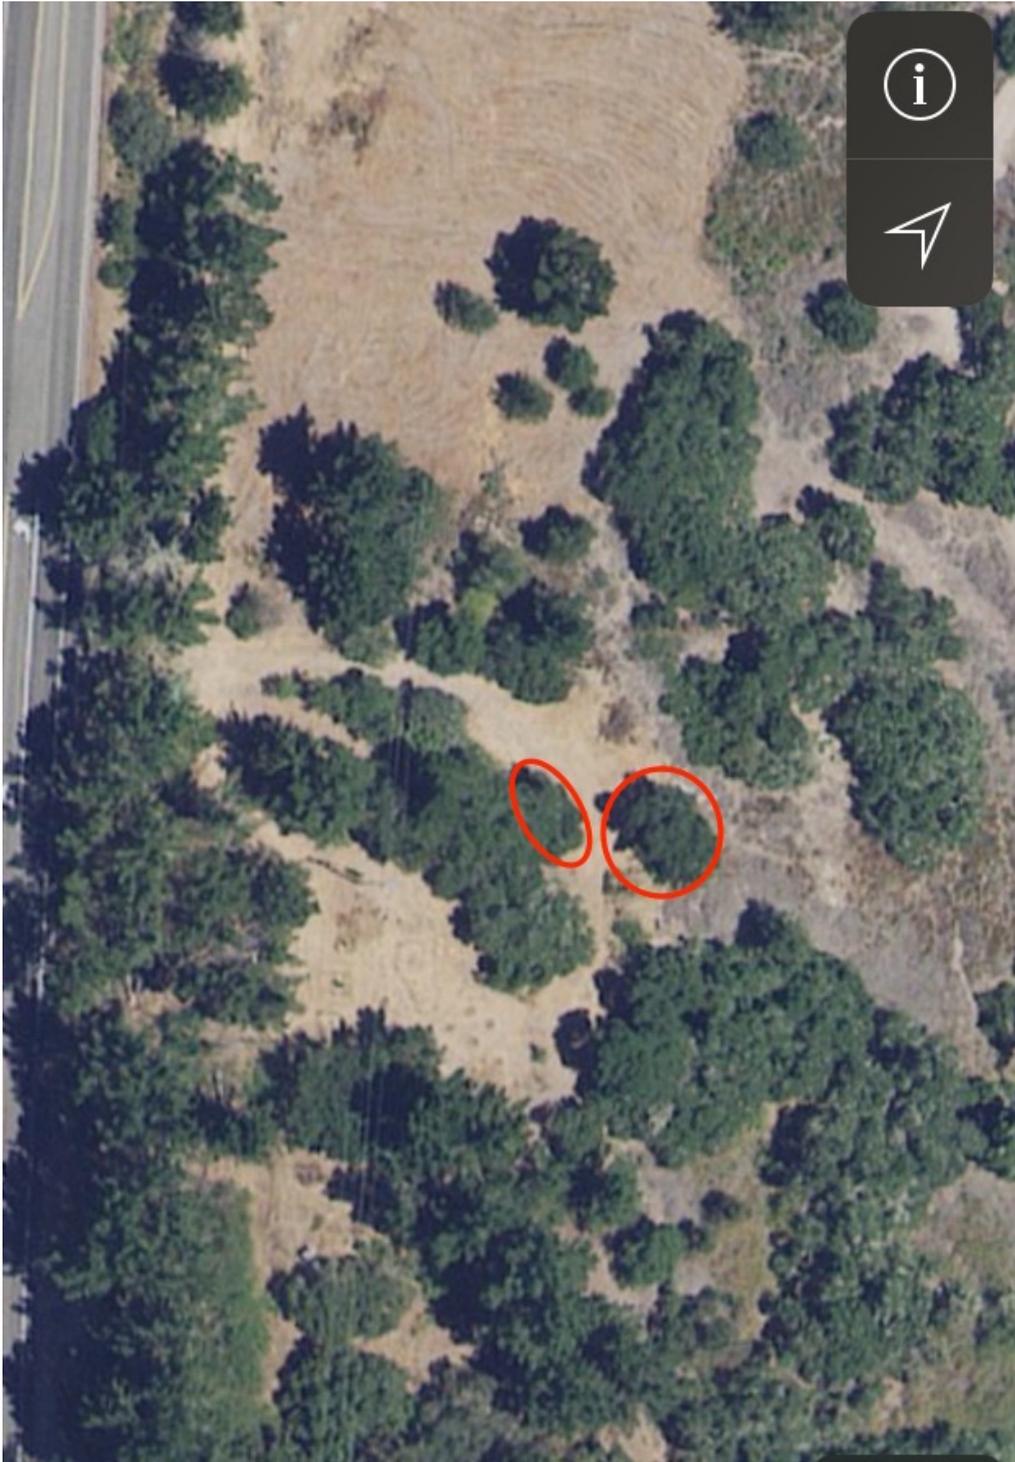
Figure 15. Two mature Coast Live Oak trees that were removed are circled in photo. Numerous other trees visible in aerial image have not been removed or impacted. Per a recent assessment, surrounding oak woodland habitat is still intact and has not been significantly impacted or compromised.

As a result of the unauthorized removal of one mature multi-trunk oak tree, the property owner has agreed to plant ten (10) 5-gallon Coast Live Oak trees (refer to corresponding Exhibits for planting locations and *Figure 15* for location of existing trees and woodland habitat) to mitigate impacts associated the non-permitted removal of the subject oak tree.
