**EXHIBIT E**  
**Kaufmann Residence**  
**3309 Camino Del Monte, Carmel CA**  
**Tree Assessment Forest Management Plan**

April 24, 2018

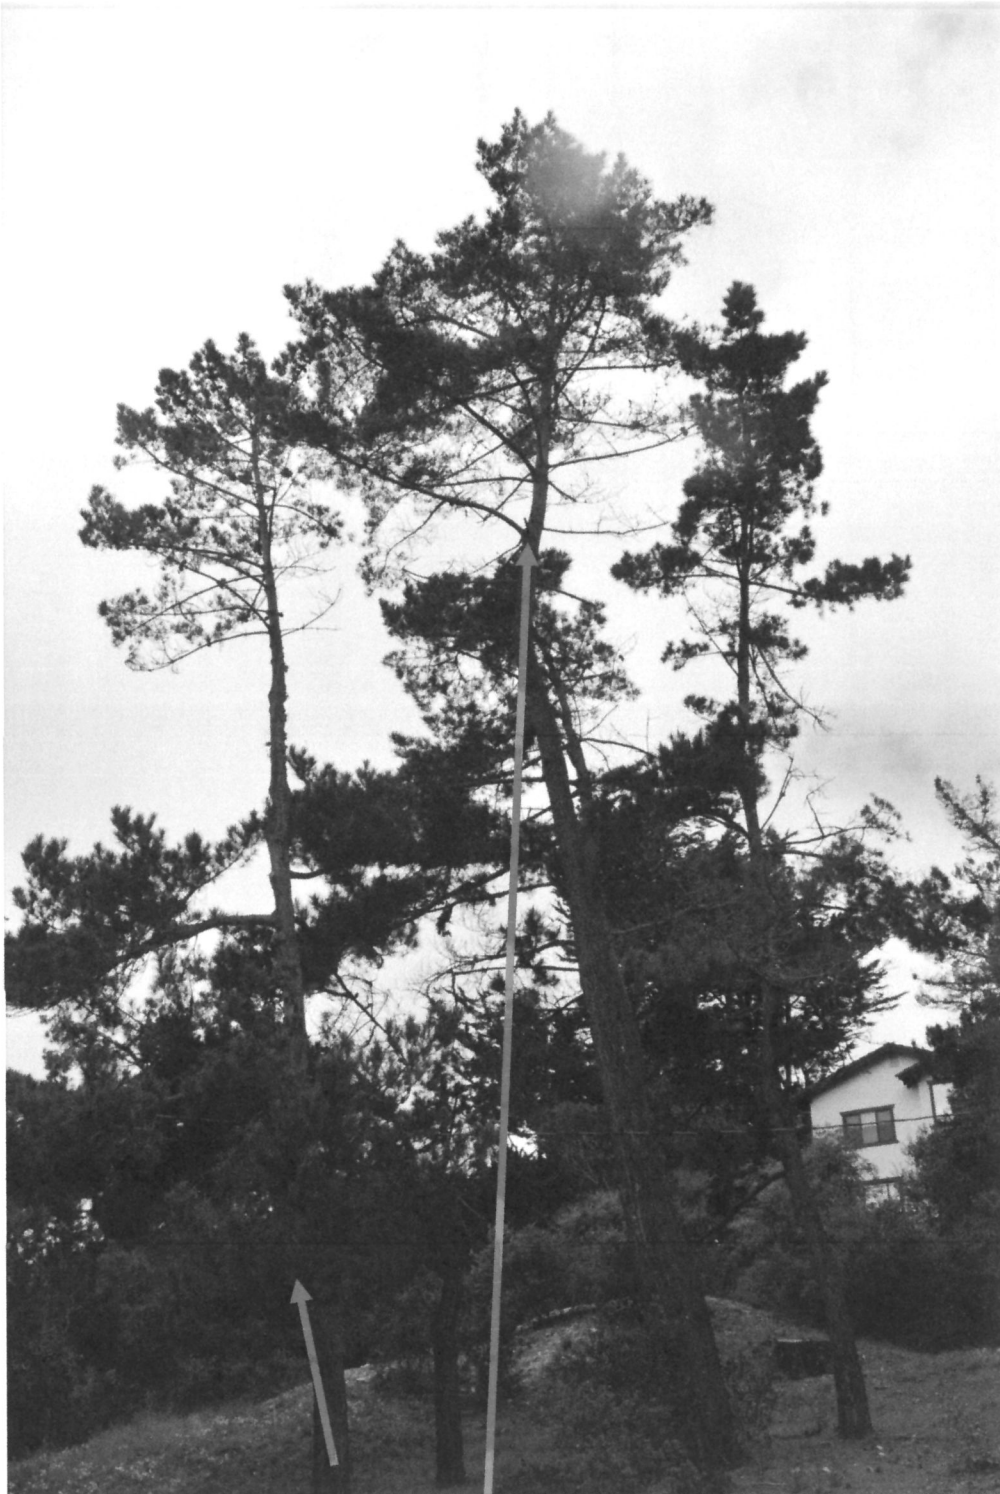
Two Pines to be retained #68 and #72 pines behind are to be removed #69, 70, and 71

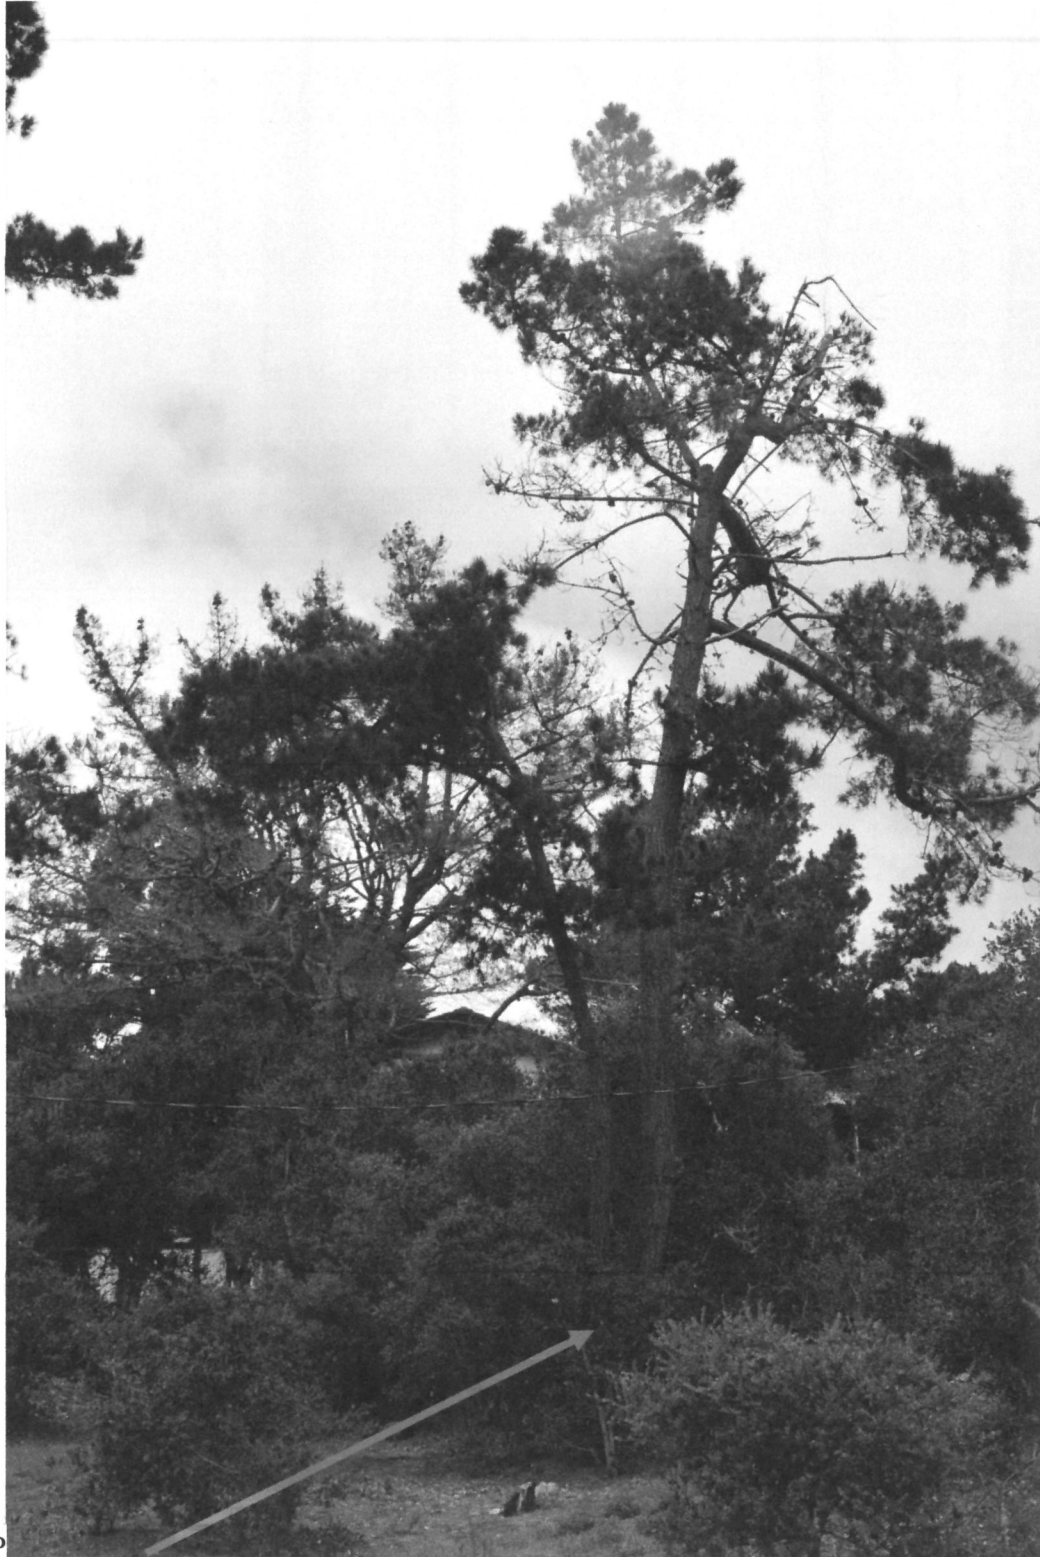
P  
Pine #84 is to be removed

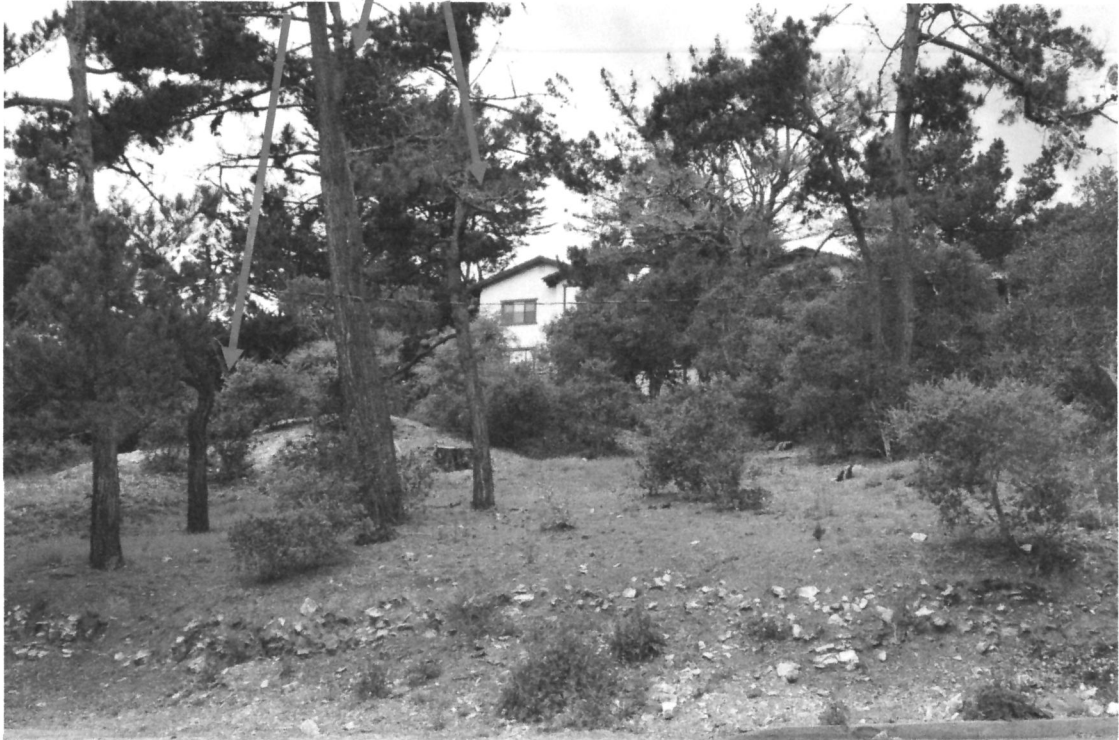
Pines to be removed #69, 70, and 71 and Small oaks behind are to be removed

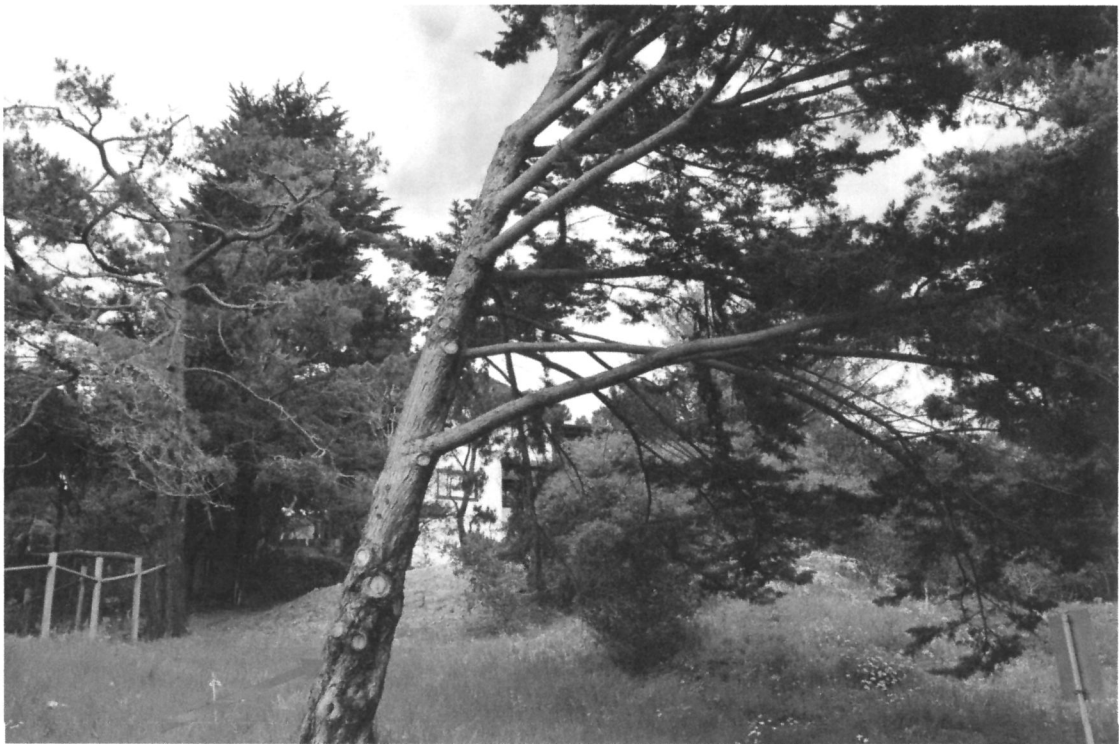
Tree #73 may need pruning of lower limbs
