May 7, 2019

RE: 25710 Rio Vista
APN: 015-052-015-000

Tree Assessment
25710 Rio Vista Drive
Carmel CA

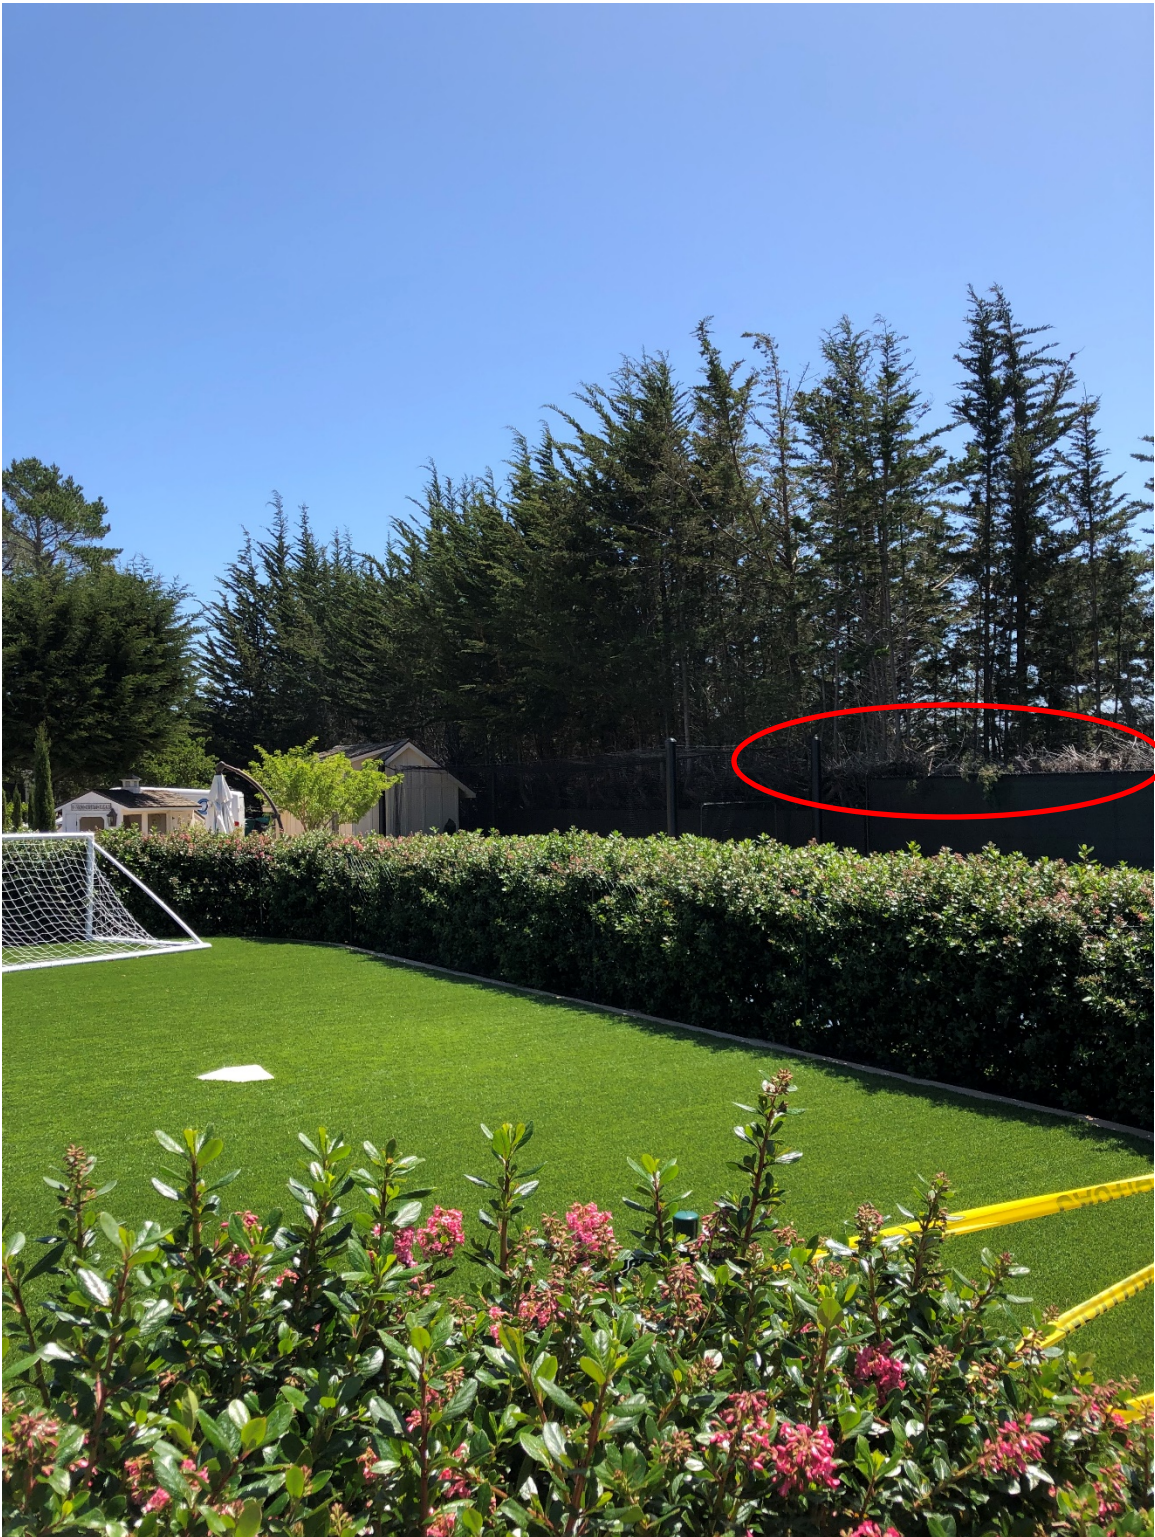
- All but one tree (18" diameter located at the southwest corner) of the 10 trees have been pruned to a point that they will not recover with ample foliage from the exposed wood that remains and should be removed and replaced.

Area of disturbance

There are nine (9) cypress trees located on the 25750 Rio Vista property that shall be cut down by a licensed insured professional tree service, cut down in smaller manageable pieces consistent with safe arboricultural work practices, to grade level. At no time shall the remaining portions of trees to be removed be dropped in one piece so as to damage any surrounding trees or property. Tree wood and clippings are to be disposed of consistent with California Department of Forestry guidelines which would include stockpiling of material on site or disposal at an approved refuse site.

The removal of the trees will be offset by the replacement planting of nine Monterey cypresses planted in between the remaining stumps of where the trees are to be removed. Replacement trees are to be planted in between removed trees, a few feet (2-5) of where the trees have been removed where ample light is found and where water can be supplied for survival.

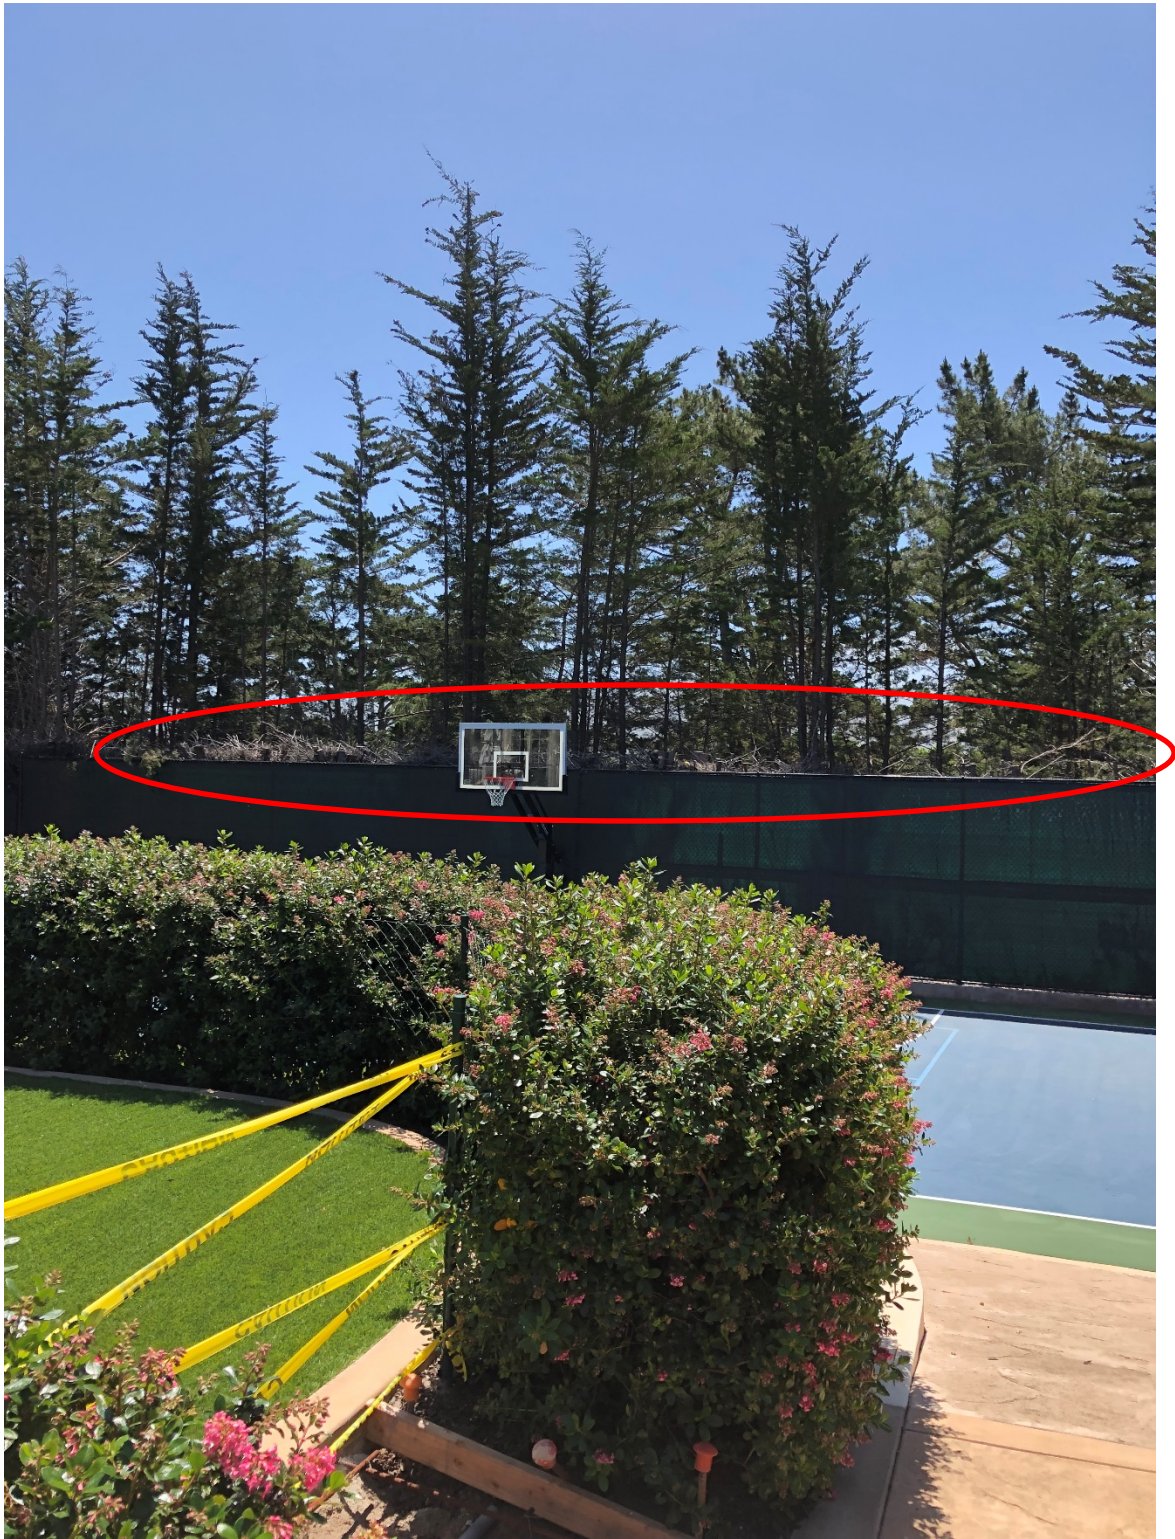
Area of disturbance

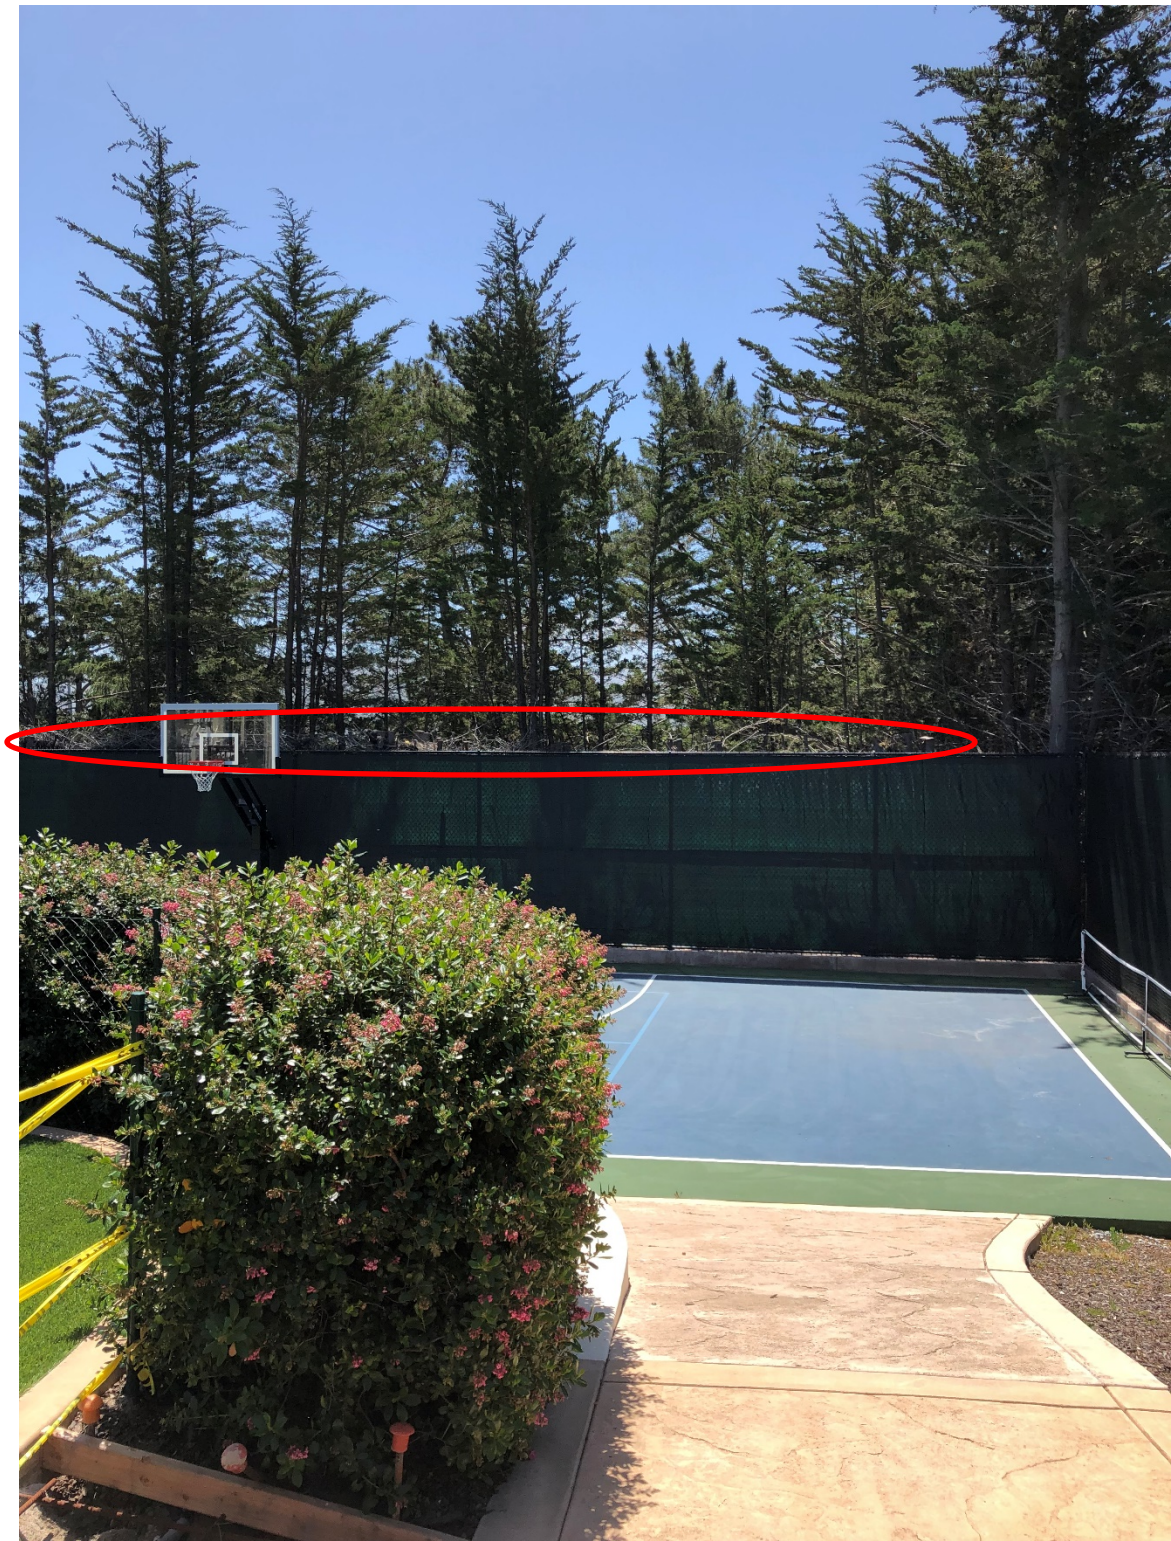
Area of disturbance where trees will be removed, and new trees planted
