CONSTRUCTION IMPACT ANALYSIS
TREE PROTECTION PLAN

SANTA LUCIA PRESERVE LOT E24

Prepared for
Brian and Lorraine Hoekstra

April 2018

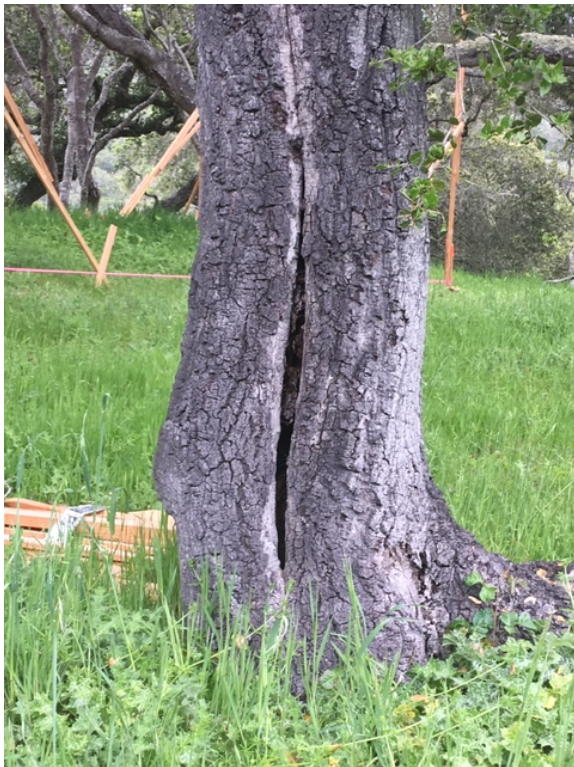
The property is a large site with areas of slope and level ground. The oaks are mix of age classes including a number of young trees clustered at the center of the homeland. The young trees are in fair to poor condition with suppressed canopy development due to the density of the system. Several mature trees display severe structural weaknesses that will lead to whole tree failure. Six trees have been identified as at risk of failure based on a number of structural or health issues. Trees #39 and #88 are pictured below, both trees have significant structural defects.

39	coast live oak	21.6	good	high	20	Remove due to risk of failure. Large fracture in main stem/Remove and plant 3 replacement trees
40	coast live oak	21.8 & 22	fair	high	25	Minor grading proposed within CRZ/Protect with fencing and barricades

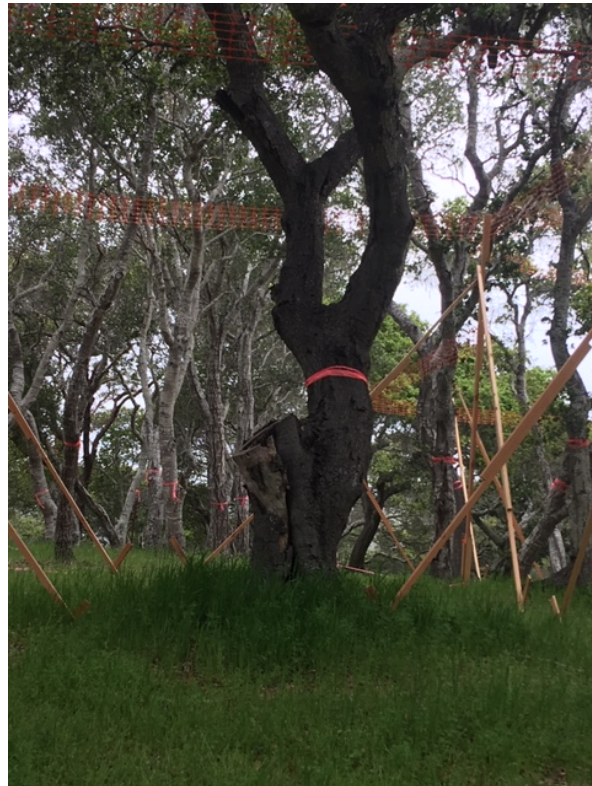
88	coast live oak	16.6	poor	moderate	16	Trunk is completely decayed evidence of previous large branch failure. Tree represents risk/Remove and plant 3 replacement trees
89	coast live oak	17.6	poor	moderate	17	Minor grading proposed within CRZ/Protect with fencing and barricades
90	coast live oak	16.4	fair	moderate	16	Minor grading proposed within CRZ/Protect with fencing and barricades

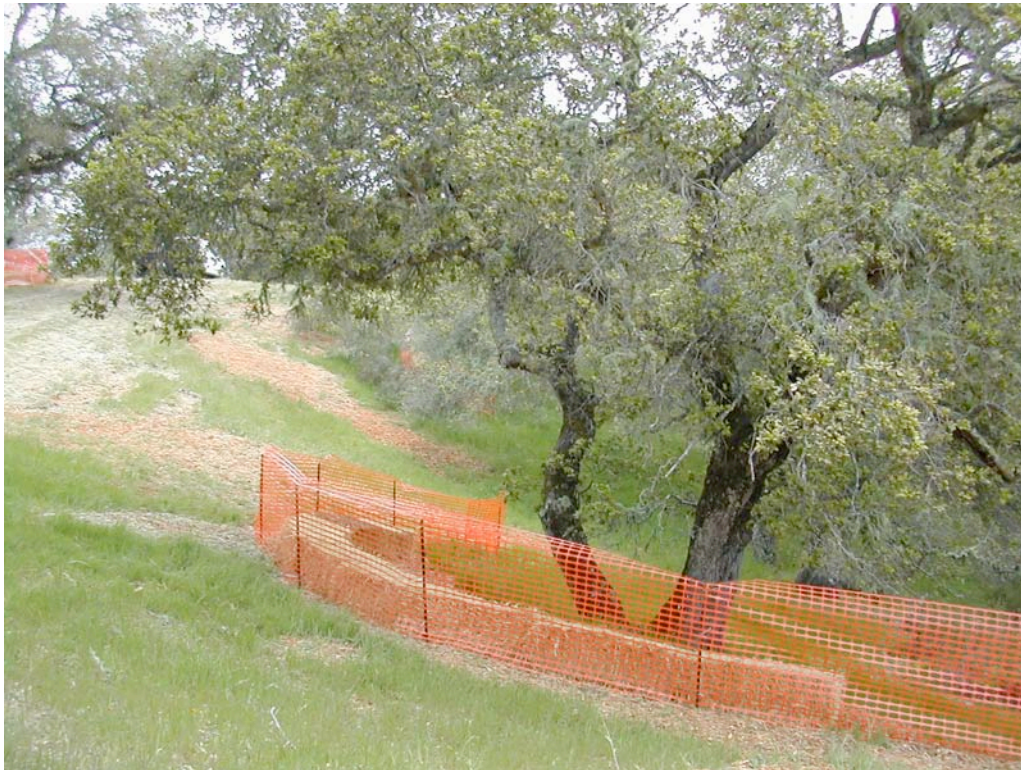
Straw bales placed end to end will be installed inside the protection fencing as shown in the photo below. This barricade will limit damage to the fencing and prevent grading spoils from encroaching into the critical root zone area and help stop excess moisture from gathering under the retained trees.
