# Exhibit D

April 20, 2012  
File: 1039-04altr.doc

Re: Geologic and Geotechnical Evaluation  
Otter House – 30650 Aurora Del Mar  
Carmel Highlands, California

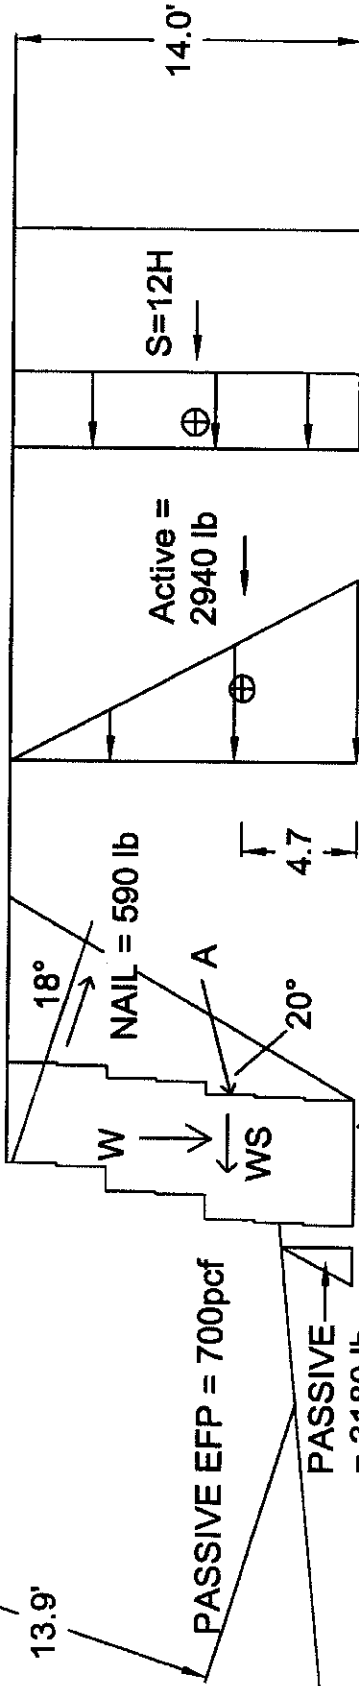
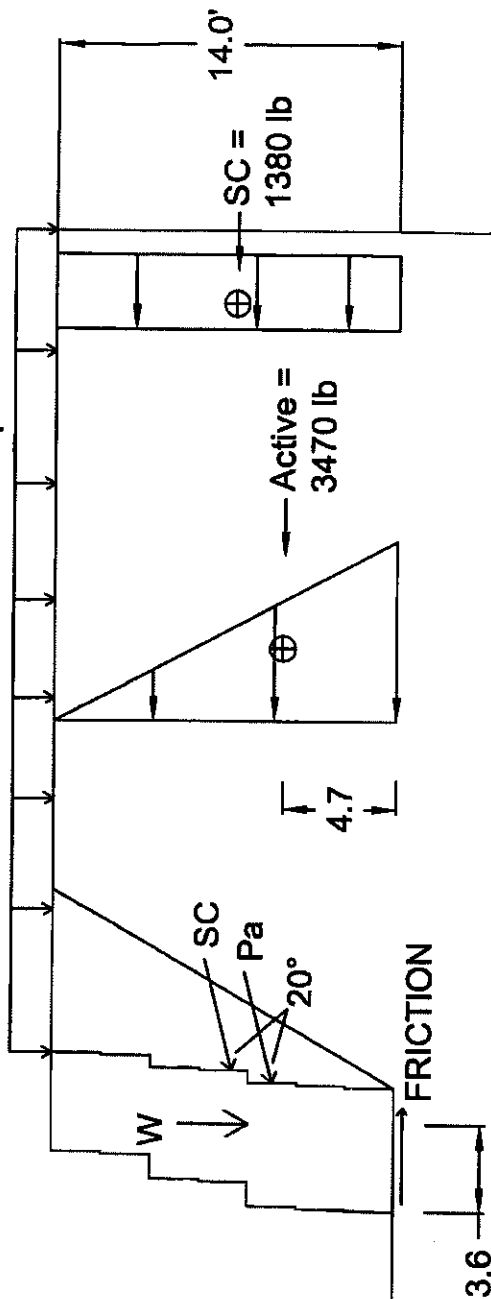
We performed stability analyses of the existing Hilfiker gabion wall on the south (arroyo) side of the Otter House under both static and seismic conditions. Our analyses indicate that, for existing conditions, factors of safety under static conditions are above 1.5 and the Hilfiker wall is stable. Factors of safety under seismic conditions (utilizing a PGA of 0.4g in accordance with our probabilistic seismic hazard analysis discussed in the preceding section) are lower, indicating marginal stability.

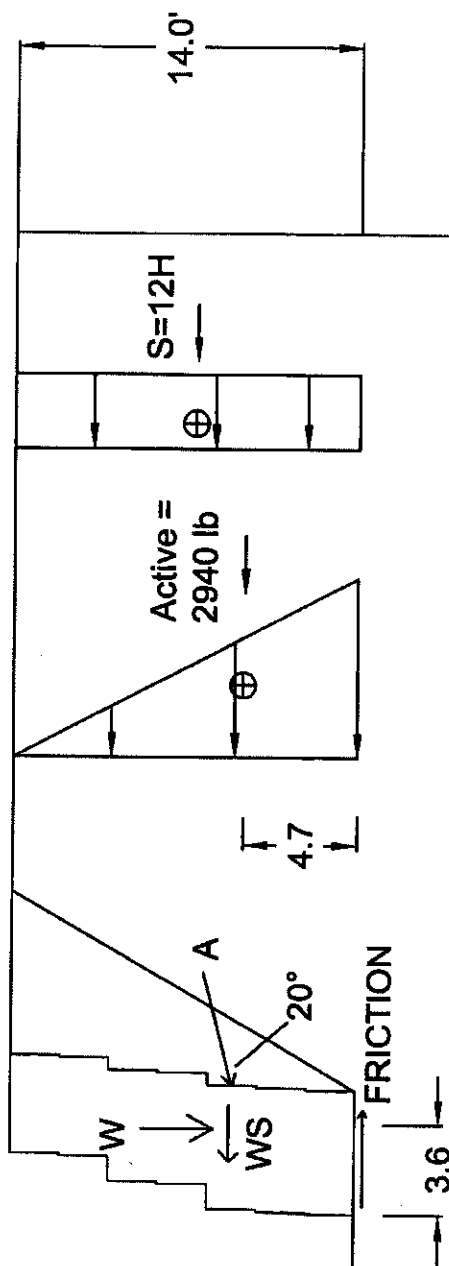
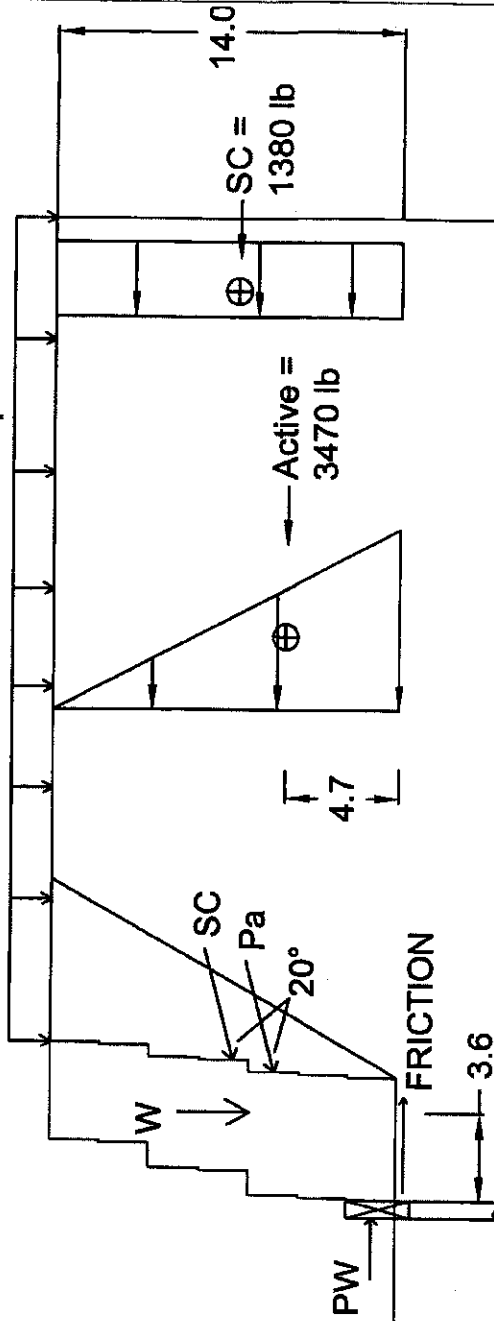
We performed further analyses assuming removal of 3 feet of engineered fill in the arroyo channel. Factors of safety under these hypothetical conditions are reduced to less than 1.0 for both static and seismic conditions, respectively. Removal of the engineered arroyo fill would result in exposure of the base of the wall and increased potential for undermining by channel scour and bank erosion, in addition to the significantly reduced stability. The results of our stability analyses are presented in Appendix A.

Based on the results of our stability analyses, the Hilfiker wall is stable under both static and seismic conditions, but is not stable when the engineered fill is removed. If engineered fill is removed, restoration of wall stability would require construction of a new, 3-foot-high reinforced concrete wall at the base of the existing Hilfiker wall. The new concrete wall would require deep foundations, such as drilled, cast-in-place concrete piers. Additional soil nails near the top of the Hilfiker wall would also be required. We estimate 10-kip capacity soil nails on approximate 6-foot centers would be needed in order to raise factors of safety to above 1.1 for seismic conditions.

If the engineered fill in the arroyo is removed, we recommend that the Hilfiker wall be stabilized by construction of a new, deep-founded reinforced concrete retaining wall at the base of the Hilfiker wall, in conjunction with installation of new soil nails as discussed above. If complete removal of the fill and Hilfiker wall is required, any replacement wall similarly should incorporate deep foundations to mitigate potential instability.

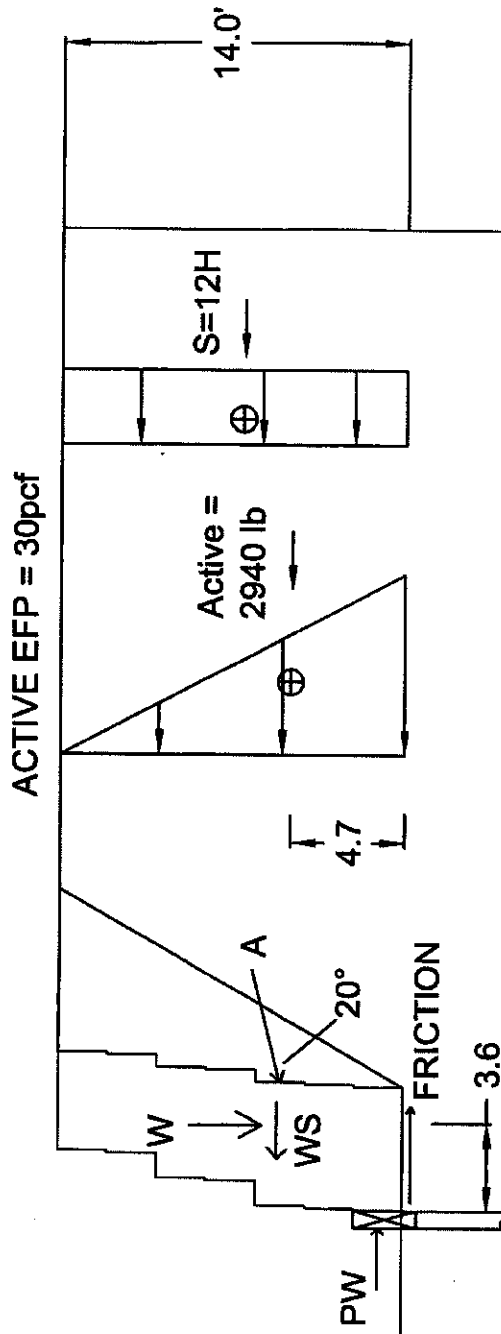
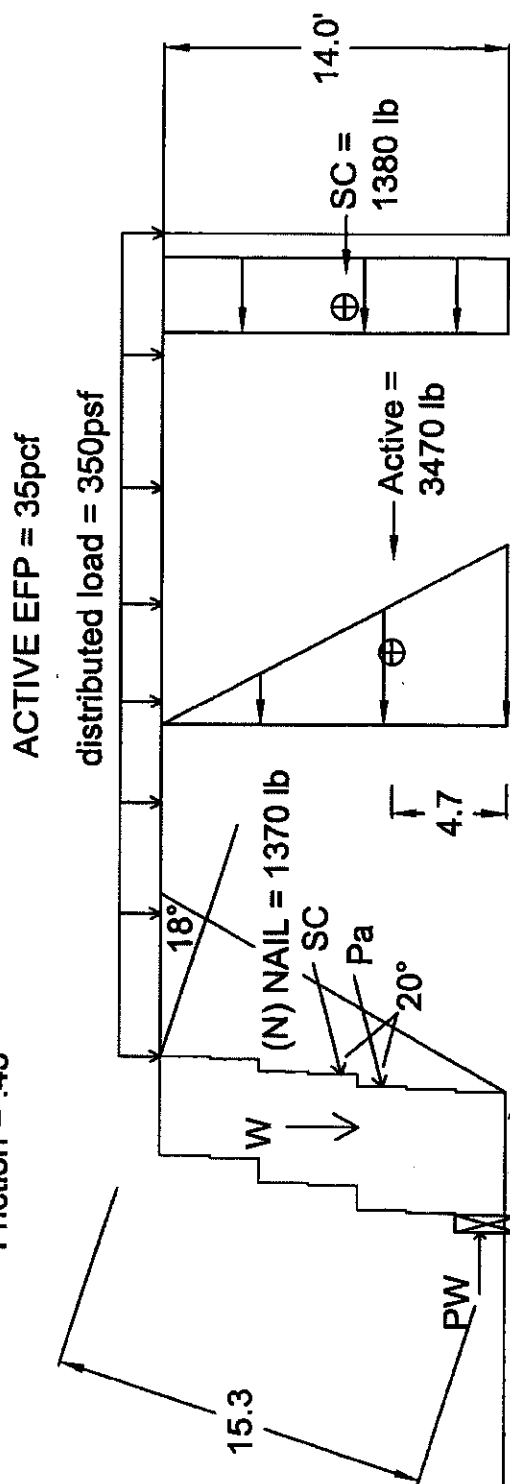
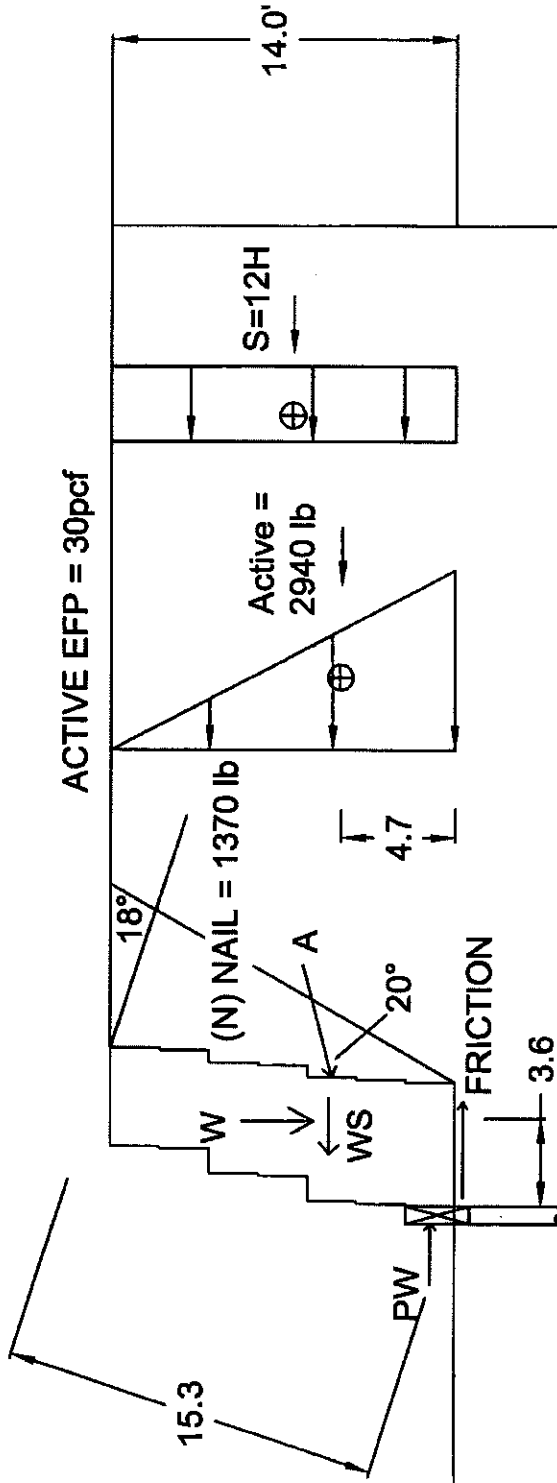
SLIDING  
 RESISTING  
 FRICTION + ACTIVE + PIER WALL  
 $= 7,920 \cdot .45 + 2940 \cdot \sin(20) \cdot .45 + 2530 = 6,550$   
 DRIVING  
 ACTIVE + SEISMIC  
 $= 2940 \cdot \cos(20) + 2350 = 5,110$   
 FACTOR OF SAFETY  
 $6,550 / 5,110 = 1.28$

OVERTURN  
 RESISTING  
 WALL + ACTIVE + PIER WALL  
 $= 7920 \cdot 3.6 + 2940 \sin(20) \cdot 5 + 2530 \cdot 1 = 36,070$   
 DRIVING  
 ACTIVE + SEISMIC + WALL SEISMIC  
 $= 2940 \cdot \cos(20) \cdot 4.7 + 2350 \cdot 7 + 7920 \cdot .4 \cdot 7 = 51,800$   
 FACTOR OF SAFETY  
 $36,070 / 51,800 = .70$
