# **Nacimiento Dam and San Antonio Dam Spillway Condition Assessment**

Chris Moss, P.E.  
Senior Water Resources Engineer

October 16, 2018  
Board of Supervisors Meeting

Nacimiento Dam Spillway Condition Assessment Report, June 2018  
by GEI Consultants, Inc.

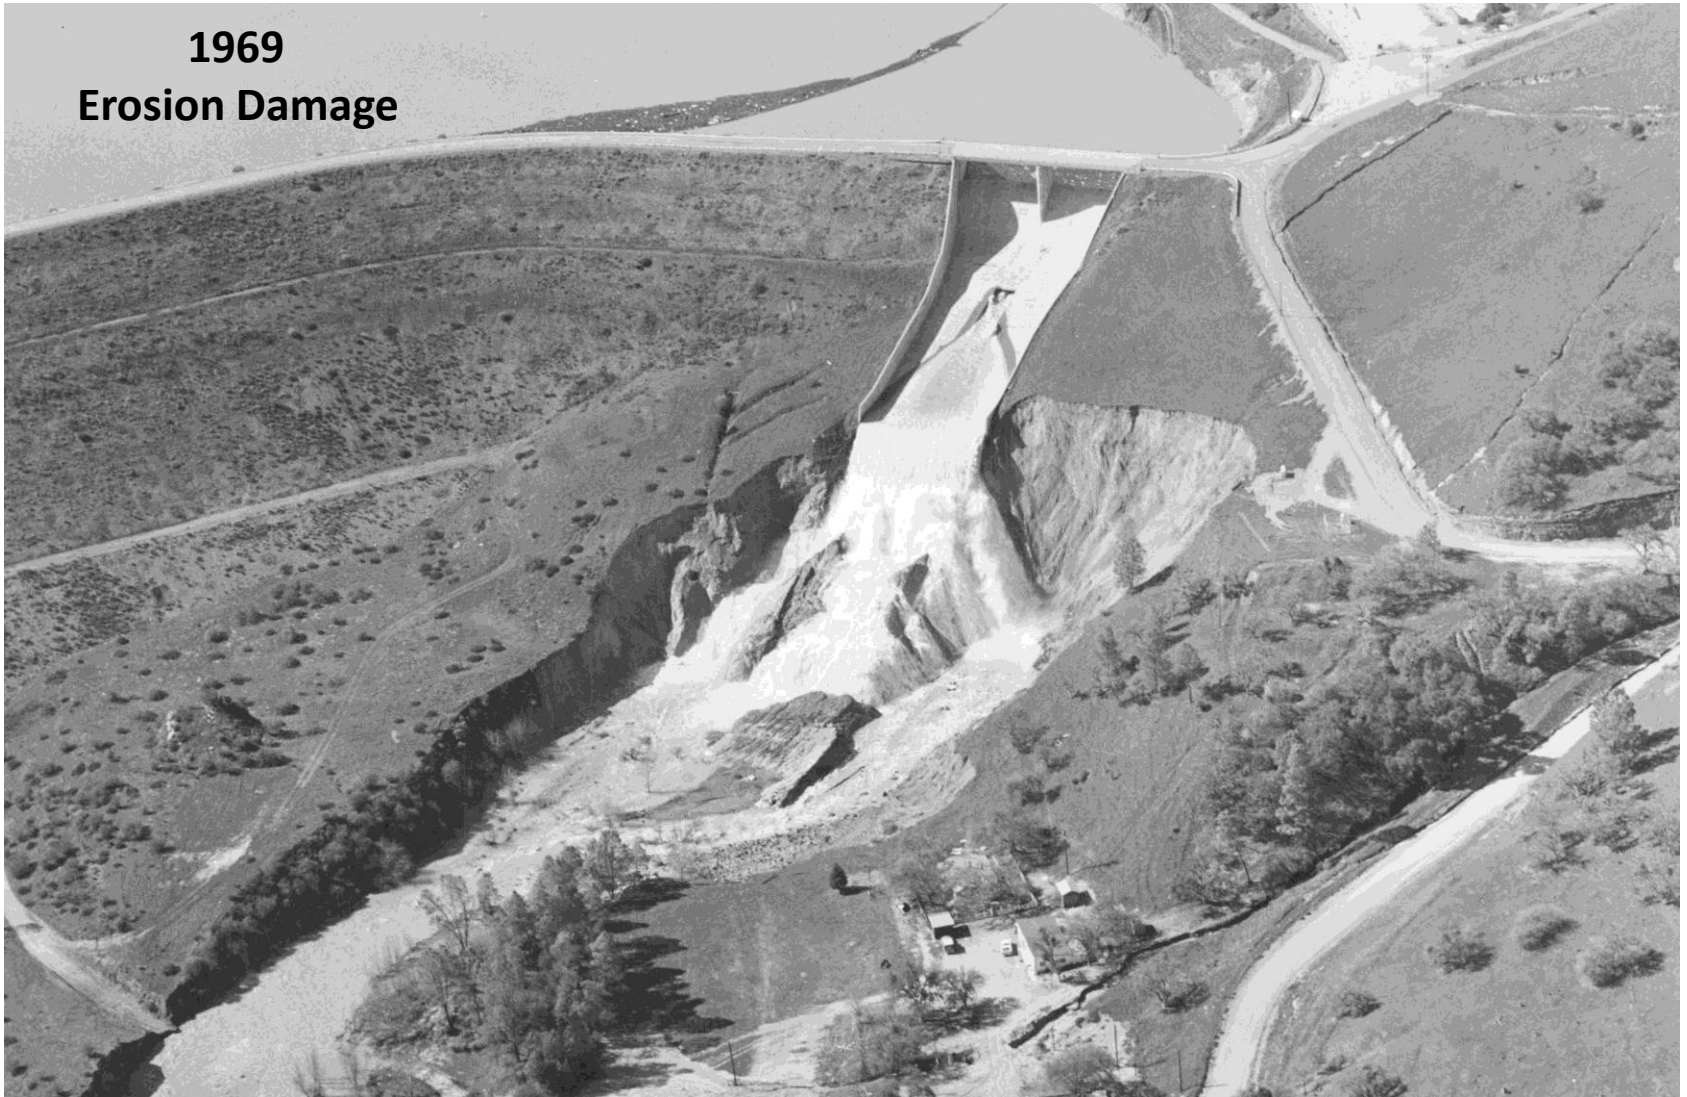
**1969**  
**Erosion Damage**

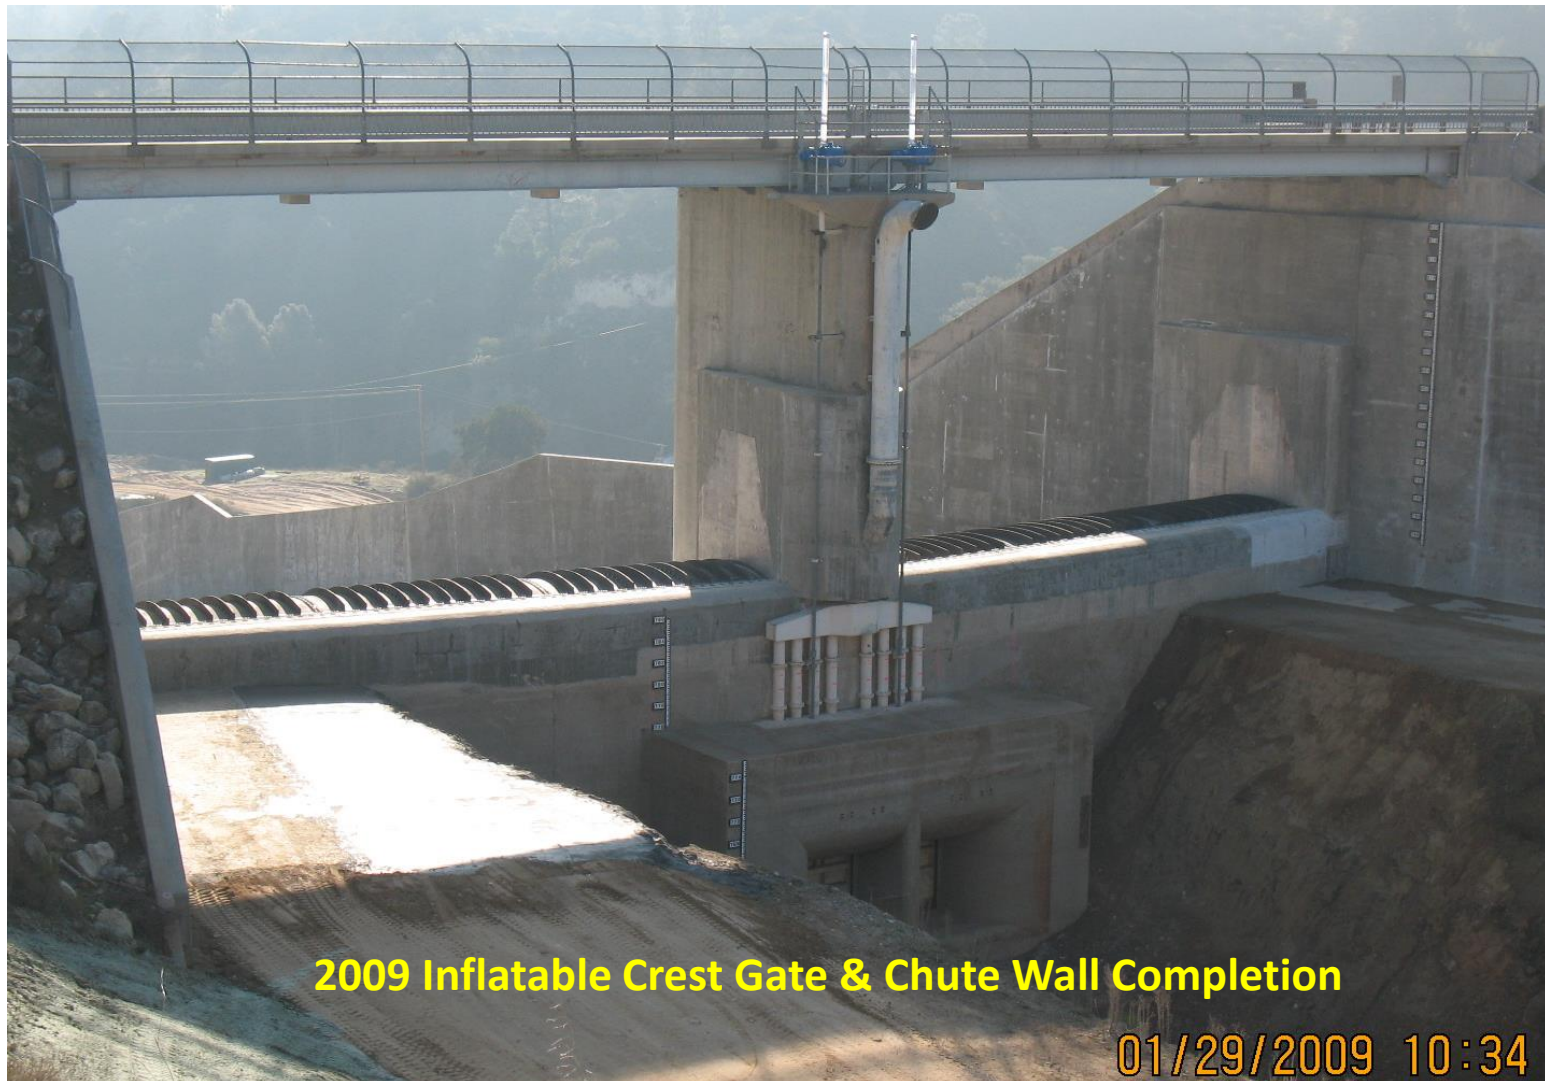
**2009 Inflatable Crest Gate & Chute Wall Completion**

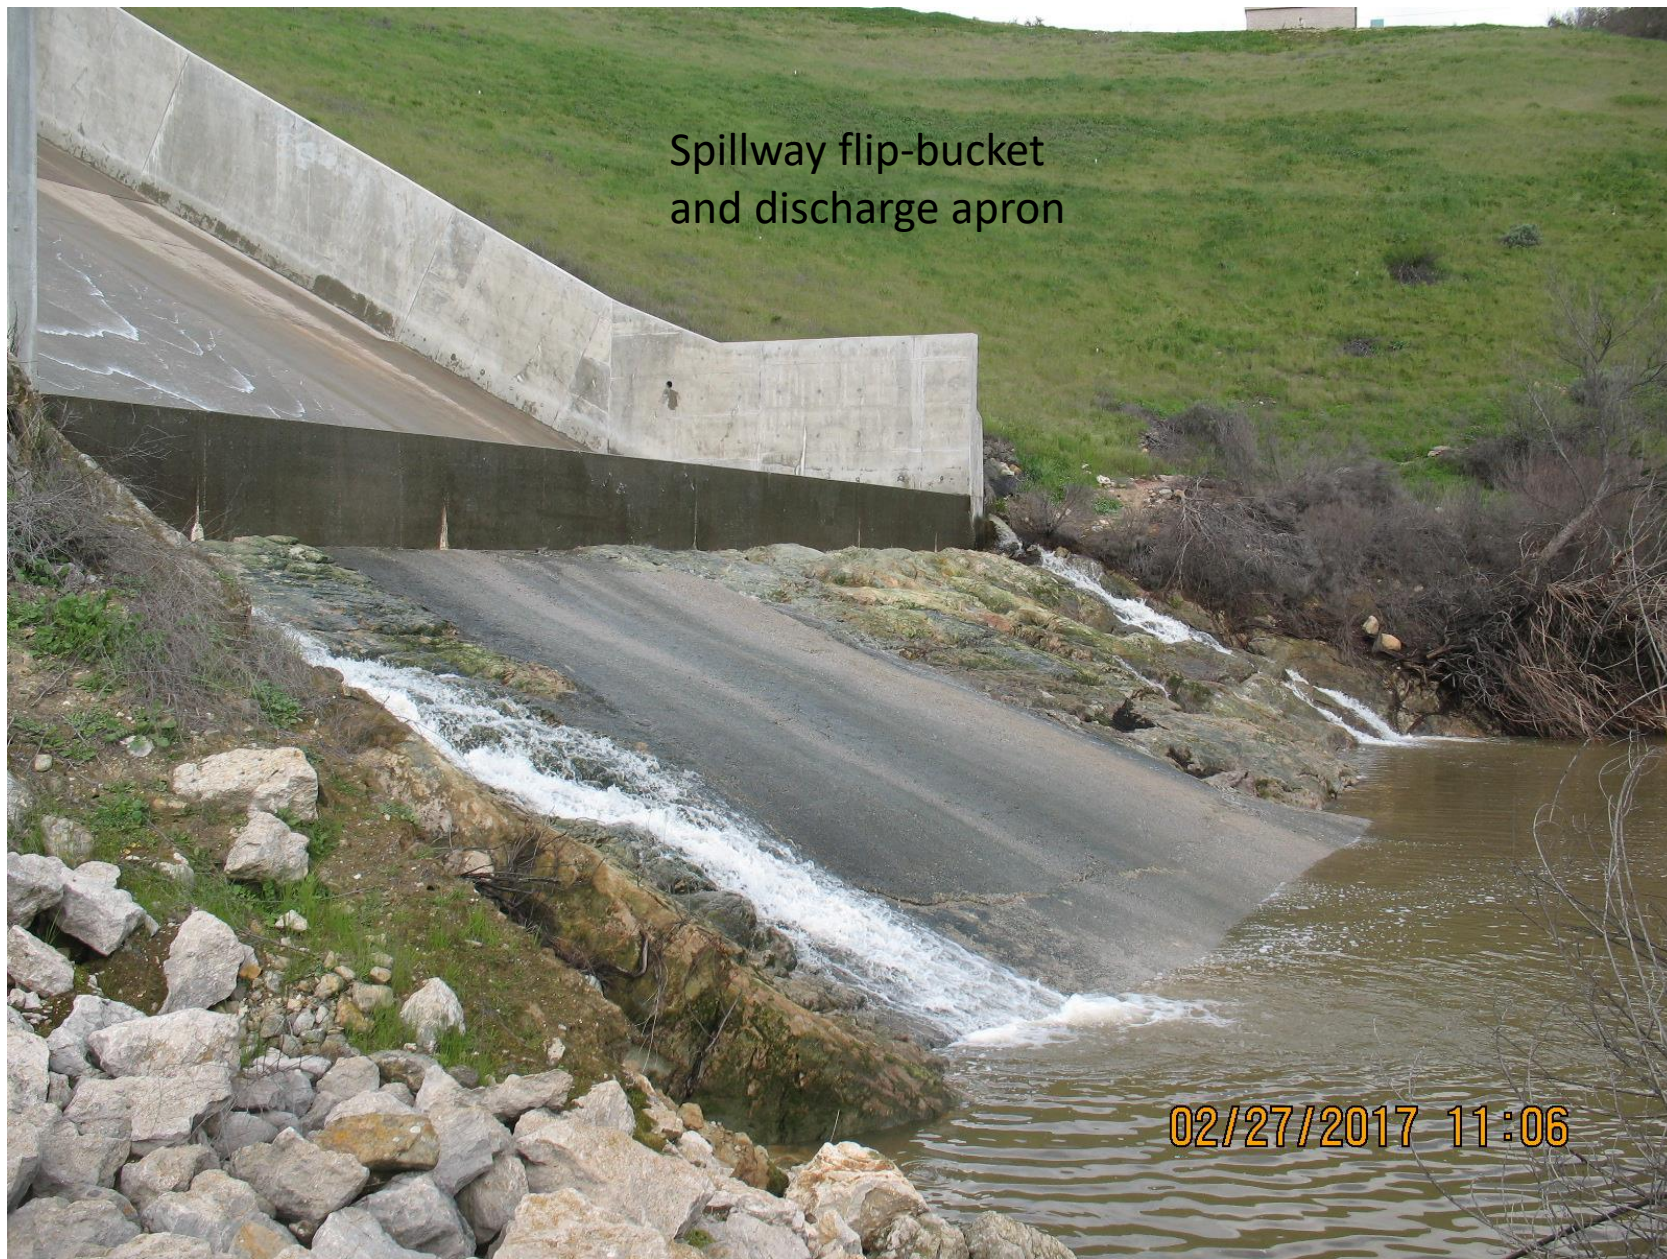
Spillway flip-bucket  
and discharge apron

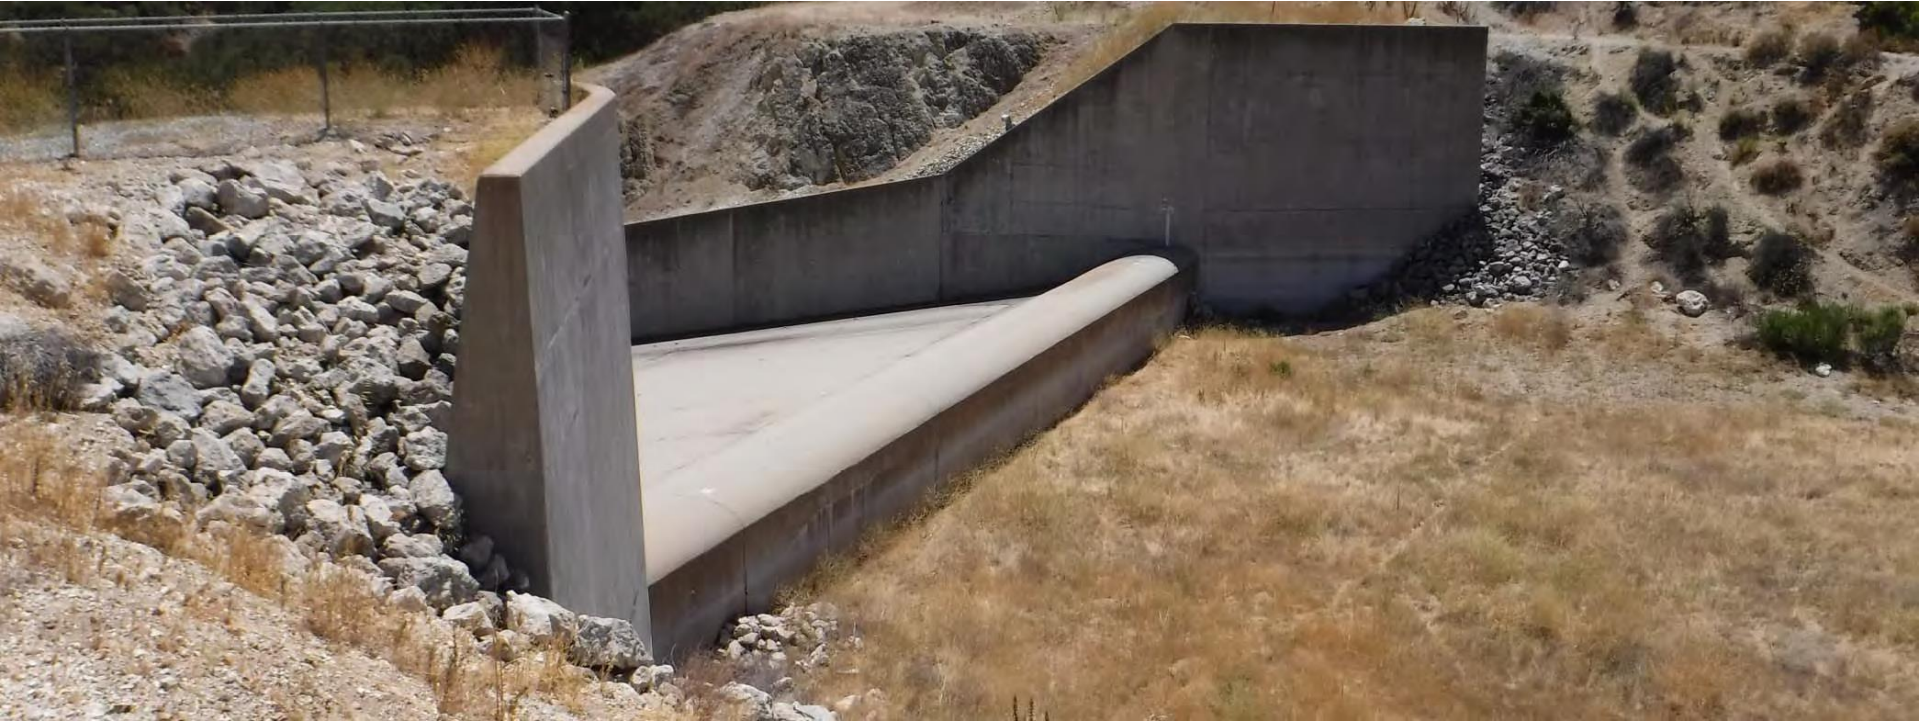
Concrete Ogee Weir

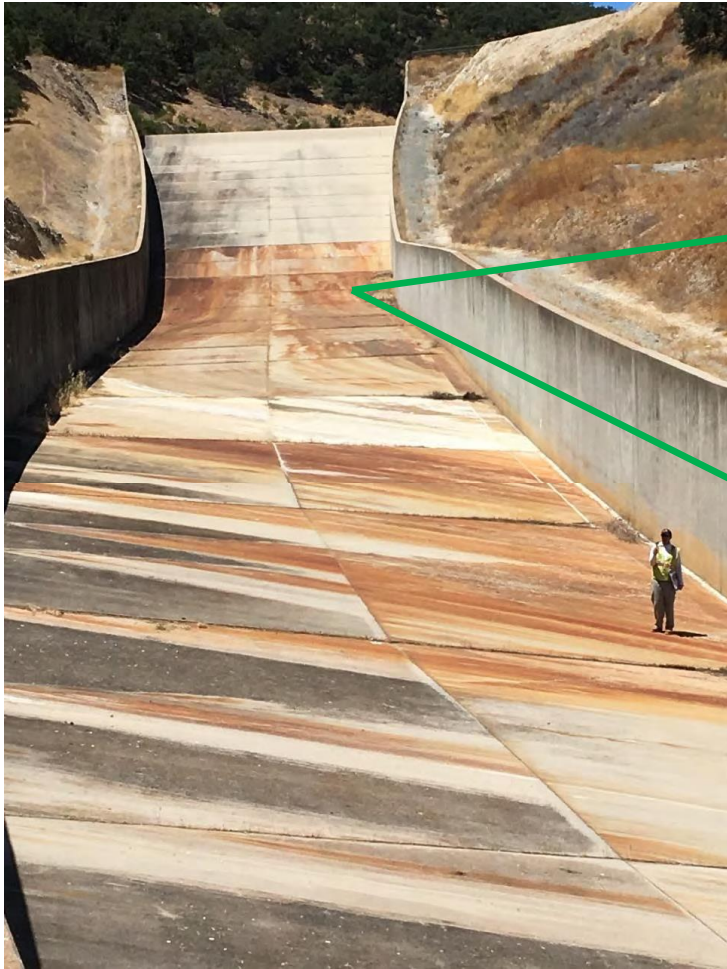
Upstream Portion Spillway Chute

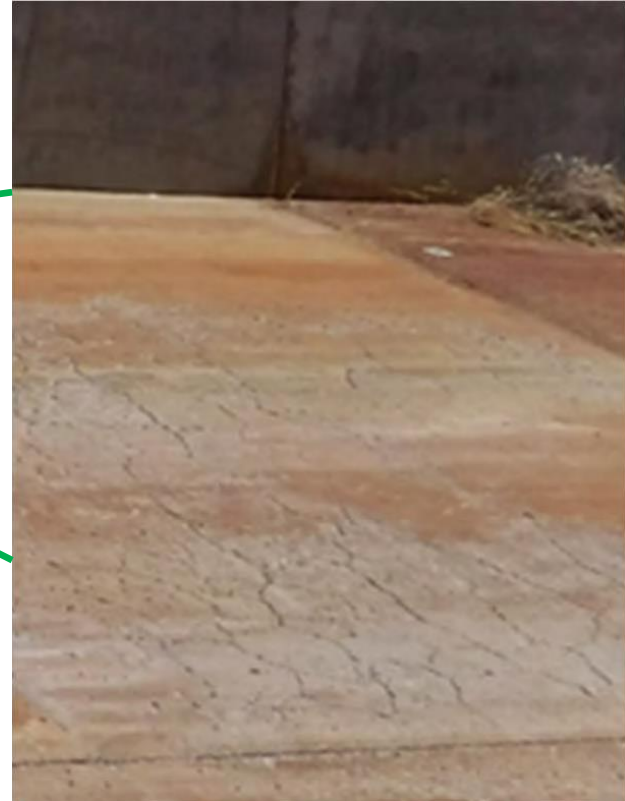
Concrete Degradation due to  
Groundwater Seepage

- R4 – Repair chute slab and wall concrete spalls, delamination, deteriorated locations
  - R5 – (a) Perform water quality testing of seepage water and reservoir water to determine source of seepage water

(b) Determine chemical composition of seepage water for reactivity assessment with concrete
  - R6 – Apply joint sealant to chute walls
  - R7 – Perform stability analysis of chute walls assuming full hydrostatic pressure on back sides of walls (due to clogged drains observed in video survey)

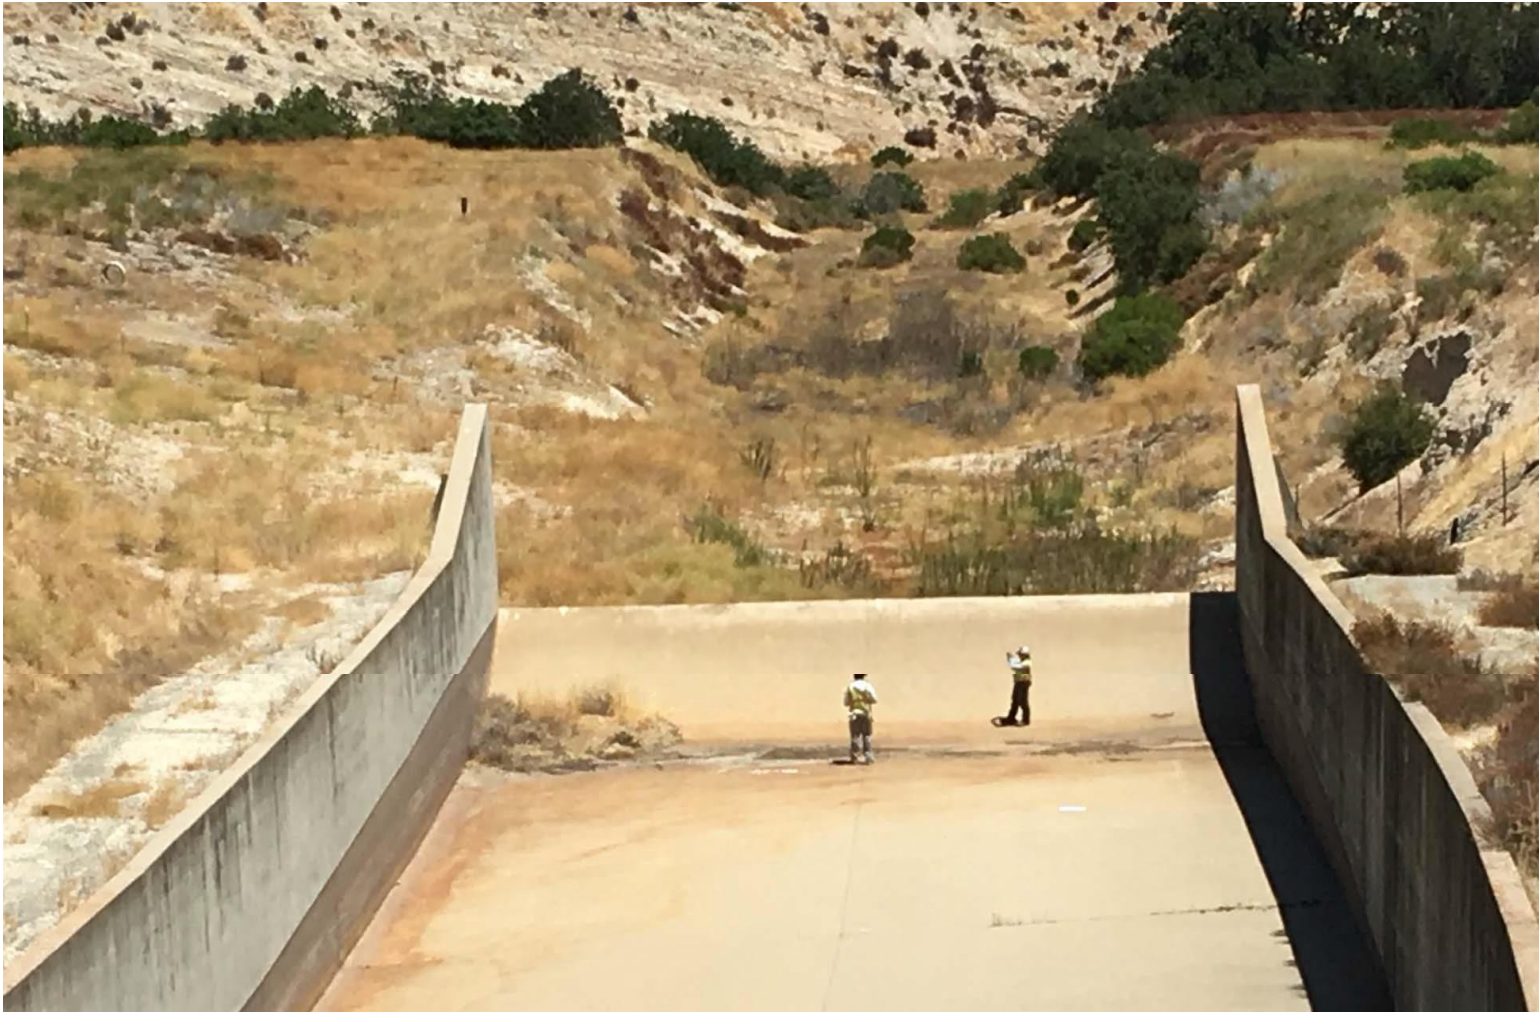
Flip Bucket and Exit Channel

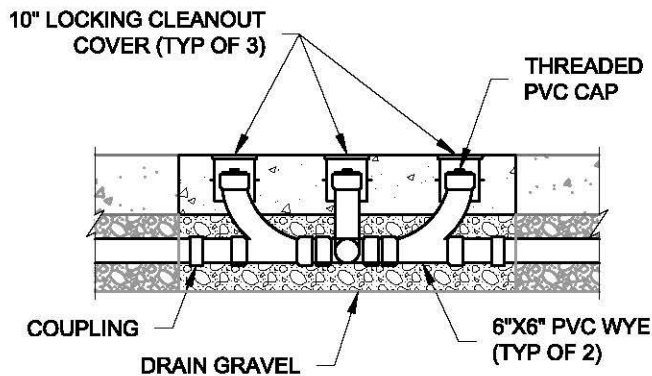
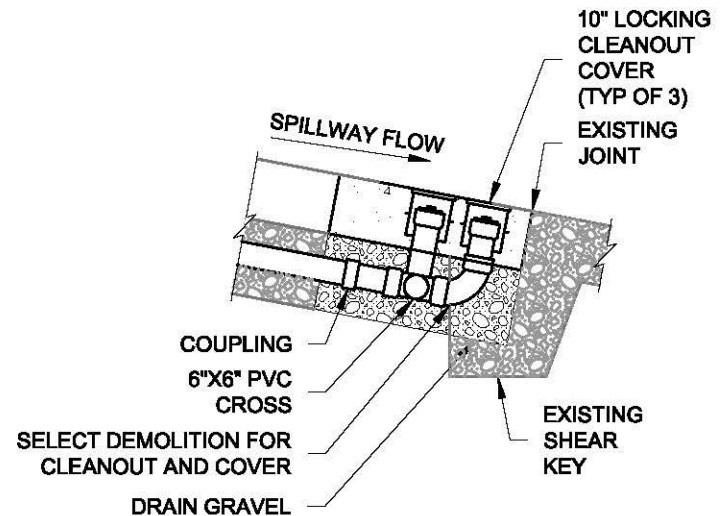
## Underdrain System Access Needed to Determine Functionality

R2 – Determine underdrain system functionality – cut through chute floor to access underdrains (Plan to be submitted to DSOD for approval)

R9 – Repair 10” spillway underdrain pipe near downstream right access manhole
