August 14, 2024

Ms. Tracy Piazza  
58 Mt. Devon Road  
Carmel, CA. 93923  
APN: 241-142-002  
Project File # PLN230339

Subject: 58 Mt. Devon Road Non-Permitted Tree Removal Assessment

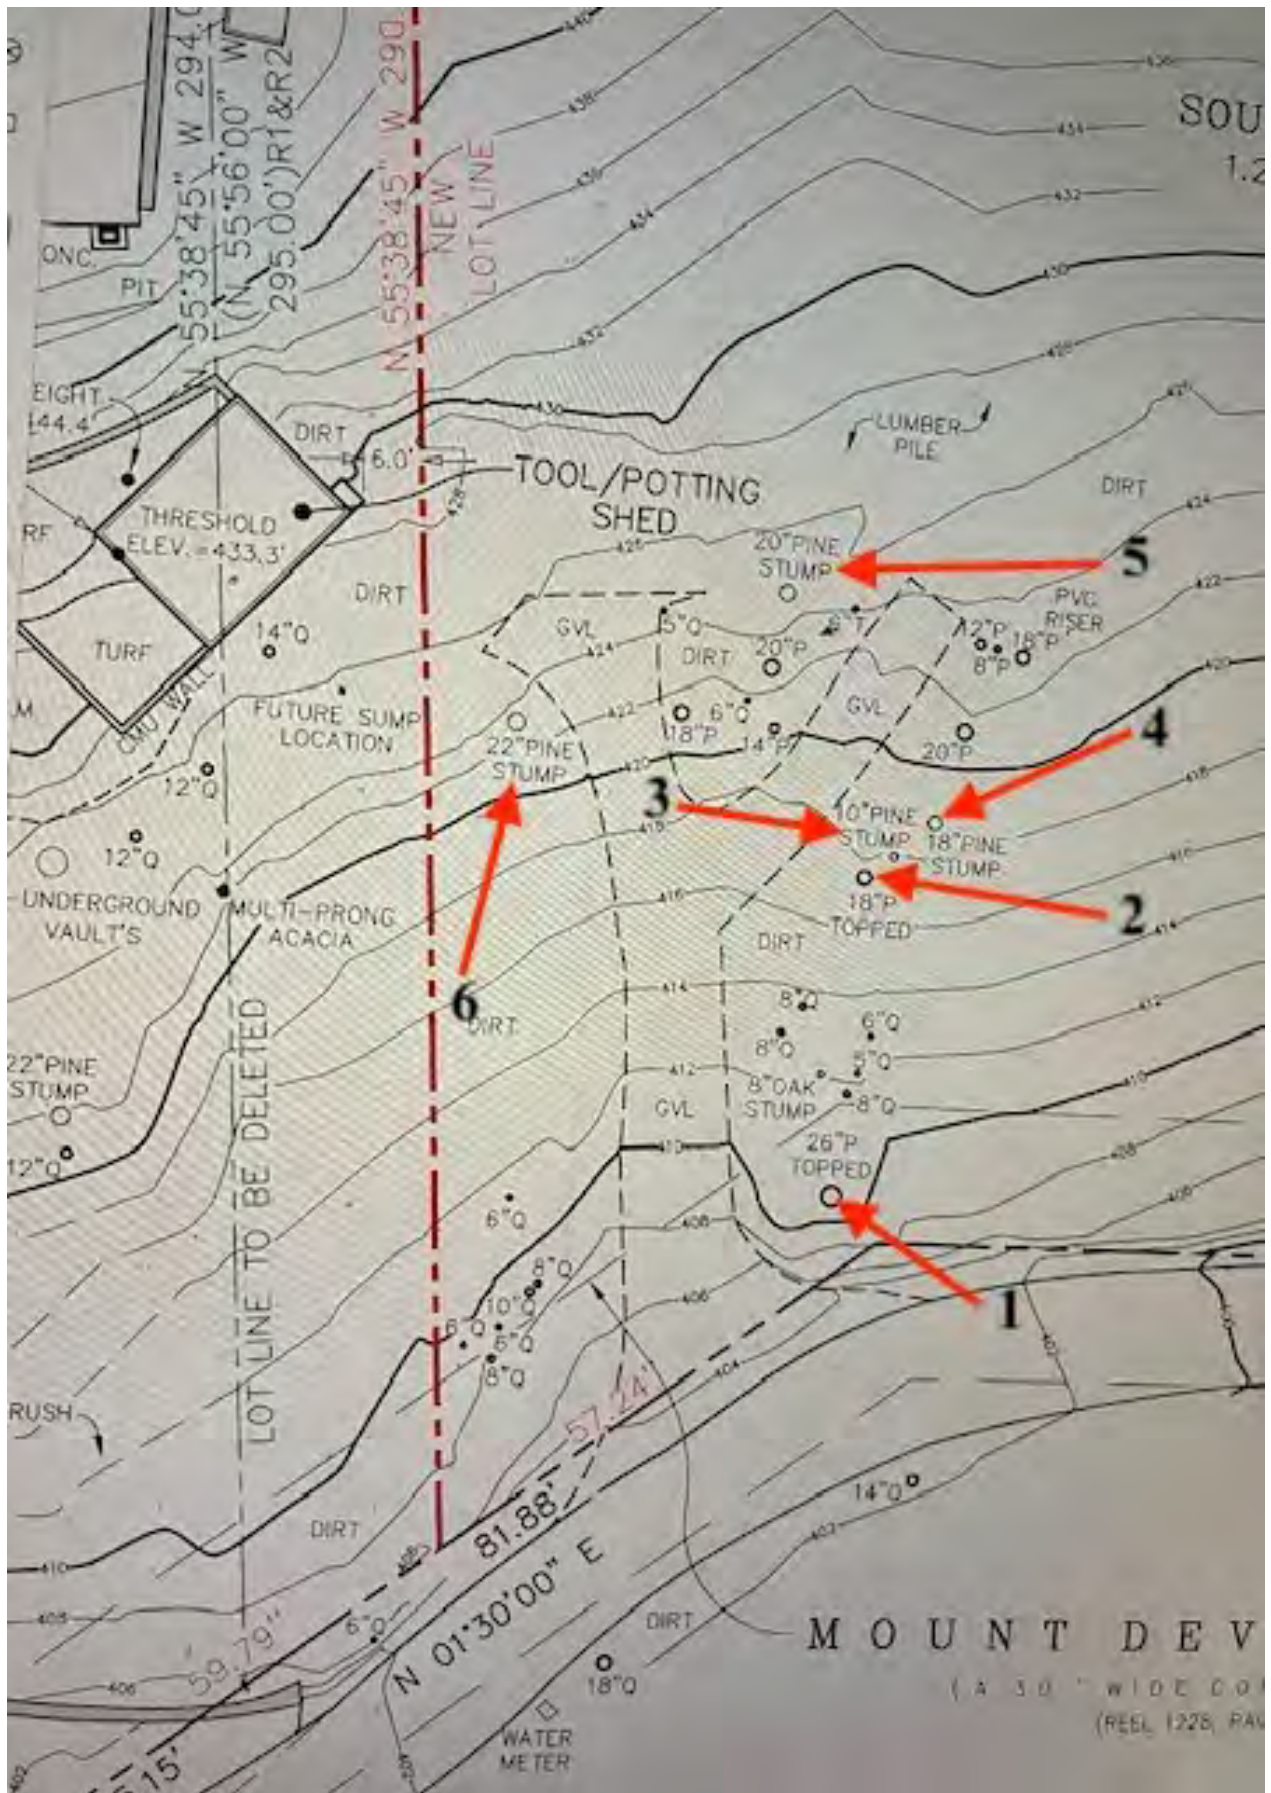
Exhibit A: Tree Removal Location Map shows the location of 6 mature and aging Monterey pine trees (identified as Tree#s 1-6) that were removed from the south parcel without a County tree removal permit.

As a result of tree removal activities, it will be necessary to plant six (6) 5 to 15-gallon Monterey pine seedlings or saplings (a 1:1 replacement ratio) in order to mitigate impacts of non-permitted tree removal and to satisfy Monterey County tree removal permit requirements. The 6 replacement plantings shall be planted in suitable and appropriate locations on the subject parcel (there are several suitable planting locations to choose from) using proper tree planting methods and best management practices (BMP's). Additionally, these 6 Monterey pine replacement plantings shall be properly cared for and maintained to assist in healthy establishment and maturation, and will be required to survive a 1-year monitoring period to satisfy Monterey County tree removal permit conditions.

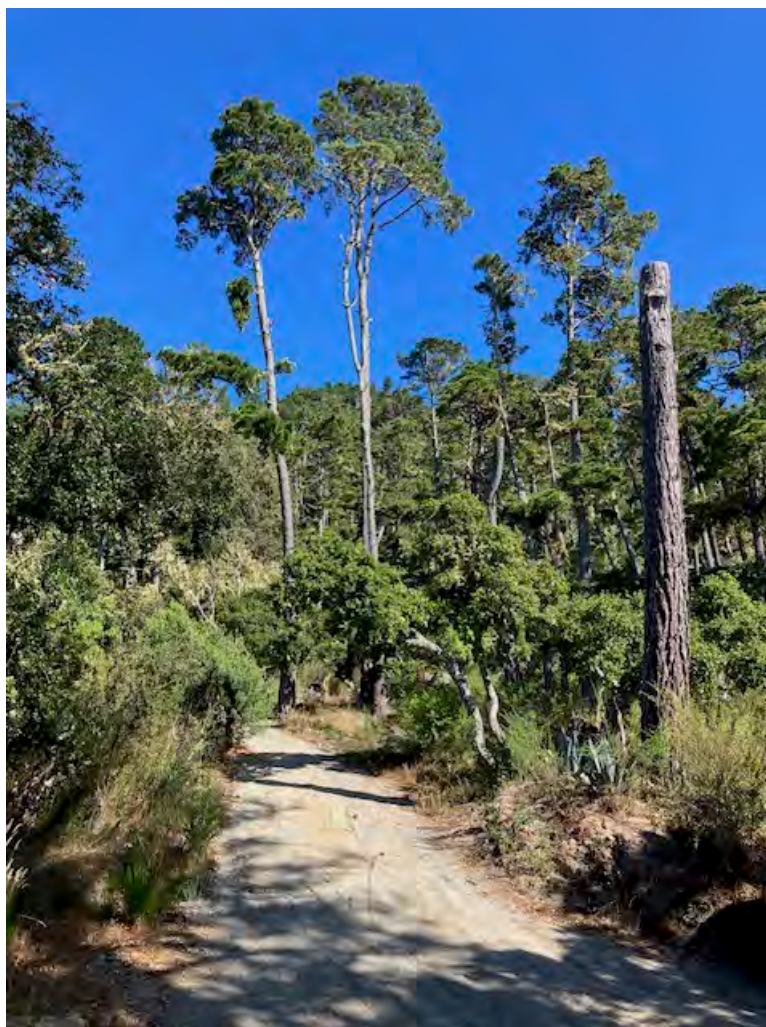
It should be noted that the remaining stumps have some wood rot and decay, which indicates that they may have been significantly declining, or perhaps dead, and/or structurally unsound and compromised at the time of removal; however, there is not enough wood decay and deterioration to conclusively say that the 6 subject pines were dead, significantly declining and/or structurally unsound when they were removed. While, based on the current evidence available, it can not be concluded that the subject pine trees were dead and hazardous at the time of removal, in my professional opinion, it is likely that these 6 pines were in declining health and condition when they were

removed, which is based on the current condition of the remaining 2 stems/snags (*Tree#s 1 & 2*; refer to *Figures 2 & 3*) and 4 stumps (*Tree#s 3-6*; refer to *Figures 4-7*).

Figure 2. Unpaved entrance to the south parcel. The pine stem/snag identified as Tree#1 is near right edge of photo.

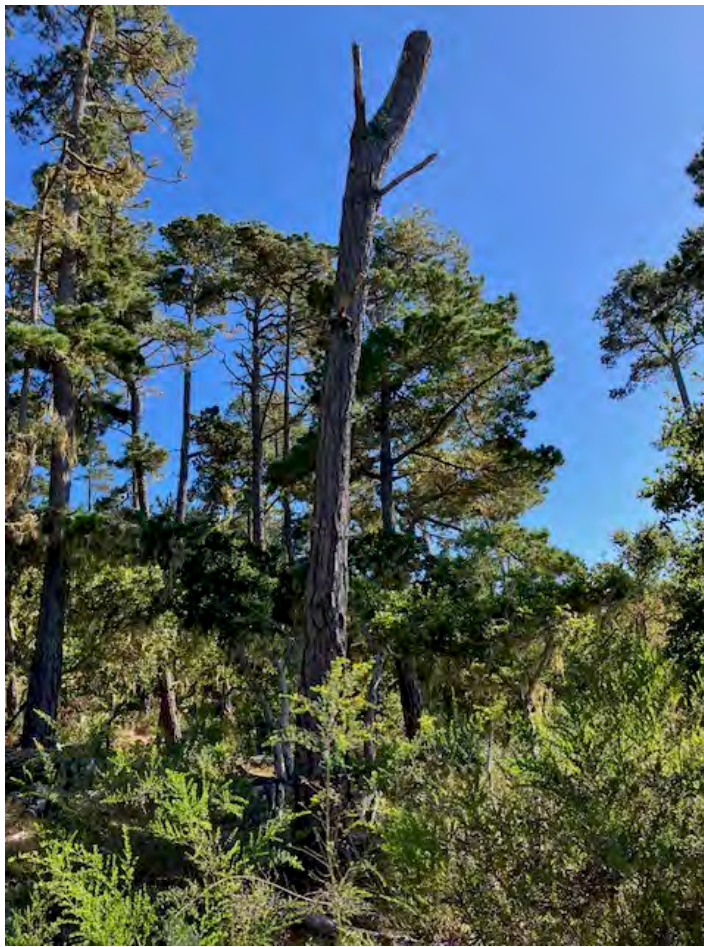
Figure 3. The other pine stem/snag identified as Tree#2 that was removed without a permit is in center of photo and is surrounded by non-native invasive French broom.

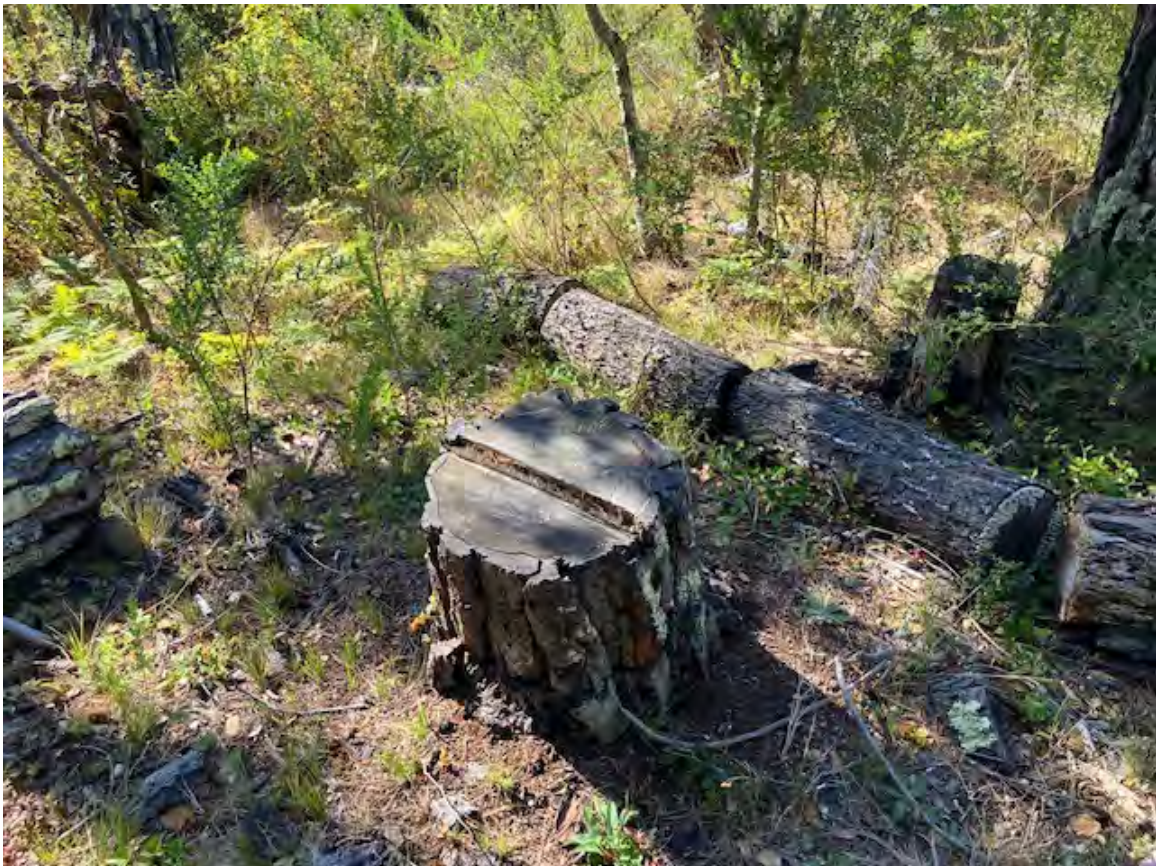
Figure 4. Pine stump identified as Tree#3 was removed without a permit.

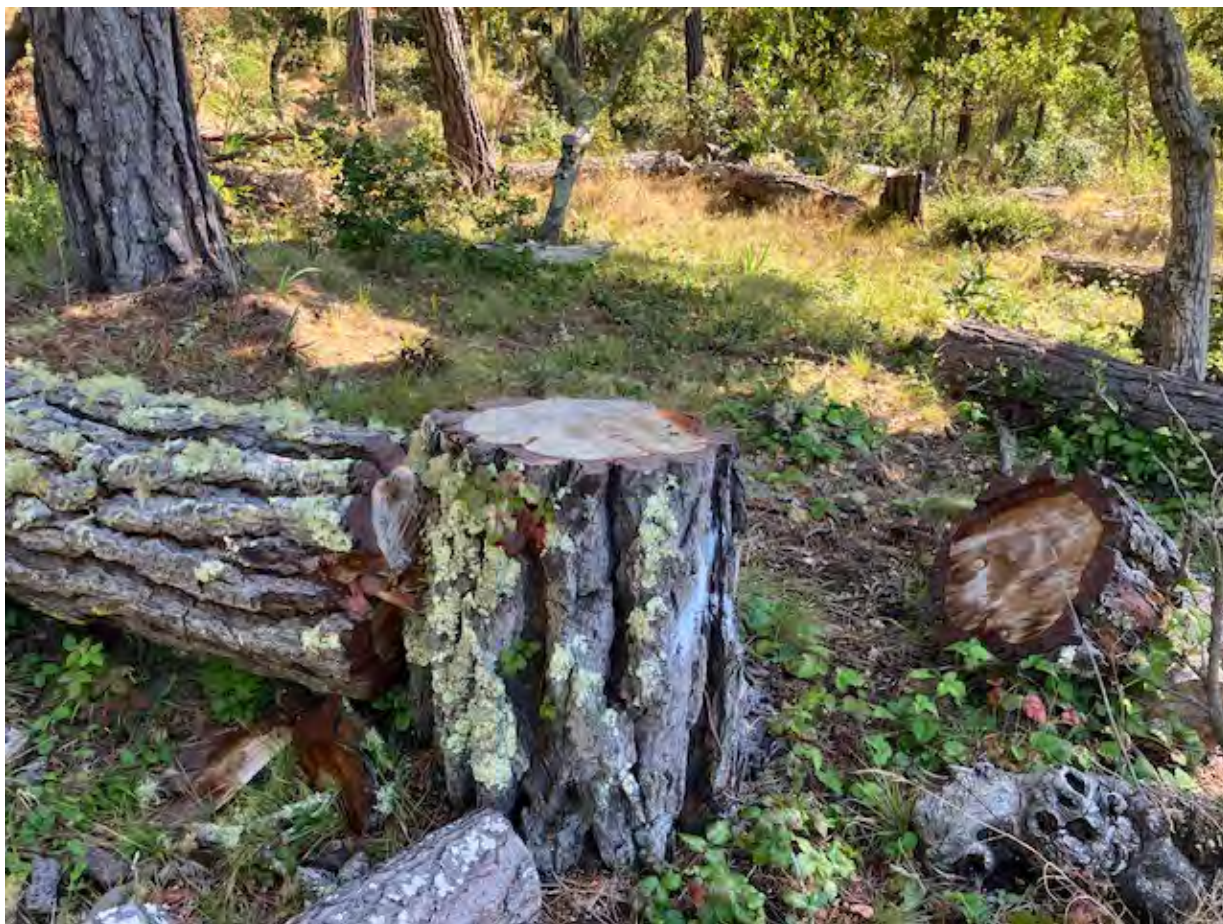
Figure 5. Pine stump identified as Tree#4 was removed without a permit.

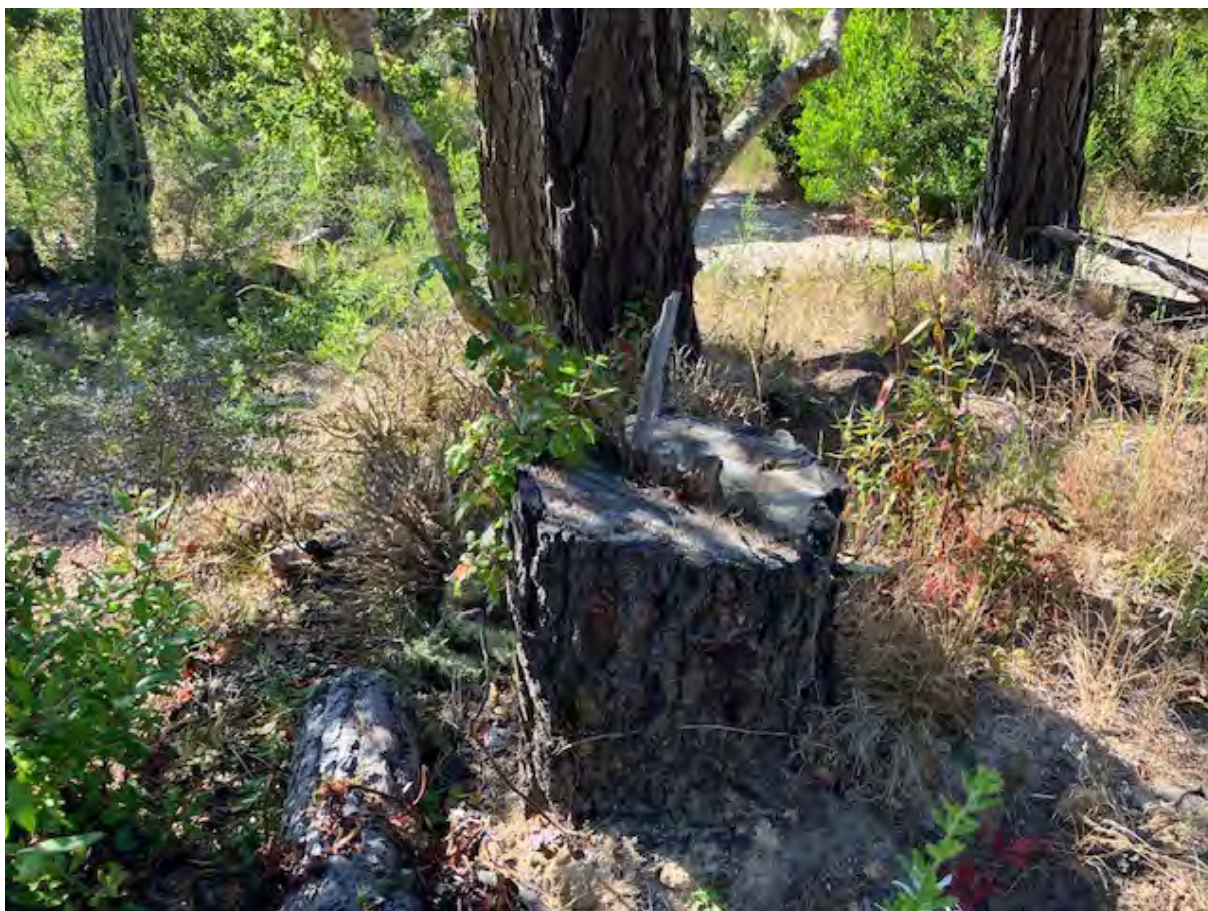
Figure 6. Pine stump identified as Tree#5 was removed without a permit.

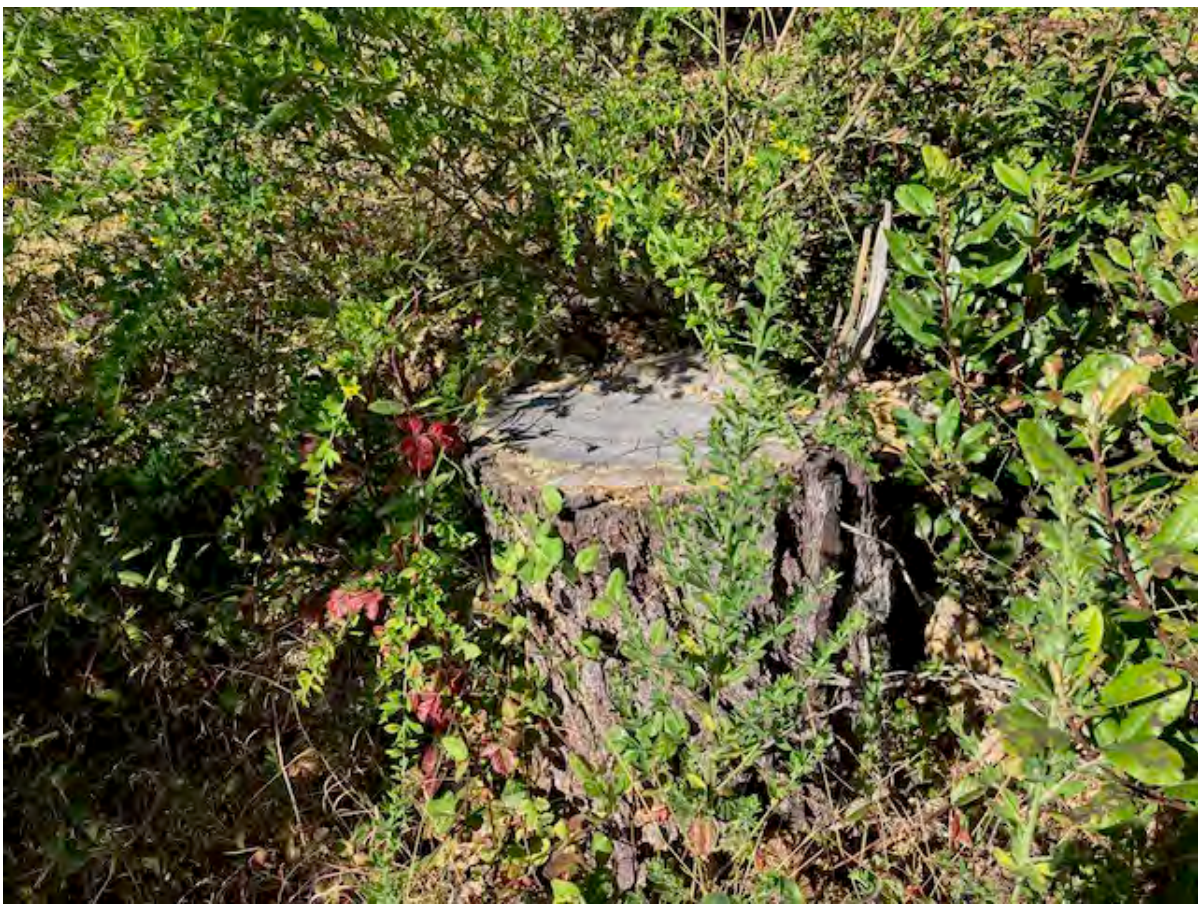
Figure 7. Pine stump identified as Tree#6 was removed without a permit.

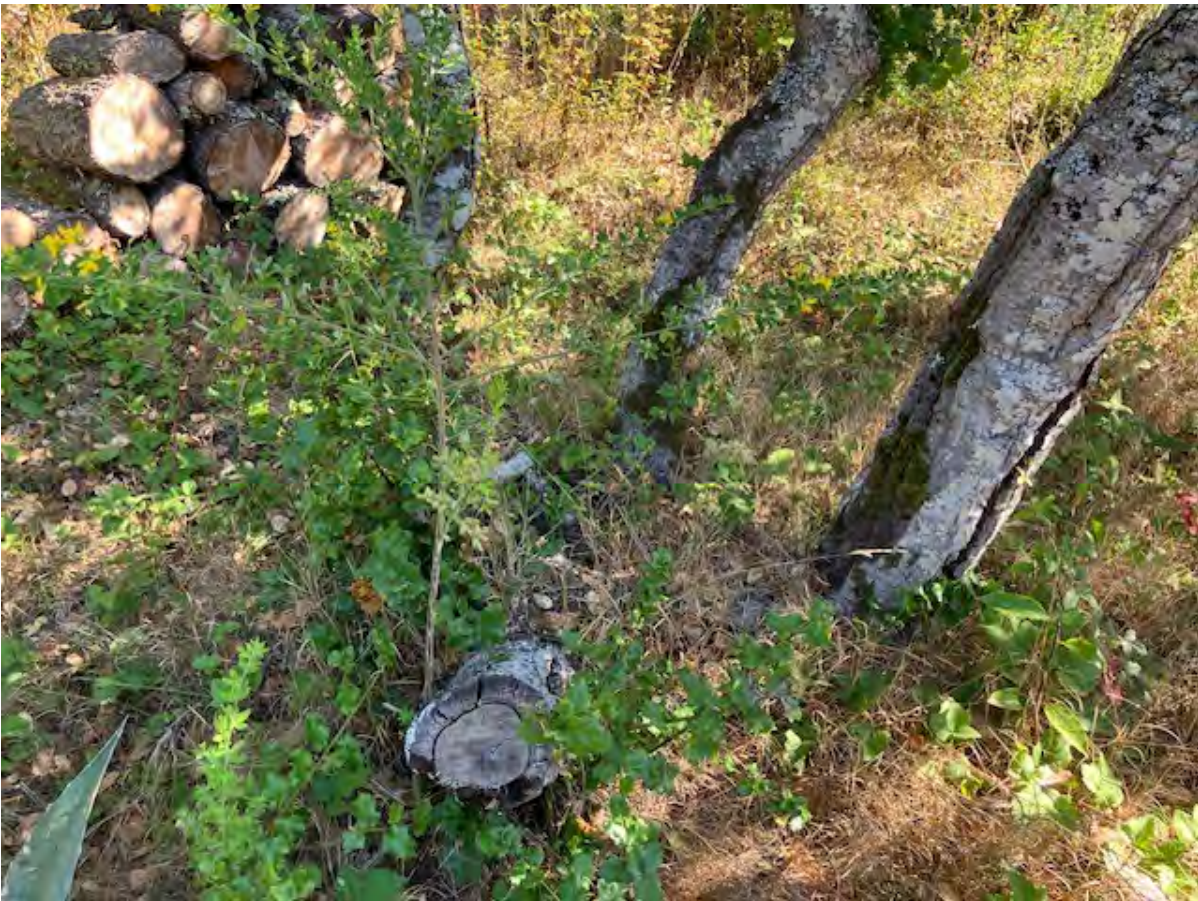
It should also be noted that a 8 inch oak stump identified on the *Exhibit A: Tree Removal Location Map* (located near the pine stem/snag identified as *Tree#1*) is actually less than 6 inches diameter, so no tree removal permit was required and the removal of this oak is not considered a violation (refer to *Figure 8*).

Figure 8. Oak stump identified on the parcel map and tree removal map is less than 6 inch diameter and no tree removal permit or mitigation planting is required.

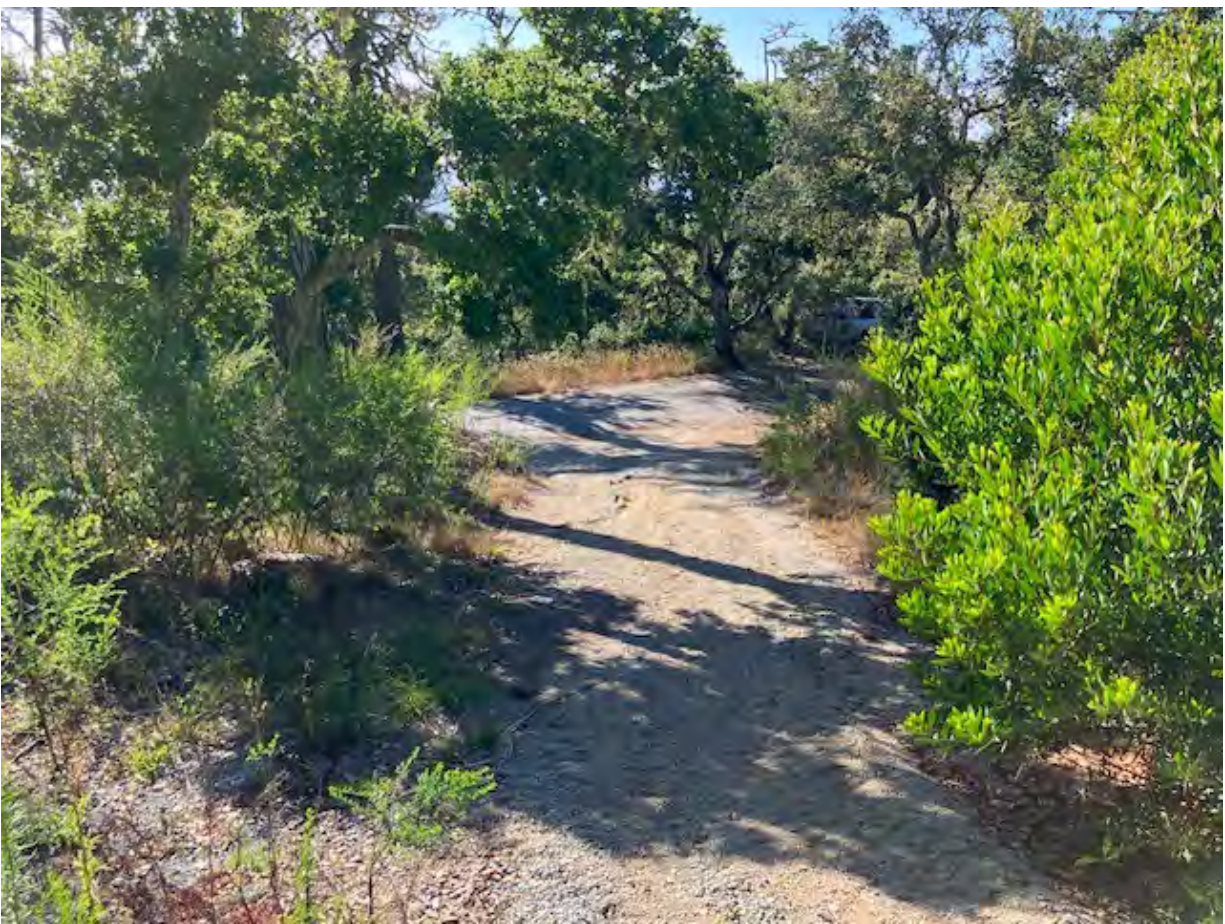
Figure 9. Unpaved gravel entrance to south parcel is surrounded by an abundance of non-native invasive French broom and acacia.
