This intent of this letter is to bring you up to date on the permitted discovery work under way at the historic Fan shell House, by noted American architect Mark Mills, located at 3137 17 Mile Dr., in Pebble Beach (APN# 008-263-001. The subject property was constructed in 1972. Constructed of slump stone blocks, the houses is segmental in design, taking a taking the form of a scalloped seashell, l in an arc shaped footprint, West to Northwest, just above the Pacific Ocean. The buildings style is Organic Modern. The structure has five bays, with massive glass windows framed with vertical steel members, piercing the roof and bolted in place. The radiating walls are set directly on the sand dunes.

Fanshell House • 3137 17 Mile Drive • Pebble Beach, California
Repair & Maintenance – August 2024

DESIGN REVIEW PHOTO SUBMITTAL- FANSHELL HOUSE

DOWLER RESIDENCE
3137 17 MILE DRIVE
PEBBLE BEACH, CA 93953

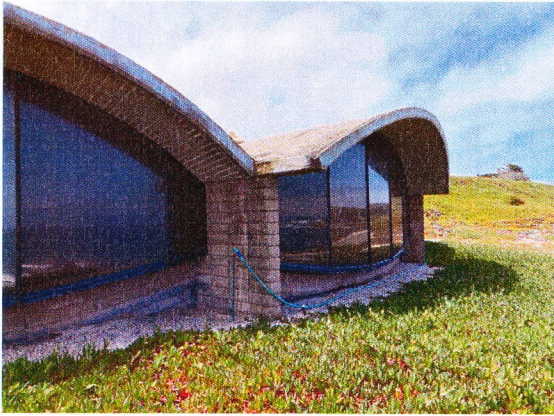
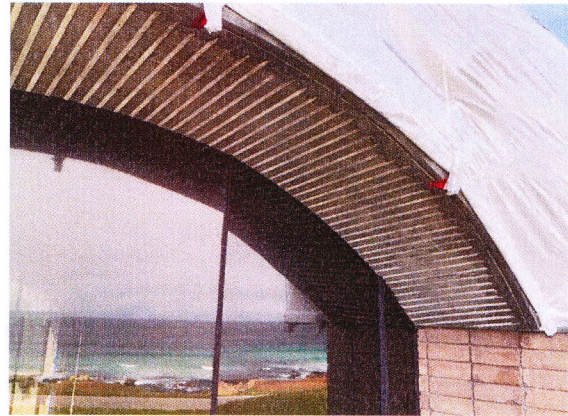
Roof Repair - Northwest Elevation

The eave shows patched concrete edge at each of the roof vaults.

- ☒ Replace damaged concrete shell roof eave extensions and fascia on the west elevation replacing reinforcing as necessary
- ☒ Strengthen the concrete shell with SikaQuick VOH structural topping material to thicken the shell calibrated to the original design dimensions

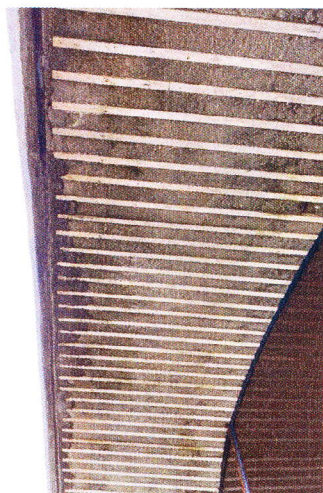
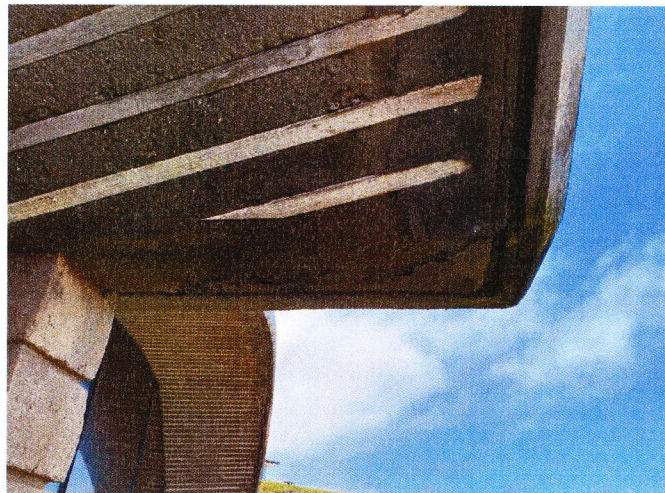
Details of patches at fascia and beams due to corrosion of embedded rebar at fascia.

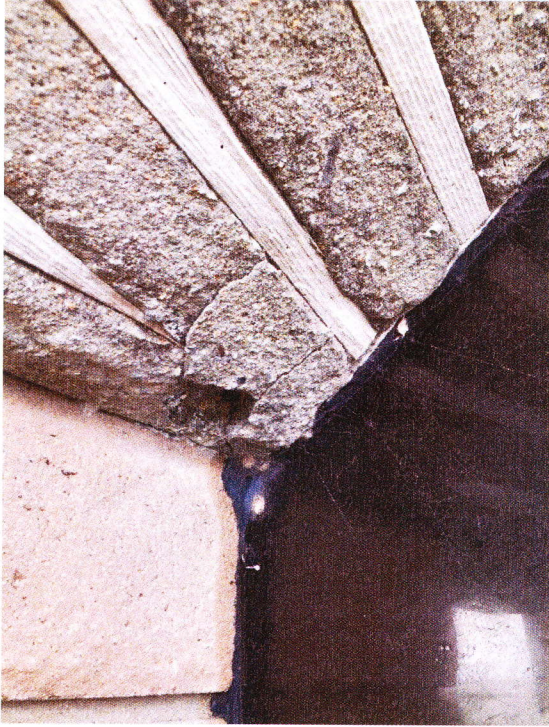
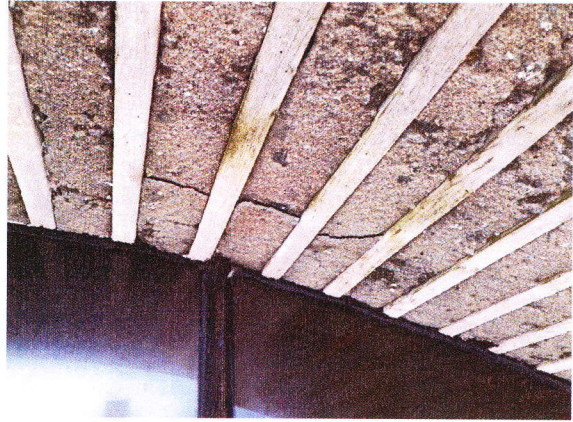
Cracked concrete at window wall due to water intrusion and rebar corrosion

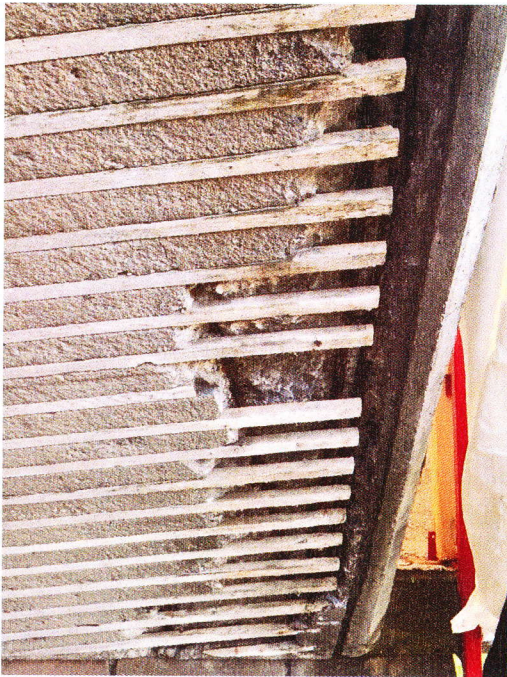
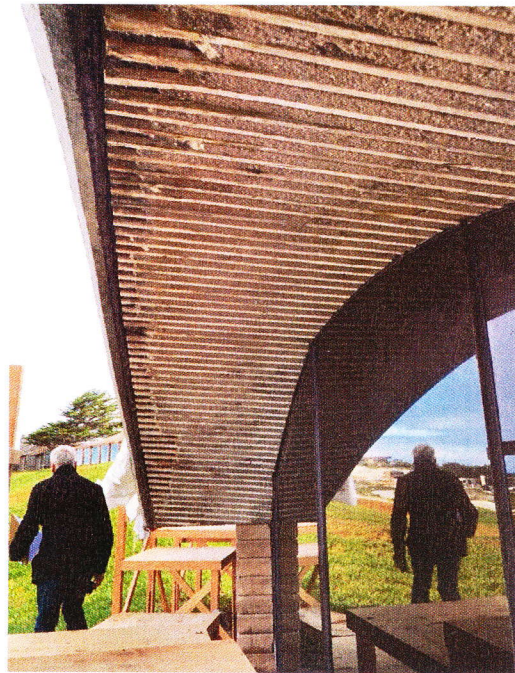
Removal of patched concrete to expose extent of corrosion of rebar. Exploration uncovered corrosion from roof edge to window line was consistent at each roof segment.

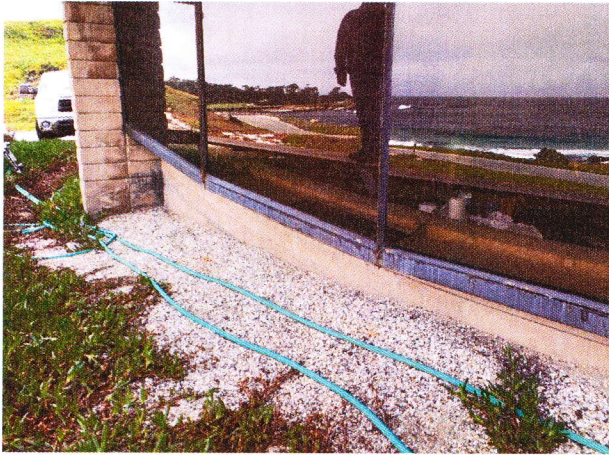
Painted steel sill of projected window wall

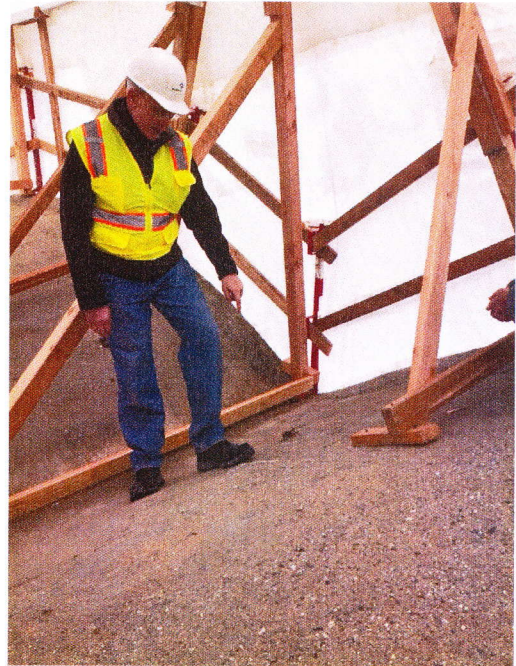
Steel frame embedded and protruding through the concrete roof shell

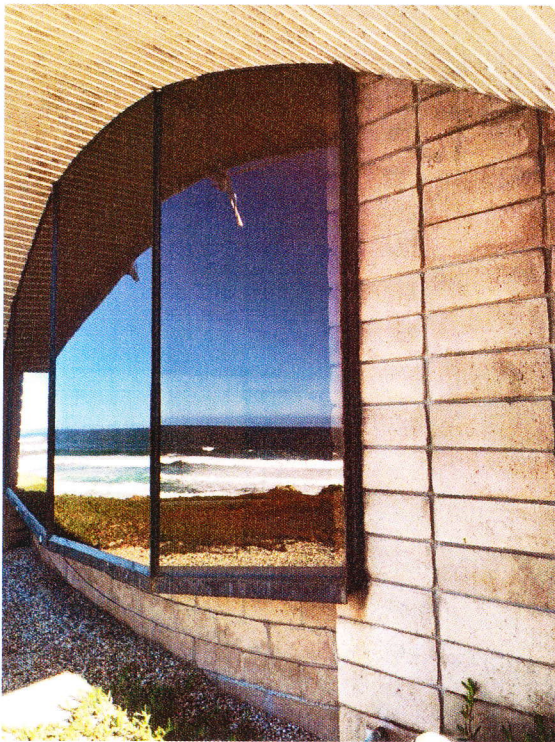
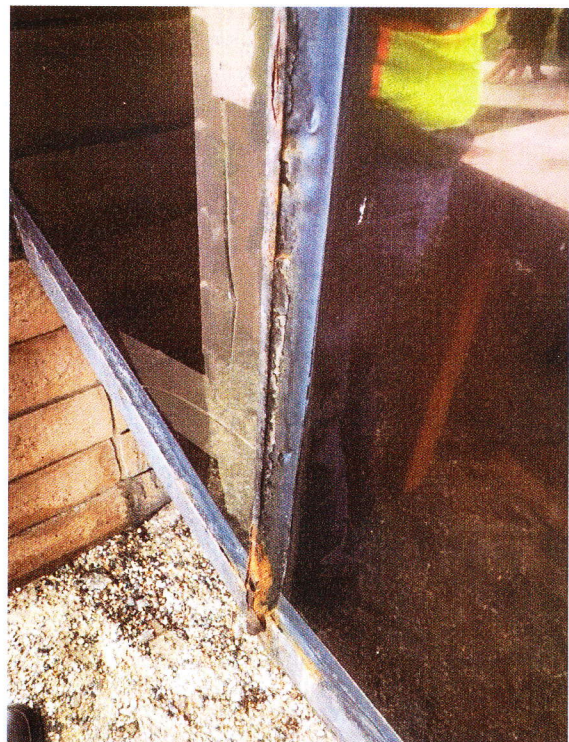
Considerable corrosion of mullions and sill

Due to extensive corrosion the steel frames are not serviceable. The glass window wall facing the ocean is a primary feature of the house that we wish to replace with insulating glass and thermally broken steel frames. We have researched extensively to find a manufacturer that can closely replicate the thinness of the existing windows and the mullion pattern. A modified structural support for the projected window wall is proposed to be contained entirely on the interior of the building so as not to modify the low wall. Given that the vaulted concrete roof structure is the primary significant feature of the house, few opportunities exist to increase the thermal performance of the building. The energy efficiency of the glass being the one element that can make a tangible improvement, without the loss of design features or intent, seems the most feasible treatment to create a more comfortable environment.

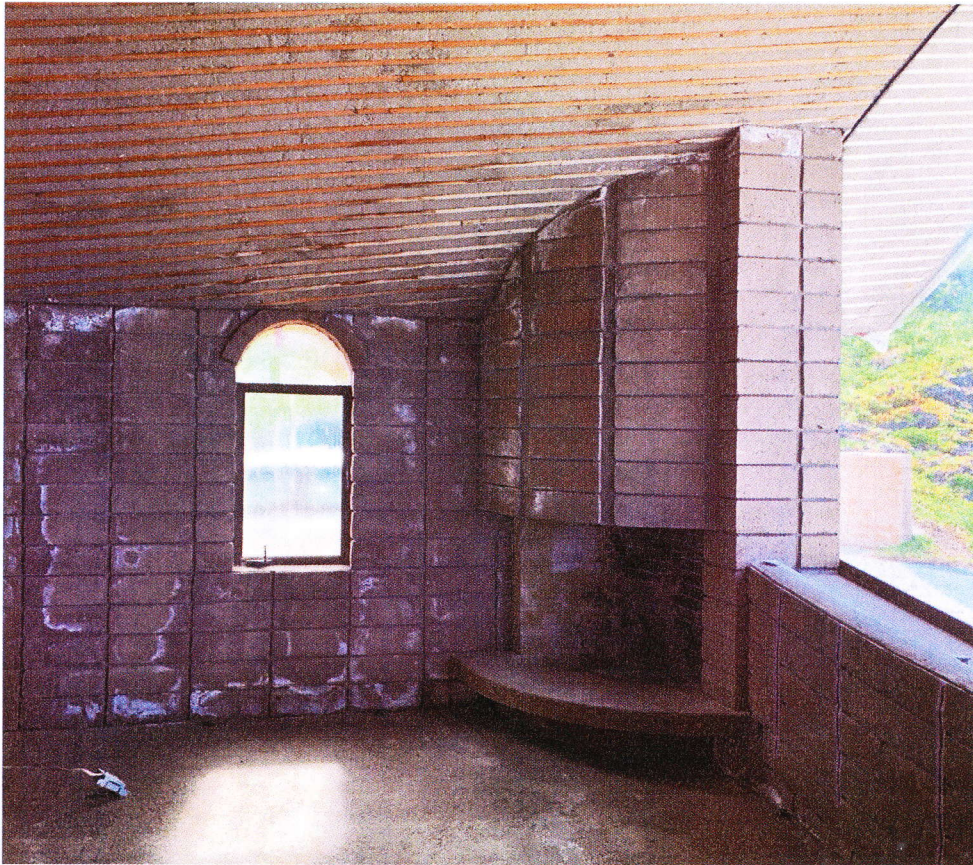
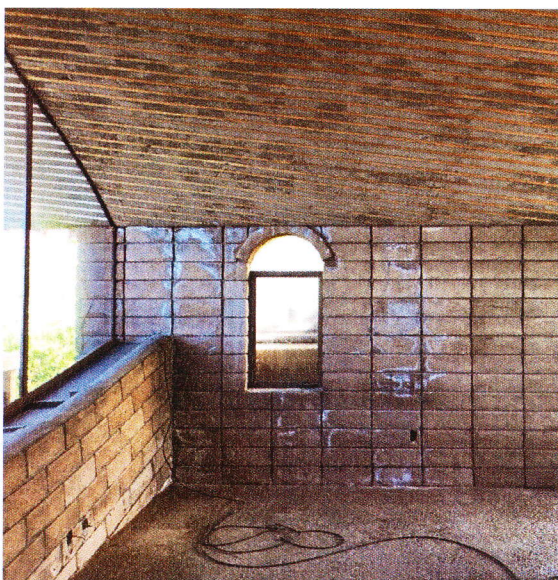
Interior view of south exterior wall at Primary Bedroom. Water intrusion from damaged roof edge, and chimney. Proposed replacement trellis at end walls would capture roof water run off in a new gutter to reduce water sheeting over the roof edge down the wall face.

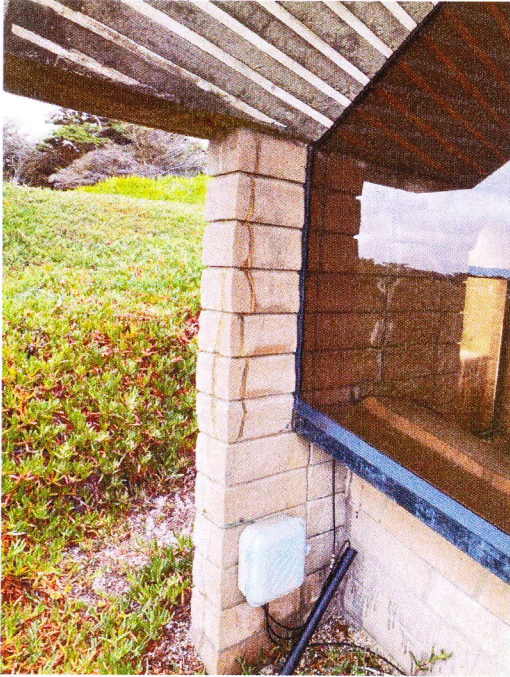
Cracked and previously repaired

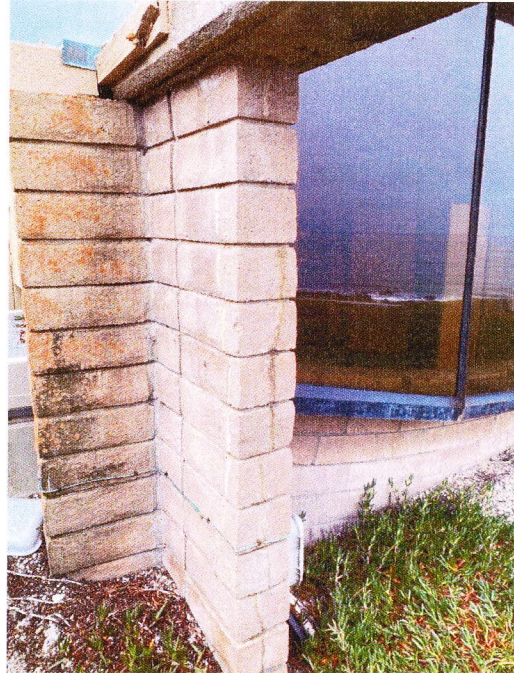
Northern most column and remnants of original trellis at roof edge

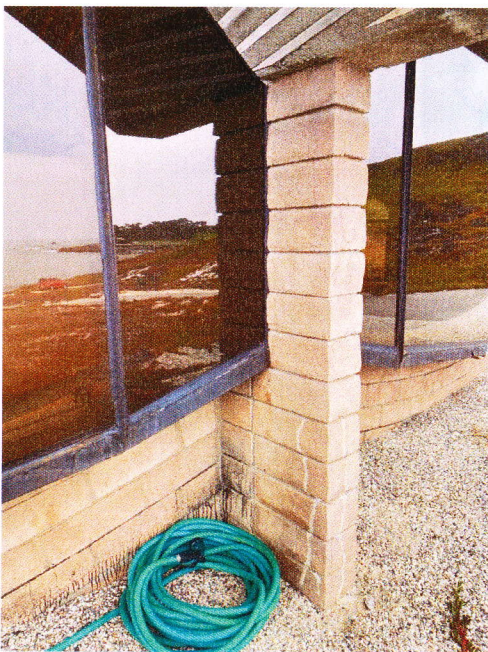
Moisture intrusion from grade as well

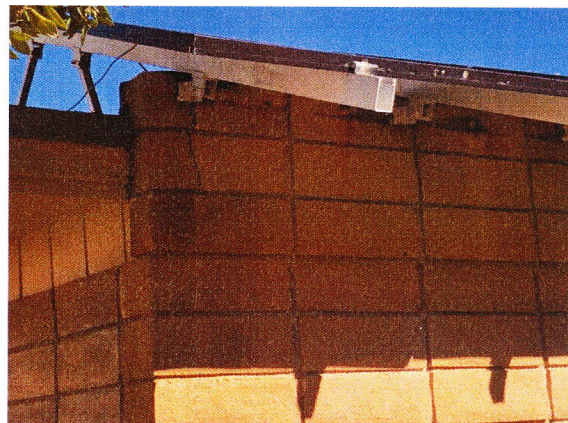
Garage roof parapet cracked below solar panel and along parapet top
