March 31, 2025

Cowell Residence
62 Chamisal Pass (Lot 138)
Carmel, CA. 93923
APN: 239-041-009-000

Subject: 62 Chamisal Pass (Lot 138) Pre-construction Tree Impact Assessment

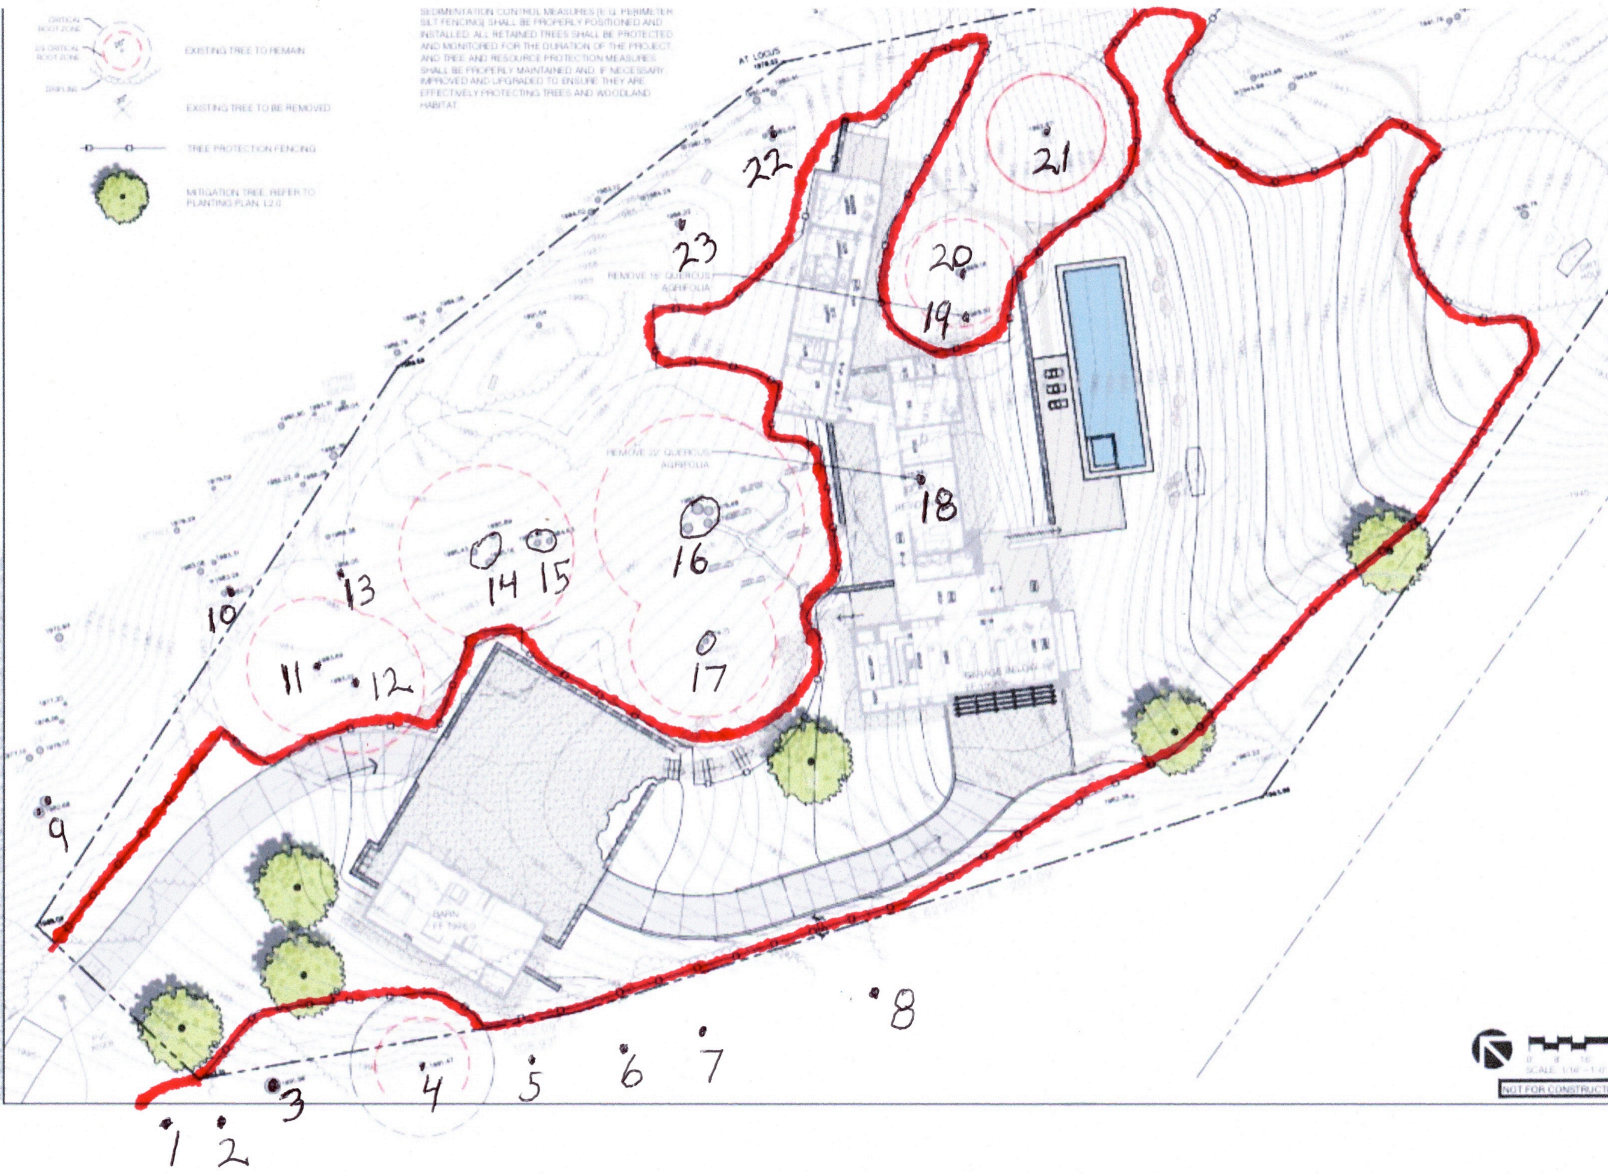
Exhibit A: Tree Location Map. The location of the 23 trees recorded and evaluated in preparation for this project are identified as Tree#s 1-23 on this site map. Tree#s 18 & 19 are proposed for removal. The red lines identify the approximate location of welded wire tree protection fencing.

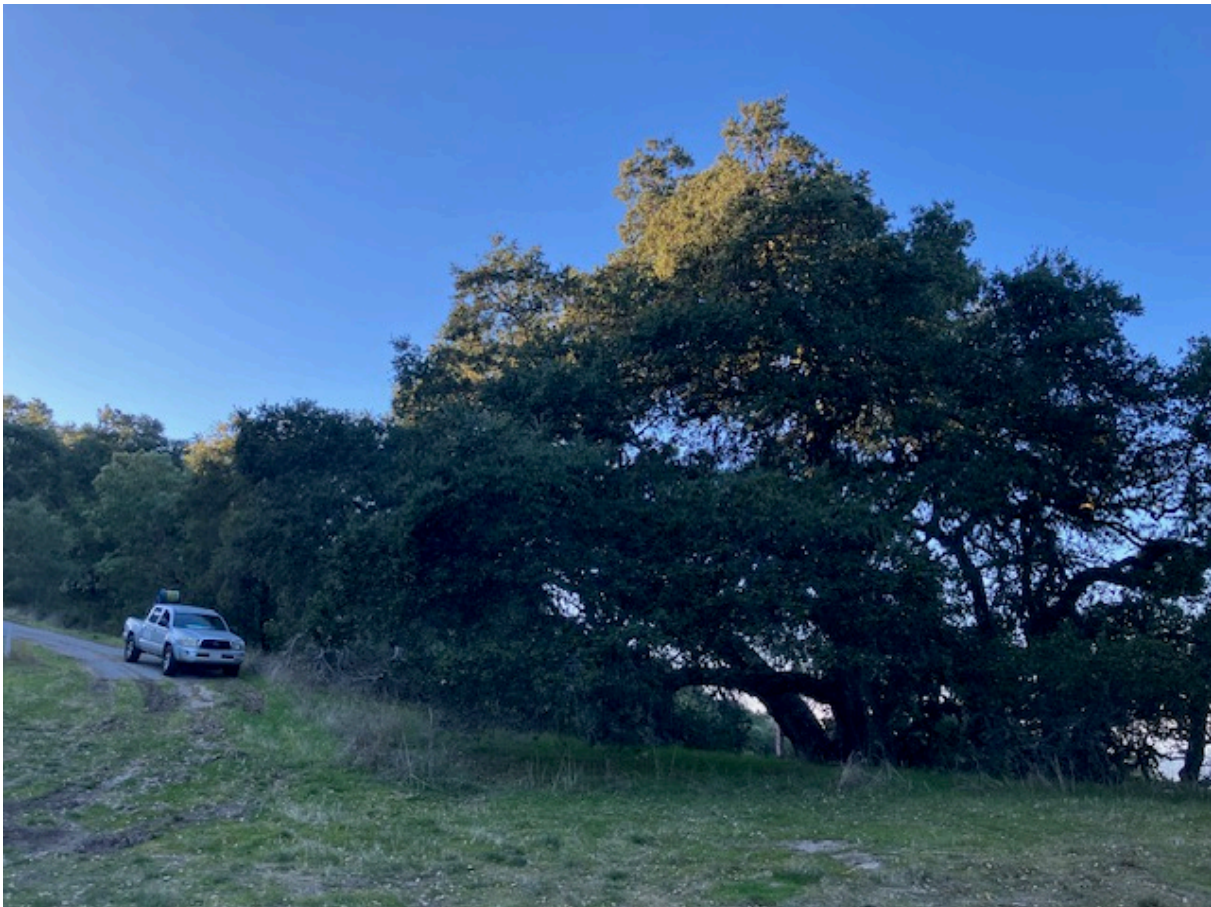
Figure 2. Another view of entrance to Homeland. The large oak identified as Tree#9 (right of center) is located in the Openlands and will be retained and protected.

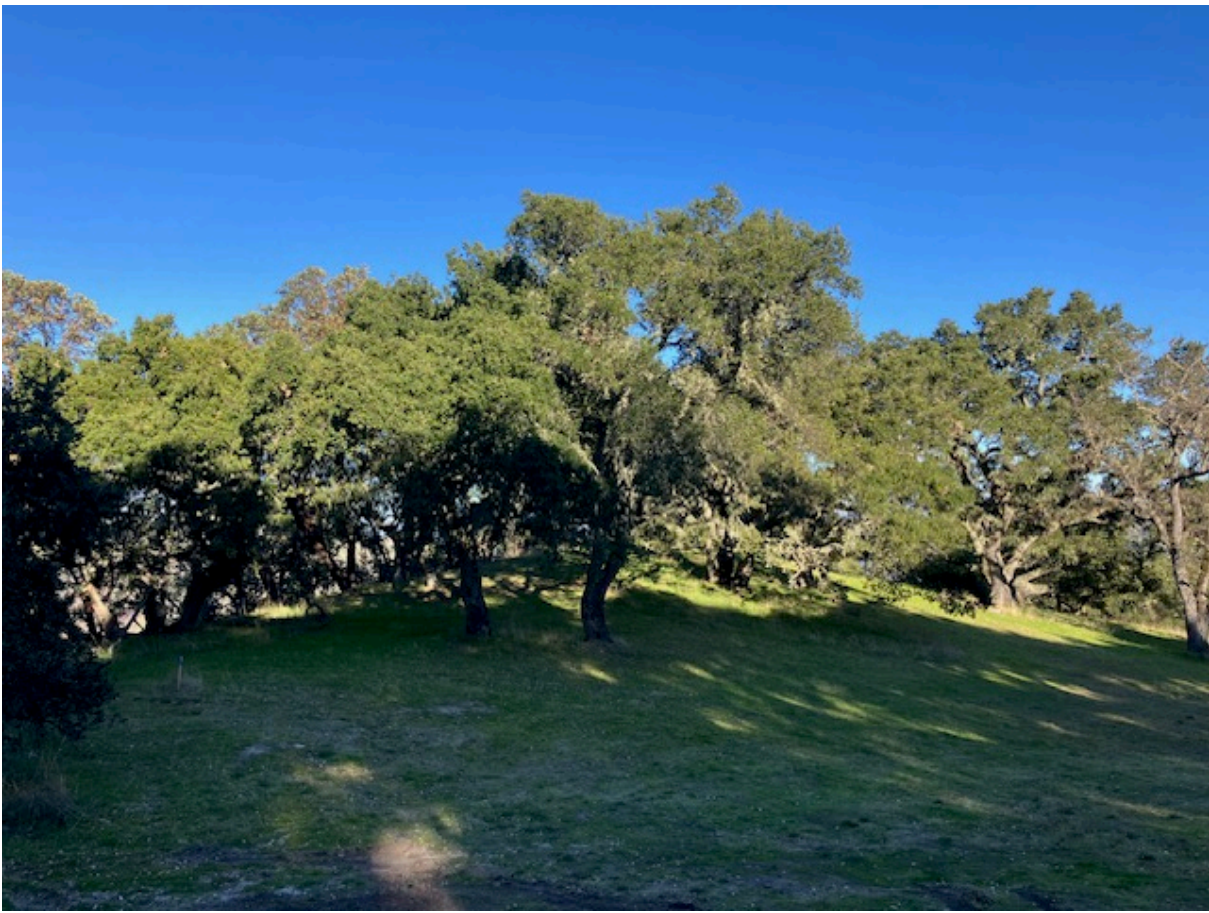
Figure 3. The oaks identified as Tree#s 10-16 are visible along edge of oak woodland and will be retained and protected. Auto court area will be right of center in clearing.

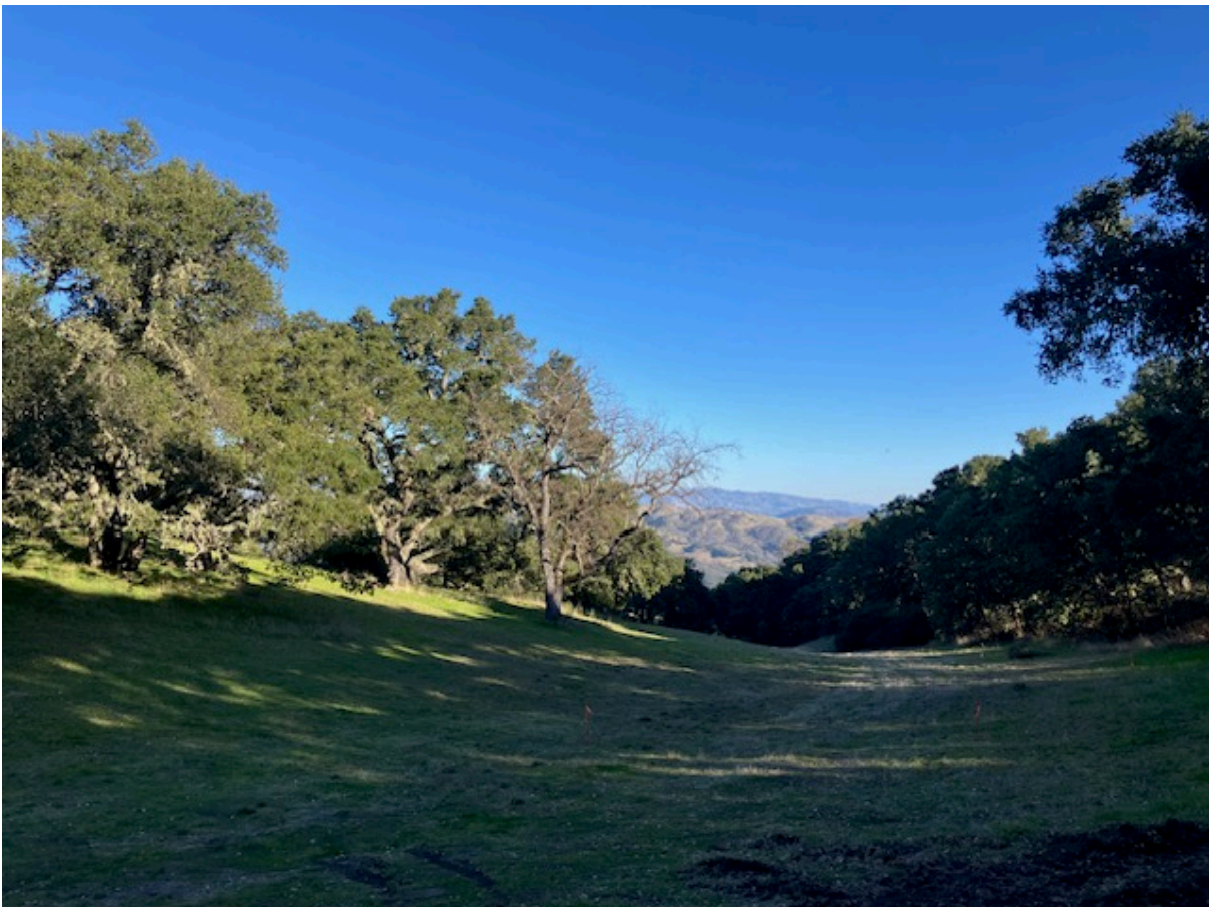
Figure 4. Auto court will be center foreground, barn to the right and home in the background. Tree#s 15-17 are visible to the left.

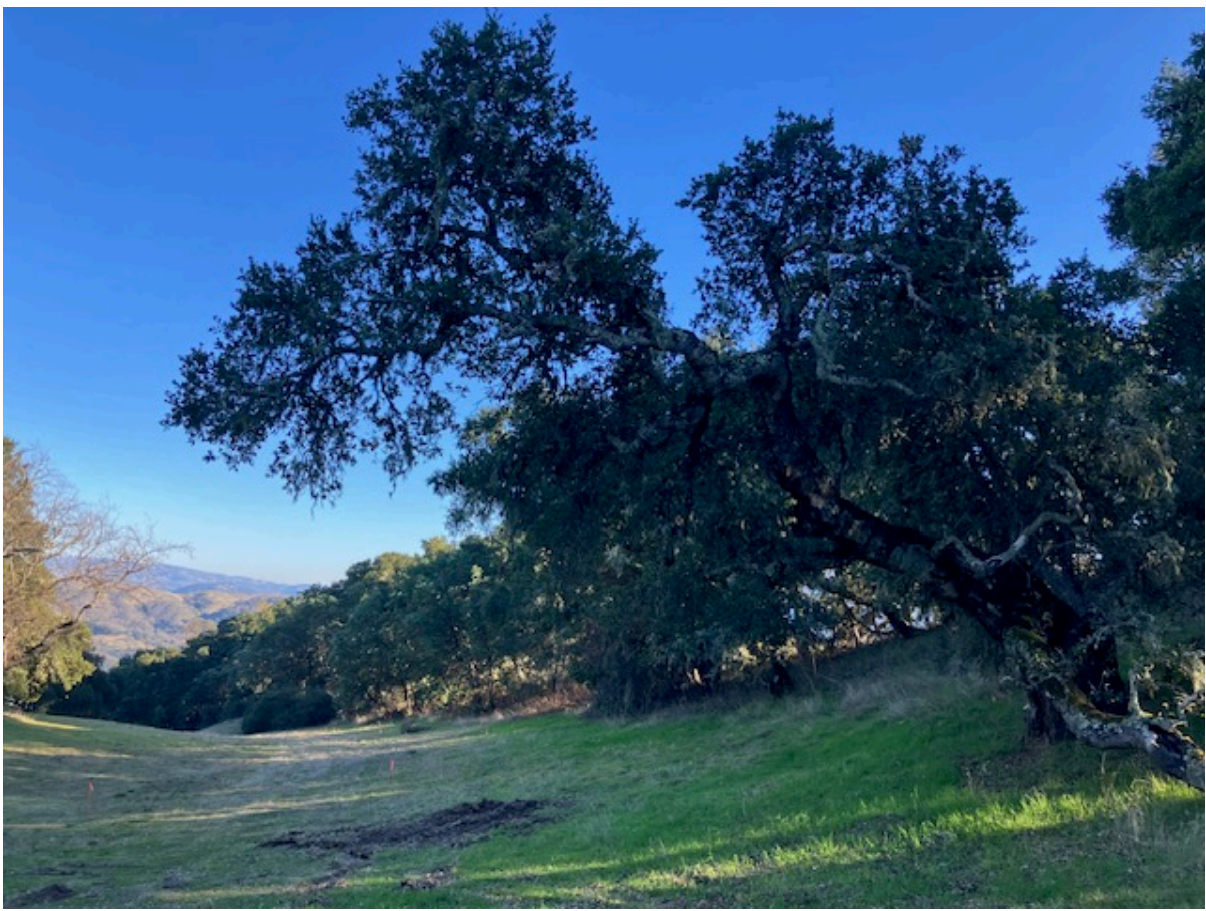
Figure 5. Area to the right where oaks identified as Tree#s 1-8 are located (all in the Openlands) will be retained and protected.

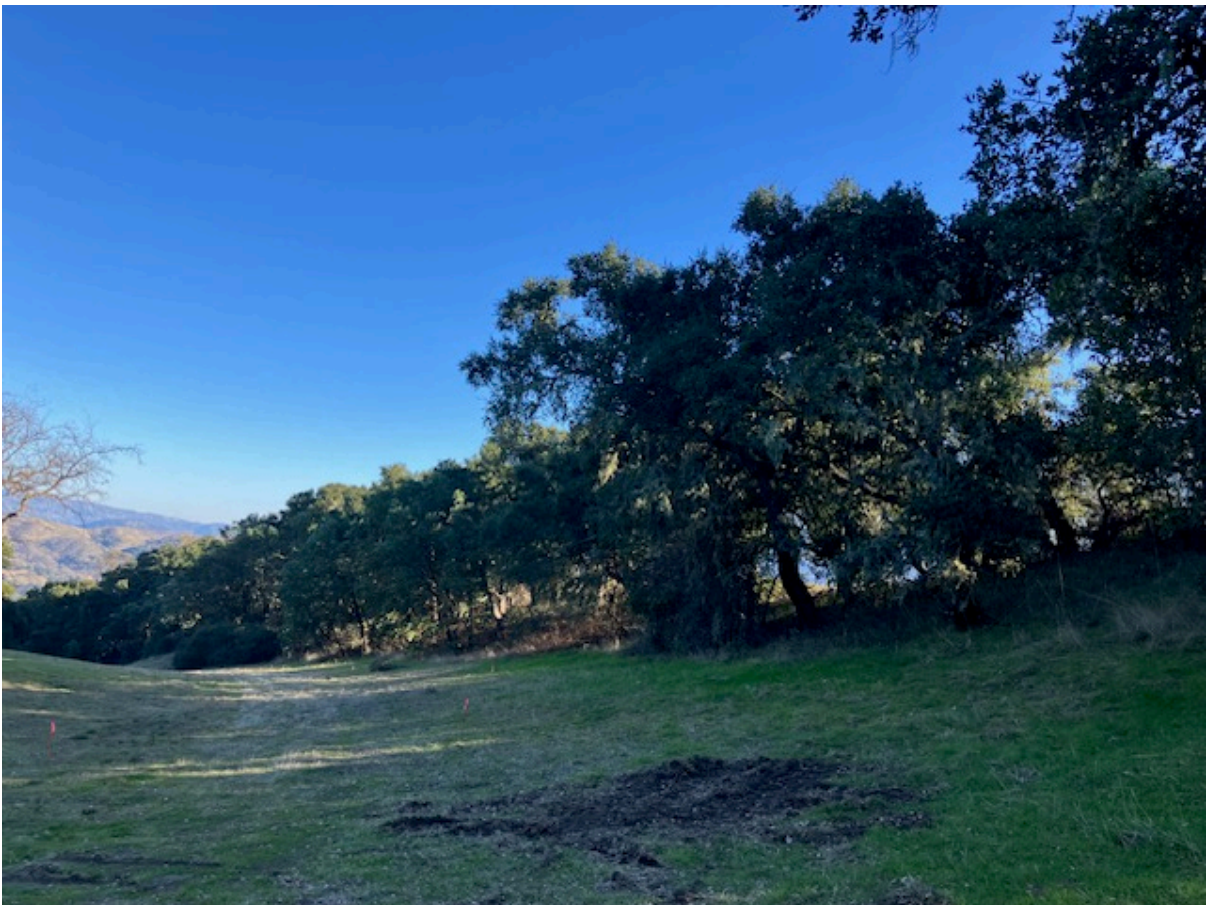
Figure 6. Another view of woodland area to the right where Tree#s 6-8 are located. Oaks are in Openlands and will be retained and protected.

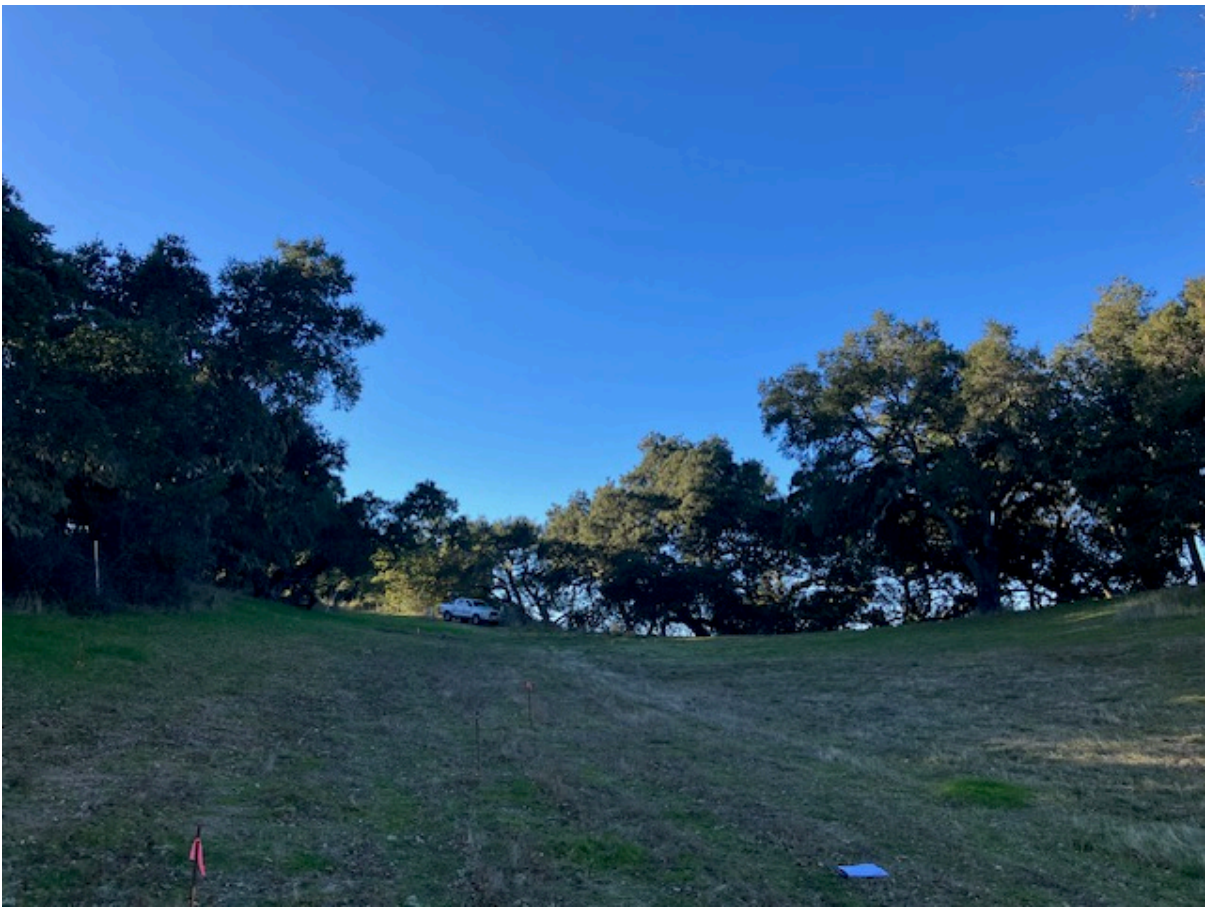
Figure 7. Proposed barn and auto court area looking towards entrance. Surrounding oaks will be protected with minimal impacts.

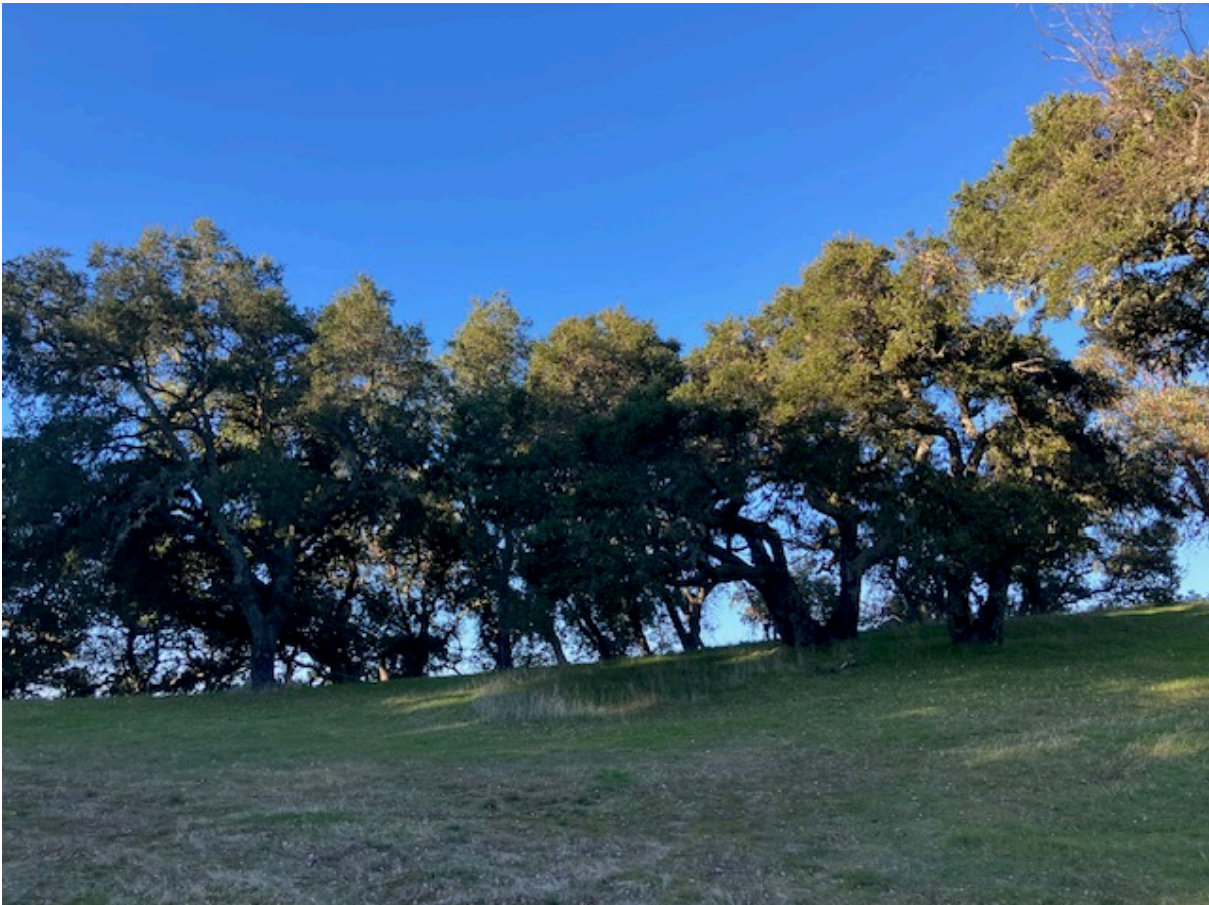
Figure 8. Another view of woodland edge area where coast live oaks identified as Tree#s 11-15 are located. Auto court is planned for this area and trees will be retained and protected with minimal and insignificant impacts.

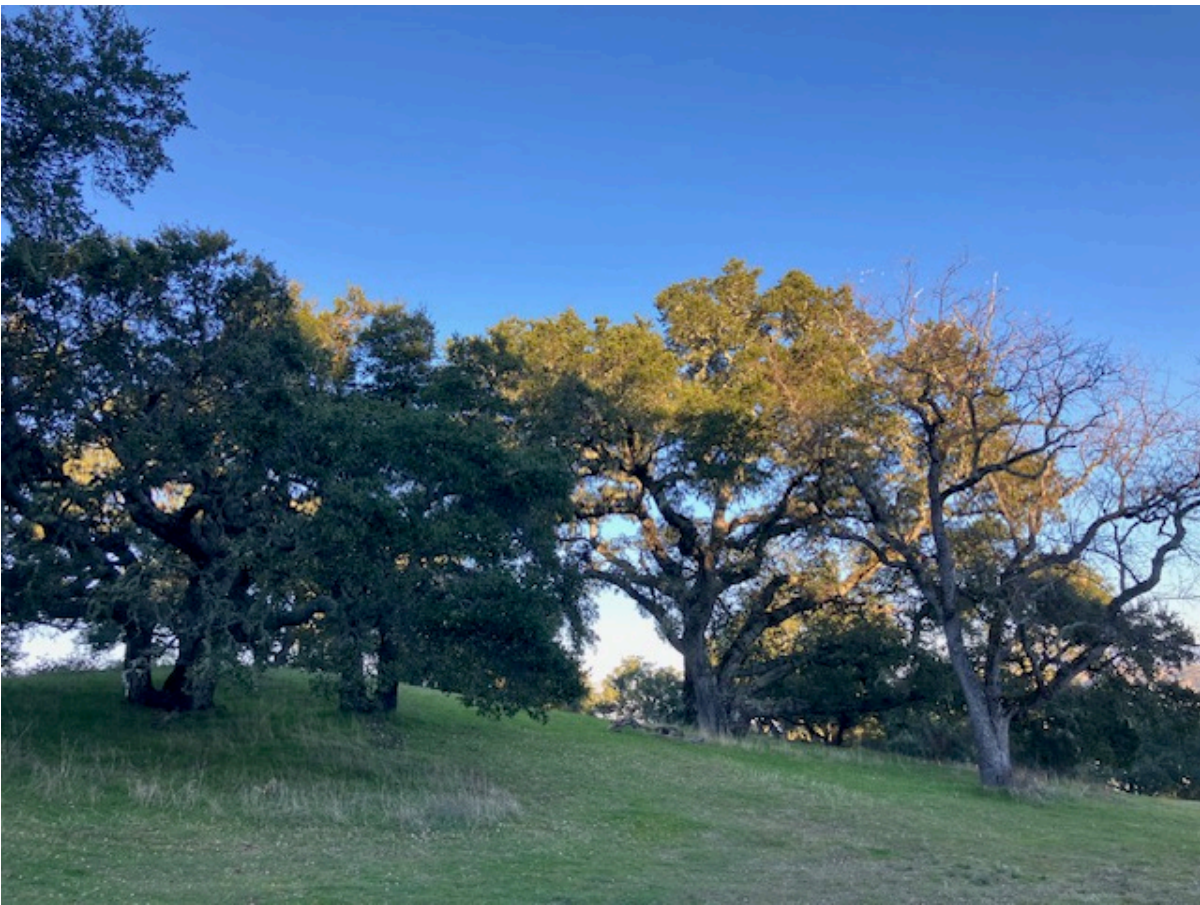
Figure 9. Oaks ID'd as Tree#s 14-17 are visible in photo. These significant oaks will be retained & protected with minimal impacts.

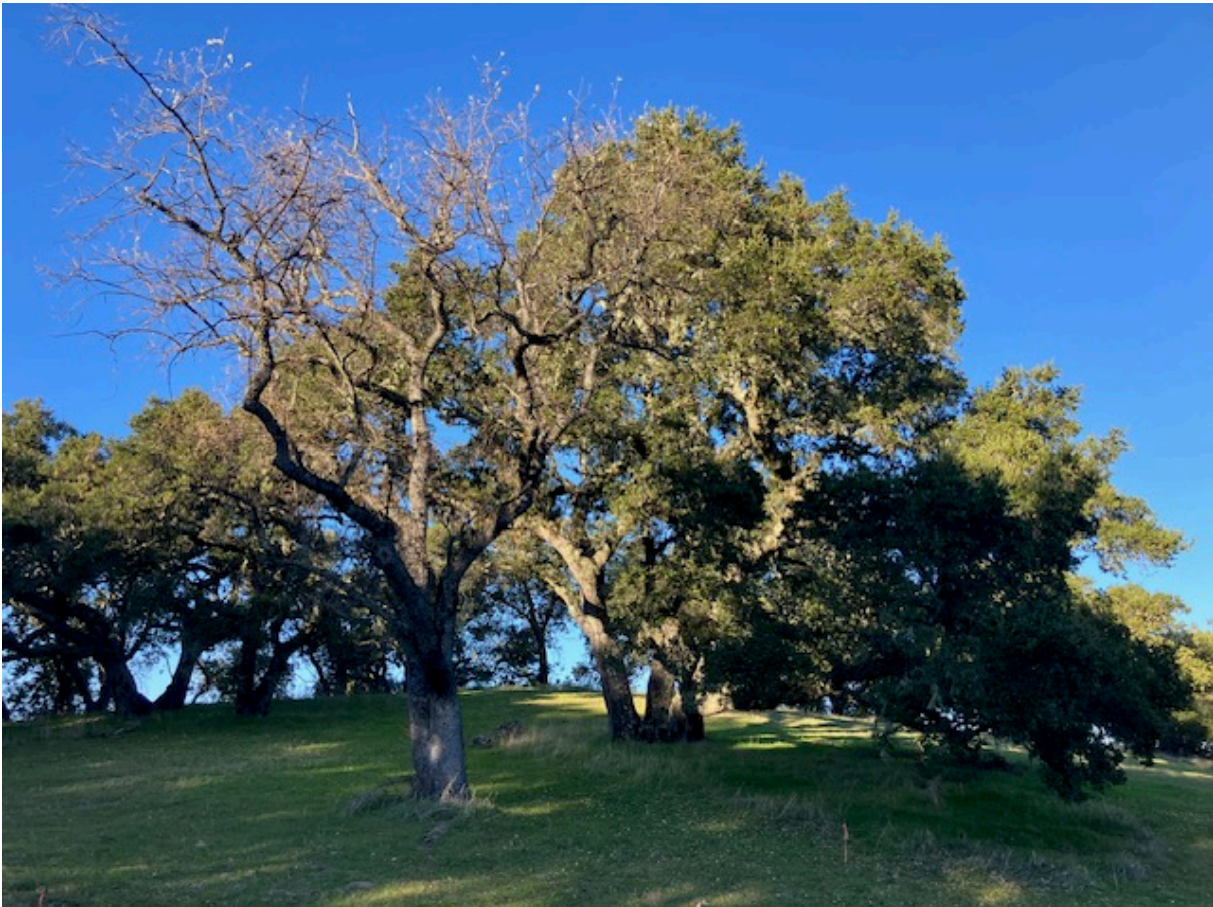
Figure 10. Large and significant coast live oak identified as Tree#16 is in center background and valley oak (Tree#17) is in foreground. These oaks will be retained and protected.

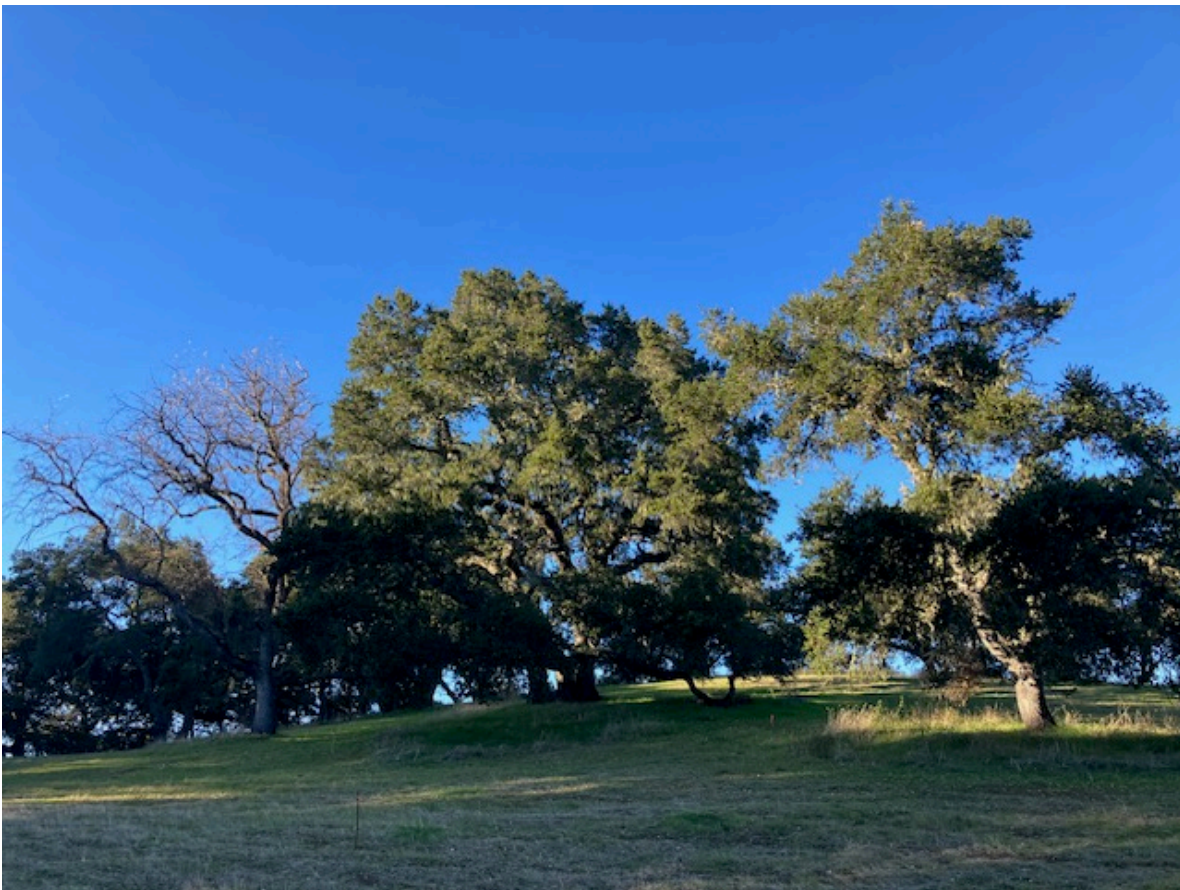
Figure 11. From to left to right Tree#s 17, 16 & 18. Oak to the right (Tree#18) is proposed for removal due location in building footprint.

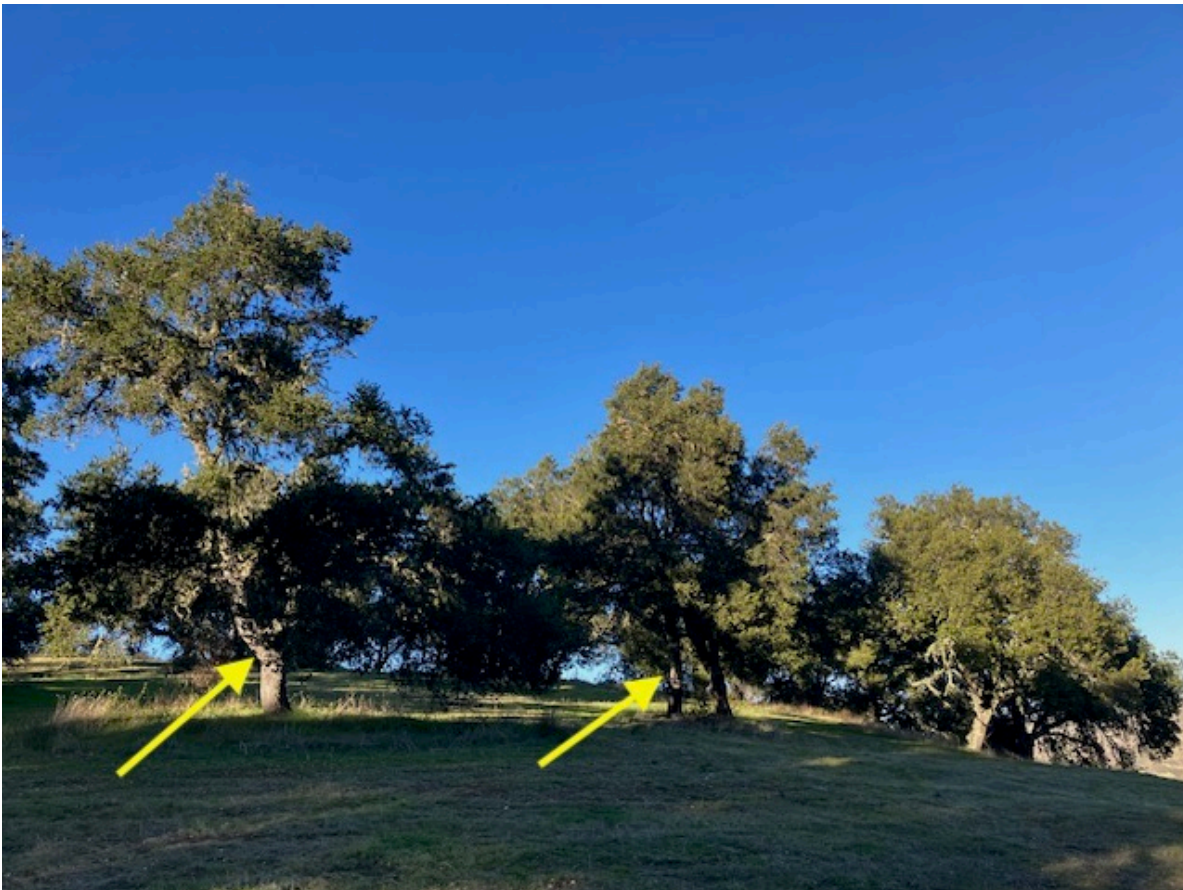
Based on the project design plans and as previously stated, two coast live oak trees identified as *Tree#s 18 & 19* are planned for removal in preparation for home construction activities. The mature 20 inch DBH coast live oak identified as *Tree#18* is presently in fair physiological health and structural condition and is proposed for removal due to its location within the building footprint for the main house (refer to *Figures 11, 12 & 17*). The 15 inch DBH coast live oak identified as *Tree#19* is in fair physiological health, but poor structural condition due to poor canopy balance and symmetry, and is also planned for removal due to it being located directly adjacent to the proposed construction footprint for the home (refer to *Figures 12 & 18*). Per *Monterey County HCD* tree removal permit requirements, 6 replacement coast live oak seedlings or saplings of good health and condition (5 to 15 gallon container size is advised) will need to be planted in suitable locations in the Homeland and survive a 5-year monitoring period to comply with County permit conditions.

Figure 12. From left to right Tree#s 18-21. Two coast live oaks ID'd as Tree#s 18 & 19 (yellow arrows) are proposed for removal due to construction impacts.

Lastly, in the interest of complying with *Monterey County HCD* tree removal permit conditions for the removal of 2 coast live oaks (*Quercus agrifolia*), as well as preserving and sustaining the health and character of oak savanna and woodland habitat, six (6) 5 to 15 gallon container size

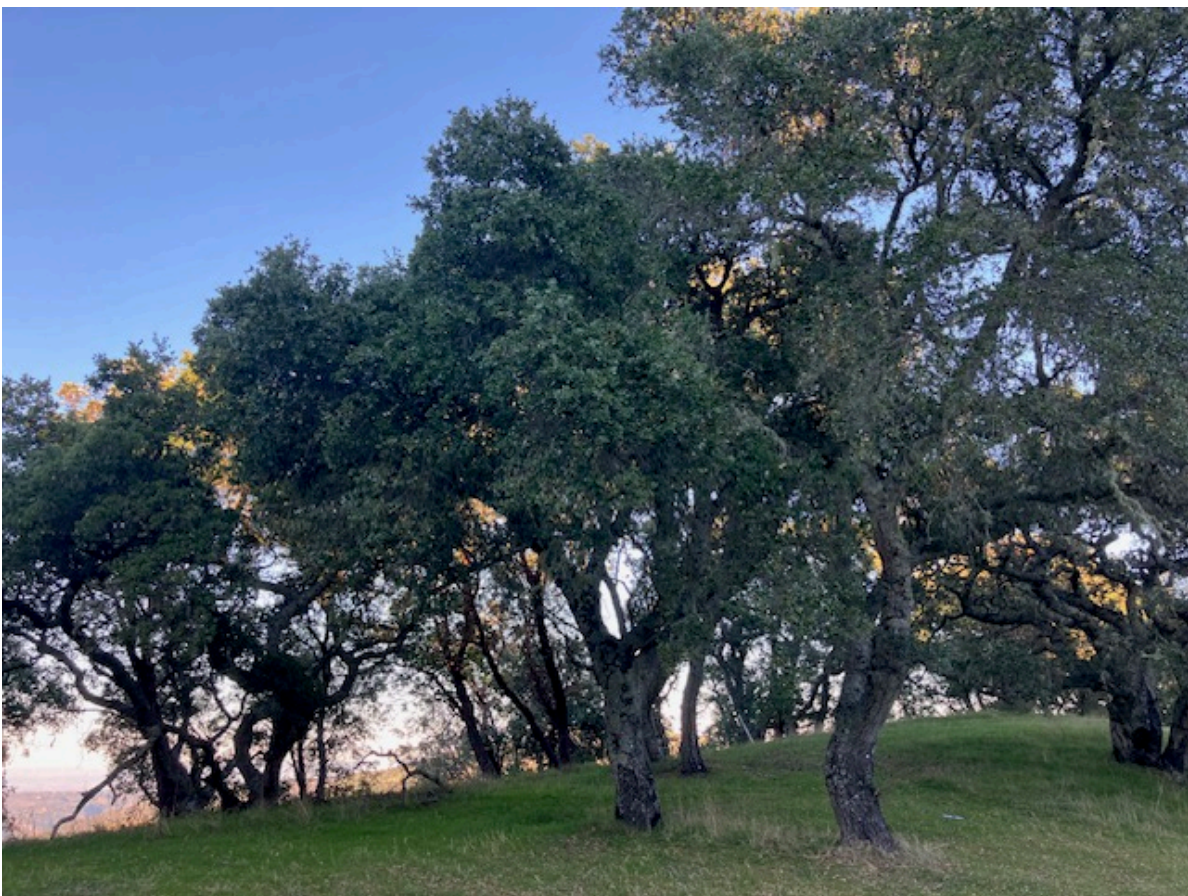
Figure 13. A closer view of Tree#s 11 & 12 in foreground. Tree#s 10, 13 & 14 are visible from left to right in background. Oaks will be retained and protected and will not be significantly impacted by construction activities.

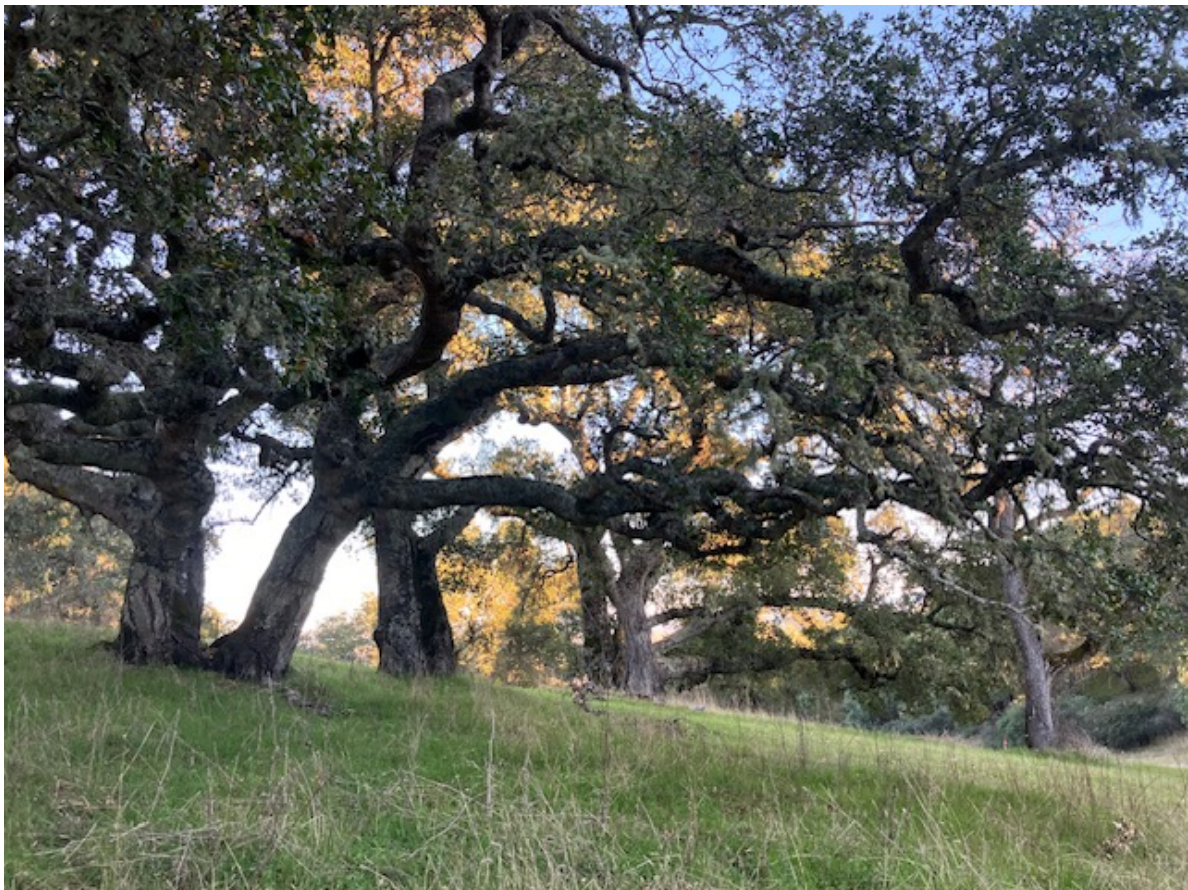
Figure 14. Oaks identified as Tree#s 14-17 (left foreground to right background) will be retained and protected, and are not expected to be significantly impacted by construction activities.

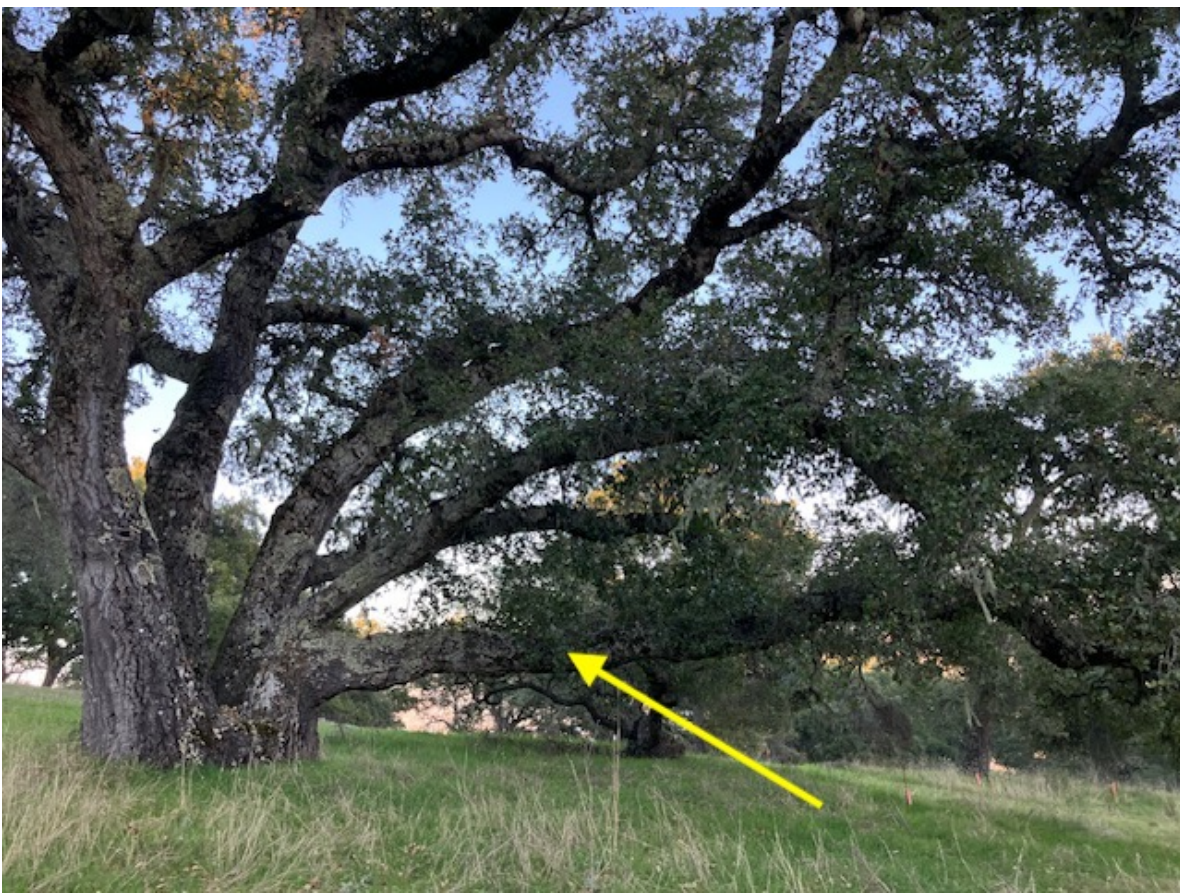
Figure 15. The significant coast live oak identified as Tree#16 is the largest tree on the lot. Weight reduction pruning should be performed, such as the large lower horizontal limb identified by yellow arrow, to reduce the likelihood of structural failure.

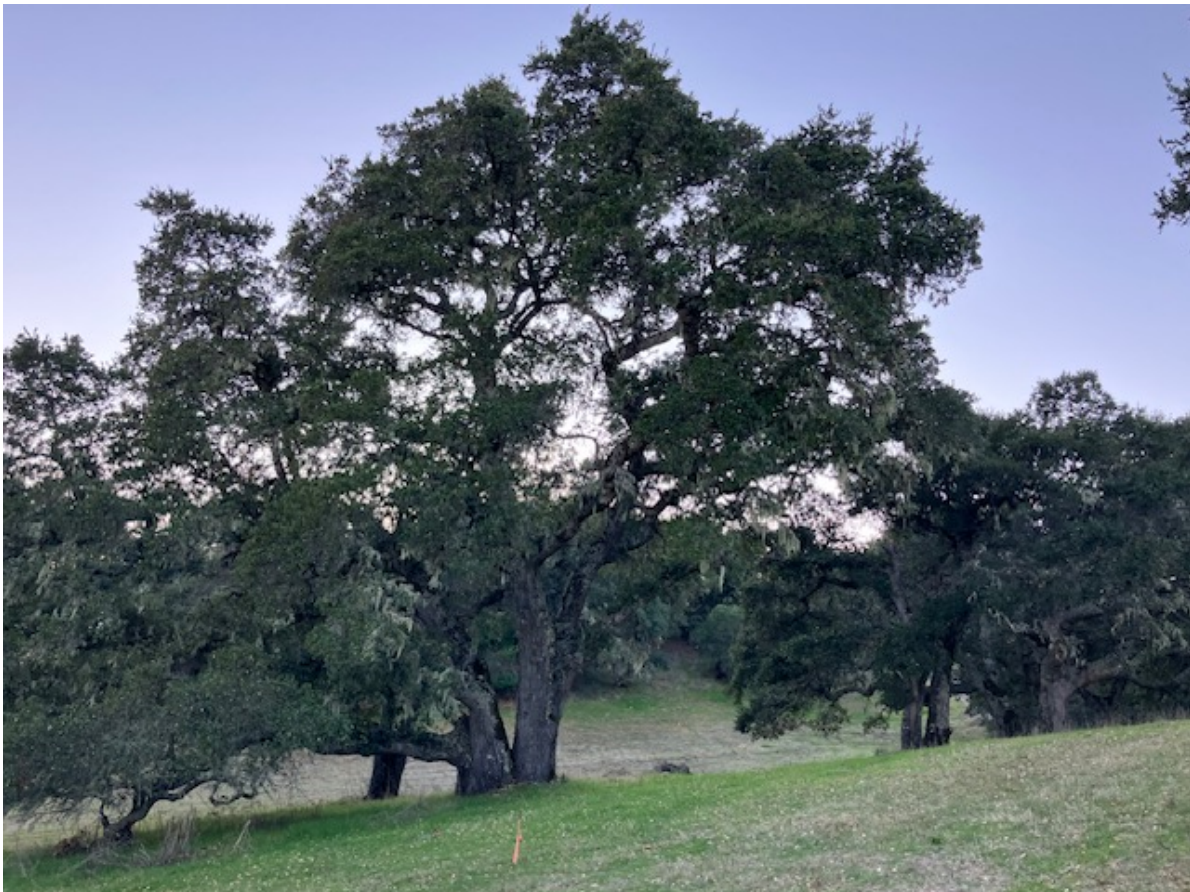
Figure 16. Another view of Tree#16 (center foreground) and surrounding oaks that will be retained and protected. Impacts to Tree#16 and other nearby oaks are expected to be insignificant.

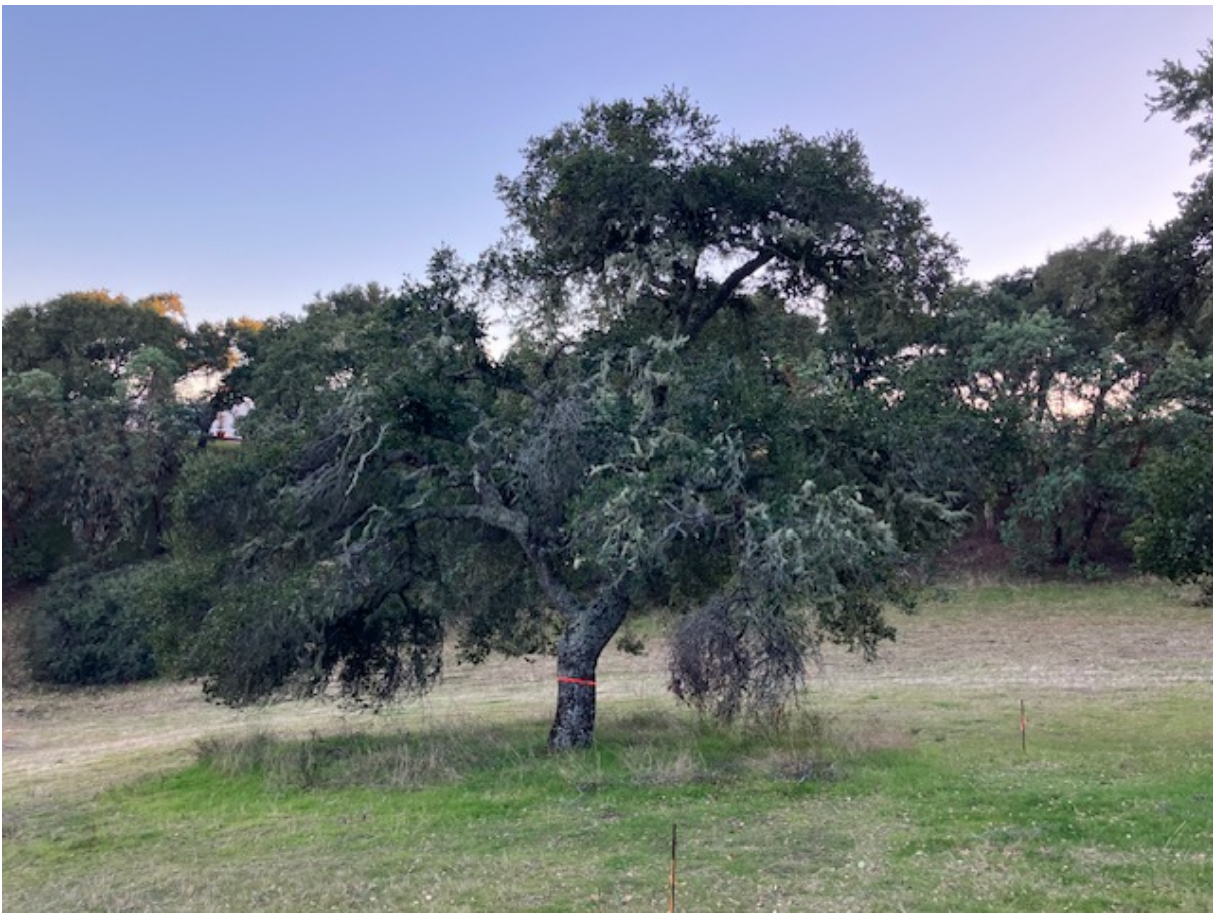
Figure 17. Coast live oak identified as Tree#18 is proposed for removal due to its location within home construction footprint.

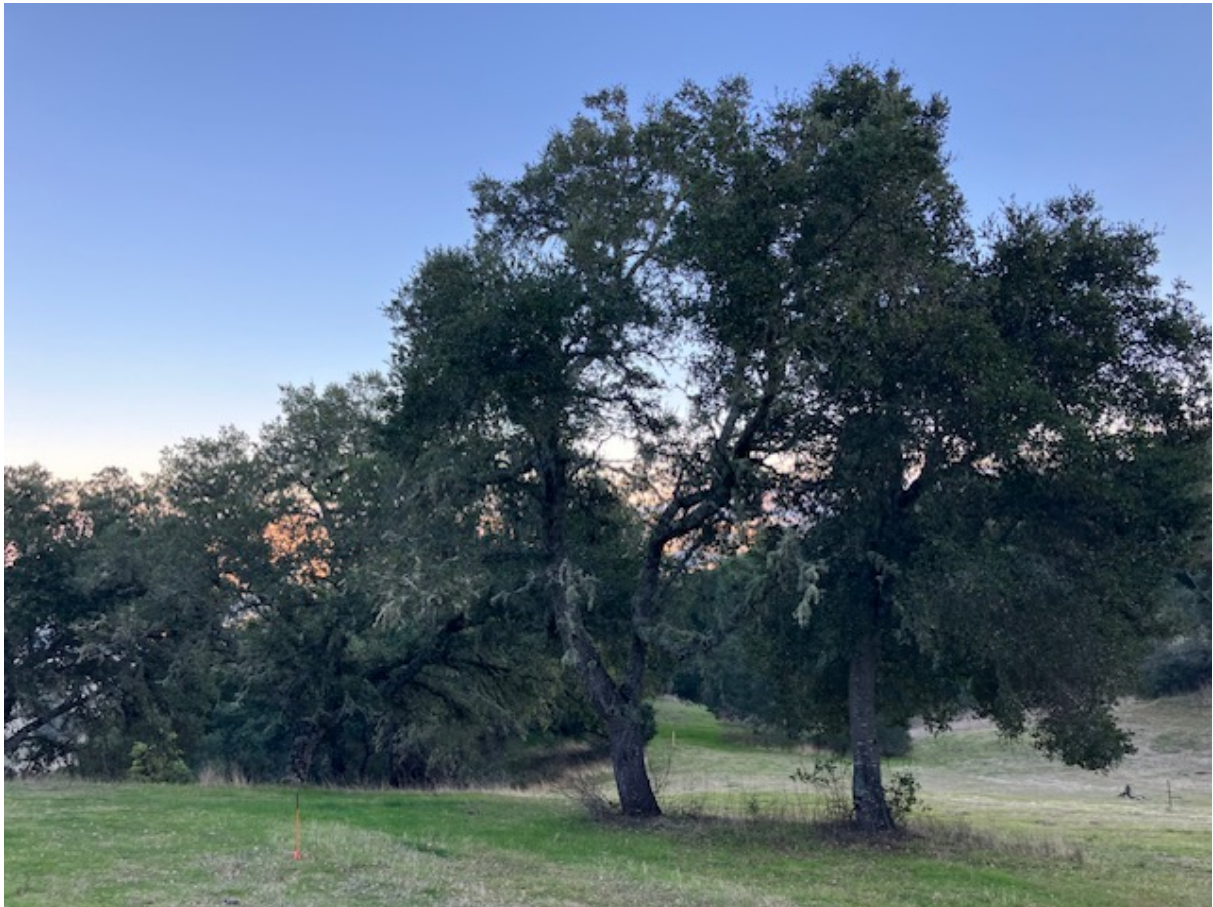
Figure 18. Oaks identified as Tree#s 19 & 20. Tree#19 to the right is proposed for removal due to location adjacent to construction footprint. Tree#20 will be retained and protected.

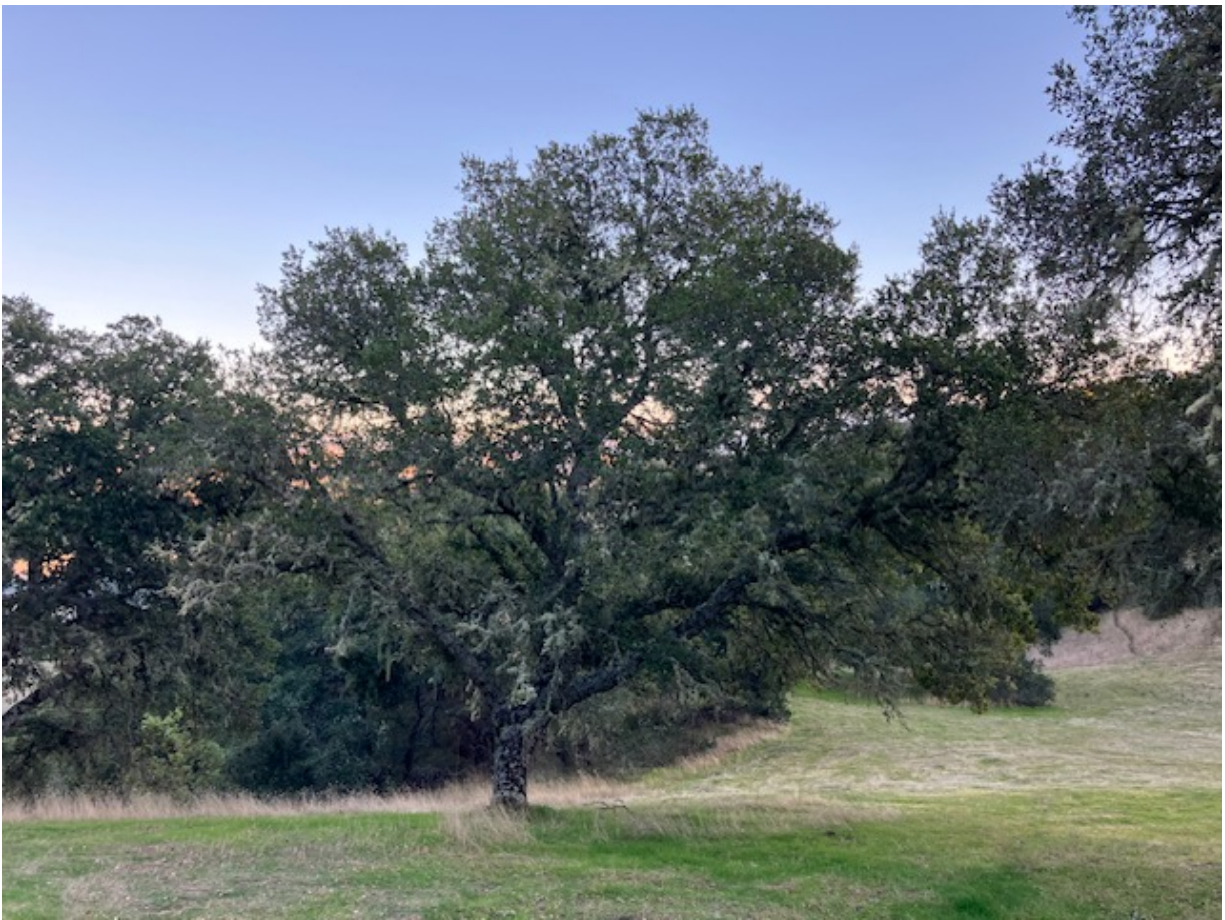
Figure 19. Coast live oak identified as Tree#21 will be retained and protected and not significantly impacted by project operations.
