March 31, 2025

Cowell Residence
62 Chamisal Pass (Lot 138)
Carmel, CA. 93923
APN: 239-041-009-000

Subject: 62 Chamisal Pass (Lot 138) Pre-construction Tree Impact Assessment

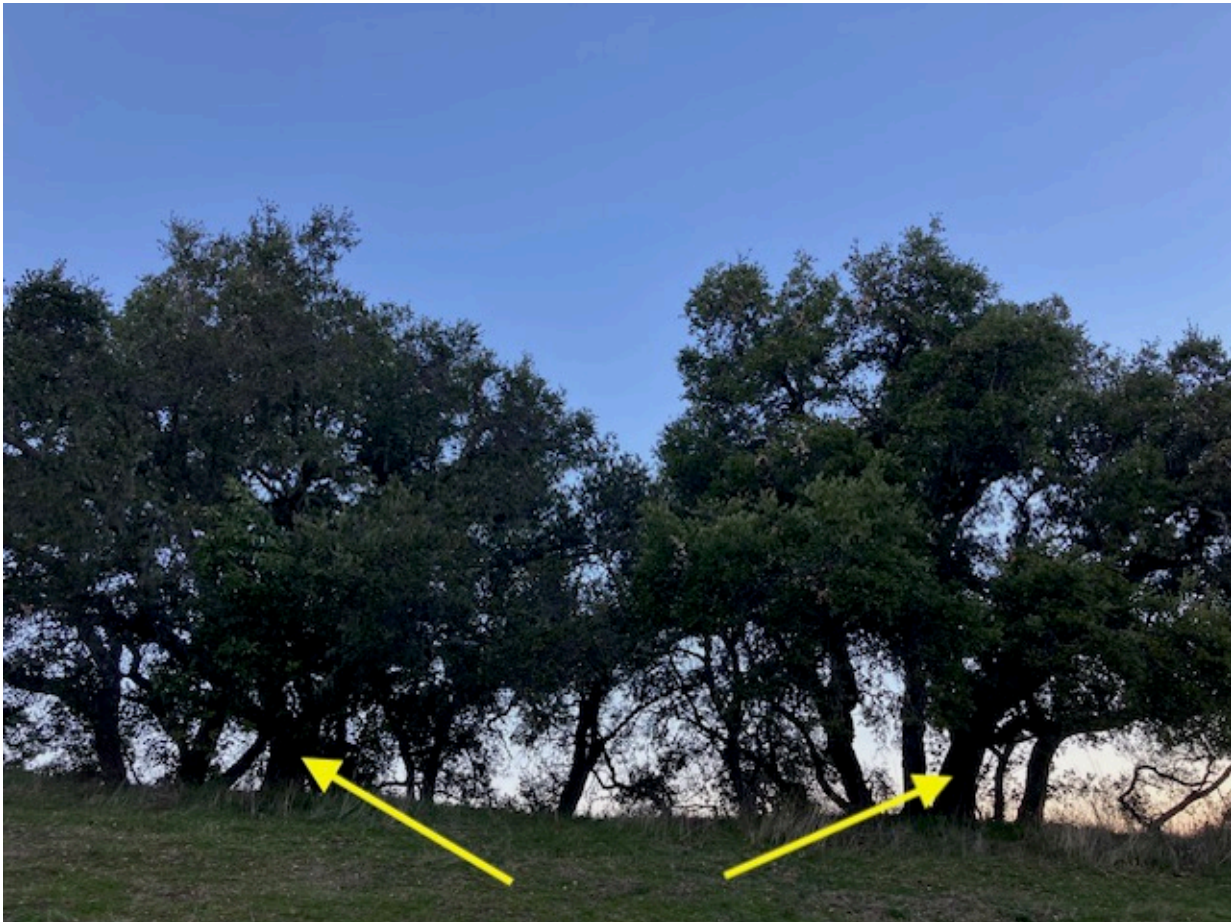
Figure 20. Oak to the right is Tree#22 and oak to the left is Tree#23. Both will be retained and protected with minimal impacts.
