2 Wild Boar Run Residence  
Carmel CA  
Tree Assessment/Forest Management Plan

March 25, 2021

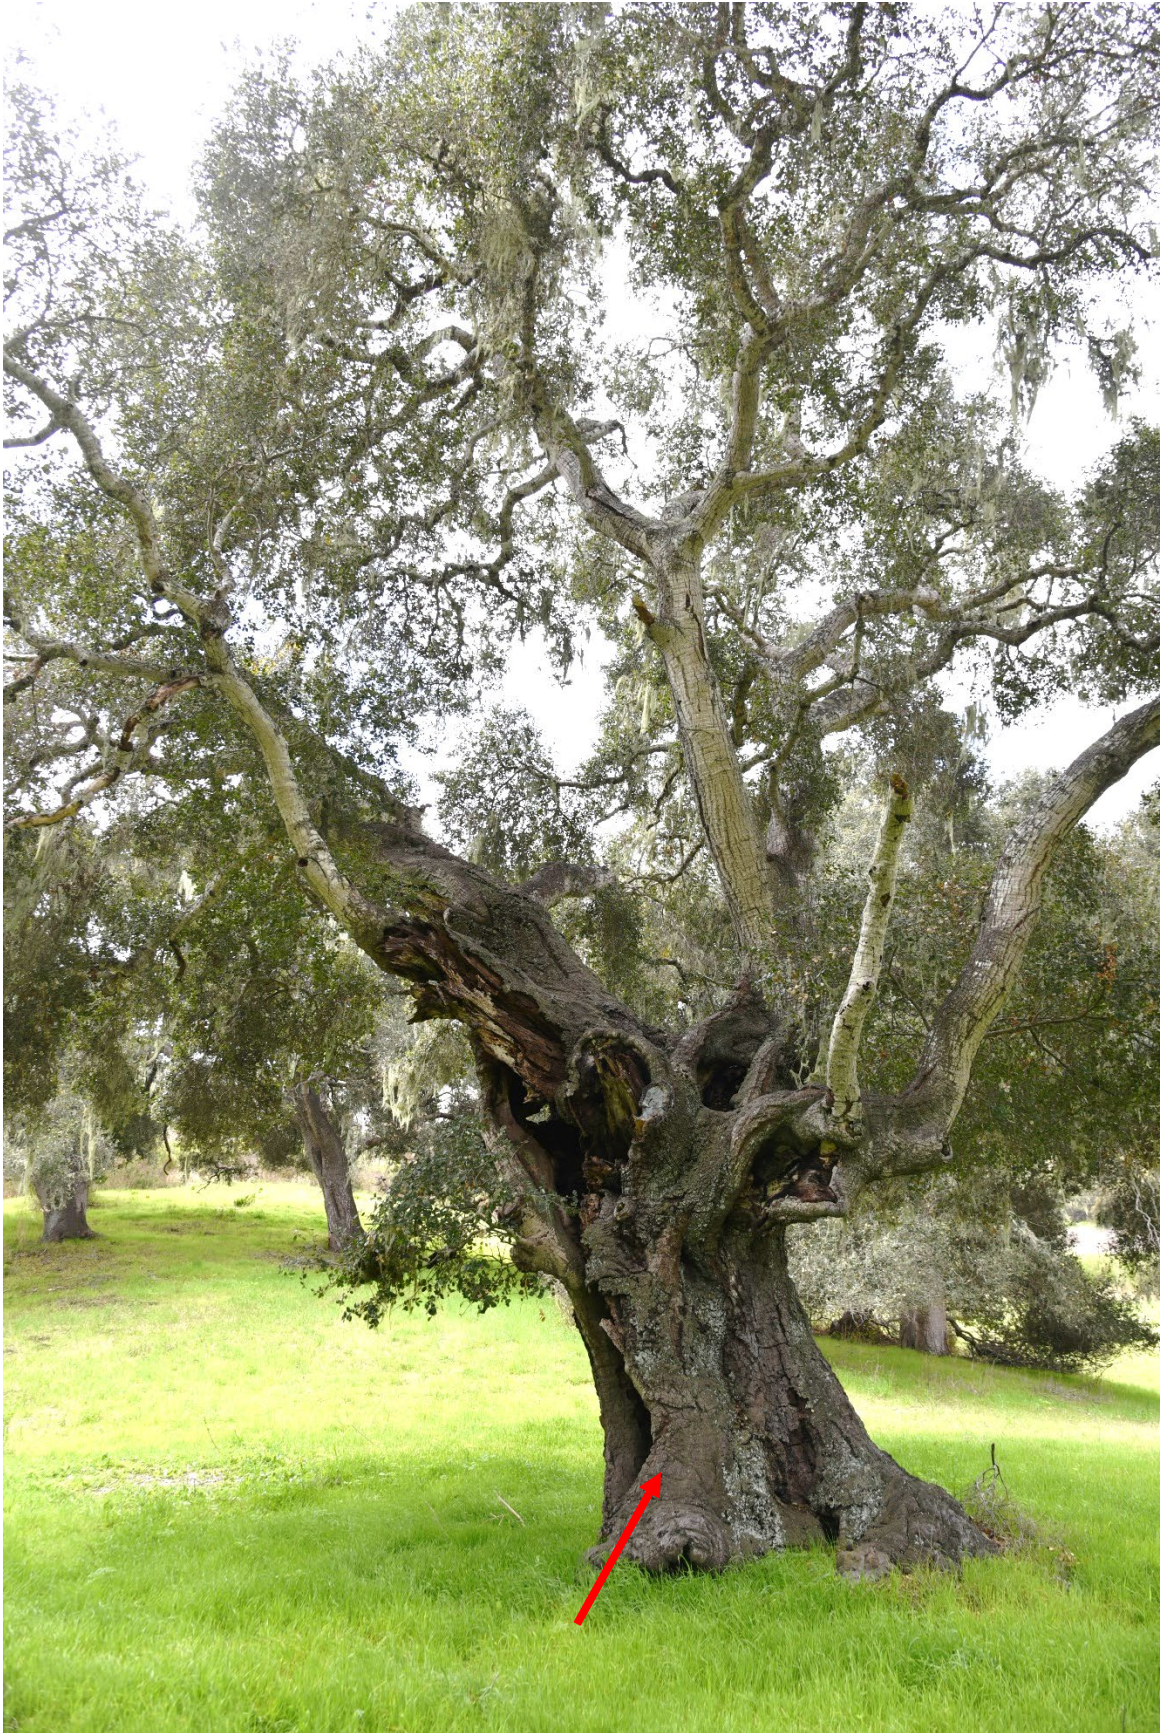
- One fragmented oak tree (#1802 - 84" diameter) is proposed for removal with this design. This tree is fragmented with multiple branch failures and cavities. It has significant decay spreading in its trunk and branch attachments. The base of the tree is ruptured, however, growth in the crown appears to be healthy. Retention of this tree is not recommended because the base of the tree will not be able to support the weight of extending weakly attached epicormic formation of new branching and foliage. It presents future safety concerns for a developed project.

#1802 for removal

With this design, two trees are recommended for removal for construction purposes (one -#1802 is within the building and grading areas, the other -#1807, is in poor health and structure). Removal is the minimum for this case to build a single-family residence and driveway and. The project as planned maintains the existing oak woodland environment allowing it to continue to exist and regenerate over time; tree removal conforms to Oak woodland best management practices. The remaining tree cover shall remain undisturbed. A natural opening has been expanded to accept the development components while keeping the perimeter of the existing woodland intact with the main footprint of the development located in a large opening that occurs naturally between the tree groupings. The proposed tree removal does not significantly disturb the integrity of the entire stand, fragment the overstory component or create a new forest "edge". Home construction and driveway development will be near several trees, but adverse effects may be mitigated through alternative building techniques such as root bridging and/or avoidance.

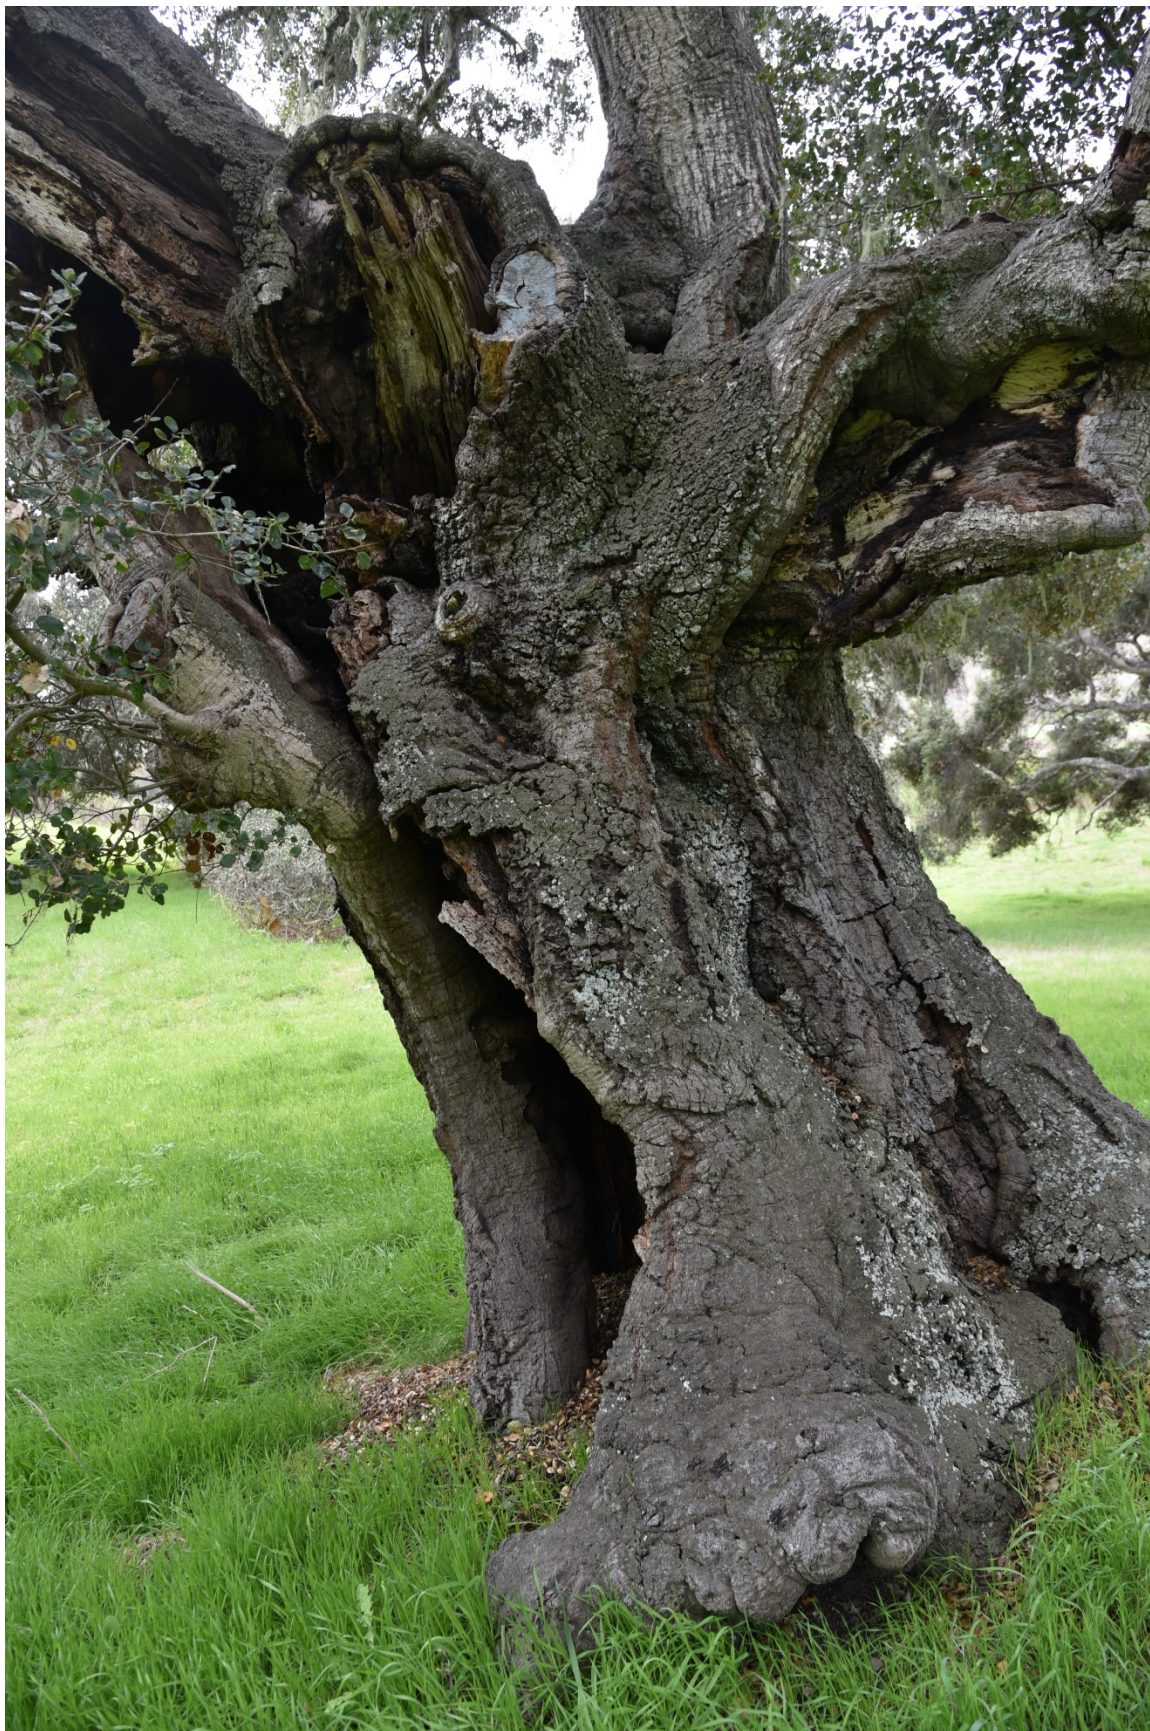
The base of #1802

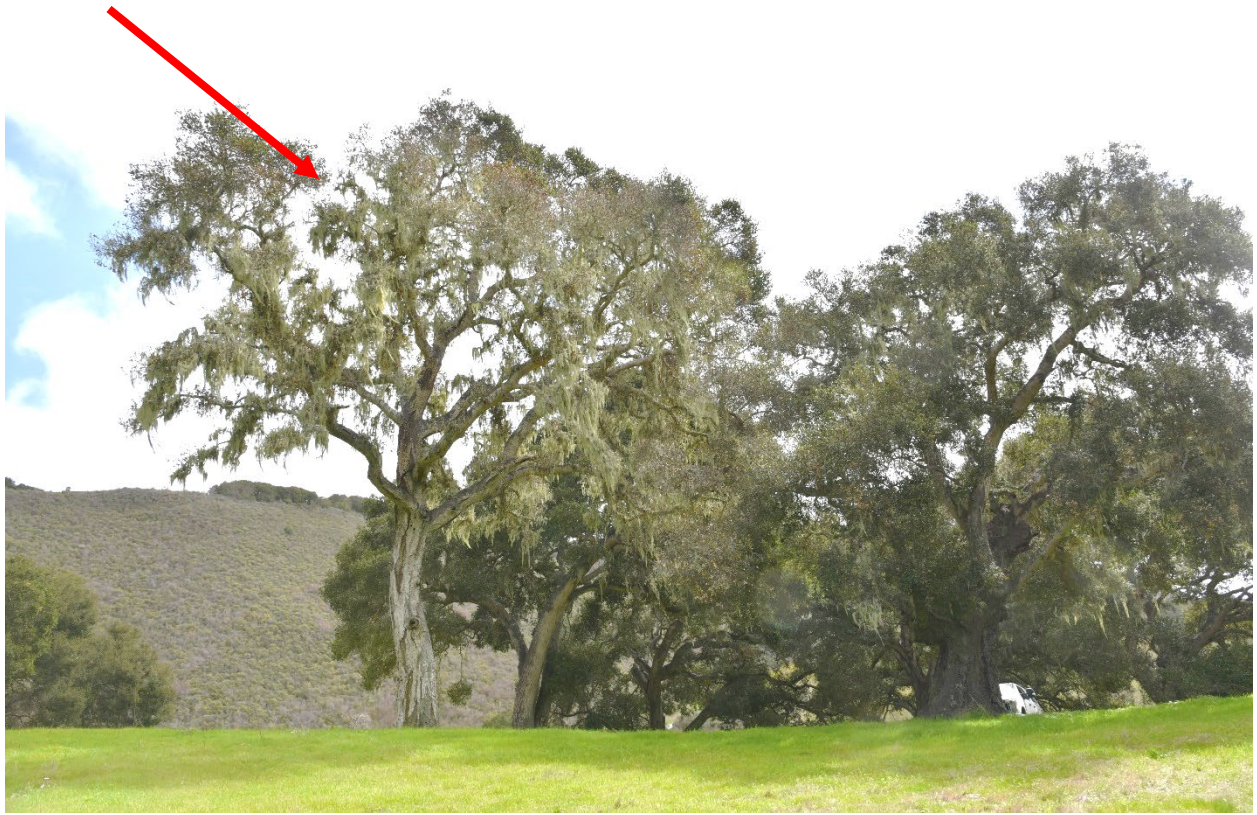
- An additional tree, (#1807 - 48" diameter) is located adjacent to the proposed structure and in decline due to the presence of Diplodia. The tree is located adjacent to the proposed structure. It is in poor condition and should be removed, it will be impacted not survive the grading process.

#1807 for removal

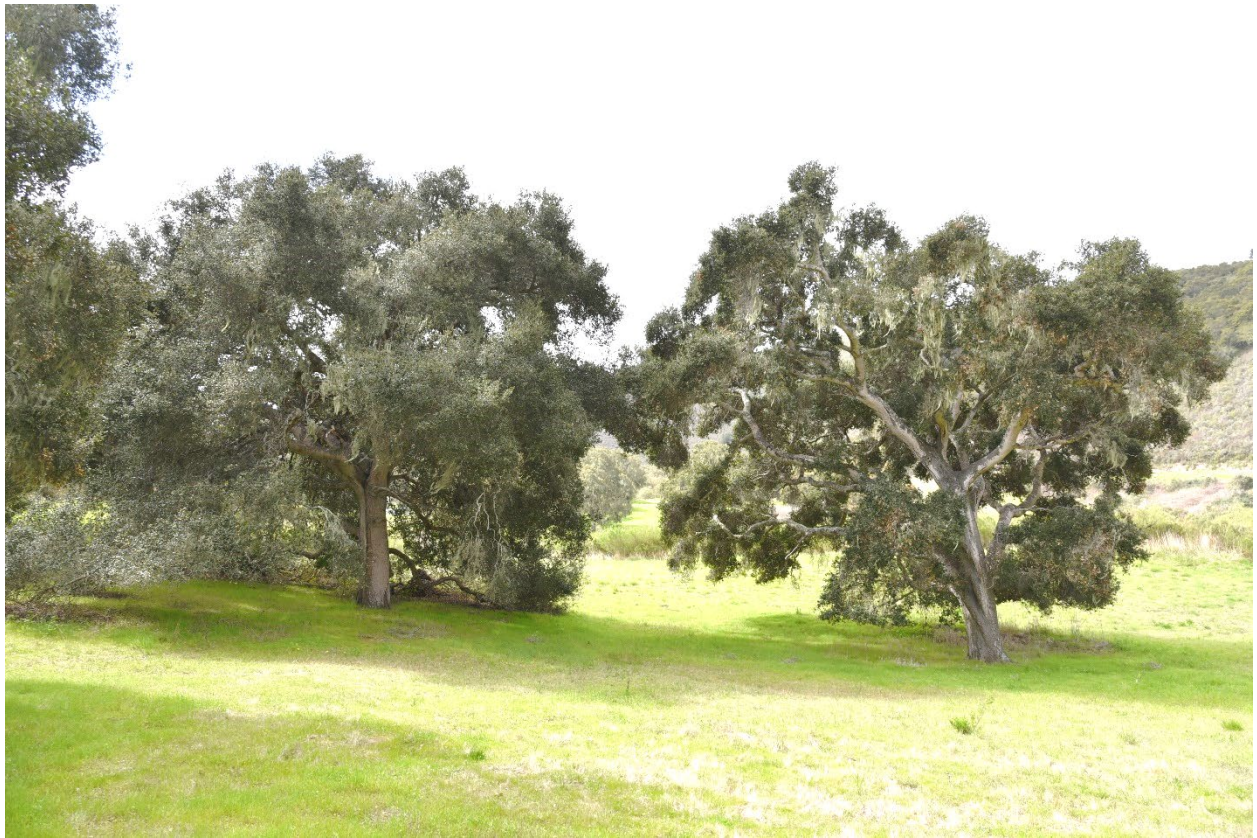
- Tree #1803 (43" oak) has a very full crown with overextended limbs lying on the ground.
- Tree #1809 (53" diameter oak) also with full crown and has limbs lying on the ground.

#'s 1808 and 1809 with Diplodia fungus exhibited on branch ends and foliage

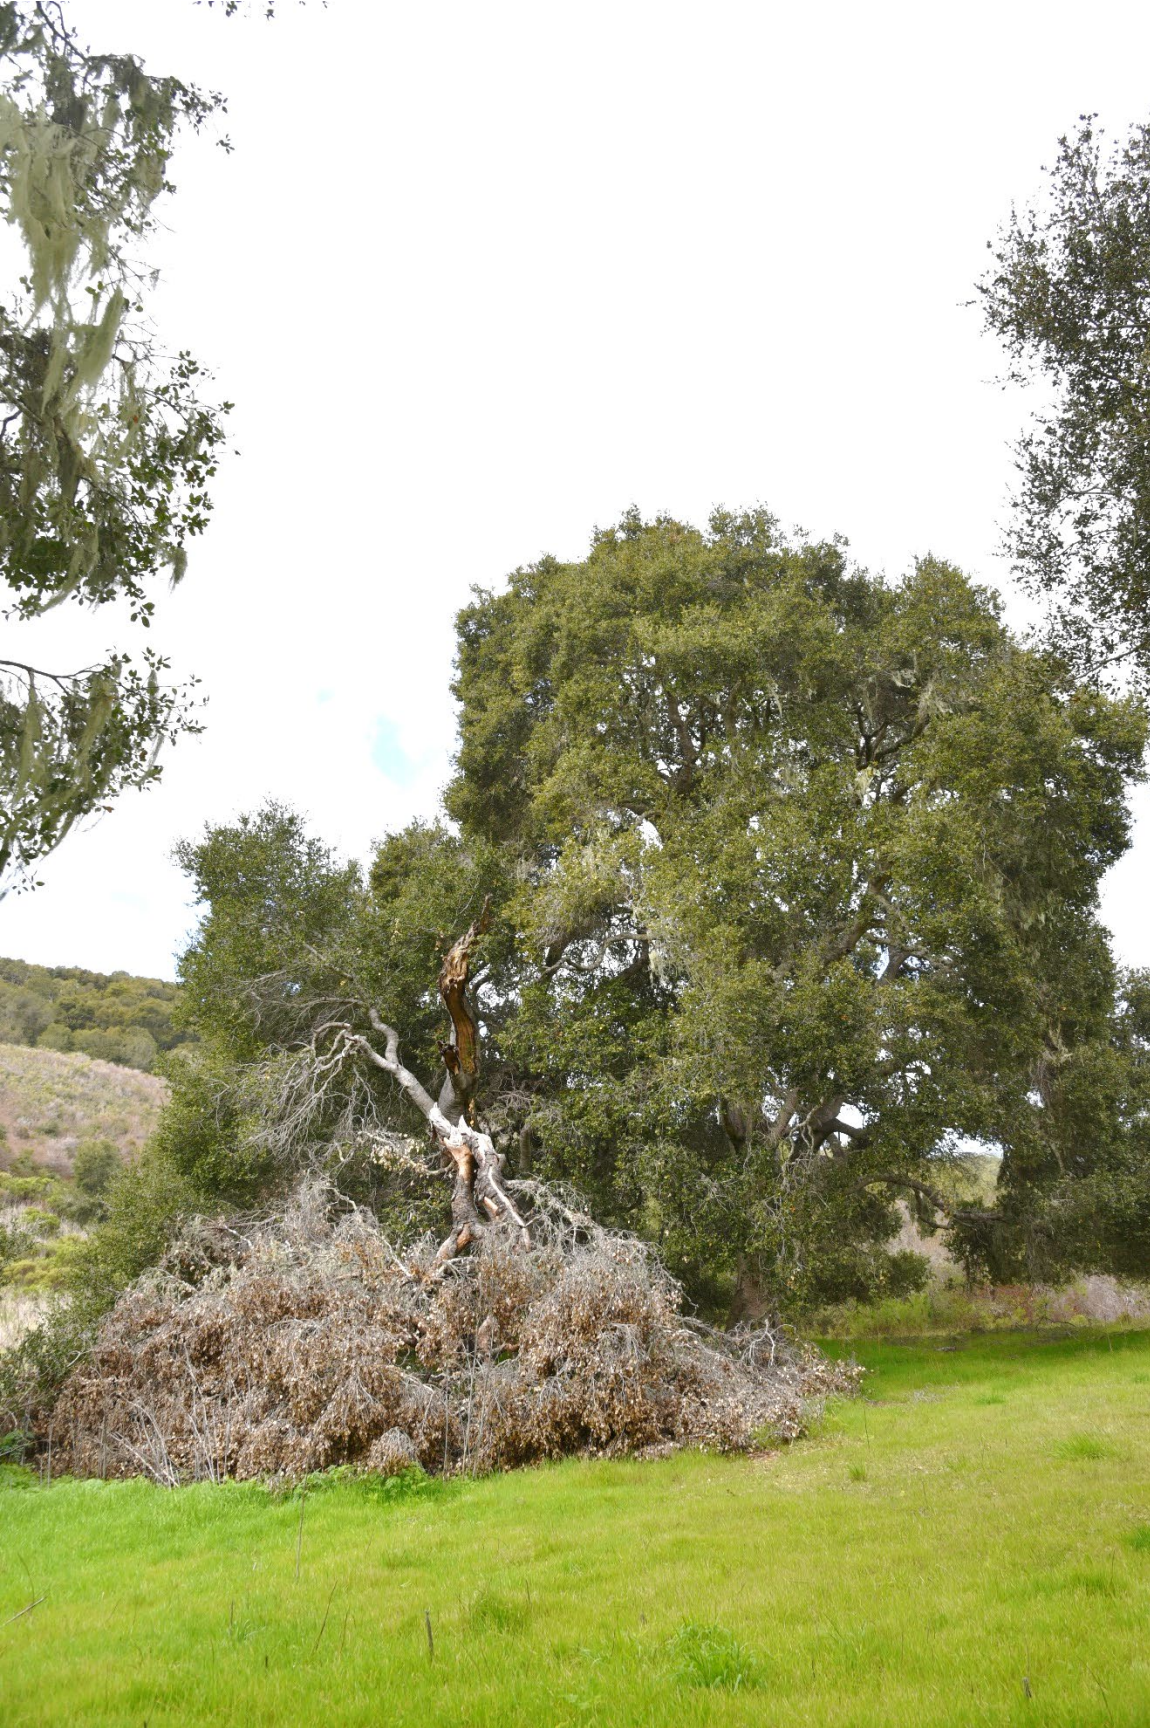
#1818

1817	22	QuAg	Excellent	Good	Dominant	
1818	38	QuAg	Fair	Poor	Codominant	Stem failure
1819	60	QuAg	Fair	Poor	Dominant	Ganoderma Conk, Heart rot
1820	52	QuAg	Fair	Poor	Codominant	overextended limbs
1821	15	QuAg	Good	Good	Codominant	
1822	9	QuAg	Good	Good	Codominant	
1823	15	QuAg	Good	Fair	Codominant	Multiple stems

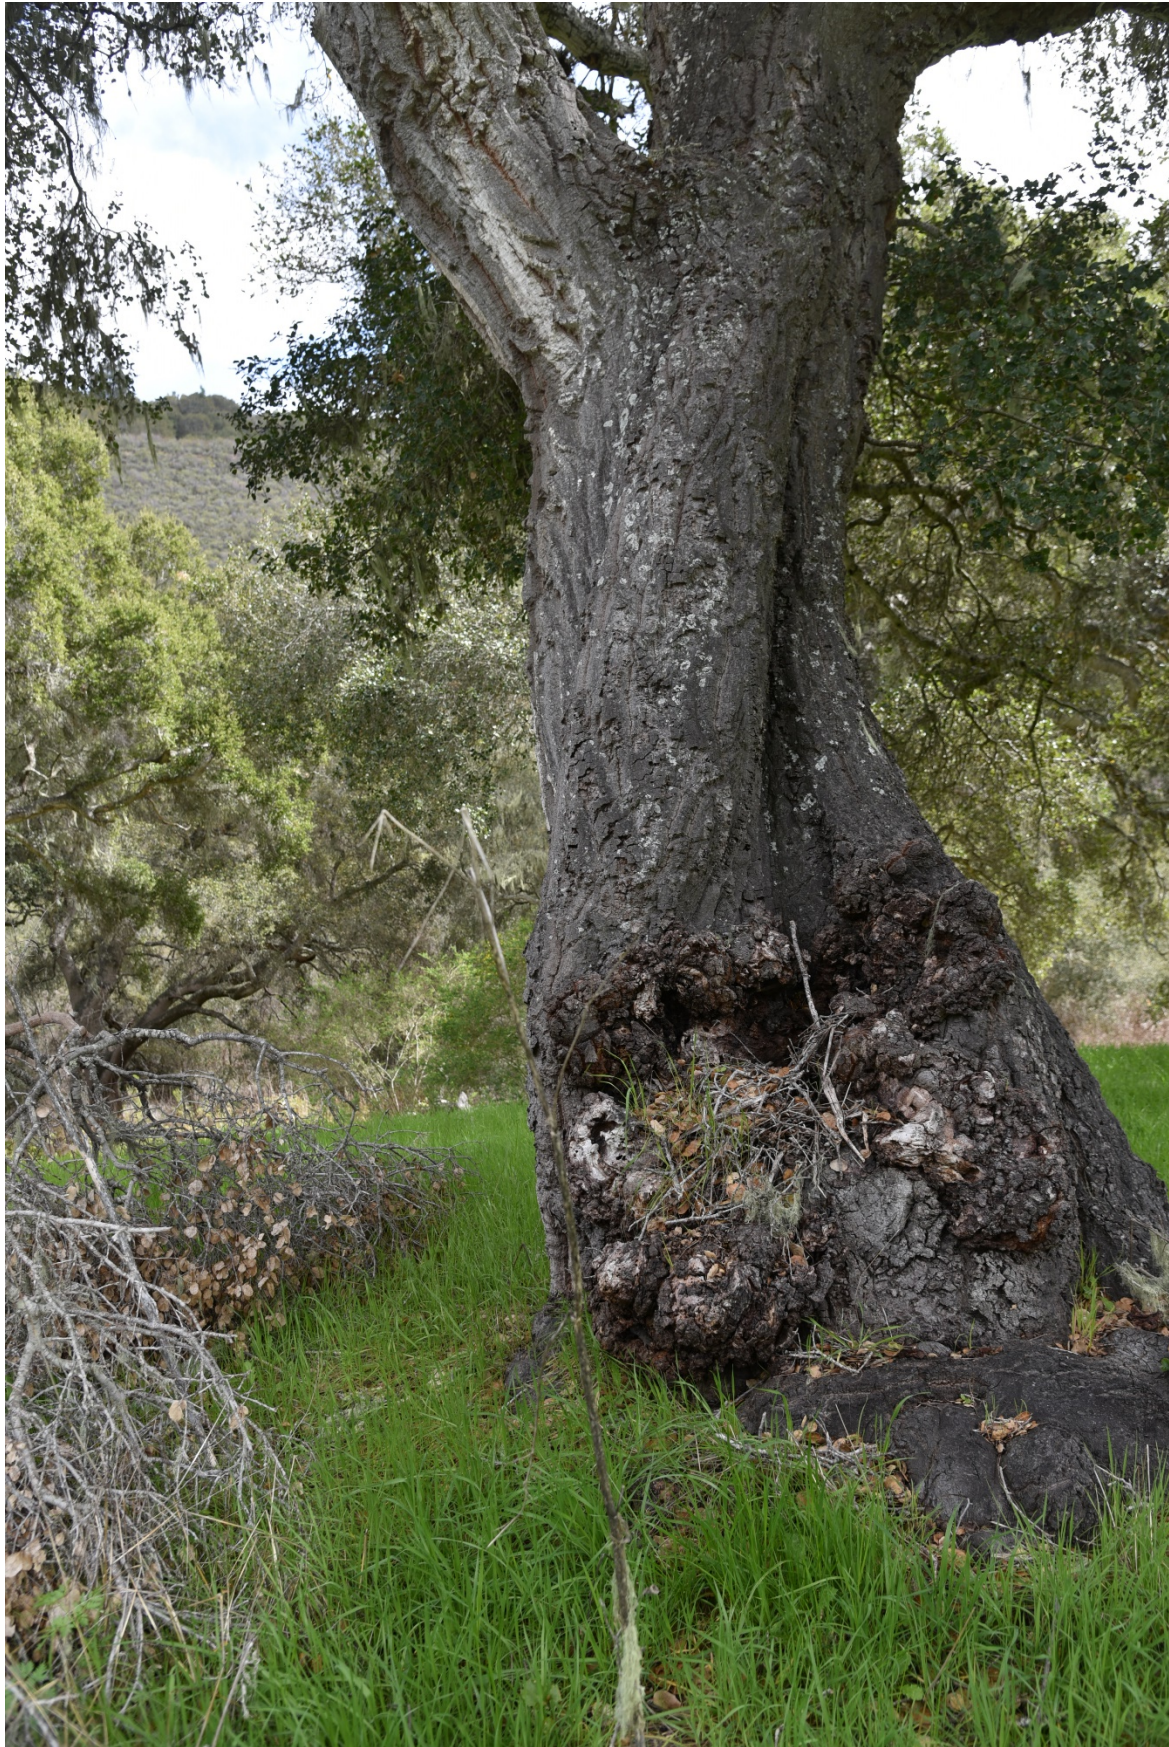
The base of #1807 – this tree is recommended for removal
