TREE RESOURCE ASSESSMENT
&
PRELIMINARY CONSTRUCTION
IMPACT ANALYSIS

Prepared by **COAST WILDLAND** for **Groza Construction** on behalf of
P. Wiley Curran, Owner

3038 Alta Avenue, Carmel, CA 93923

April 2, 2026

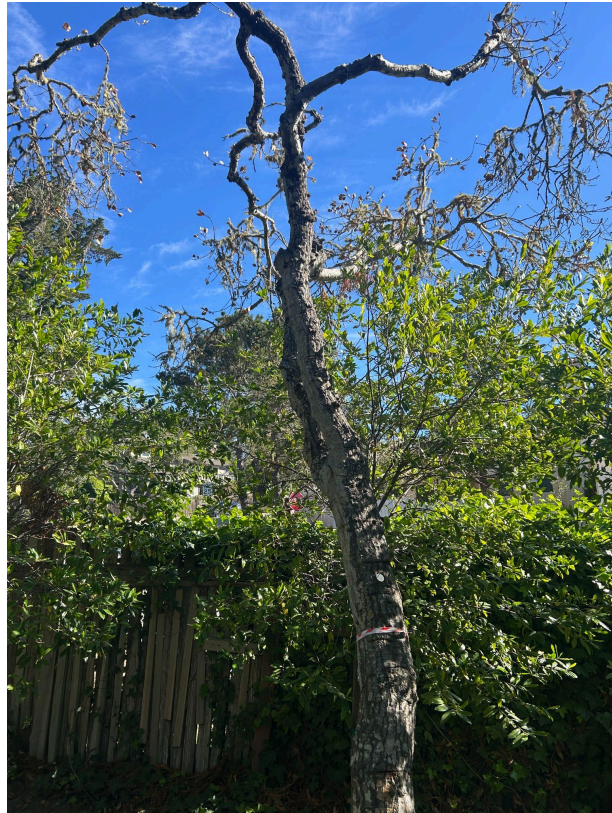
- 4.) Tree #055 would be replaced with one Coast live oak with the location to be determined by the final approved Landscape Plan.
- 5.) Tree #035, an 8.5" diameter Coast live oak, is obviously dead (it has no green foliage and has cracking/peeling bark). This tree should be removed for fire safety reasons. No replacement planting for this tree is recommended.

Tree #035 is an 8.5" Coast live oak that is obviously dead and should be removed for fire safety reasons. Replacement planting is not recommended due to crowded conditions.

035	Clo	8.5'	Dead	N/A	N/A	<i>Dead tree. Remove for fire safety reasons. See photos. The tree is marked with red and white striped flagging tape.</i>
036	Crw	55.5''*	Good/Good	28'	Low	<i>Landmark Coast redwood. Large burl visible at base of trunk and root flare. Growing along the adobe wall perimeter within the irrigated landscape area. Tree likely benefiting from landscape irrigation. Remove suckering water sprouts for fire safety.</i>
037/491*	Clo	24''*	Poor/Fair	24'	Low	<i>Landmark Coast live oak tree. Found tag #491 on tree. Left tag #491 and added #037 adjacent to it. Bark missing, canker/sap flow and decay visible at base of trunk and at historic branch removal site. Leaf loss, twig dieback and necrotic tissue visible in the canopy. Growing within the irrigated landscape area. Recommend not irrigating under canopy drip line during dry season in order to prevent further decay.</i>
038	Clo	7''	Fair/Poor	7'	Low	<i>Growing within an irrigated landscape area leaning over the fence toward Camino Del Monte.</i>

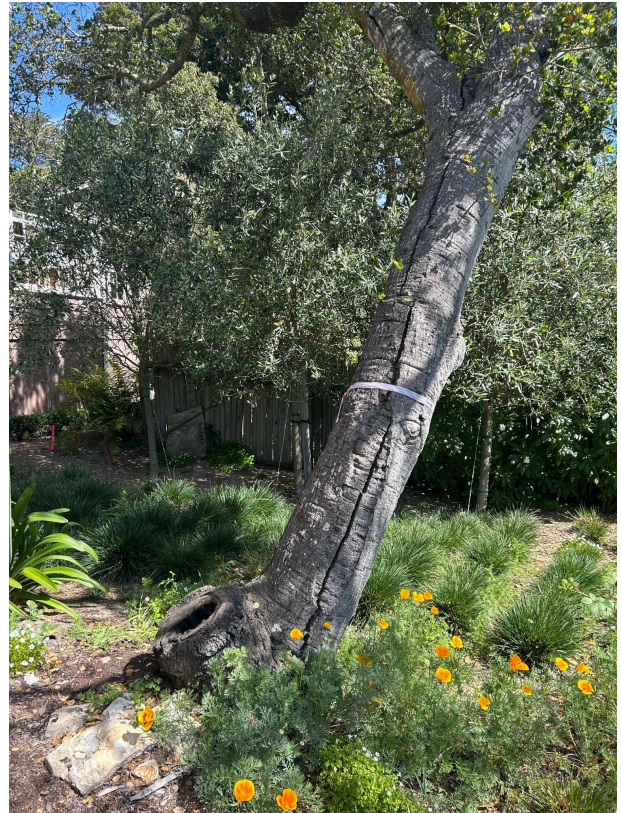
- 1.) One tree (tag #055) is located within the proposed ADU footprint and is proposed for removal. This tree is a 16" diameter Coast live oak in a state of *fair* health with *poor* structure. It shows obvious signs of decay at a historic secondary trunk removal site and has a significant lean toward the fence to the southeast. There were no signs of bird nesting or activity in tree #055 at time of assessment.

Tree #055 is a 16" Coast live oak tree planned for removal. Obvious signs of decay are visible at an historic secondary trunk removal site. The tree has a significant lean toward the fence to the southeast and is growing within the proposed ADU footprint. There were no signs of bird nesting or activity at the time of assessment. Replace with one 15 gallon Coast live oak.

055	Clo	16"	Fair/Poor	N/A	N/A	<i>Planned for removal. Obvious signs of decay at historic secondary trunk removal site. Significant lean toward the fence to the southeast. Growing within the proposed ADU footprint. No signs of bird nesting or activity at time of assessment. Replace with one Coast live oak as mitigation.</i>
056	Clo Cluster	11.5"-13.5"	Fair/Fair	20'	High	<i>Three stem oak growing adjacent to existing shed and planned ADU. Protect with sturdy high visibility, fencing during construction and minimize ground disturbance under canopy drip line. Monitor for any changes in condition.</i>
057	Clo	11.5"	Fair/Fair	11.5'	High	<i>Growing within 4 feet of the main house. Signs of decay at historic branch removal sites. Protect with sturdy high visibility, fencing during construction and minimize ground disturbance under canopy drip line. Monitor for any changes in condition.</i>
058	Nn	5"	Fair/Poor	5'	Mod	<i>Exotic (Leptospermum spp.) landscape tree species growing adjacent to the fence.</i>

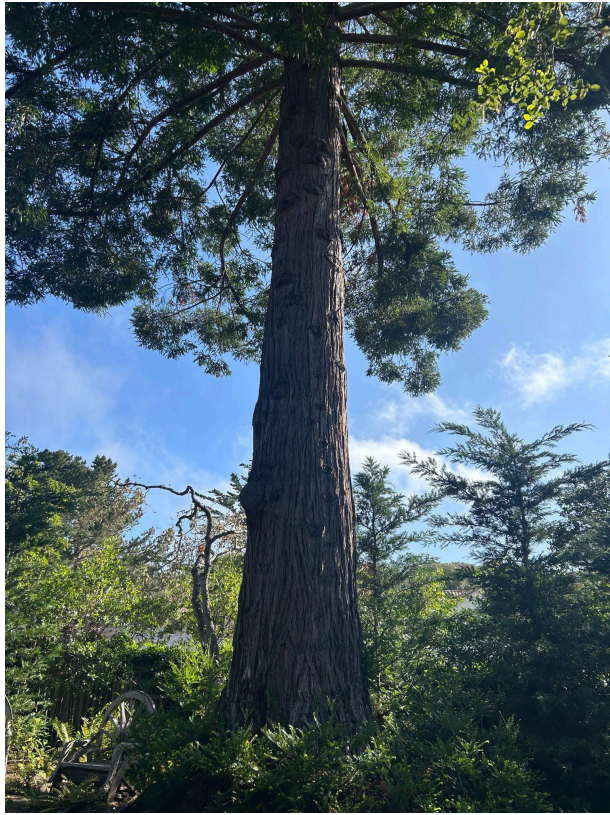
Tree #036 is a 55" diameter Landmark Coast redwood in good health with good structure and a large burl visible at base of trunk and root flare. It is growing along the adobe wall perimeter within the irrigated landscape area. This tree, unlike the Coast live oaks growing nearby, is likely benefiting from landscape irrigation. Regularly remove suckering water sprouts for fire safety.

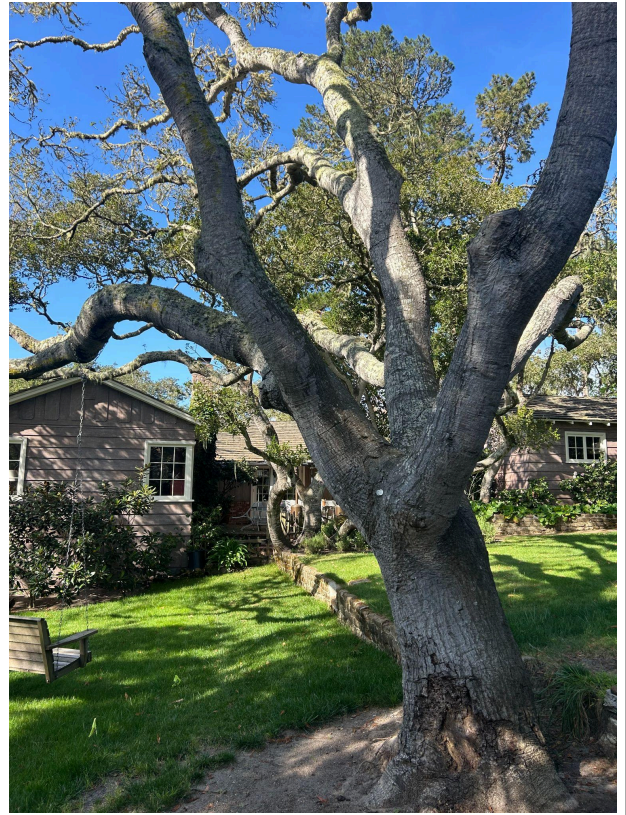
Tree #037/491 is a 24" Landmark Coast live oak tree in poor health with fair structure. I found tag #491 on this tree. I left tag #491 and added tag #037 adjacent to it. The tree has bark missing and cankers with sap flow and decay visible at the base of its trunk and at an historic branch removal site. Significant leaf loss, twig dieback and necrotic tissue were visible in the canopy. Growing within the irrigated landscape area. Recommend not irrigating under canopy drip line during dry season in order to prevent further decay.

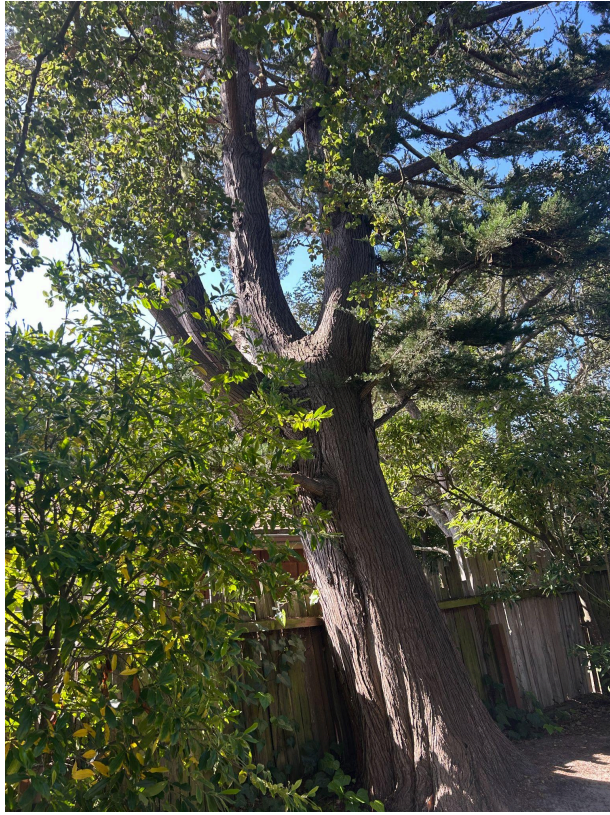
Tree #048 is a 38.5" Landmark Monterey cypress in good health with fair structure, leaning over the fence toward the Neighbor to the south.

048	Cyp	38.5''*	Good/Fair	38.5'	Low	<i>Large Landmark cypress leaning on fence with a significant lean toward Neighbor to the south.</i>
049	Clo	11.5''	Fair/Fair	11.5'	Low	<i>Growing within 4 feet of the main house. Recommend removing pittosporum shrubs below the canopy for fire safety reasons.</i>
050	Clo	13''	Fair/Fair	13'	Low	<i>Growing within 4 feet of the main house.</i>
051	Clo	7.5''	Fair/Fair	7.5'	Low	<i>Growing within 8 feet of the main house. Recommend removing pittosporum shrubs below the canopy for fire safety reasons.</i>
052	Clo	12''	Fair/Poor	12'	High	<i>Leaning over the fence into the neighbor's yard. Recommend removing landscape shrubs growing below the canopy for fire safety reasons. Prune according to the Fuel Management Plan and ANSI A300 Tree Care Standards. Protect during construction with sturdy high visibility fencing.</i>
053	Clo	13.5'', 16''	Fair/Fair	16'	High	<i>Two trunk oak leaning over the fence into the neighbor's yard. Protect during construction with sturdy high visibility fencing.</i>

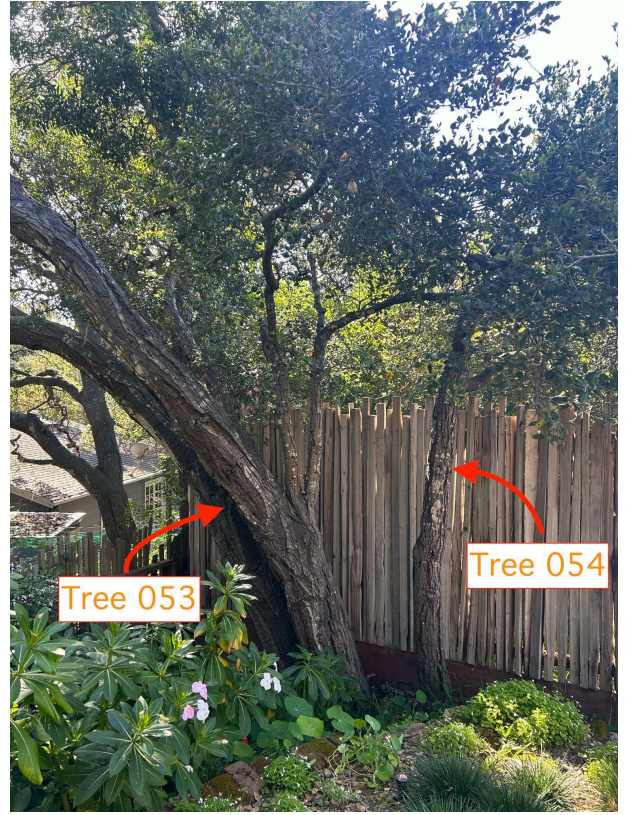
Trees #053 and #054

Tree #053 is a two trunk oak (13.5", 16") Coast live oak in fair health with fair structure leaning over the fence into the neighbor's yard.

Tree #054 is an 8" diameter Coast live oak in fair health with poor structure.

Both of these trees have high potential to be impacted by the proposed construction and should be protected by highly visible, sturdy tree protection fencing.

054	Clo	8''	Fair/Poor	8'	High	<i>Protect during construction with sturdy high visibility fencing.</i>

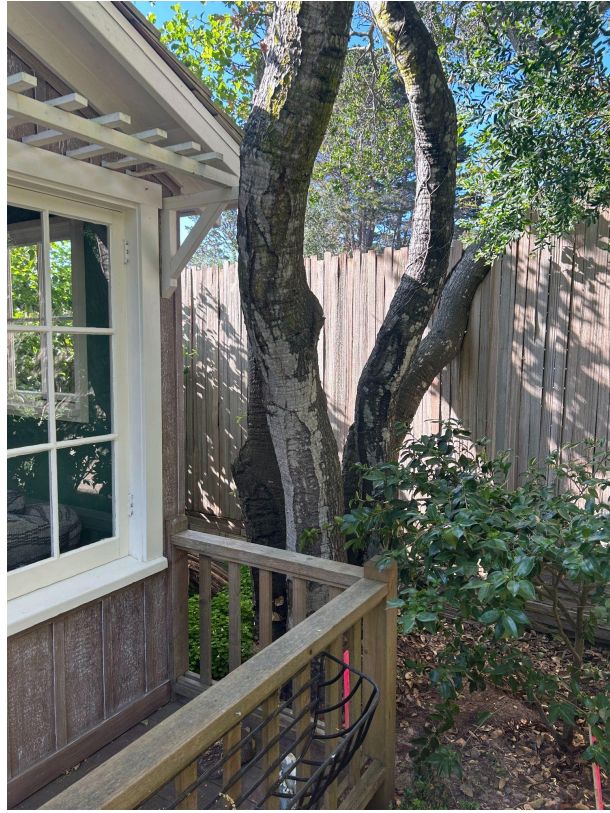
Tree #056 is a three stem (11.5"-13.5") Coast live oak in fair health with fair structure growing adjacent to the existing shed and planned ADU. Protect with sturdy high visibility, fencing during construction and minimize ground disturbance under canopy drip line. Monitor for any changes in condition during and after construction.

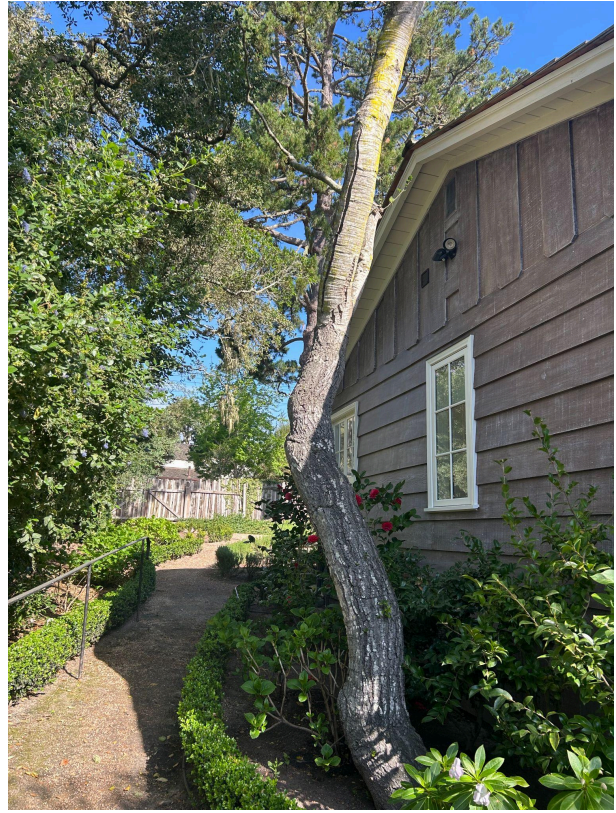
Tree #057 is a 11.5" Coast live oak in fair health with fair structure growing within 4 feet of the existing main house. It shows signs of decay at historic branch removal sites. Protect with sturdy high visibility, fencing during construction and minimize ground disturbance under canopy drip line. Monitor for any changes in condition.

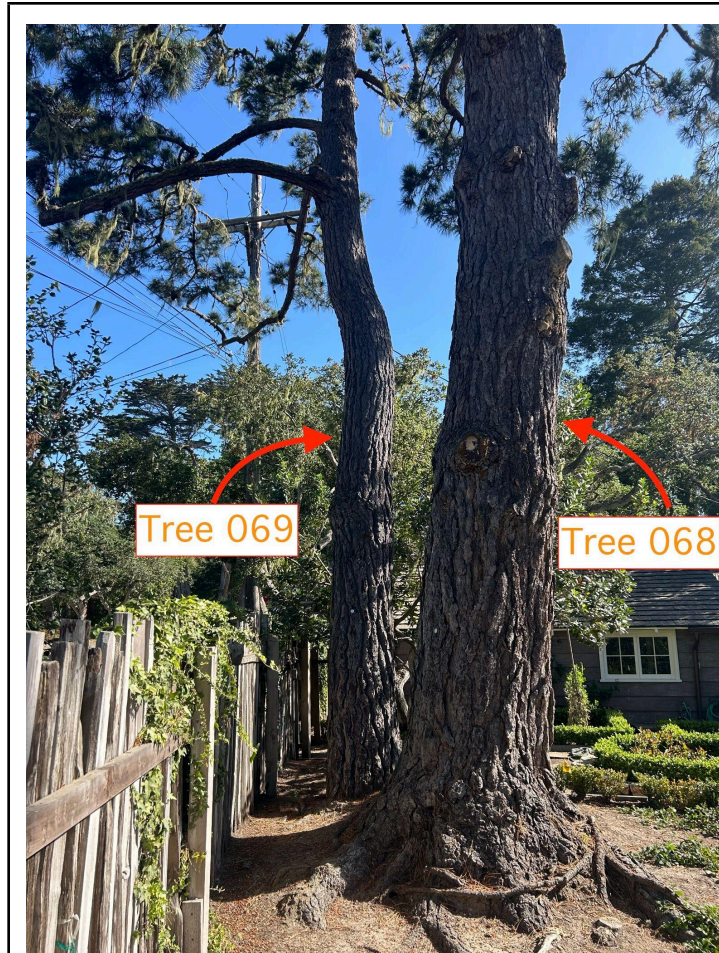
Tree #068 and Tree #069

Tree #068 is a 40" Landmark Monterey pine tree in good health with fair structure. Girdling roots are visible at the root flare. Protect during construction with sturdy high visibility fencing.

Tree #069 is a 24.5" Landmark Monterey pine in fair health with fair structure. It is leaning toward utility lines and a utility pole. Protect with sturdy, high visibility fencing during construction.

069	Mp	24.5''*	Fair/Fair	30'	Low	<i>Landmark Monterey pine with a lean toward utility lines and utility pole. Protect with sturdy, high visibility fencing during construction.</i>
070	Toyon	5''	Poor/Fair	5'	Mod	<i>CA Native Toyon shrub pruned to tree shape growing adjacent to entrance pathway. Obvious signs of decay at the base of the trunk likely made worse from irrigation. Recommend not irrigating under canopy during dry season. Protect with sturdy high visibility fencing during construction.</i>
071	Clo	9'', 12.5''	Fair/Fair	15.5'	Mod	<i>Two trunk oak with a lean toward the garage and main house, growing adjacent to the entrance footpath. Protect with sturdy high visibility fencing during construction.</i>
072	Clo	9''	Fair/Fair	9'	Low	<i>Growing directly under and into powerlines.</i>
