THOMPSON
WILDLAND MANAGEMENT

October 2, 2025

Nunnelee Residence
3144 Spruance Road
Pebble Beach, CA. 93953
APN: 008-501-004-000

Subject: 3144 Spruance Road Pre-construction Tree Impact Assessment

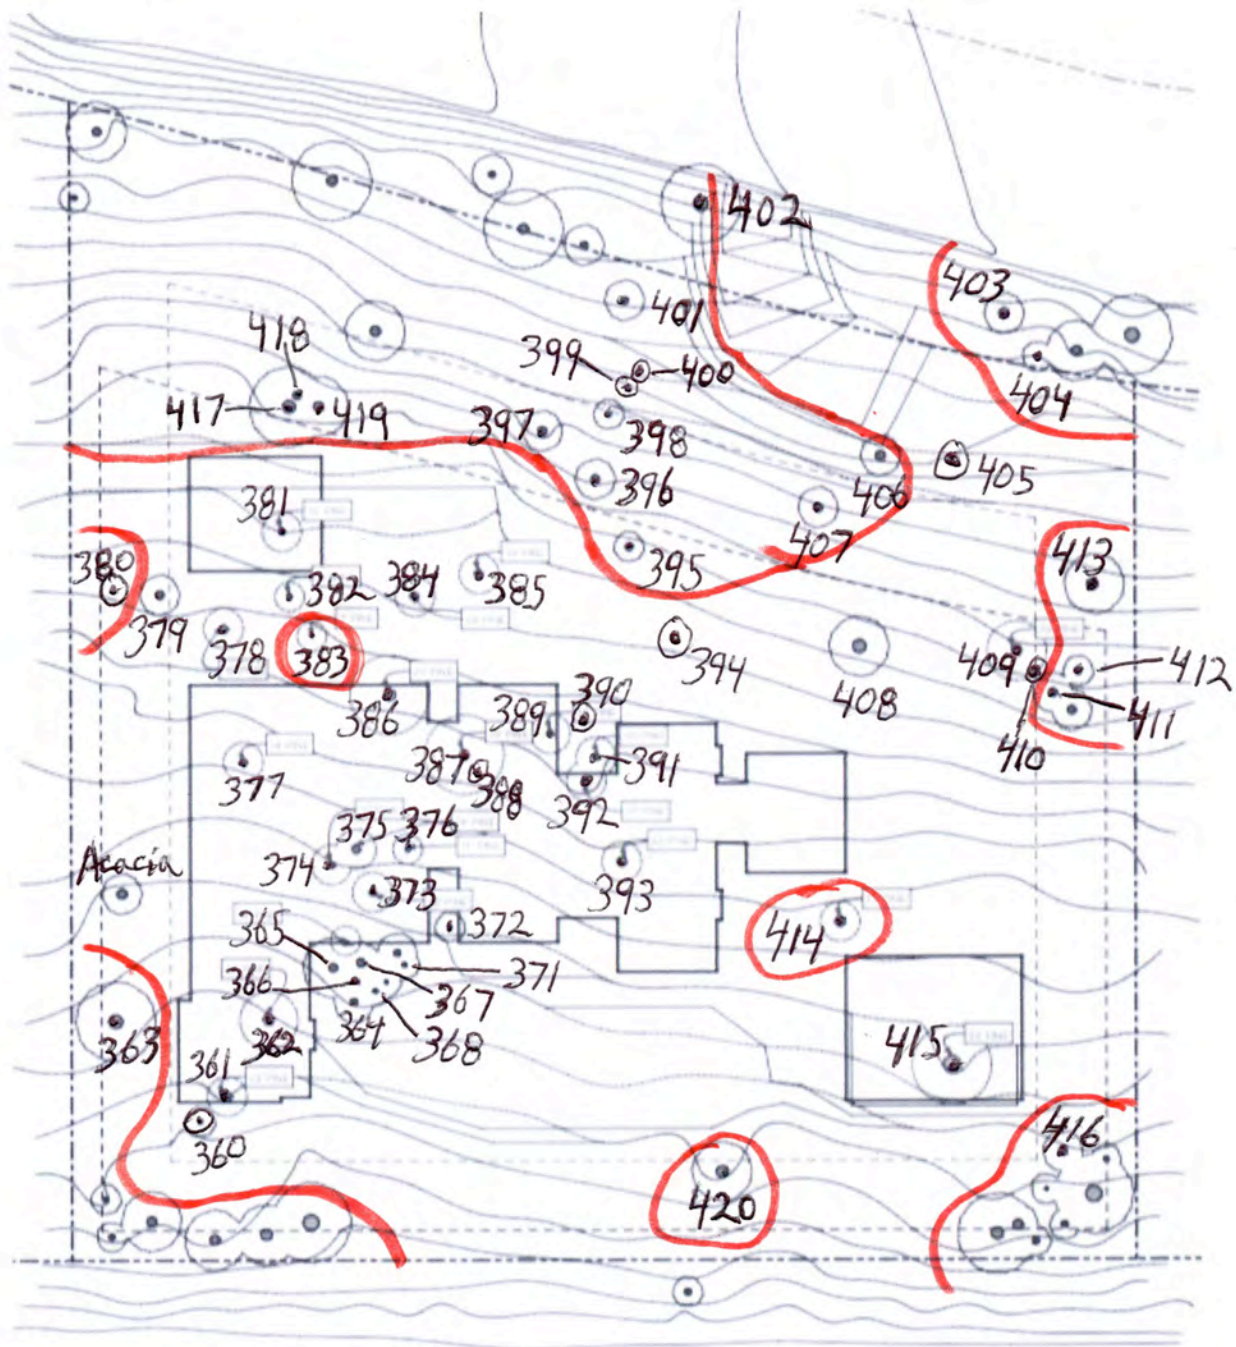
⊗ SITE PLAN - TREE REMOVAL
SCALE 1/8" = 1'-0"

Exhibit A: Tree Location & Tree Protection Fencing Map shows the location of 61 Monterey pine trees that were tagged and evaluated during a pre-construction impact assessment. This includes 40 pines proposed for removal, as well as several pines that will be retained and protected during property development activities. The red lines identifies the approximate location of tree protection fencing that will be installed to protect trees for the duration of the project.

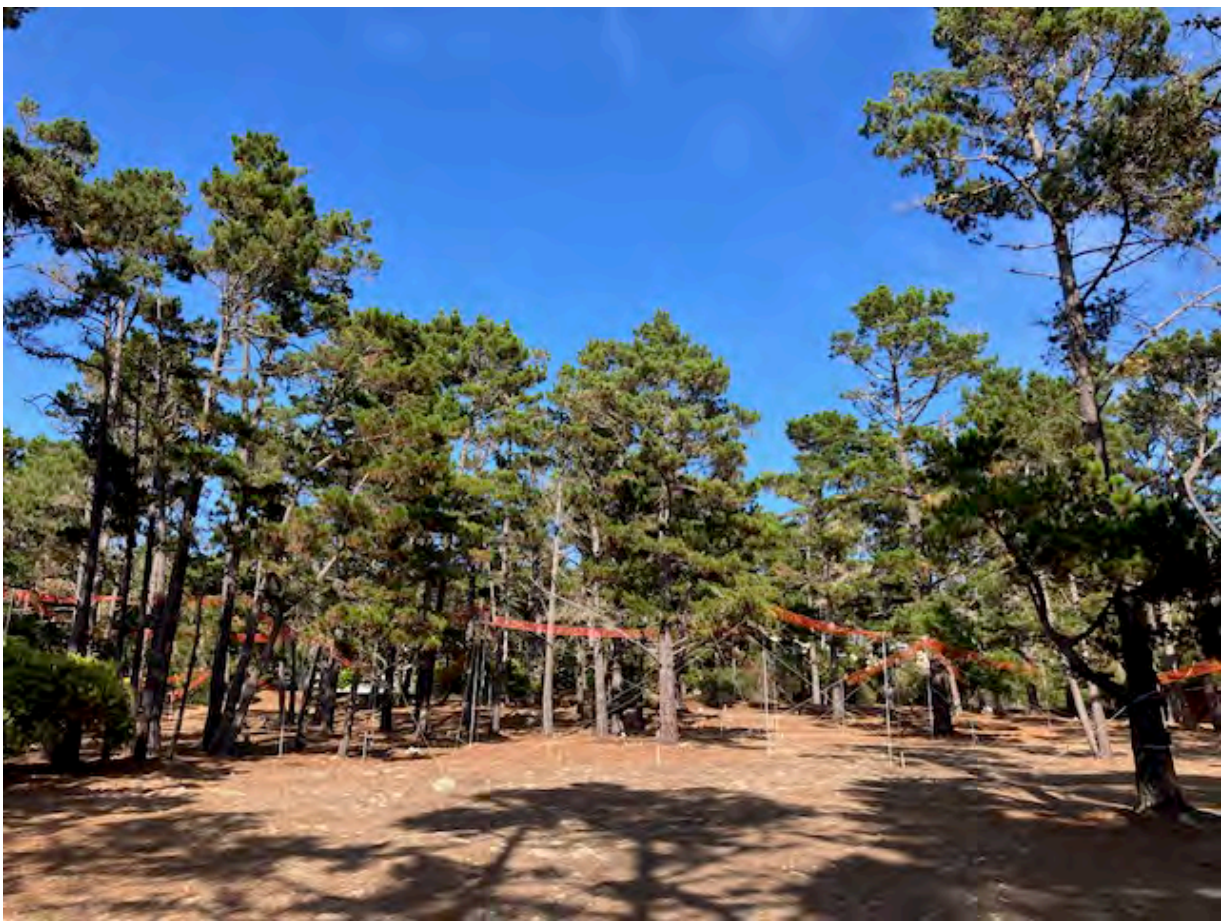
Figure 1. The proposed home and property development construction site is located in a Monterey pine woodland community.

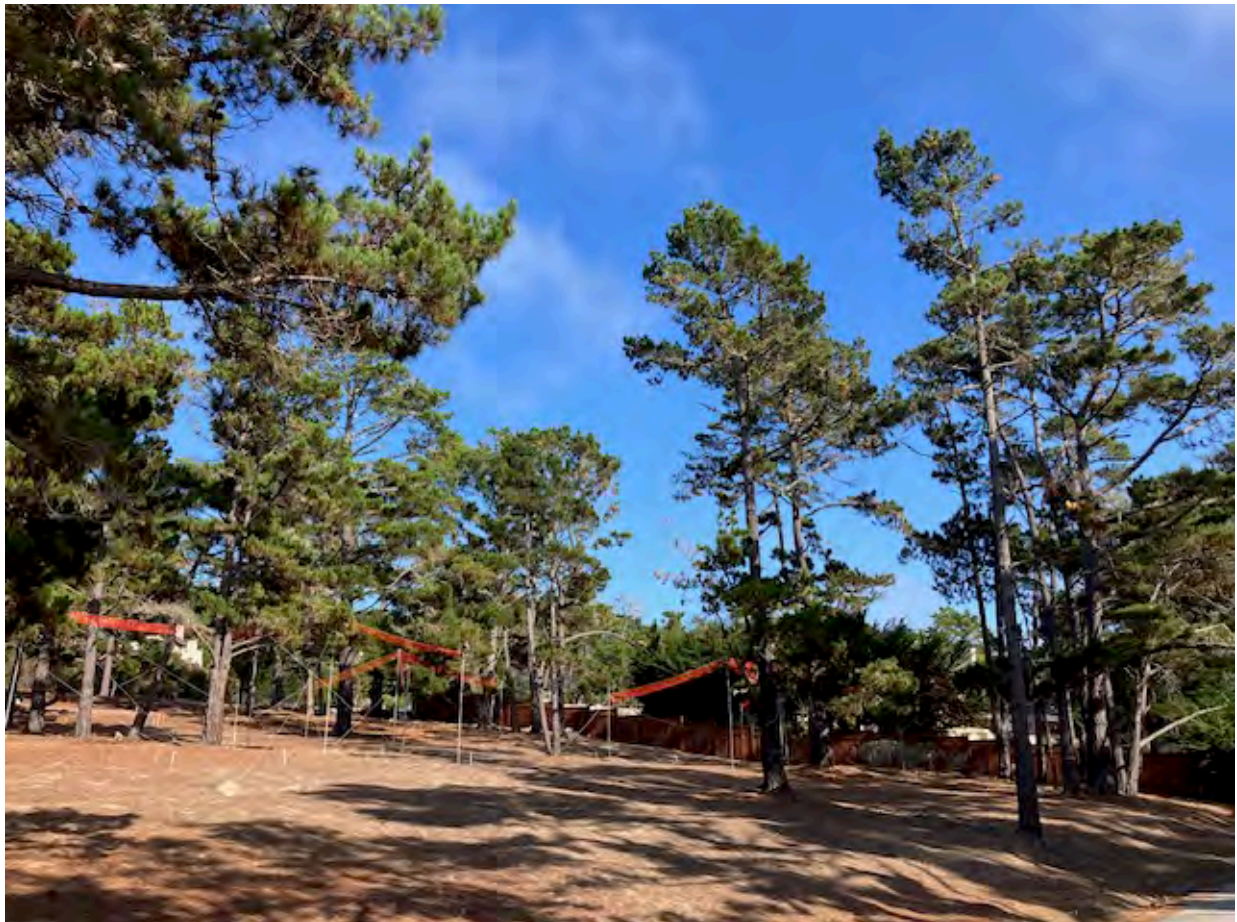
Figure 2. Another view of the proposed homesite, as well as a small ADU site (located right of center) from Deer Path Road.

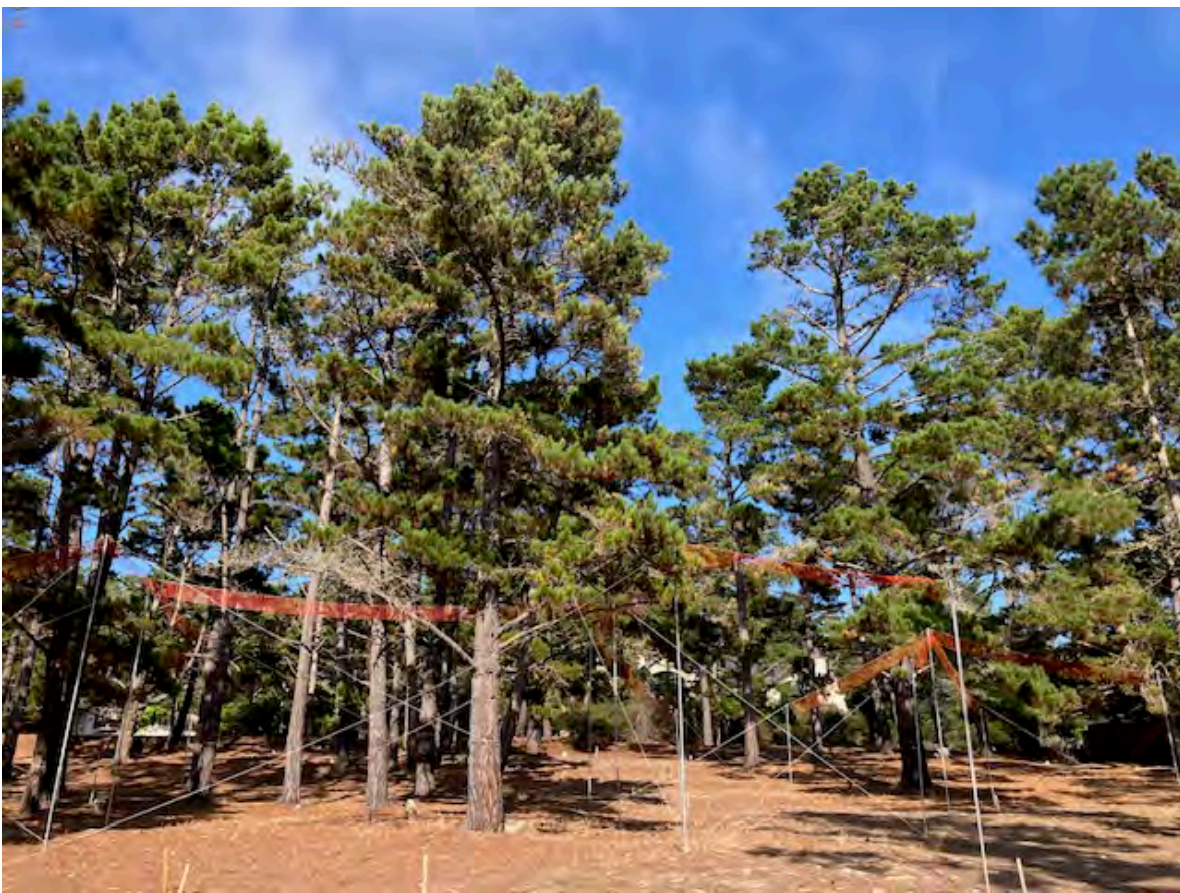
Figure 3. Close view of a portion of the proposed homesite located in a fairly densely wooded area of the lot. 40 pine trees are proposed for removal in preparation for property development activities and 46 will be retained and protected.

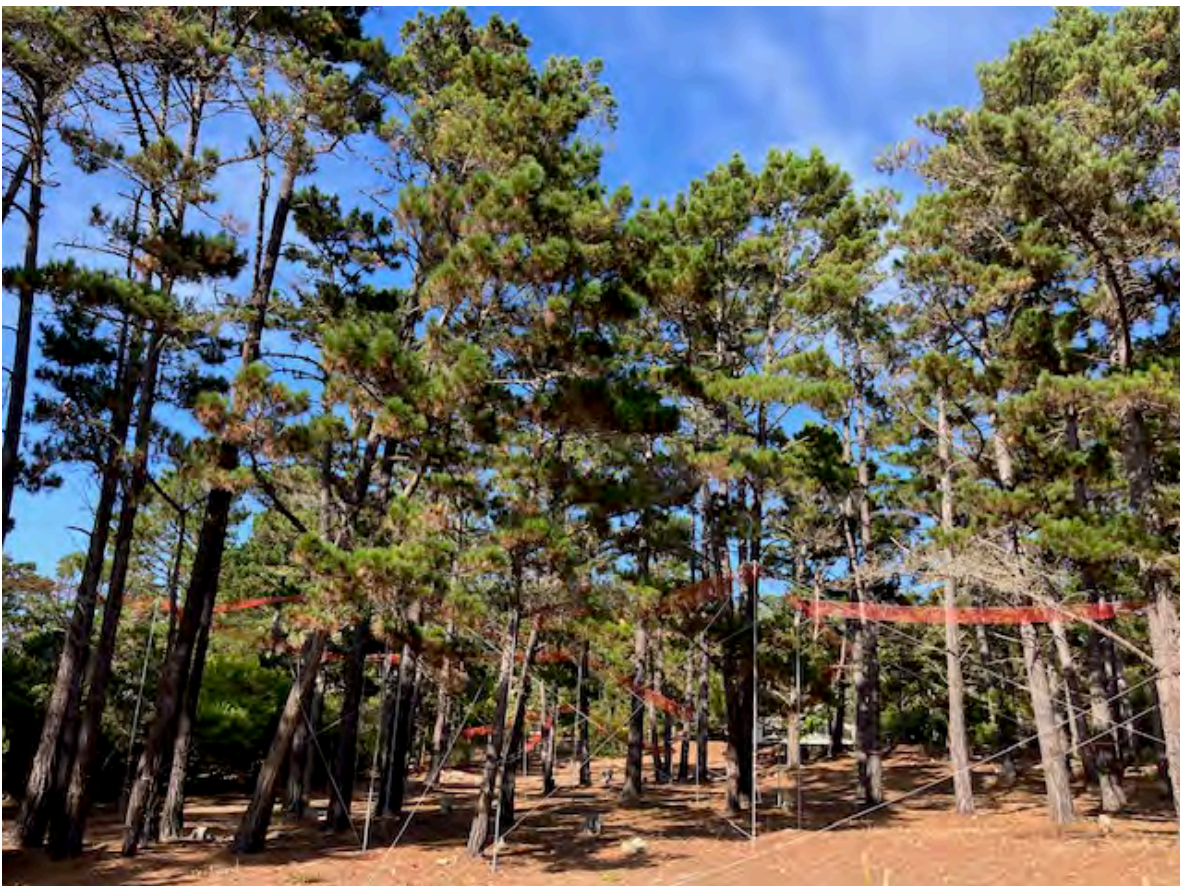
Figure 4. Another view of proposed homesite from Deer Path road. This parcel is dominated by mature and aging Monterey pines, several of which are in poor and declining physiological health and structural condition.

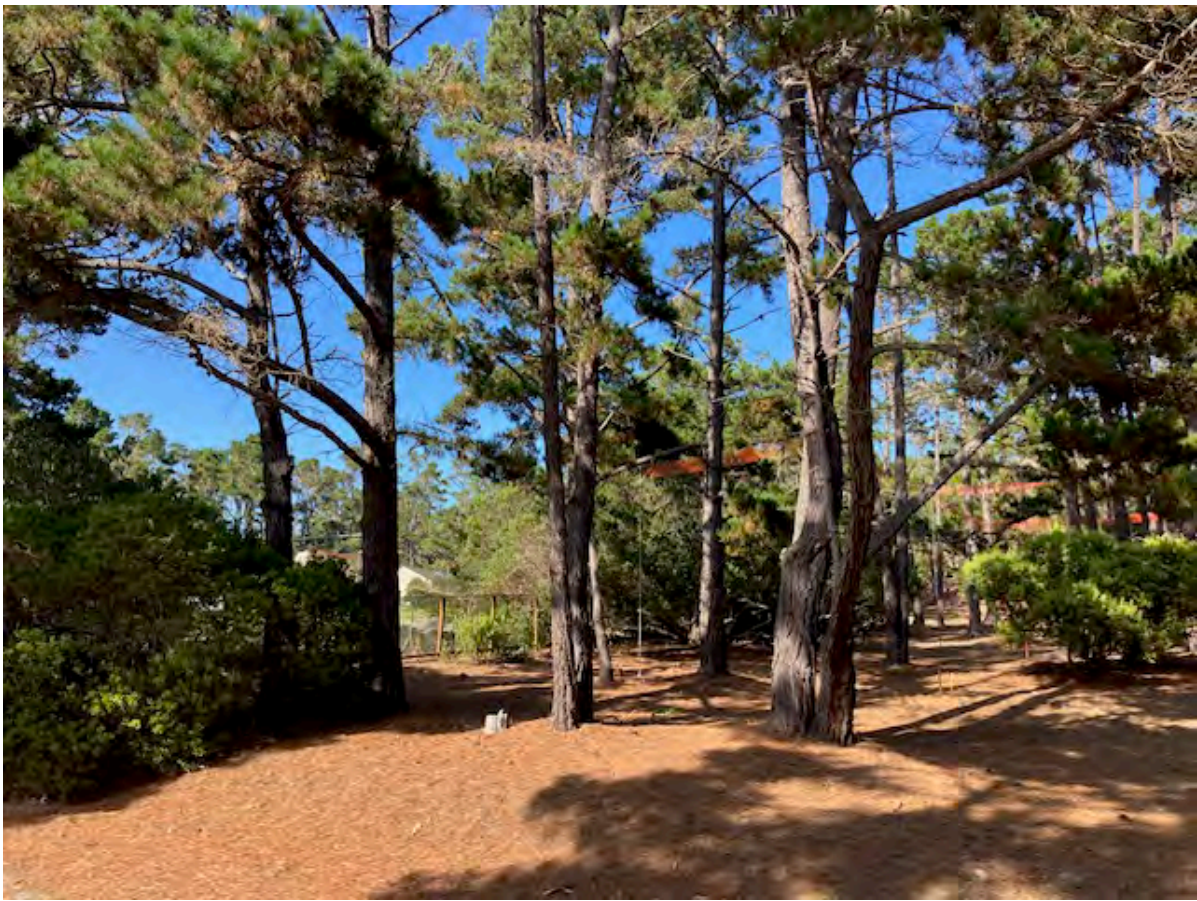
Figure 5. In addition to mature pine trees, which dominate the property, there are also several large non-native invasive acacias (a few are visible in this photo) that are located on the northwest side of the lot.

Woodland understory vegetation is sparse and limited on the subject parcel due to past vegetation removal and fuel reduction operations (refer to *Figures 1-9*). Native understory flora observed includes the following species: Poison oak (*Toxicodendron diversilobum*), coyote brush (*Baccharis pilularis*), woolly leaf manzanita (*Arctostaphylos tomentosa*), sticky monkey flower (*Mimulus aurantiacus*), Pacific blackberry (*Rubus ursinus*), Douglas iris (*Iris douglasiana*), California aster (*Symphyotrichum chilense*) and a few species of native bunch grasses. Non-native invasive plant species observed on the lot was limited to golden wattles (*Acacia longifolia*), which can be described as large shrubs or small trees, as well as a few species of exotic grasses. Non-native invasive plants can be harmful and degrading to habitat and should be controlled, managed and, where possible, eradicated.

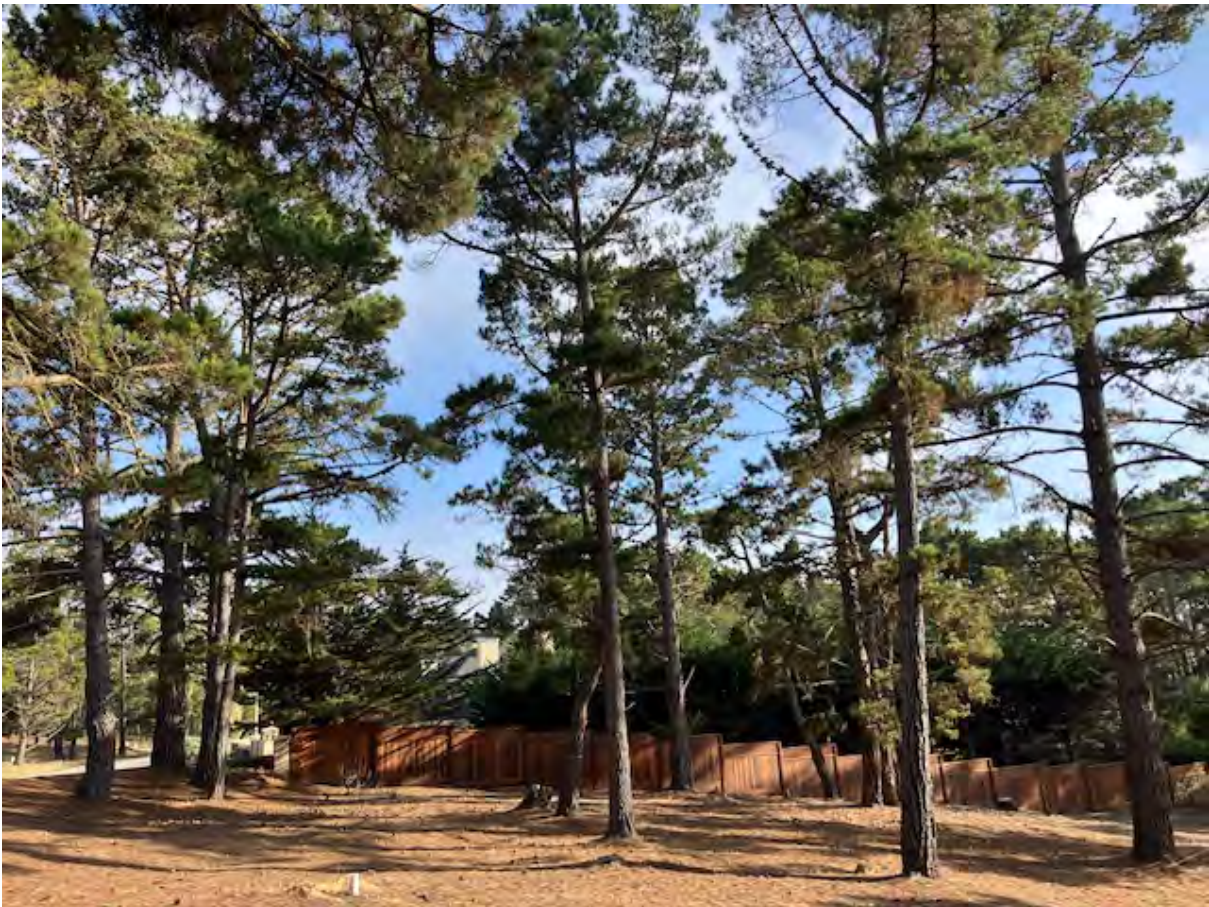
Figure 6. View of this pine woodland lot up towards the northeast Spruance Road side of the property.

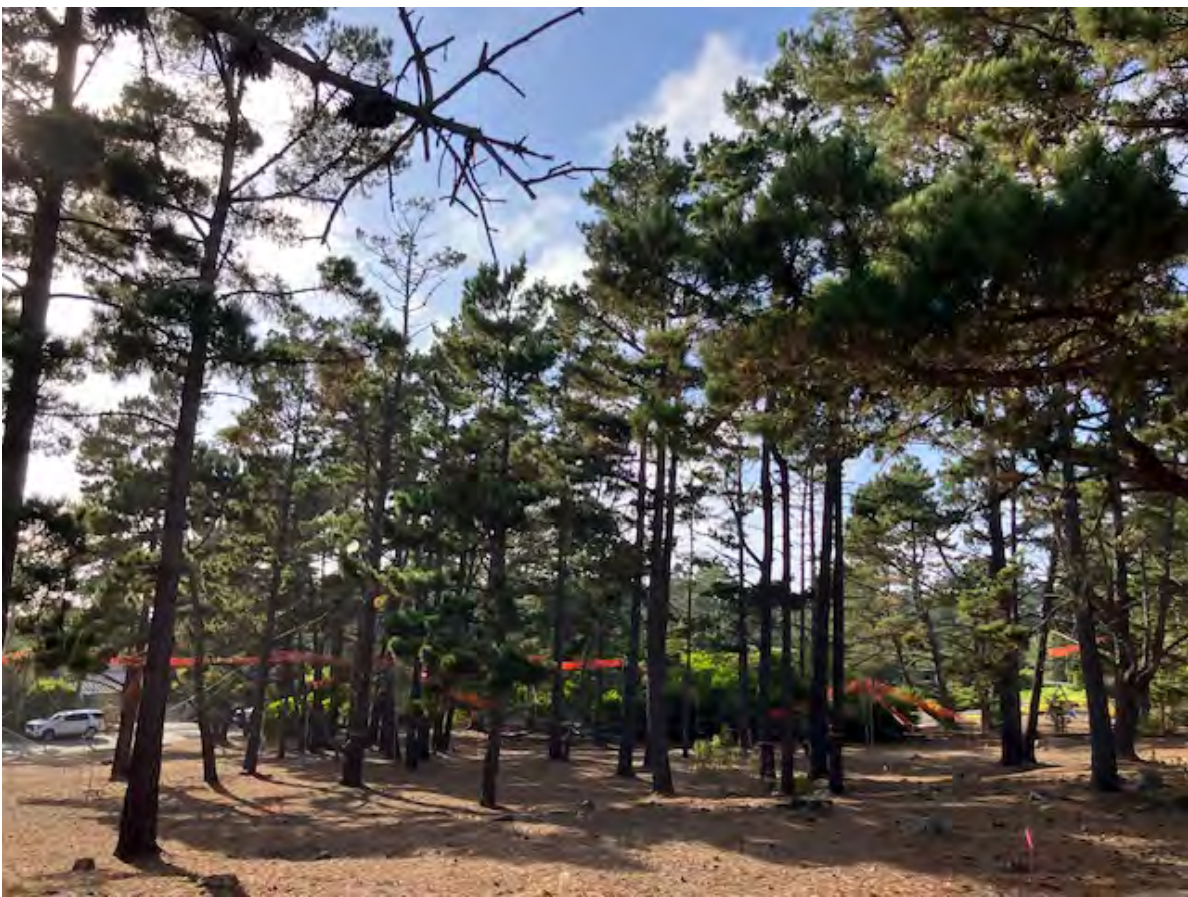
Figure 7. Another view of proposed homesite area from the Spruance Road side of the lot. The detached garage is flagged on the right side area of the photo.

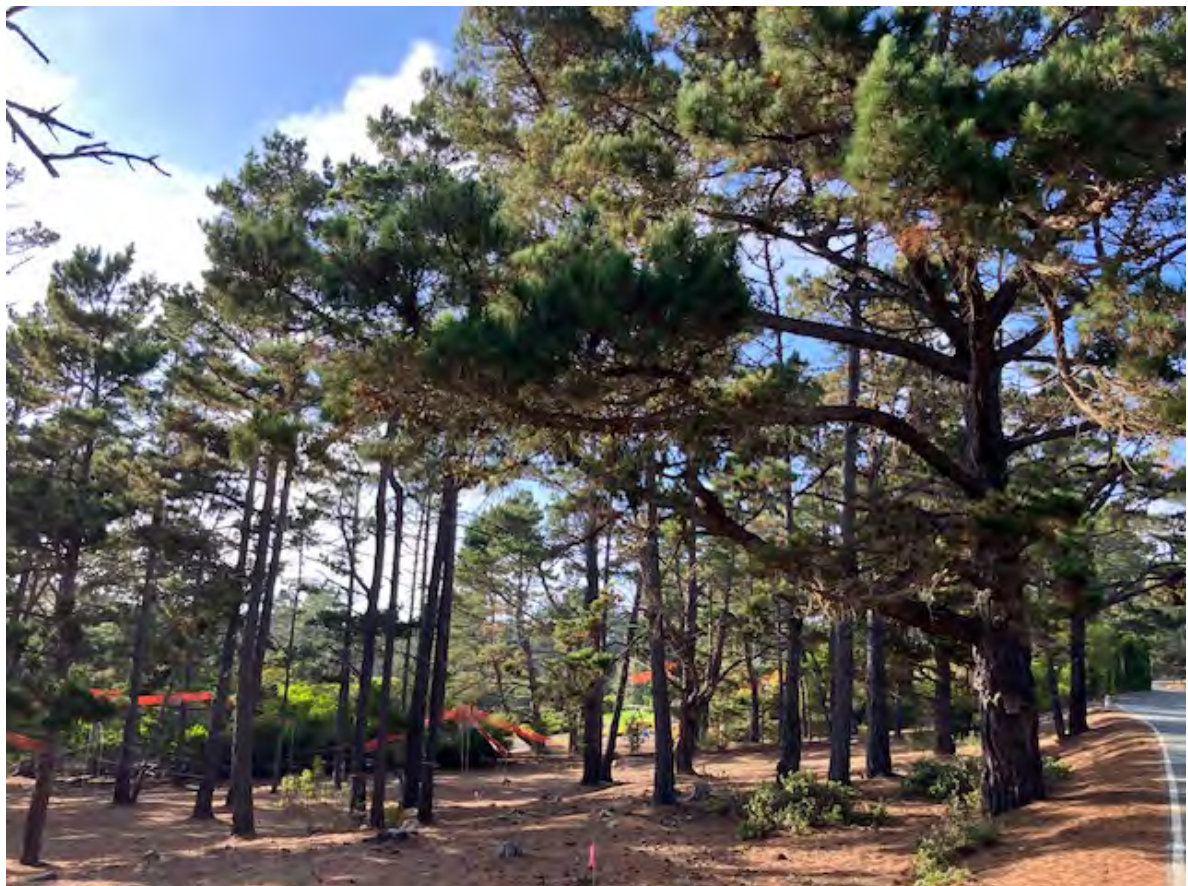
Figure 8. View from area where the proposed paved driveway will access the property. The detached garage will be located in the center area of the photo.

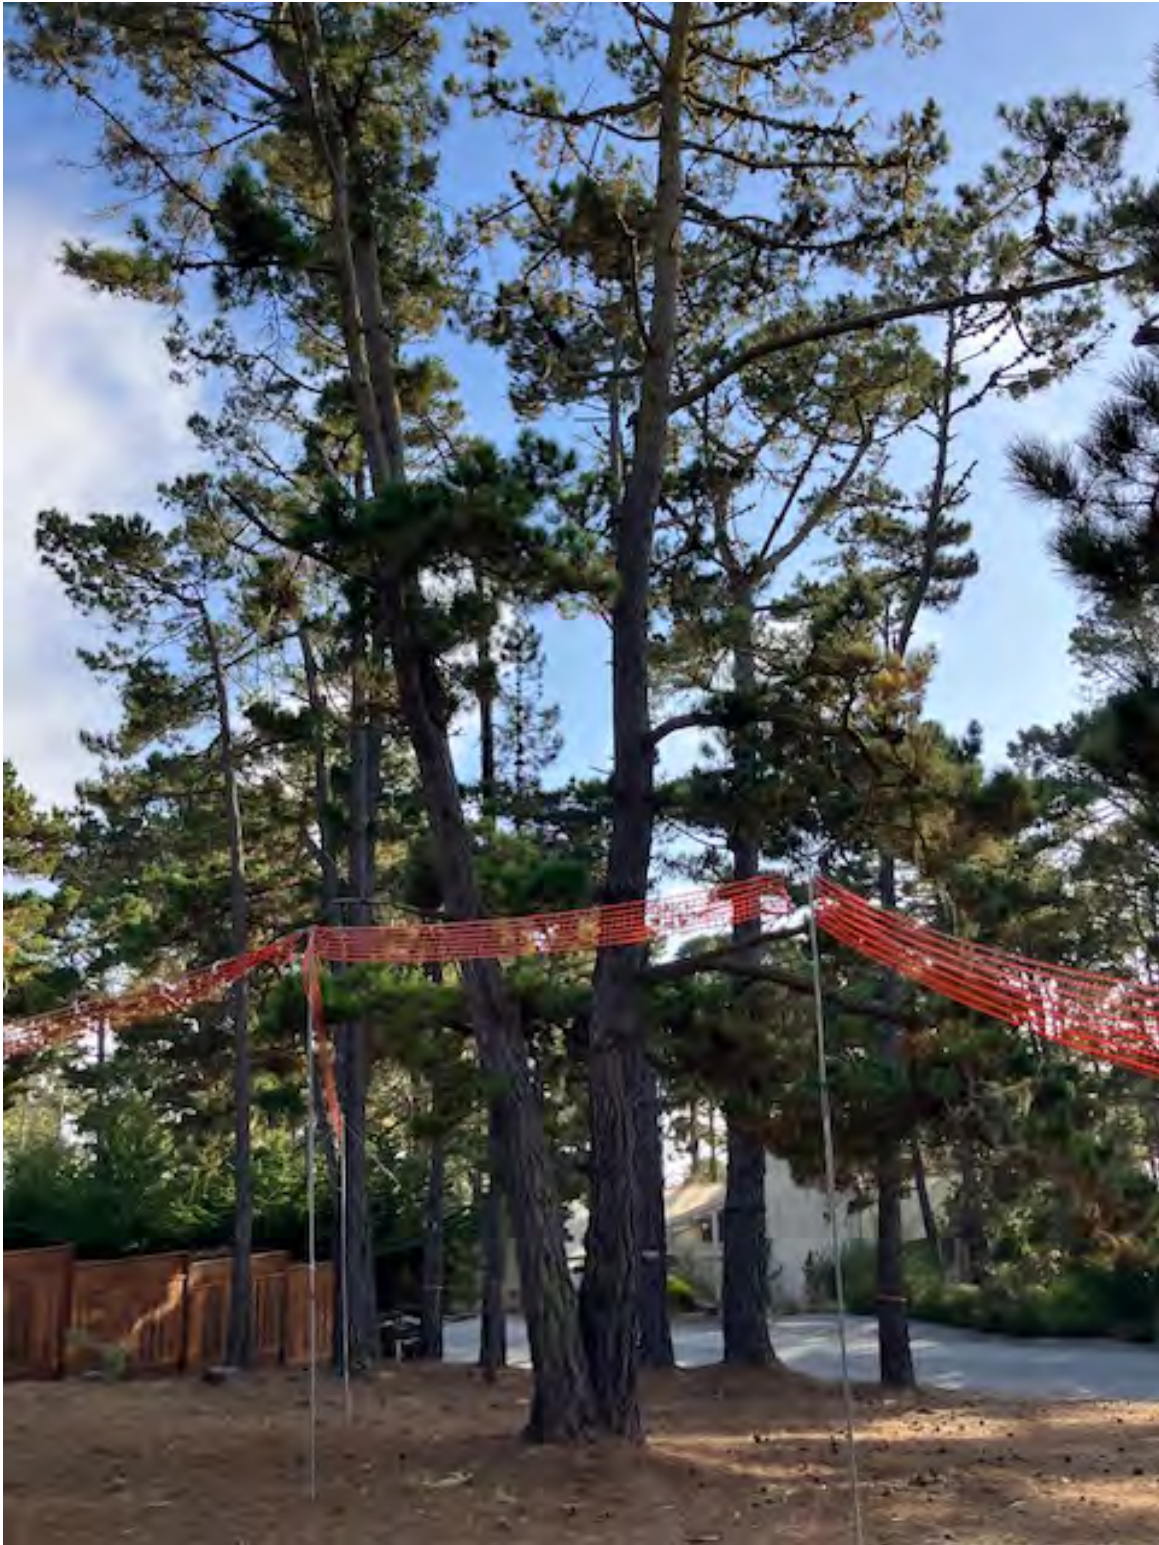
Figure 9. The detached ADU is proposed for this location towards the south end of the lot near Deer Path road and will involve the removal of the forked double stem pine (i.e., a co-dominant trunk) visible in center of photo. The grouping of pines in the background will be retained and protected. In total, 40 Monterey pines are proposed for removal due to construction related impacts, and a total of 46 pines will be retained and protected for the duration of the project.

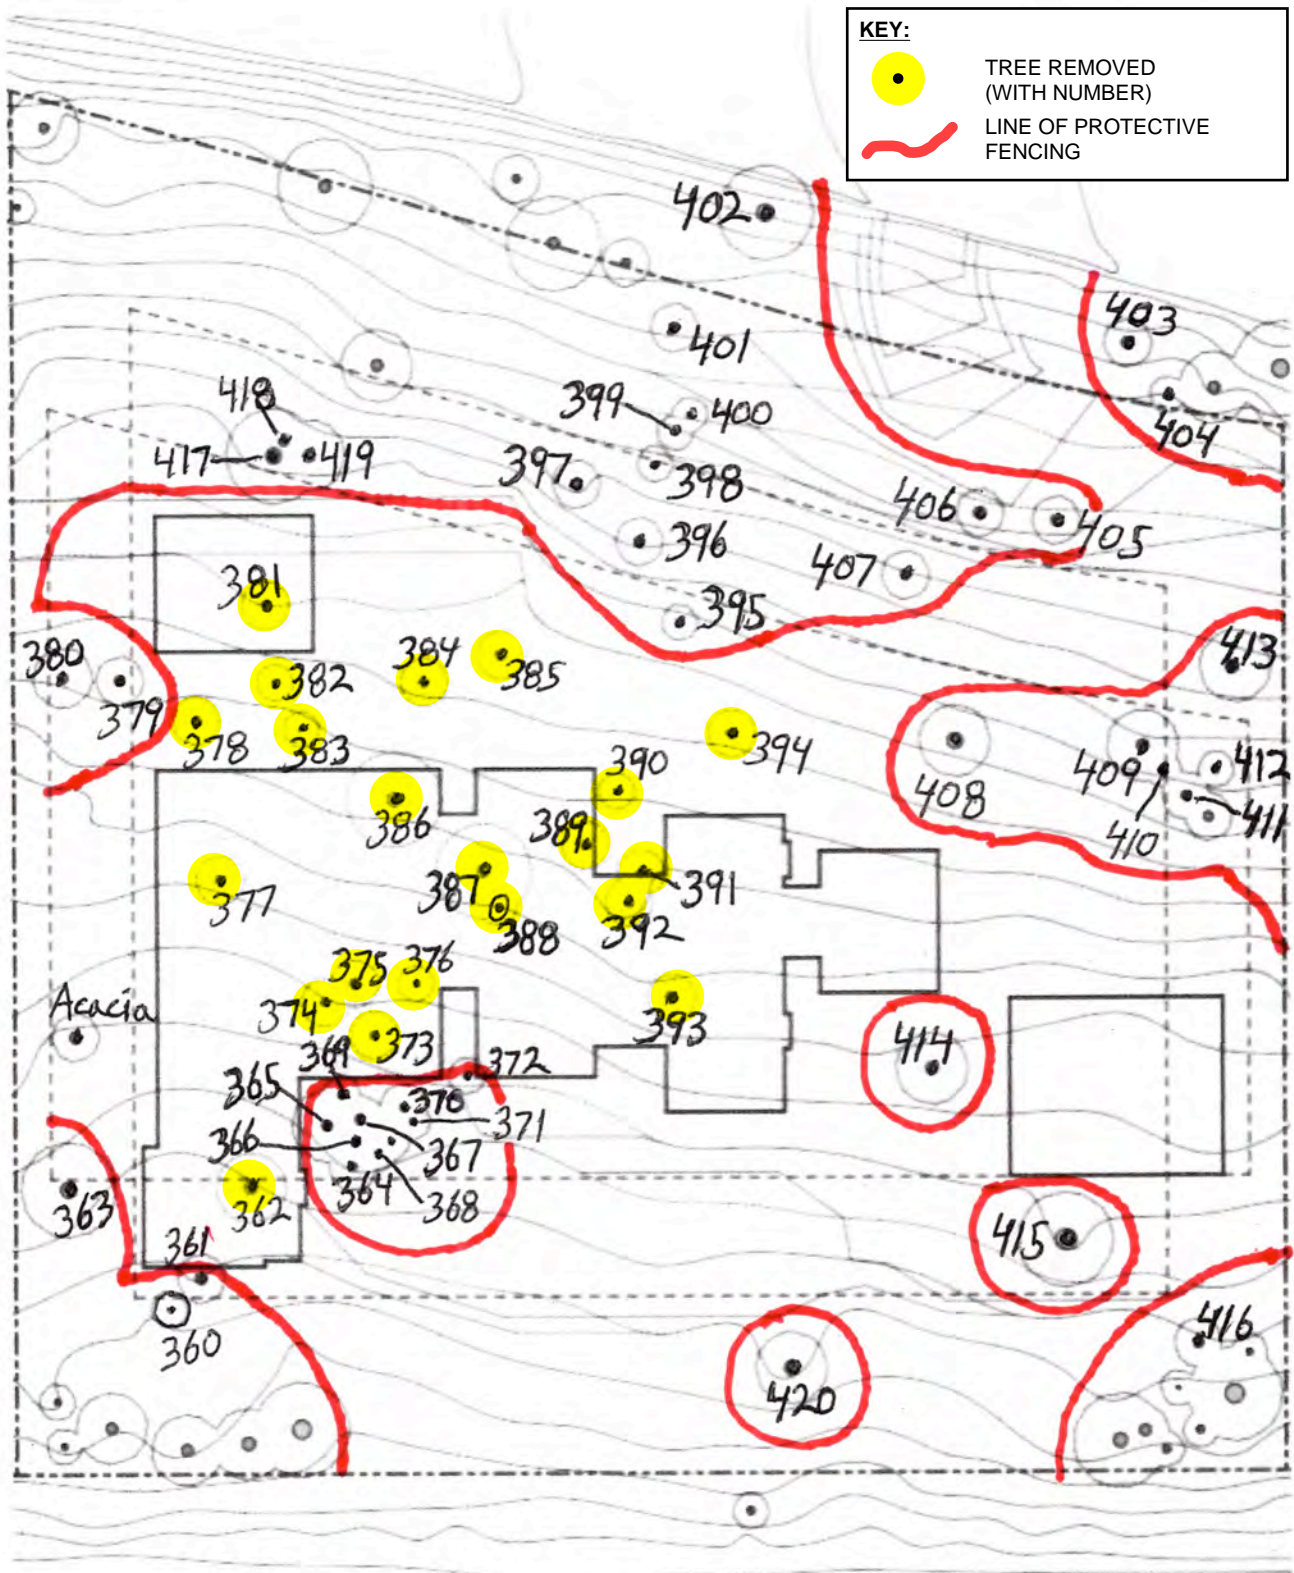
Exhibit A: Tree Location & Tree Protection Fencing Map shows the location of 61 Monterey pine trees that were tagged and evaluated during a pre-construction impact assessment. This includes 21 pines proposed for removal due to construction related impacts, as well as 40 pines that will be retained and protected during property development activities. In addition to these 40 retained pines, 25 additional pines that were not tagged and recorded due to their location a safe distance away from proposed construction activities will also be preserved and protected, for a total of 65 retained and protected trees. The red lines identifies the approximate location of tree protection fencing that will be installed; however, the final location of tree protection measures will be determined during a pre-construction site visit with the project contractor and design team.

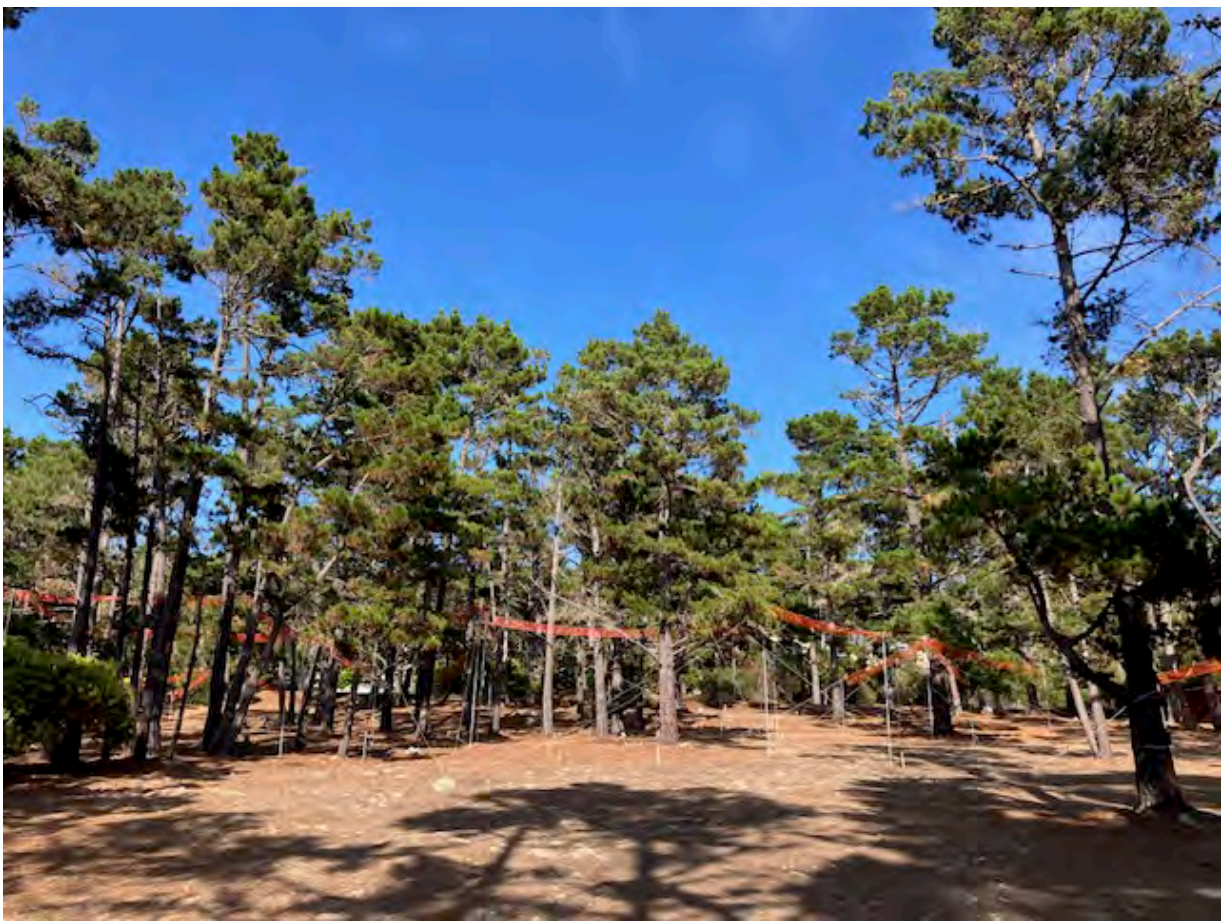
Figure 1. The proposed home and property development construction site is located in a Monterey pine woodland community.

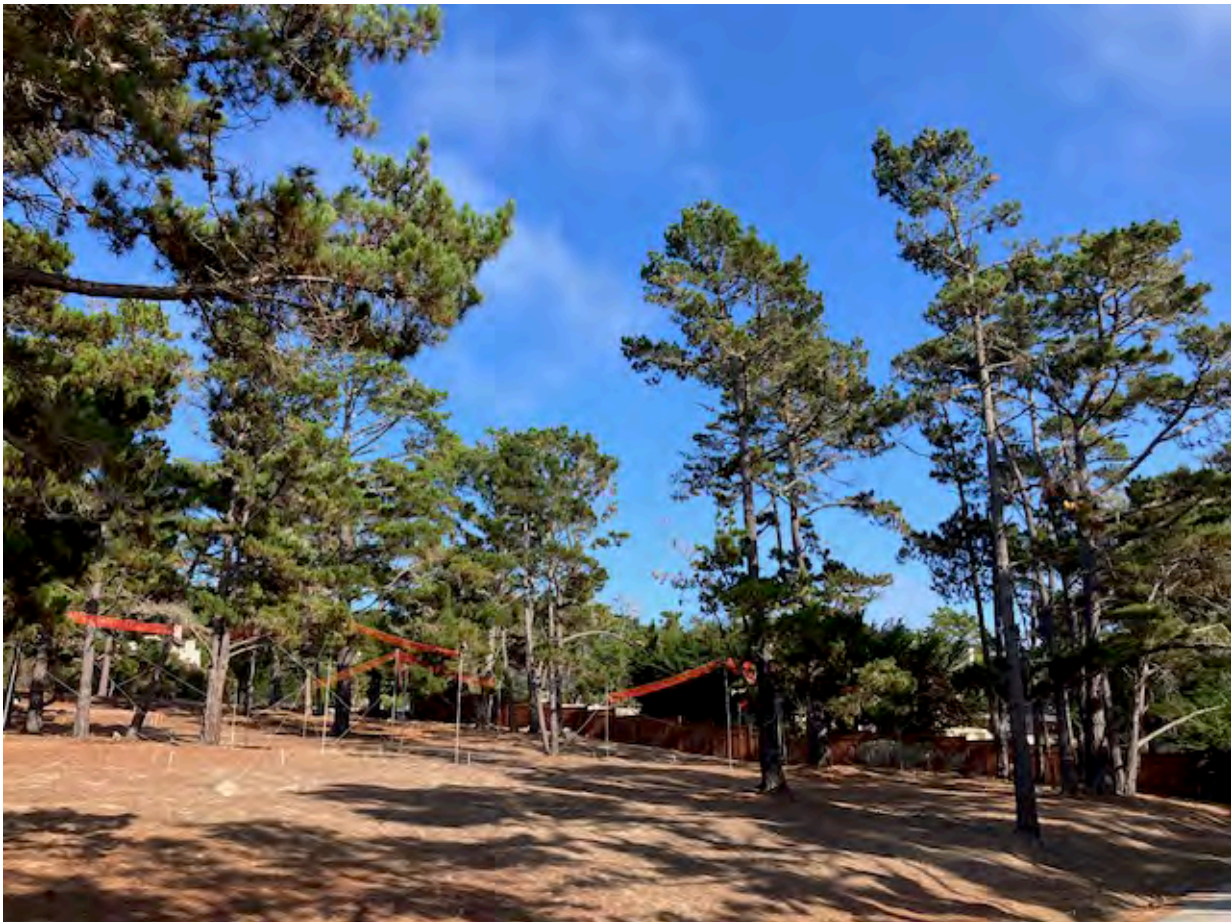
Figure 2. Another view of the proposed homesite, as well as a small ADU site (located right of center) from Deer Path Road.

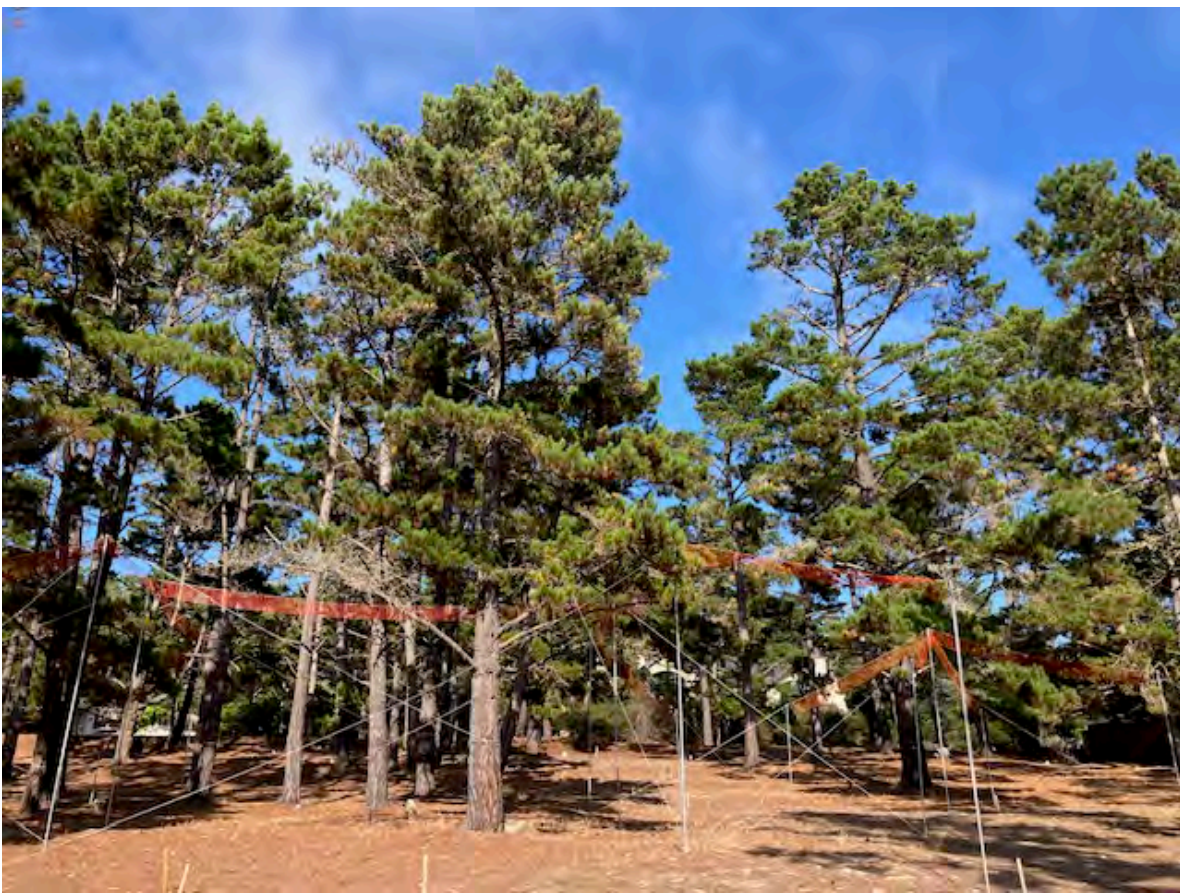
Figure 3. Close view of a portion of the proposed homesite located in a fairly densely wooded area of the lot. 21 pine trees are proposed for removal in preparation for property development activities and a total of 65 pines will be retained and protected.

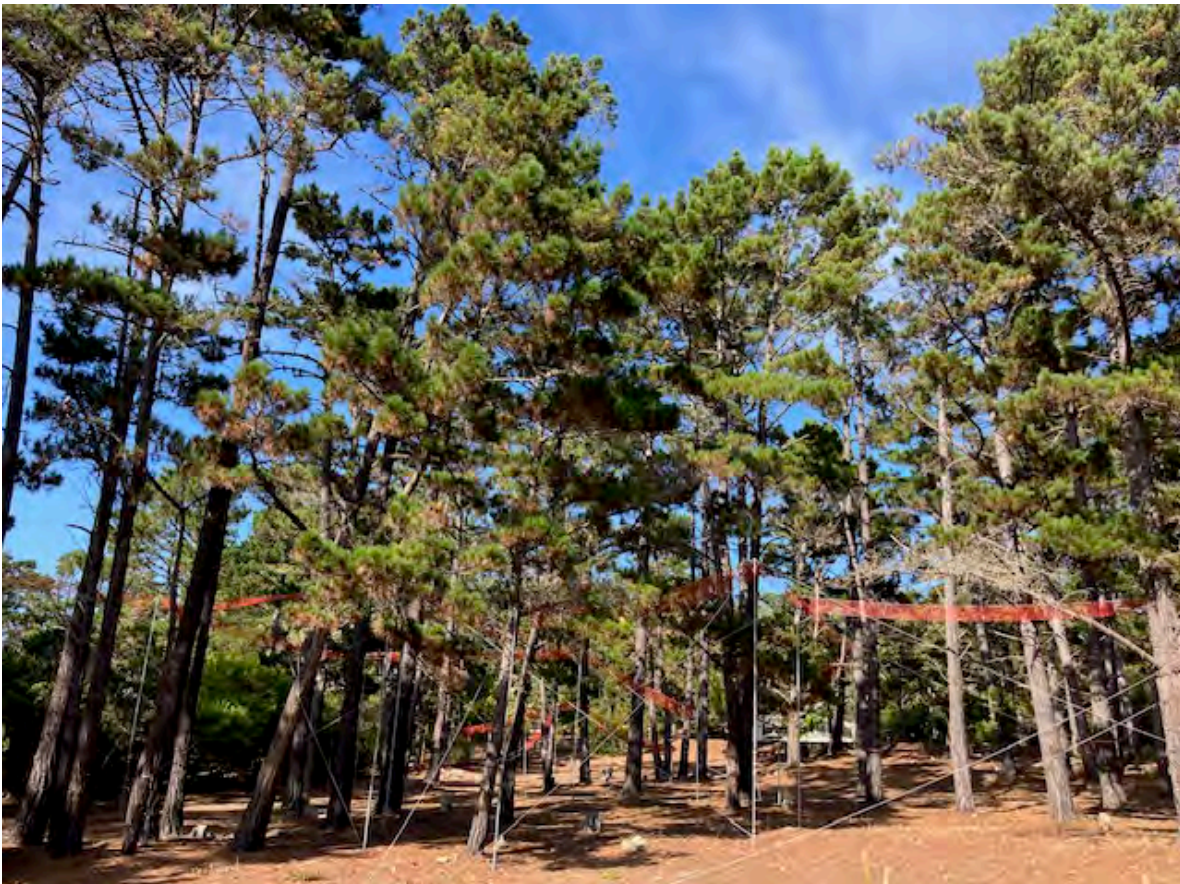
Figure 4. Another view of proposed homesite from Deer Path road. This parcel is dominated by mature and aging Monterey pines, several of which are in poor and declining physiological health and structural condition.

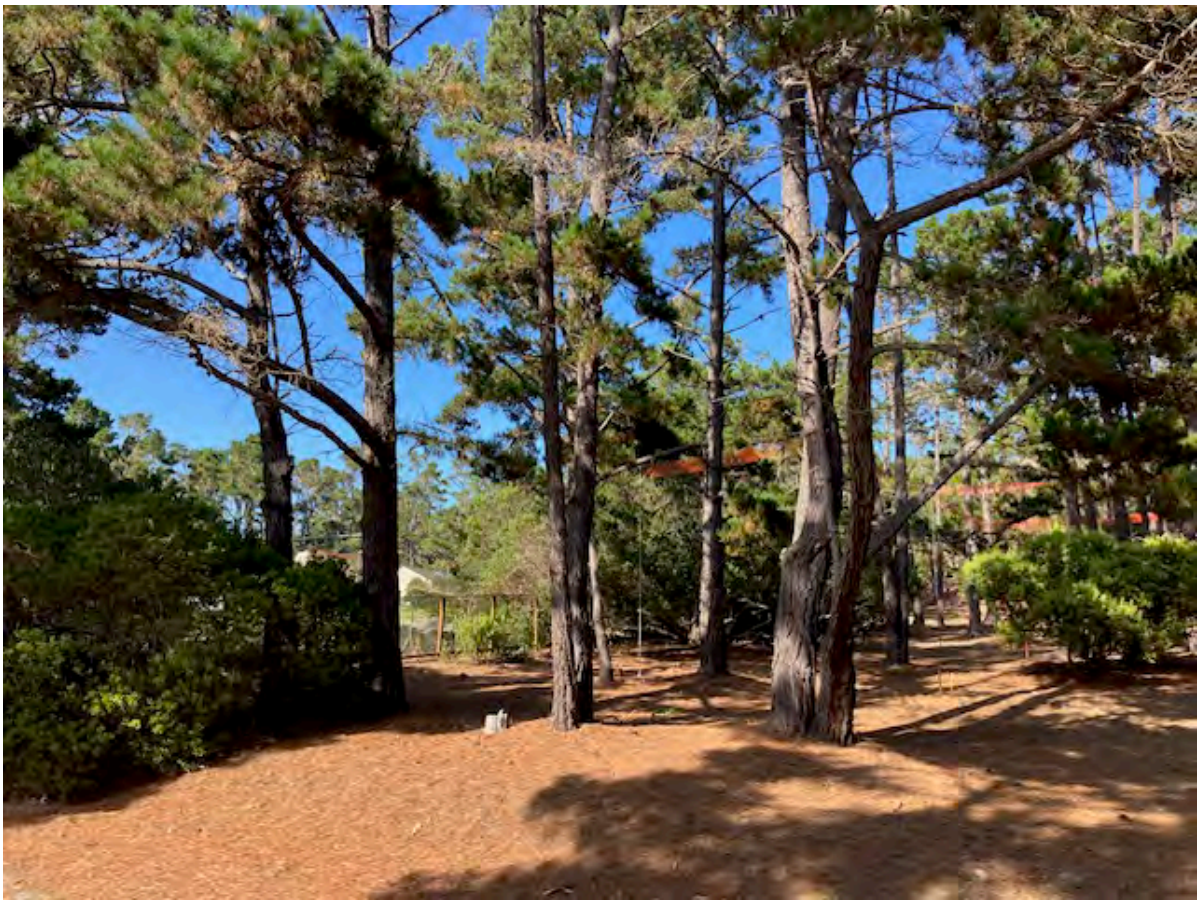
Figure 5. In addition to mature pine trees, which dominate the property, there are also several large non-native invasive acacias (a few are visible in this photo) that are located on the northwest side of the lot.

Woodland understory vegetation is sparse and limited on the subject parcel due to past vegetation removal and fuel reduction operations (refer to *Figures 1-9*). Native understory flora observed includes the following species: Poison oak (*Toxicodendron diversilobum*), coyote brush (*Baccharis pilularis*), woolly leaf manzanita (*Arctostaphylos tomentosa*), sticky monkey flower (*Mimulus aurantiacus*), Pacific blackberry (*Rubus ursinus*), Douglas iris (*Iris douglasiana*), California aster (*Symphyotrichum chilense*) and a few species of native bunch grasses. Non-native invasive plant species observed on the lot was limited to golden wattles (*Acacia longifolia*), which can be described as large shrubs or small trees, as well as a few species of exotic grasses. Non-native invasive plants can be harmful and degrading to habitat and should be controlled, managed and, where possible, eradicated.

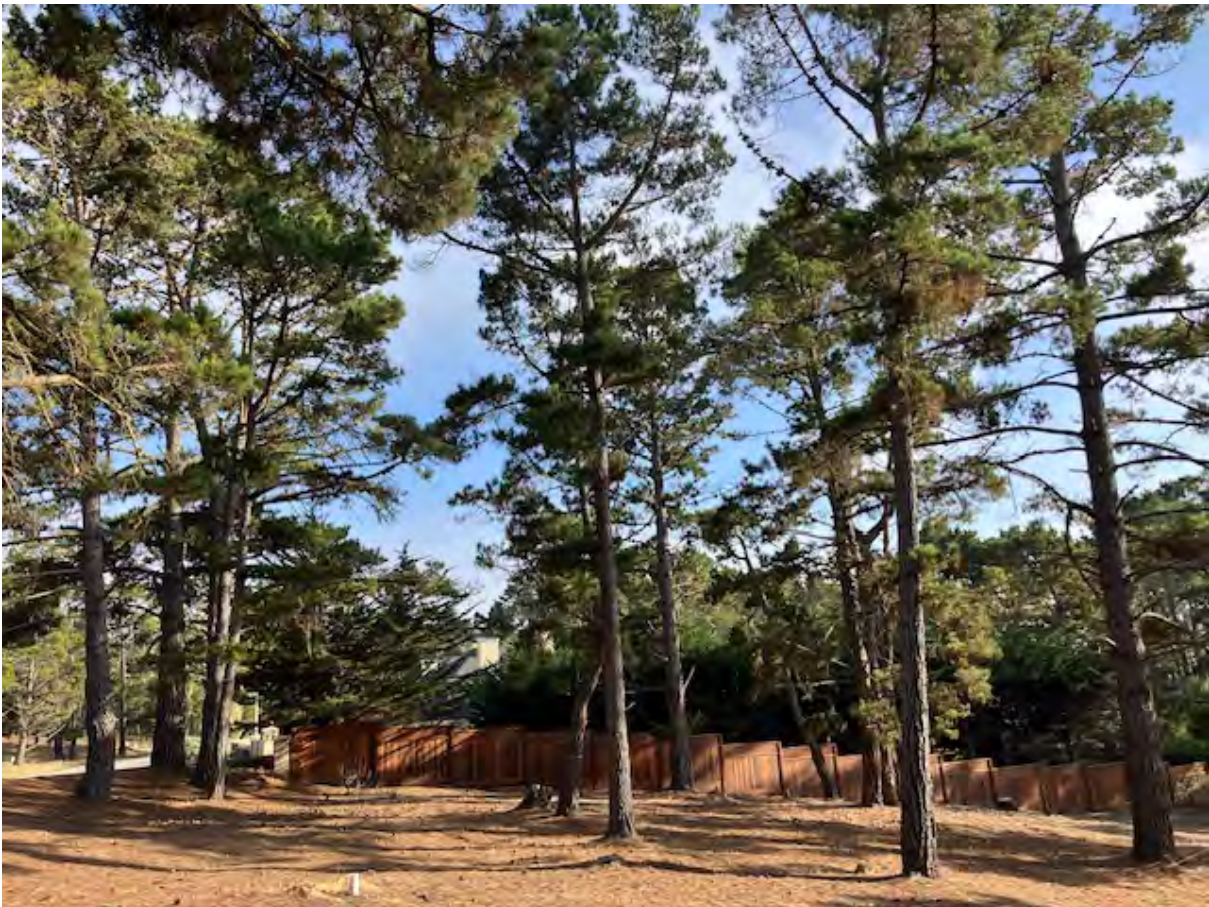
Figure 6. View of this pine woodland lot up towards the northeast Spruance Road side of the property.
