THOMPSON
WILDLAND MANAGEMENT

October 2, 2025

Nunnelee Residence
3144 Spruance Road
Pebble Beach, CA. 93953
APN: 008-501-004-000

Subject: 3144 Spruance Road Pre-construction Tree Impact Assessment

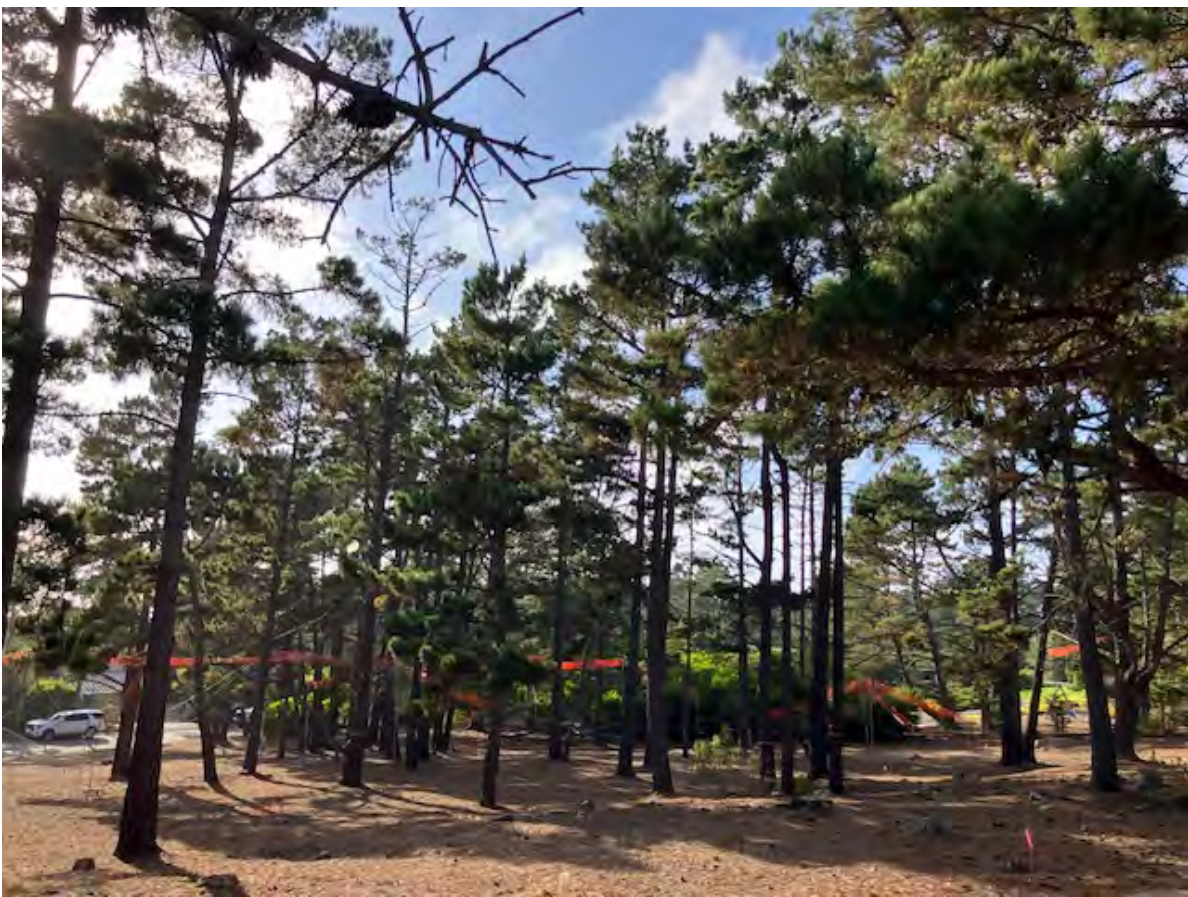
Figure 7. Another view of proposed homesite area from the Spruance Road side of the lot. The detached garage is flagged on the right side area of the photo.

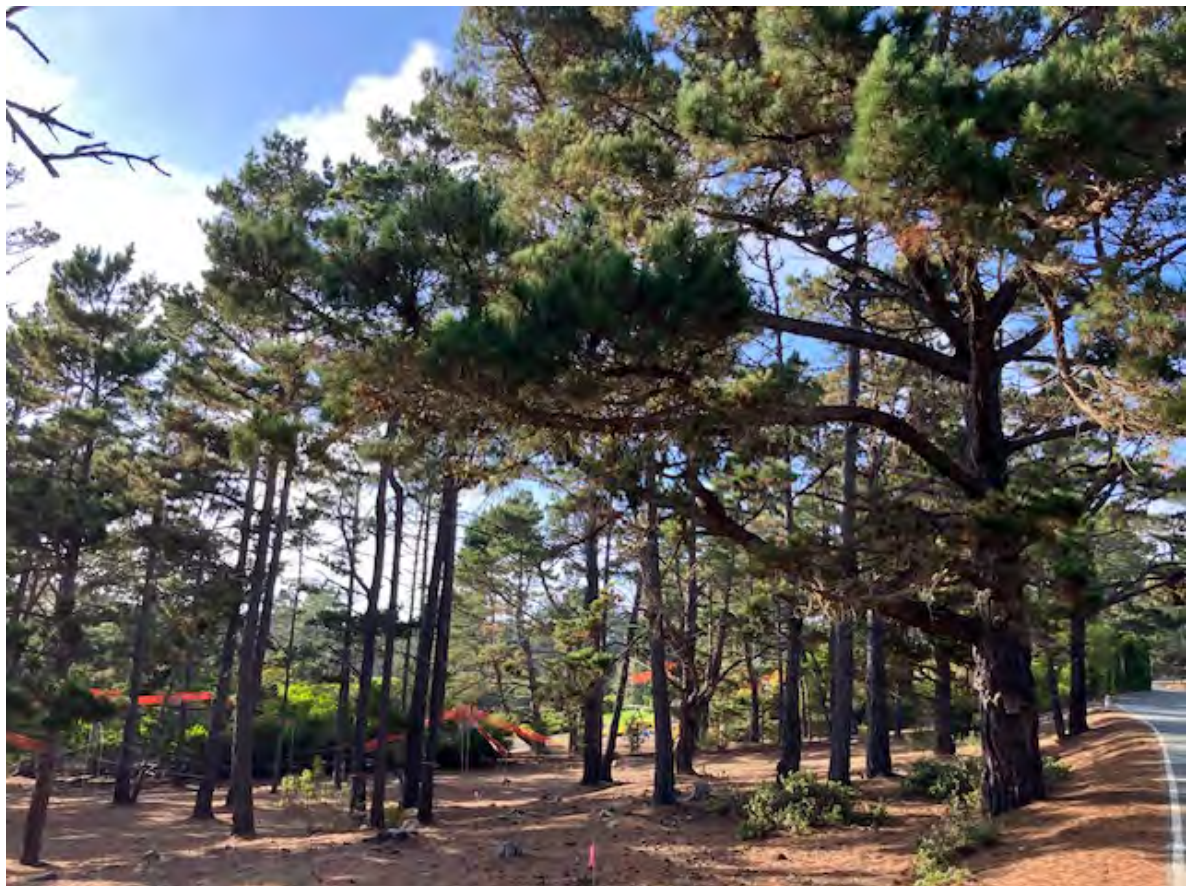
Figure 8. View from area where the proposed paved driveway will access the property. The detached garage will be located in the center area of the photo.

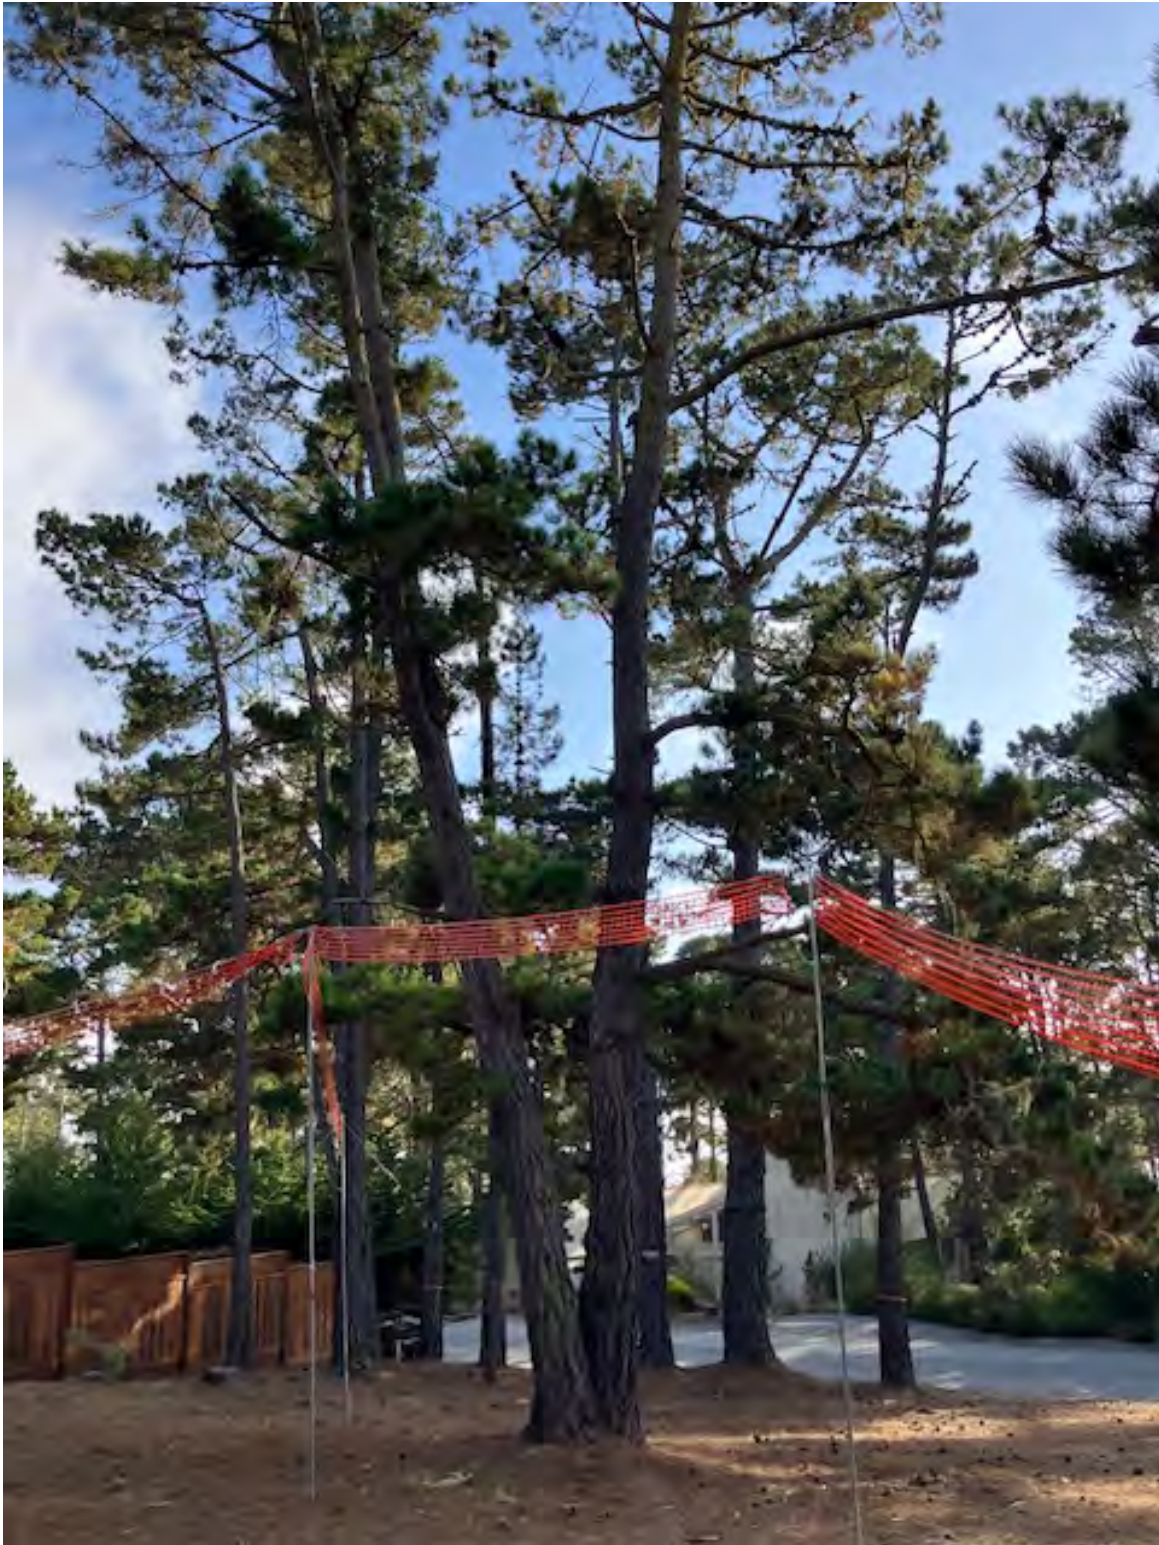
Figure 9. The detached ADU is proposed for this location towards the south end of the lot near Deer Path road. No trees are proposed for removal in preparation for the ADU. As outlined in this report, a total 21 Monterey pines are proposed for removal due to construction related impacts and 40 nearby tagged and recorded pines will be retained and protected for the duration of the project. An additional 25 pines that were not recorded due to their safe distance and location away from proposed construction activities will also be retained, for a total of 65 pines retained and protected.
