29500 Enclave Court  
Tree Assessment  
Arborist report

June 5, 2023

Frank Ono  
Urban Forestry  
Society of American Foresters I.D. # 48004  
Certified Arborist #536  
1213 Miles Avenue  
Pacific Grove, CA 93950

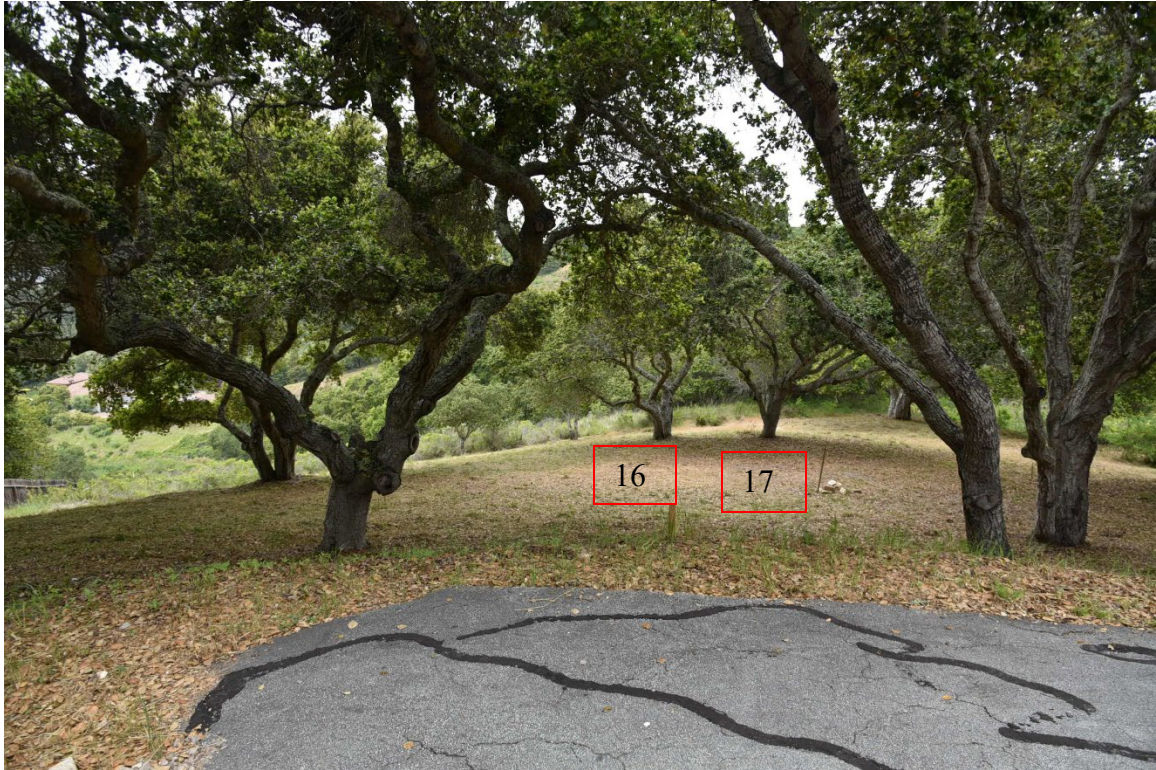
- Two trees are proposed for removal because they are within the area of the proposed construction. The two oak trees (#416-17" diameter oak, and #417- 15" diameter oak) were identified as trees located within the proposed house footprint.

The removal of two oaks (#416 and #417) is proposed for this project; The remaining trees are to remain and be protected from construction impacts.

View of lot looking from above (trees #16 and #17 are proposed for removal)

The site has a sufficient amount of room to replant with an additional two oaks on a 1:1 ratio which should be included with the landscape plan but planted on the edges of the existing tree canopies.

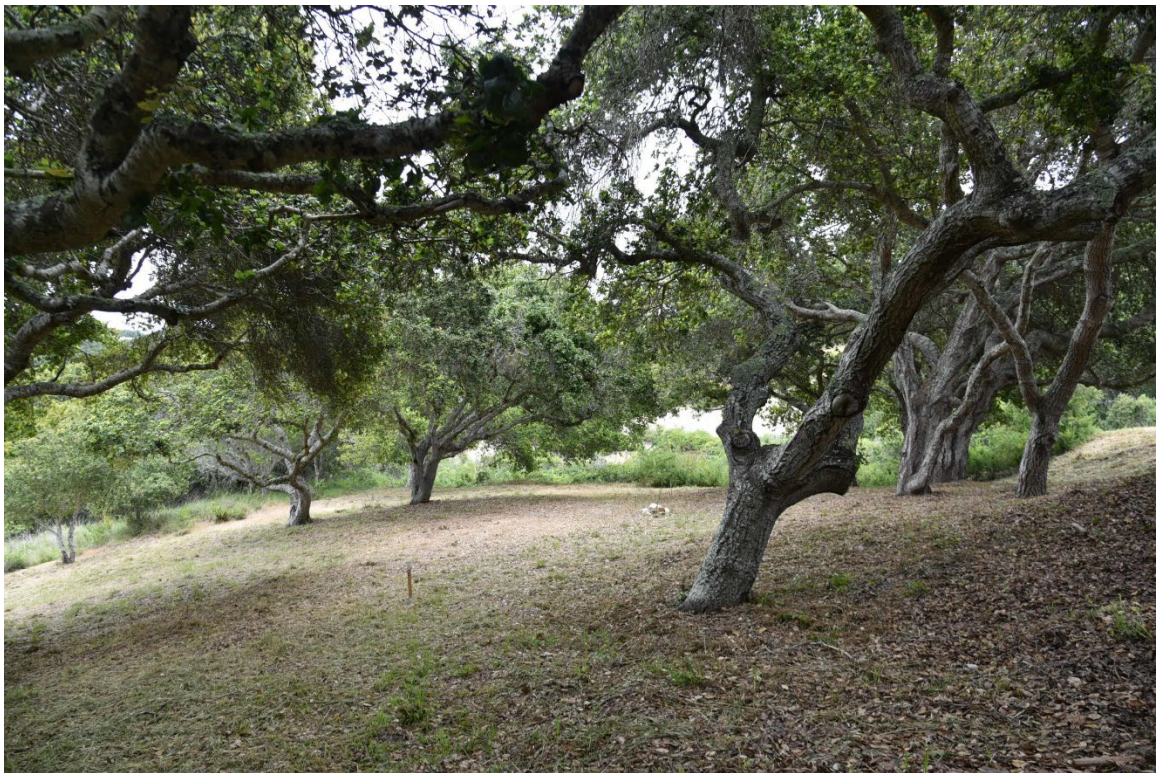
View of the lot from the driveway entrance (trees #16 and 17 are to the left)

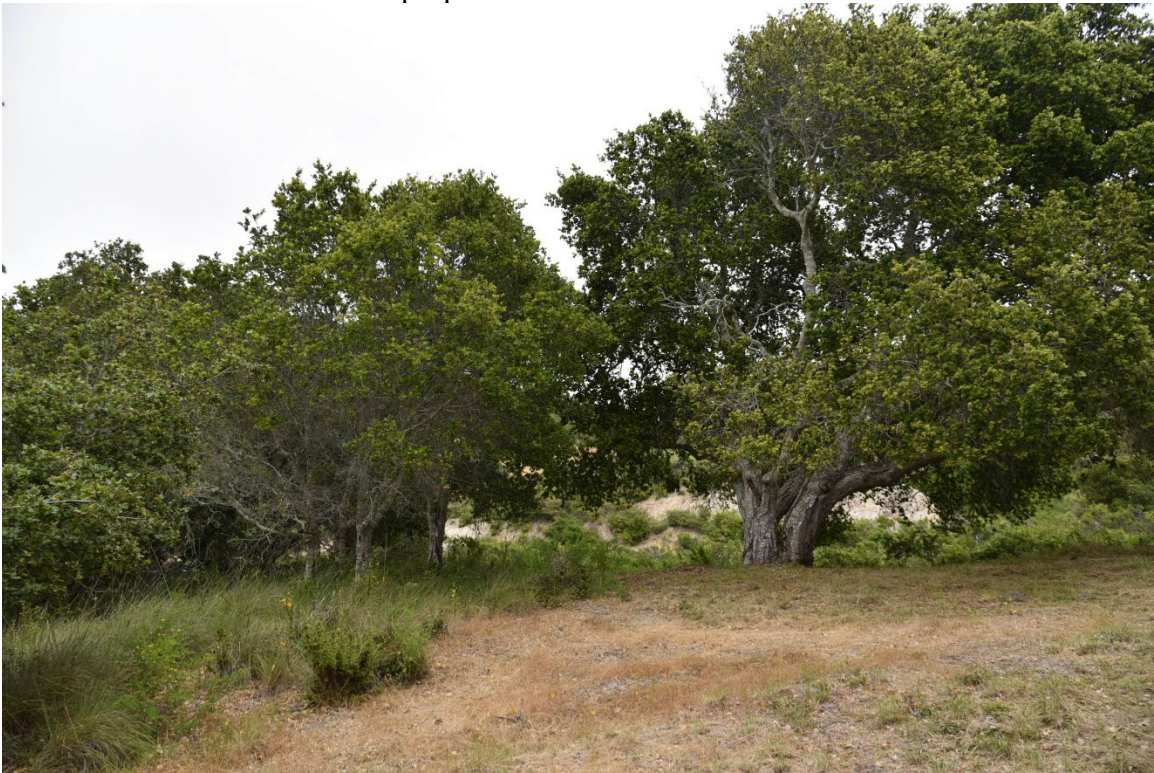
View of the lower lot from the proposed house area

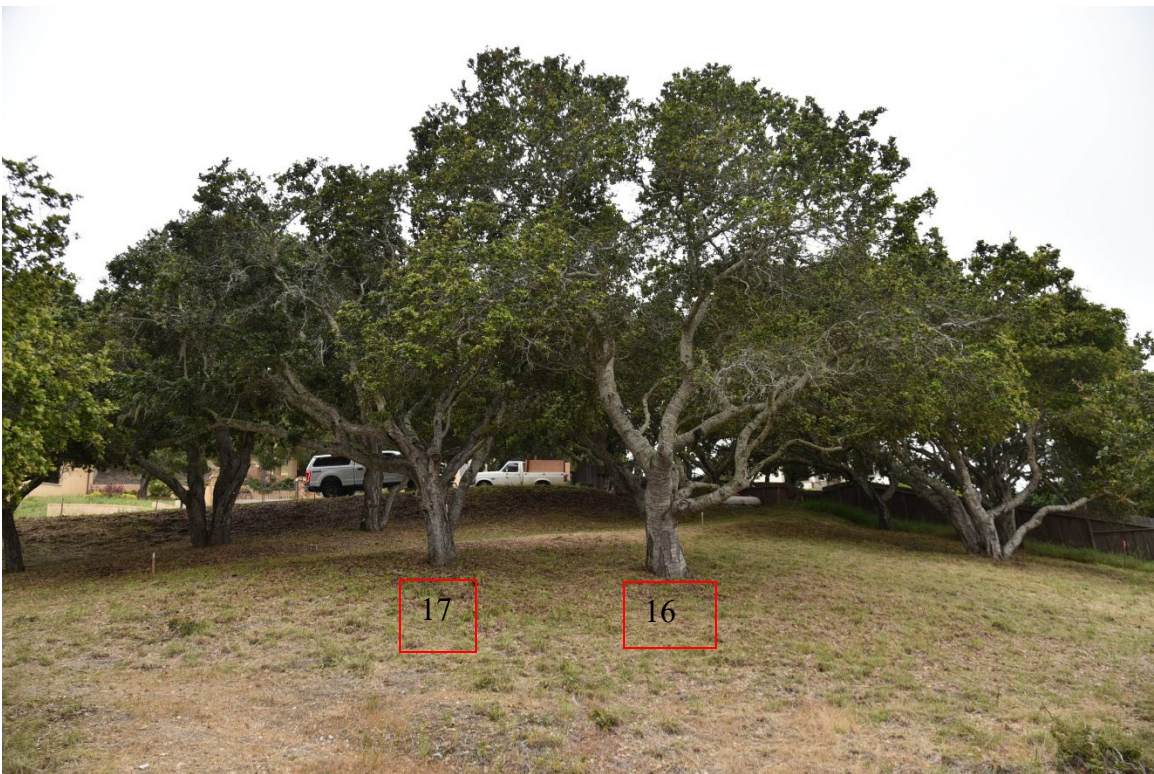
The view looking up from the edge of the slope (center trees are #16 and 17)
