# Attachment 3

55 Encina Drive – Carmel Valley, California 93924  
Richard and Bettina Moss  
Mills Act 10-Year Estimate for Rehabilitation and Maintenance Plan

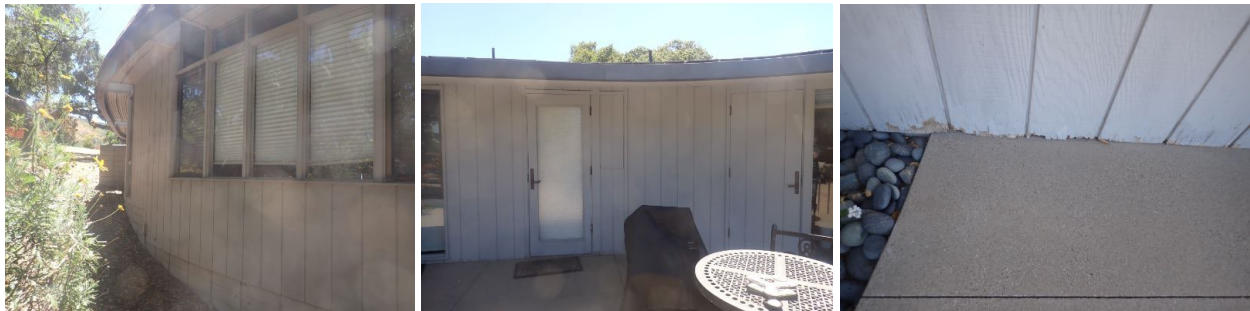
**1. Exterior Wall Repair / Maintenance:** The inspection report states there is some siding deterioration and moisture damage/ wood rot observed. Recommended that a 2" exposed flashing gap should be provided on the untreated wood in contact with deck. Repair/ patch exterior walls where needed. The inspection report states that the exterior paint systems have reached their life expectancy and recommended review by a licensed painter. Repaint exterior walls.

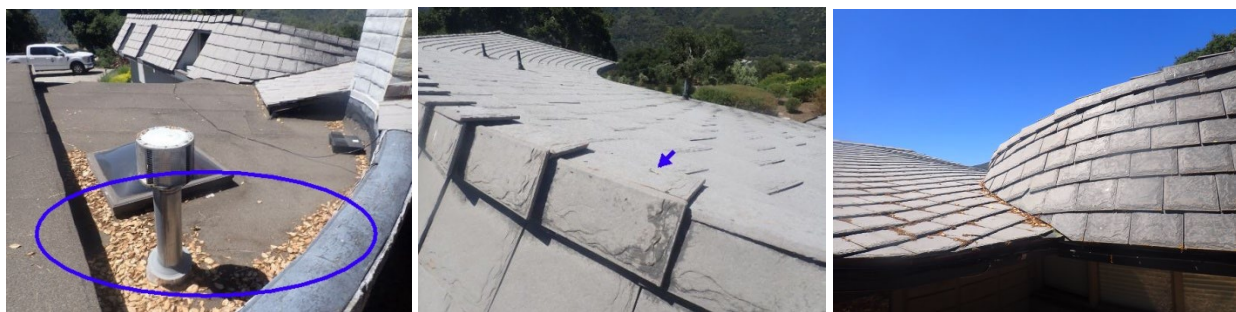
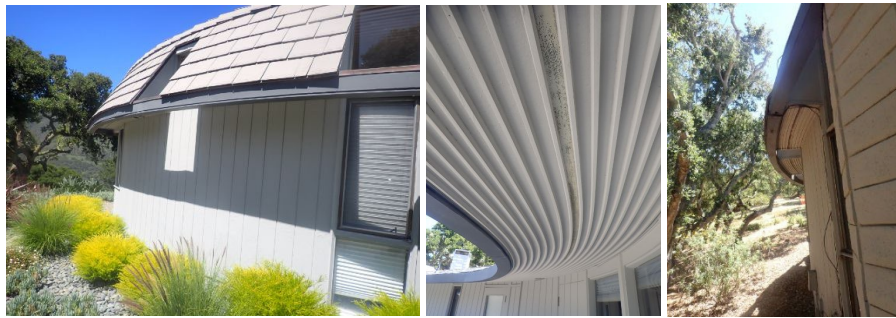
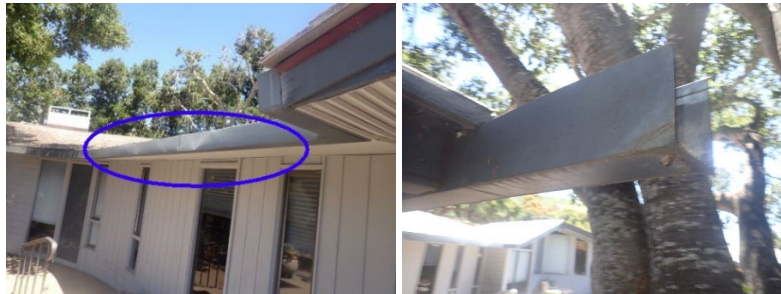
**3. Roof Repair:** The inspection report states that nails should be re-set with a ring shank type and eave venting is rusted and painted over due to high levels of moisture in the cathedral ceiling system and a lack of upper roof venting. Some roof tiles have started chipping and coming to an end-of-life cycle. Recommended to repair or replace damaged/ deteriorated gutters install gutters and downspouts on all appropriate sides of building with a proper drainage system.

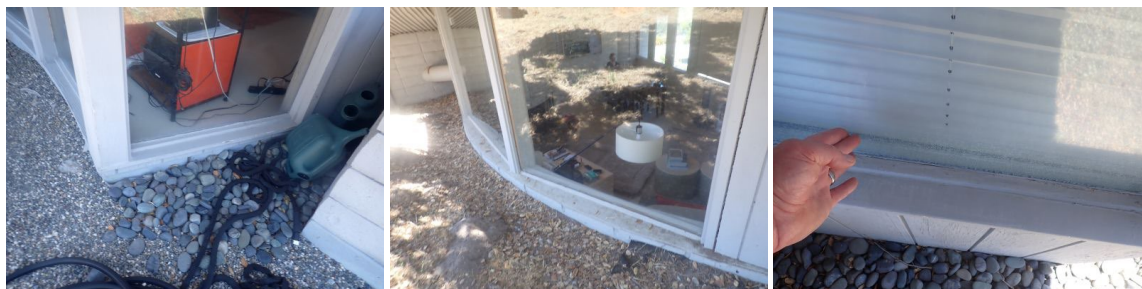
**4. Window and Exterior Door Replacement:** The inspection report states that windows within 24" of ground level should be tempered glass and suggest sealing/ caulking as part of routine maintenance. Areas of calcium water deposit/ moisture damage found on some windows. Replace/restore all windows/ exterior doors throughout home, maintaining original architecture. Replace all window vents and screens, re-paint the interior frame where necessary. Window/ door hardware to be replaced.

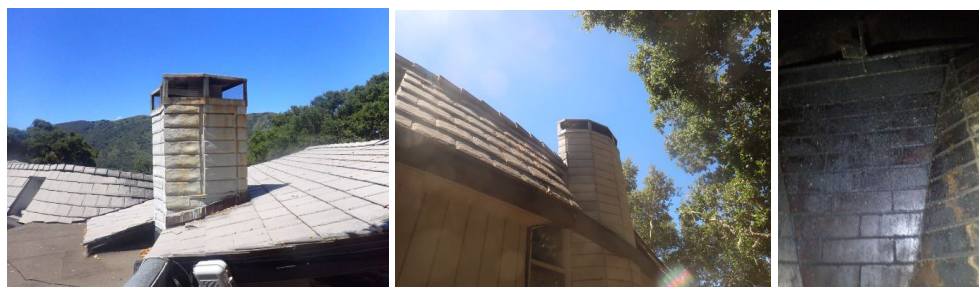
**5. Chimney Repair:** The inspection report states that there are areas of soot and rust staining. It is recommended that the chimney is power washed and painted to extend its life expectancy. A professional fireplace inspection is recommended prior to cleaning/ operating the system.

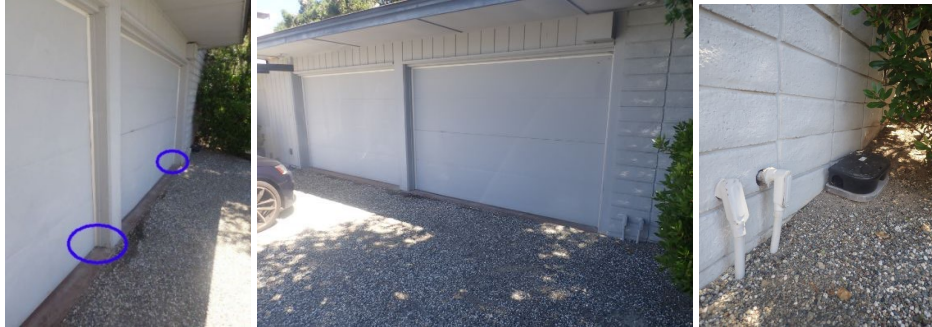
**6. Garage Repair and Repaint:** The inspection report states that there is wood rot in the jamb of overhead door. General repair and maintenance required to avoid further degradation. Open penetrations in the walls were noted and recommend proper sealing to prevent wildlife from entering. Some areas of water staining in concrete floor, recommended to remedy water migration.

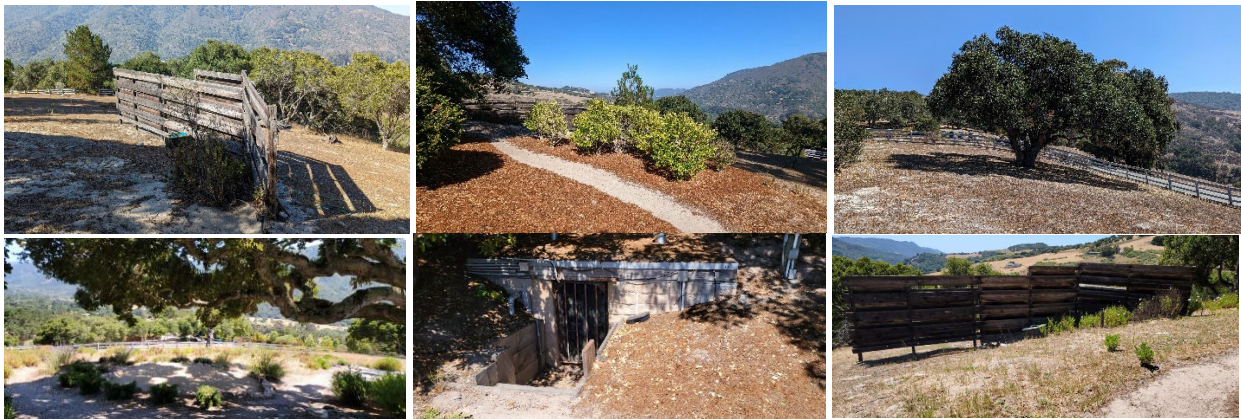
**7. Landscape Design:** Includes improvements to entry gate/fence, wind break fence, bunker, and irrigation and field management, drainage and slope on the property. The inspection report states that surface runoff water be adequately diverted away from the home and lot grading should slope away and fall a minimum of one inch every foot for a distance of six feet around the perimeter of the building.

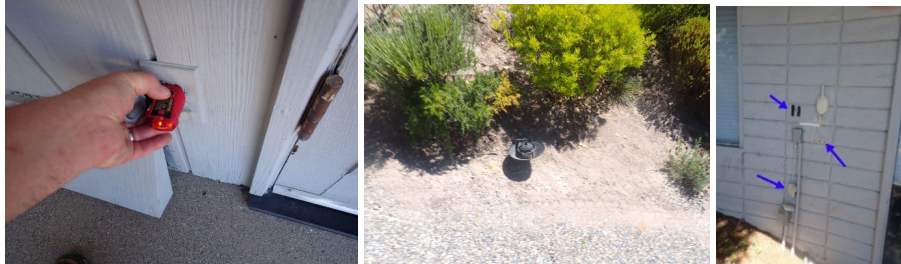
**8. Electrical Upgrades:** The inspection report states that outdoor receptacles are not GFCI protected and outdoor outlet covers are not waterproof. Some damaged exterior light fixtures. Repair loose wiring, rewire / upgrade service and replace electrical fixtures and outlets with historically compatible.

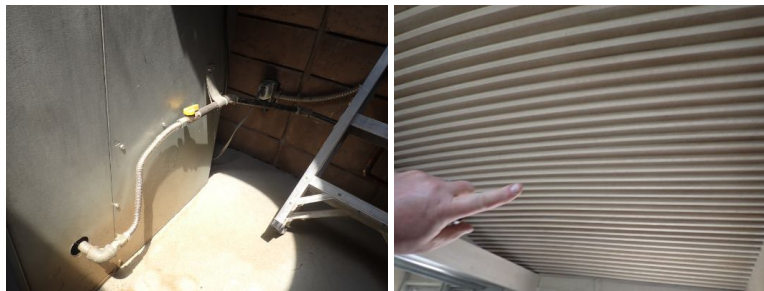
**9. Mechanical / HVAC Upgrades:** The inspection report observed the gas supply line is missing the drip leg. Upgrade HVAC system and associated features. Add exhaust fans in the bathrooms.

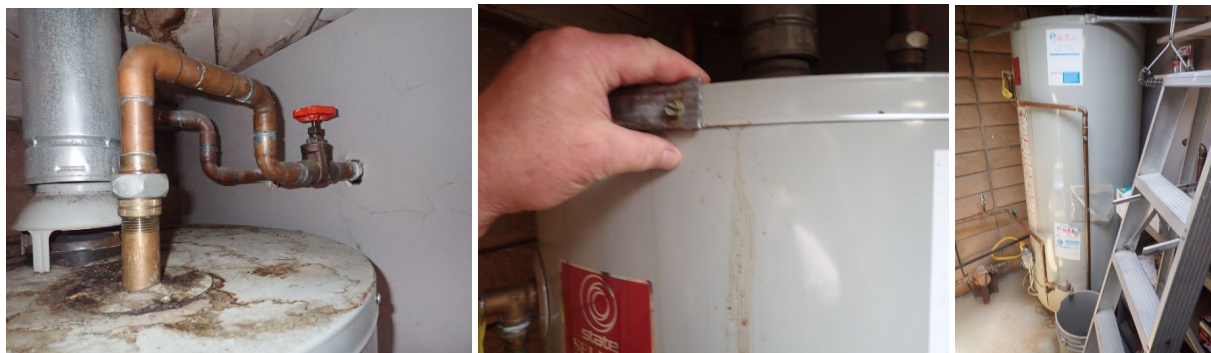
**10. Plumbing / Sewer Upgrades:** The inspection report states that the water heater is past the end of its typical service life and recommends replacement. The heater enclosure shows signs of a leak and proper sealing is recommended. All hot water pipes in crawlspace should be insulated and there is evidence of improper support and/or lack of flexible pipe connections. Upgrade HVAC system and associated features.
