ARBORIST REPORT

PORTOFINO

10 Country Club Way
Carmel Valley, CA 93924

May 22, 2023

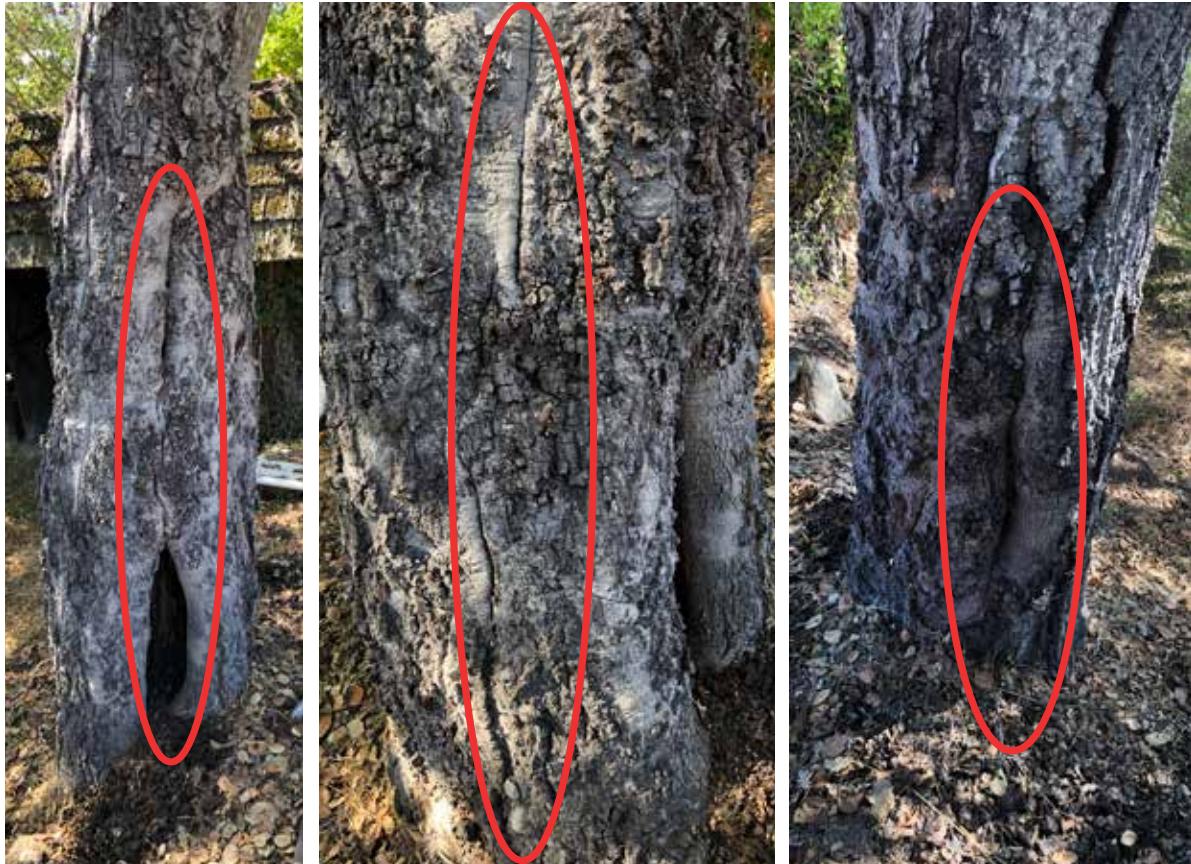
Tree 58 is a coast live oak with a 28" DBH. The original development of the property resulted in grading impacts to the root zone, and a buried root collar. It's likely that the root damage, buried

root collar, and changes in soil hydrology have led to the tree's slow decline. There are three vertical pockets of decay measuring 5-6' in height along the main trunk. The largest decay pocket is shown on the left in the photo sequence on page 8, with a cavity about 18" in depth that extends 5-6' up through the heartwood of the tree. The trunk was sounded to confirm that all three decay pockets are connected internally, and that much of the heartwood is compromised inside the trunk. Much of the sapwood remains intact, which explains the moderate health rating of the tree. Risk mitigation options are limited due to the location and extent of heartwood rot. Removal of the pool house and proposed patio areas within 1.5 times the dripline would reduce the risk to low, while removal of the tree will eliminate all risk. Tree 58 is recommended for removal to mitigate the risk associated with possible failure within the next 1 year.

Tree 58: Large vertical seams and cavities are indicators of internal decay. Lack of trunk taper indicates the root collar has been buried.

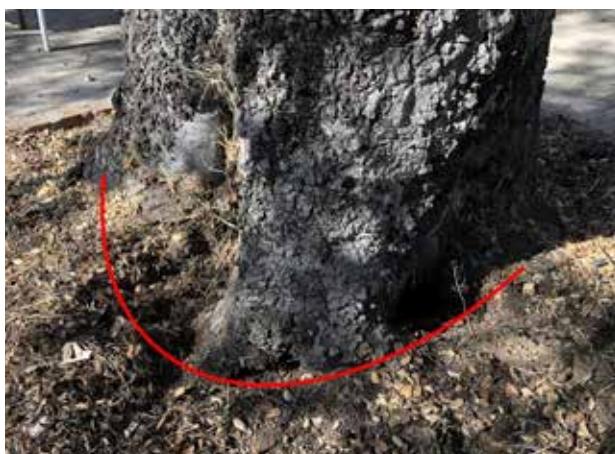
Tree 53: Extent of root rot around circumference of the root collar

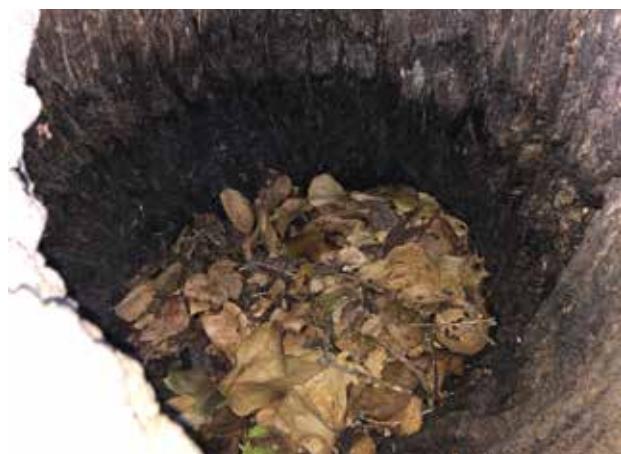
Tree 59 is a valley oak with a 30" DBH. Located just 12' from tree 58 and at about the same elevation, the impacts from the original development of the property are identical. Many years ago, about half of the crown of this tree was removed. Heartwood rot entered through the lowest pruning cut made just above the root collar. The decay now extends down through the root collar to a depth of approximately 24" and has compromised all of the heartwood at the base of the tree. Photos on page 9 show the location of the cavity on the tree, and a view inside the cavity. There were several inches of standing water inside the cavity during our first site visit in May 2021, even though it had not rained for months. The crown of tree 59 is unbalanced with most of the weight cantilevered to the southeast over a proposed patio area near the pool. Due to the northwesterly prevailing wind and the location of the crown weight, it's likely this tree will fail near the root collar and fall to the southeast. Risk mitigation options are limited due to the location and extent of the heartwood rot. Removal of the proposed patio areas within 1.5 times the dripline would reduce the risk to low, while removal of the tree would eliminate all risk. Tree 59 is recommended for removal to mitigate the risk associated with possible failure within the next 1 year.

Tree 59: View inside large cavity that extends down to the root collar inside the trunk

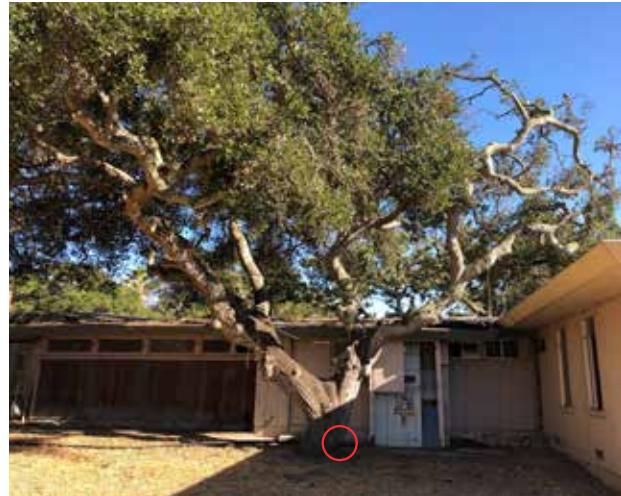
Tree 62 is a coast live oak with a 34" DBH. It is located approximately 7' from Building C, and 5' from an existing concrete walkway. The original development of the property placed the stem wall for the raised foundation building within the critical root zone of the tree, which severed close to 1/2 of the tree's water and nutrient absorbing roots. It's likely root rot entered through the severed roots and eventually made it to the root collar. Today, approximately 50% the circumference of the root collar has been compromised to a depth of 18". The location and extent of the decay has left the southern stem of tree with little access to nutrients or water, which has caused severe crown dieback in approximately 50% of the crown. With most of the crown weight on the north side of the tree and the northeasterly prevailing winds, it's likely the tree will fail at the root collar and fall to the north or northeast. The proposed project shows a lawn area and the Building C footprint to remain largely unchanged within the target zone of the tree. Risk mitigation options are limited due to the location and extent of the root rot. Removal of the proposed lawn area within 1.5 times the dripline and a crown cleaning does not reduce the risk of the tree, while removal of the tree would eliminate all risk. Tree 62 is recommended for removal to mitigate the risk associated with probable

Tree 62: The right half of the crown has extensive dieback due to the disruption of water and nutrient flow through the cambium due to root rot (circled)

failure within the next 1 year.

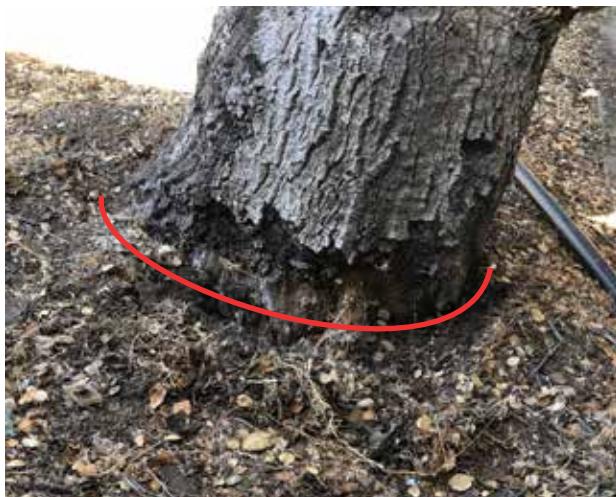
Tree 62: The extent of root rot along the circumference of the root collar

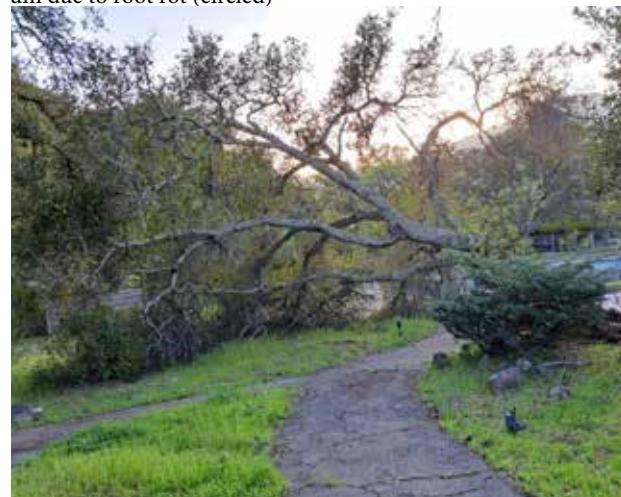
Tree 49: Winter 2022-2023 failure of tree 49

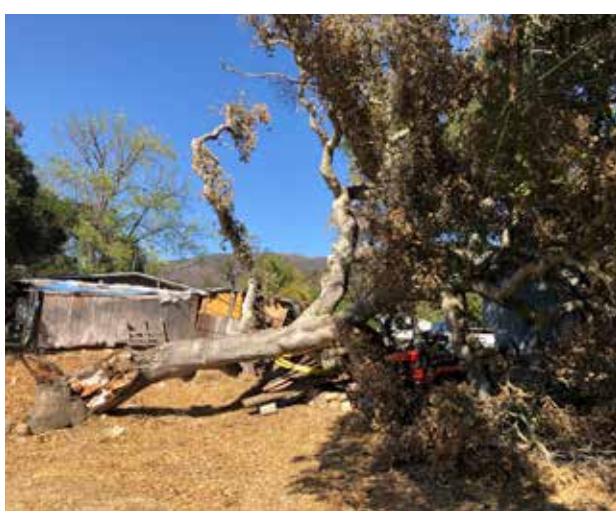
Tree 66: September 2022 failure of tree 66

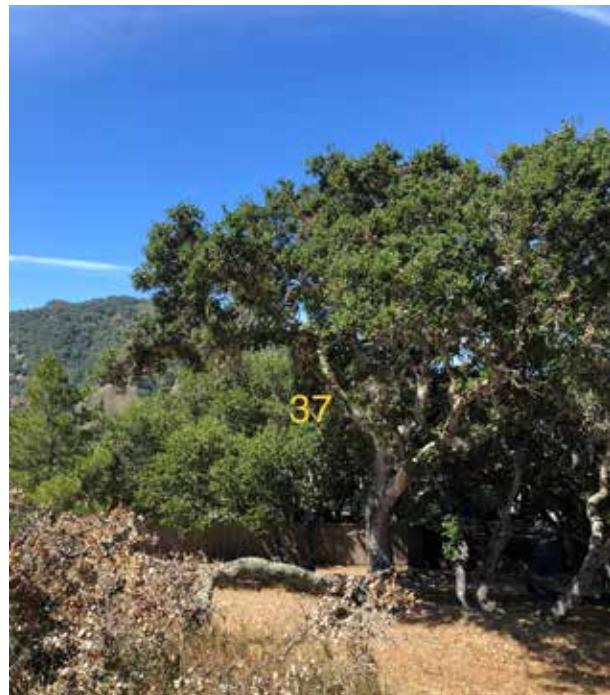
Large, recent failure at the root collar of tree 37

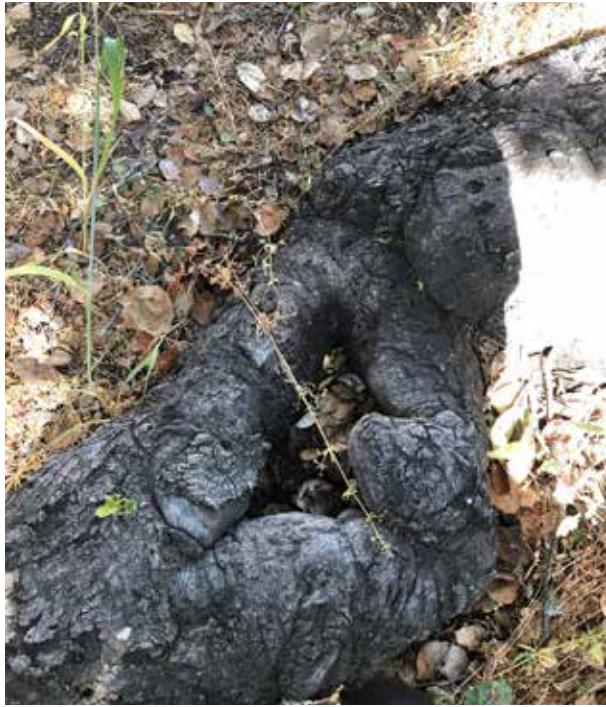
Large cavity in the root collar of tree 42

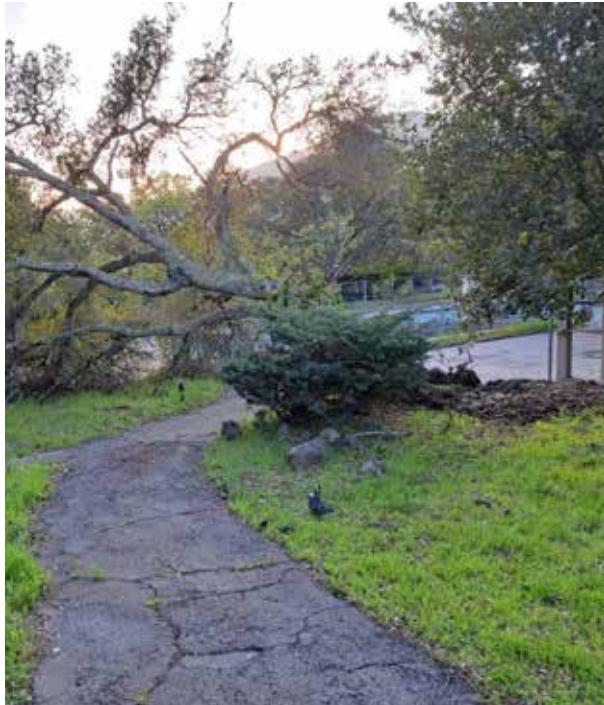
Tree 49, after failure during 2022-2023 winter storms

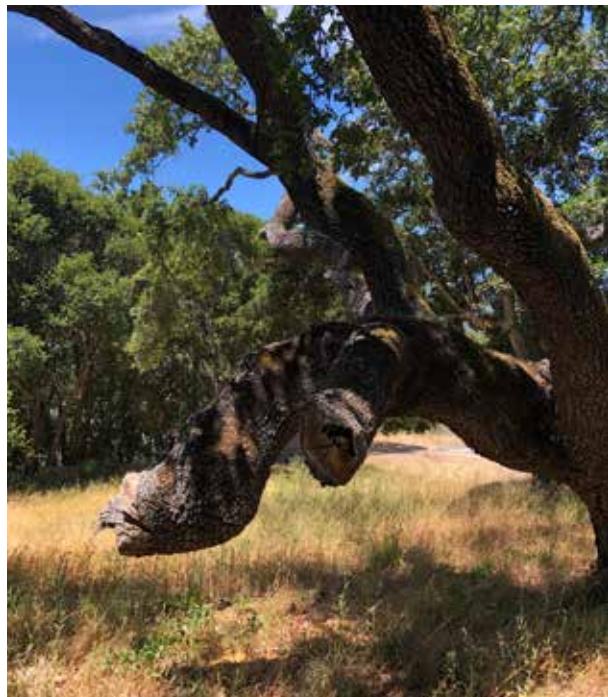
Large uncompartmentalized limb removal from many years ago is now a source of decay for tree 51

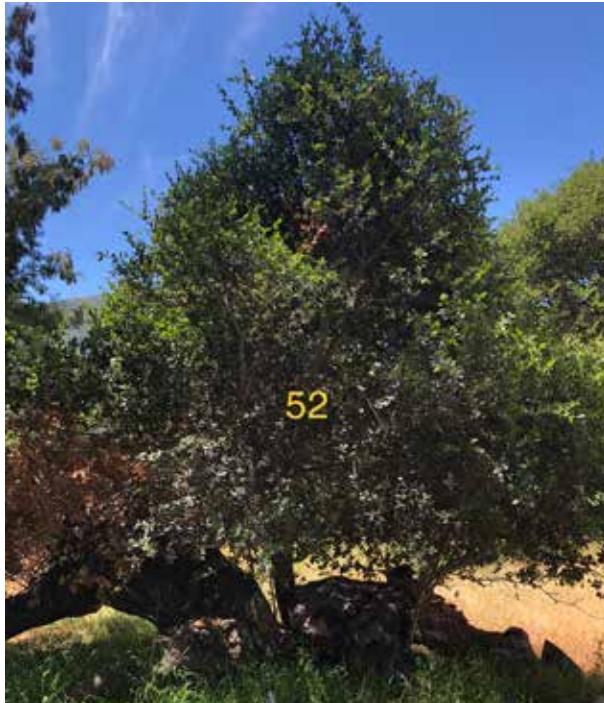
Tree 52 crown sprouting from a large tree failure years ago

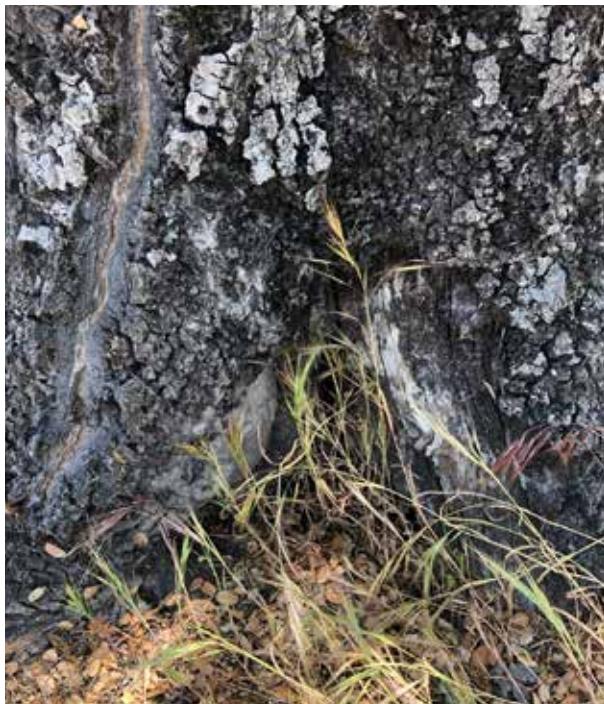
Large cavity from decay at the root collar of tree 53 (1 of 2)

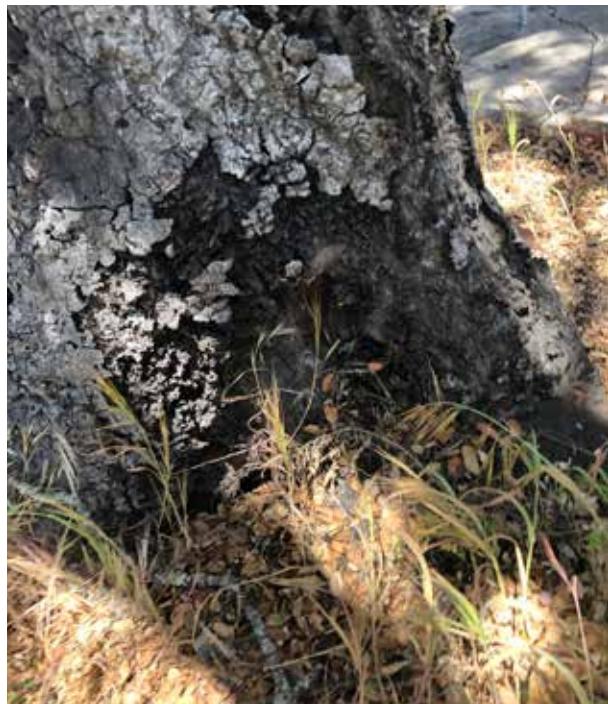
Large cavity from decay at the root collar of tree 53 (2 of 2)

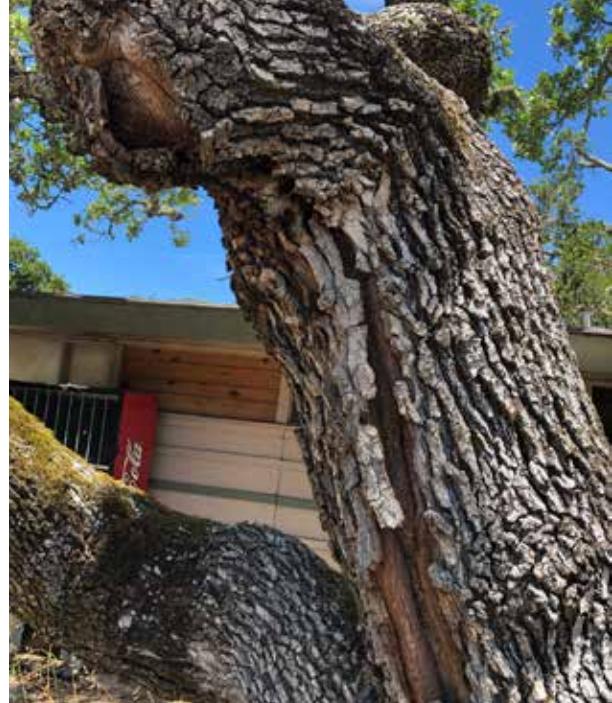
Large area of decay on tree 54. Recommend removal of this branch

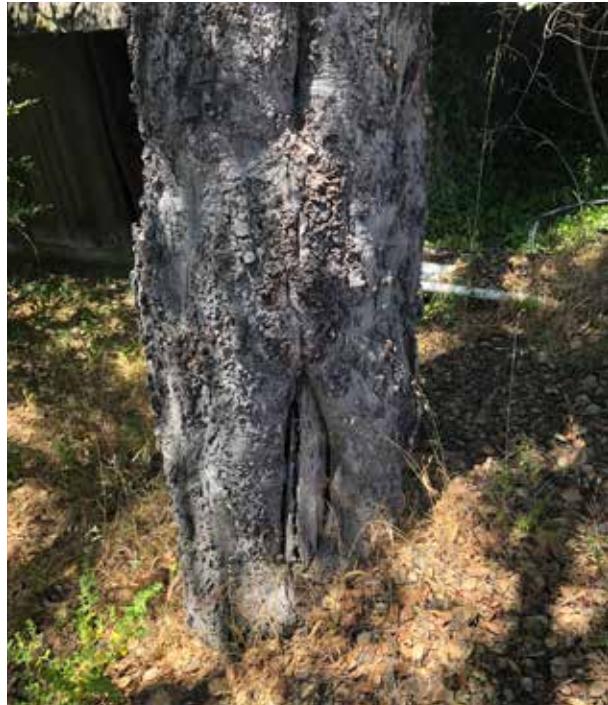
Large areas of decay on tree 58

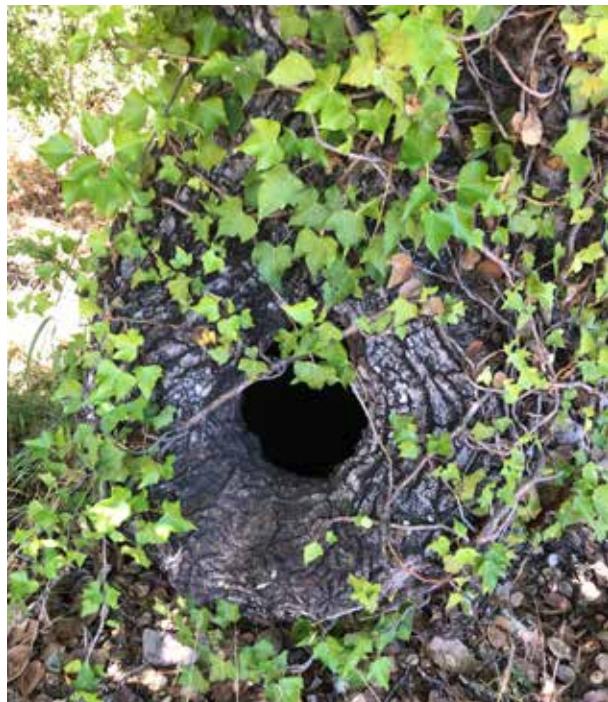
Large cavity on tree 59 filled with standing water

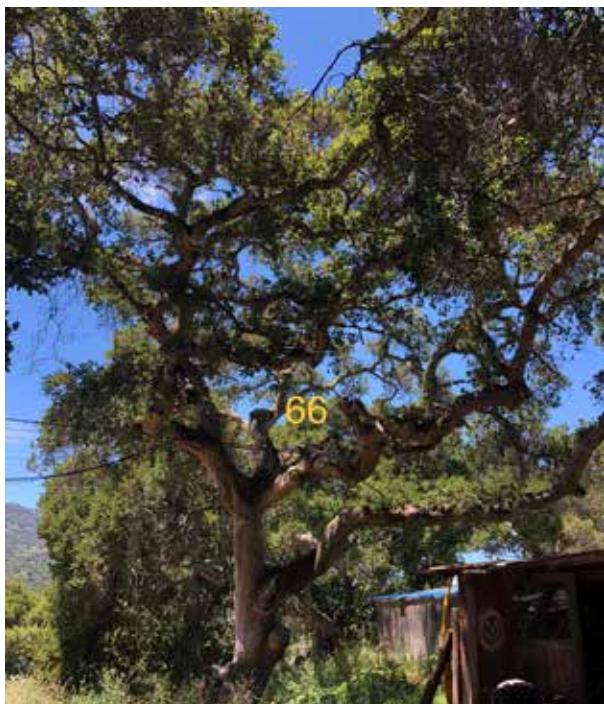
Tree 66, May 2021 prior to failure from heartwood rot

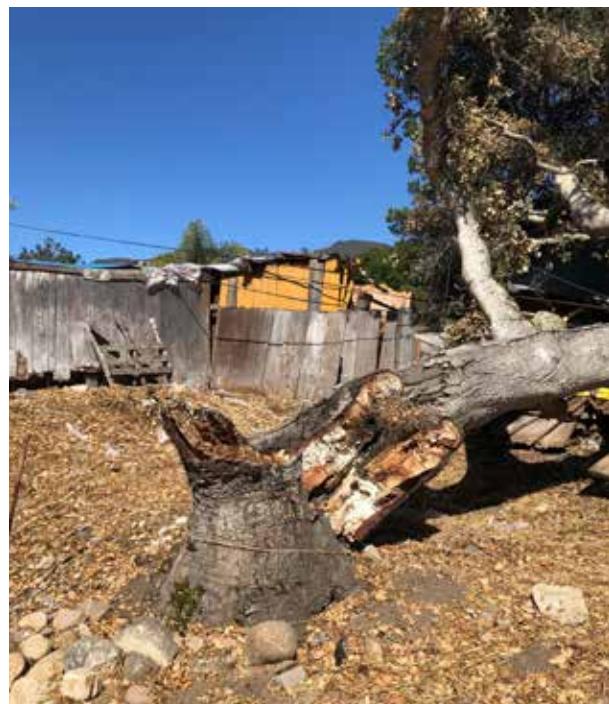
Tree 66, September 2021 after failure

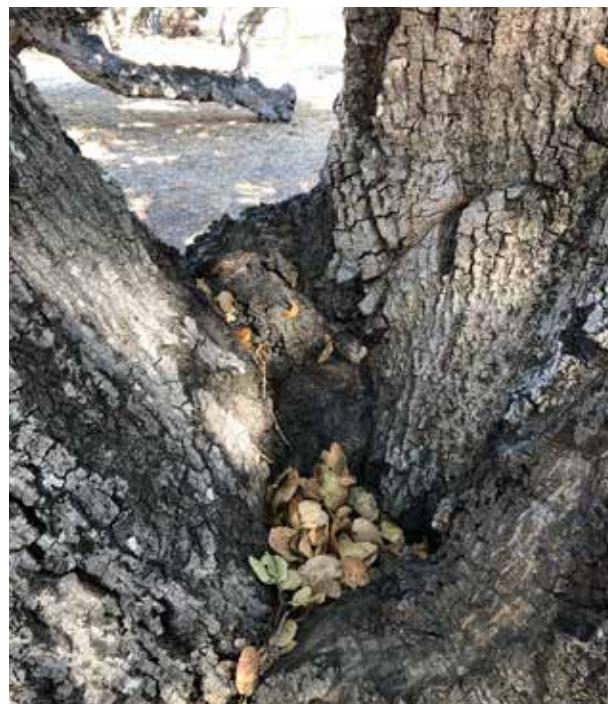
Tree 69 location of probable decay at codominant stem crotch
