UPDATE GEOLOGIC INVESTIGATION

Krimson Coast Holdings, LLC

36240 Highway 1

Easton Geology Job No. C21014

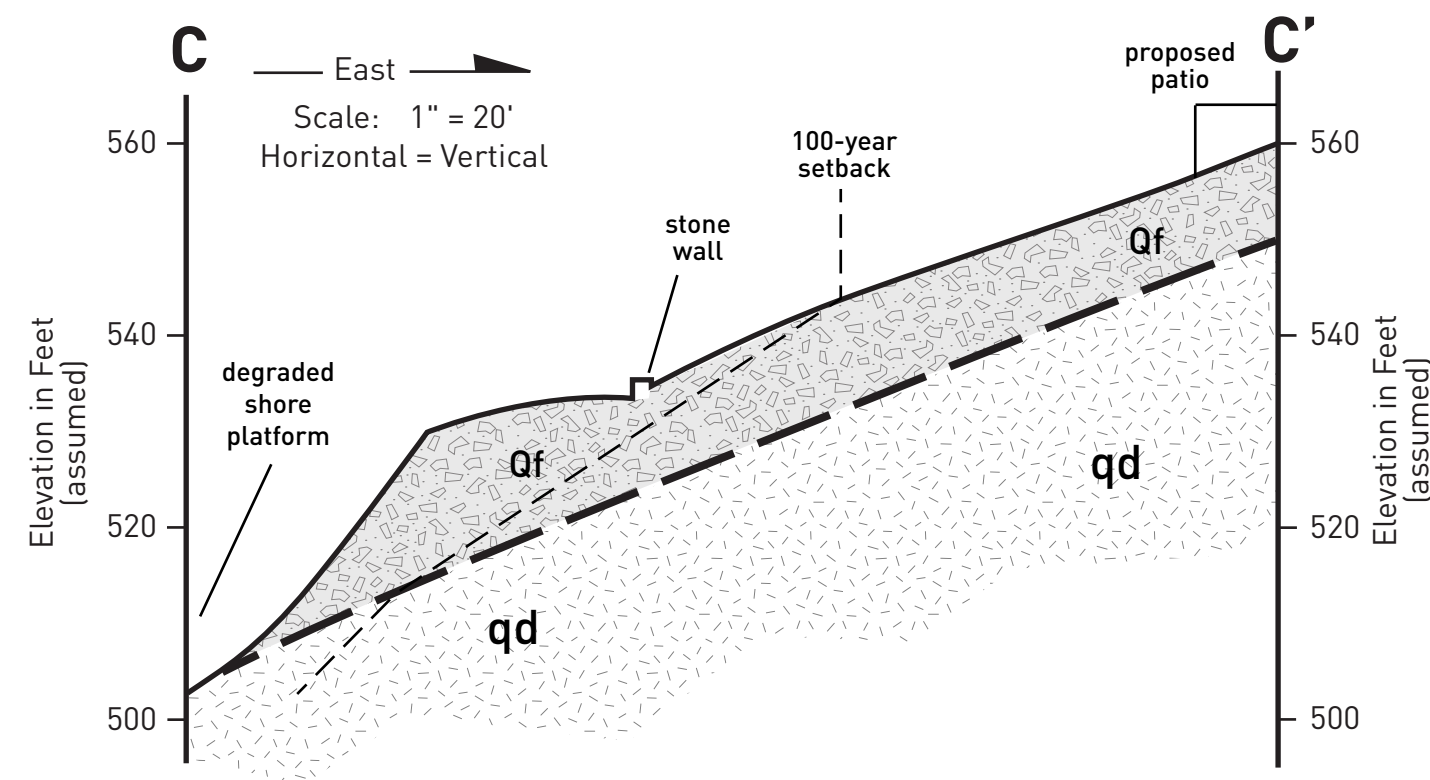
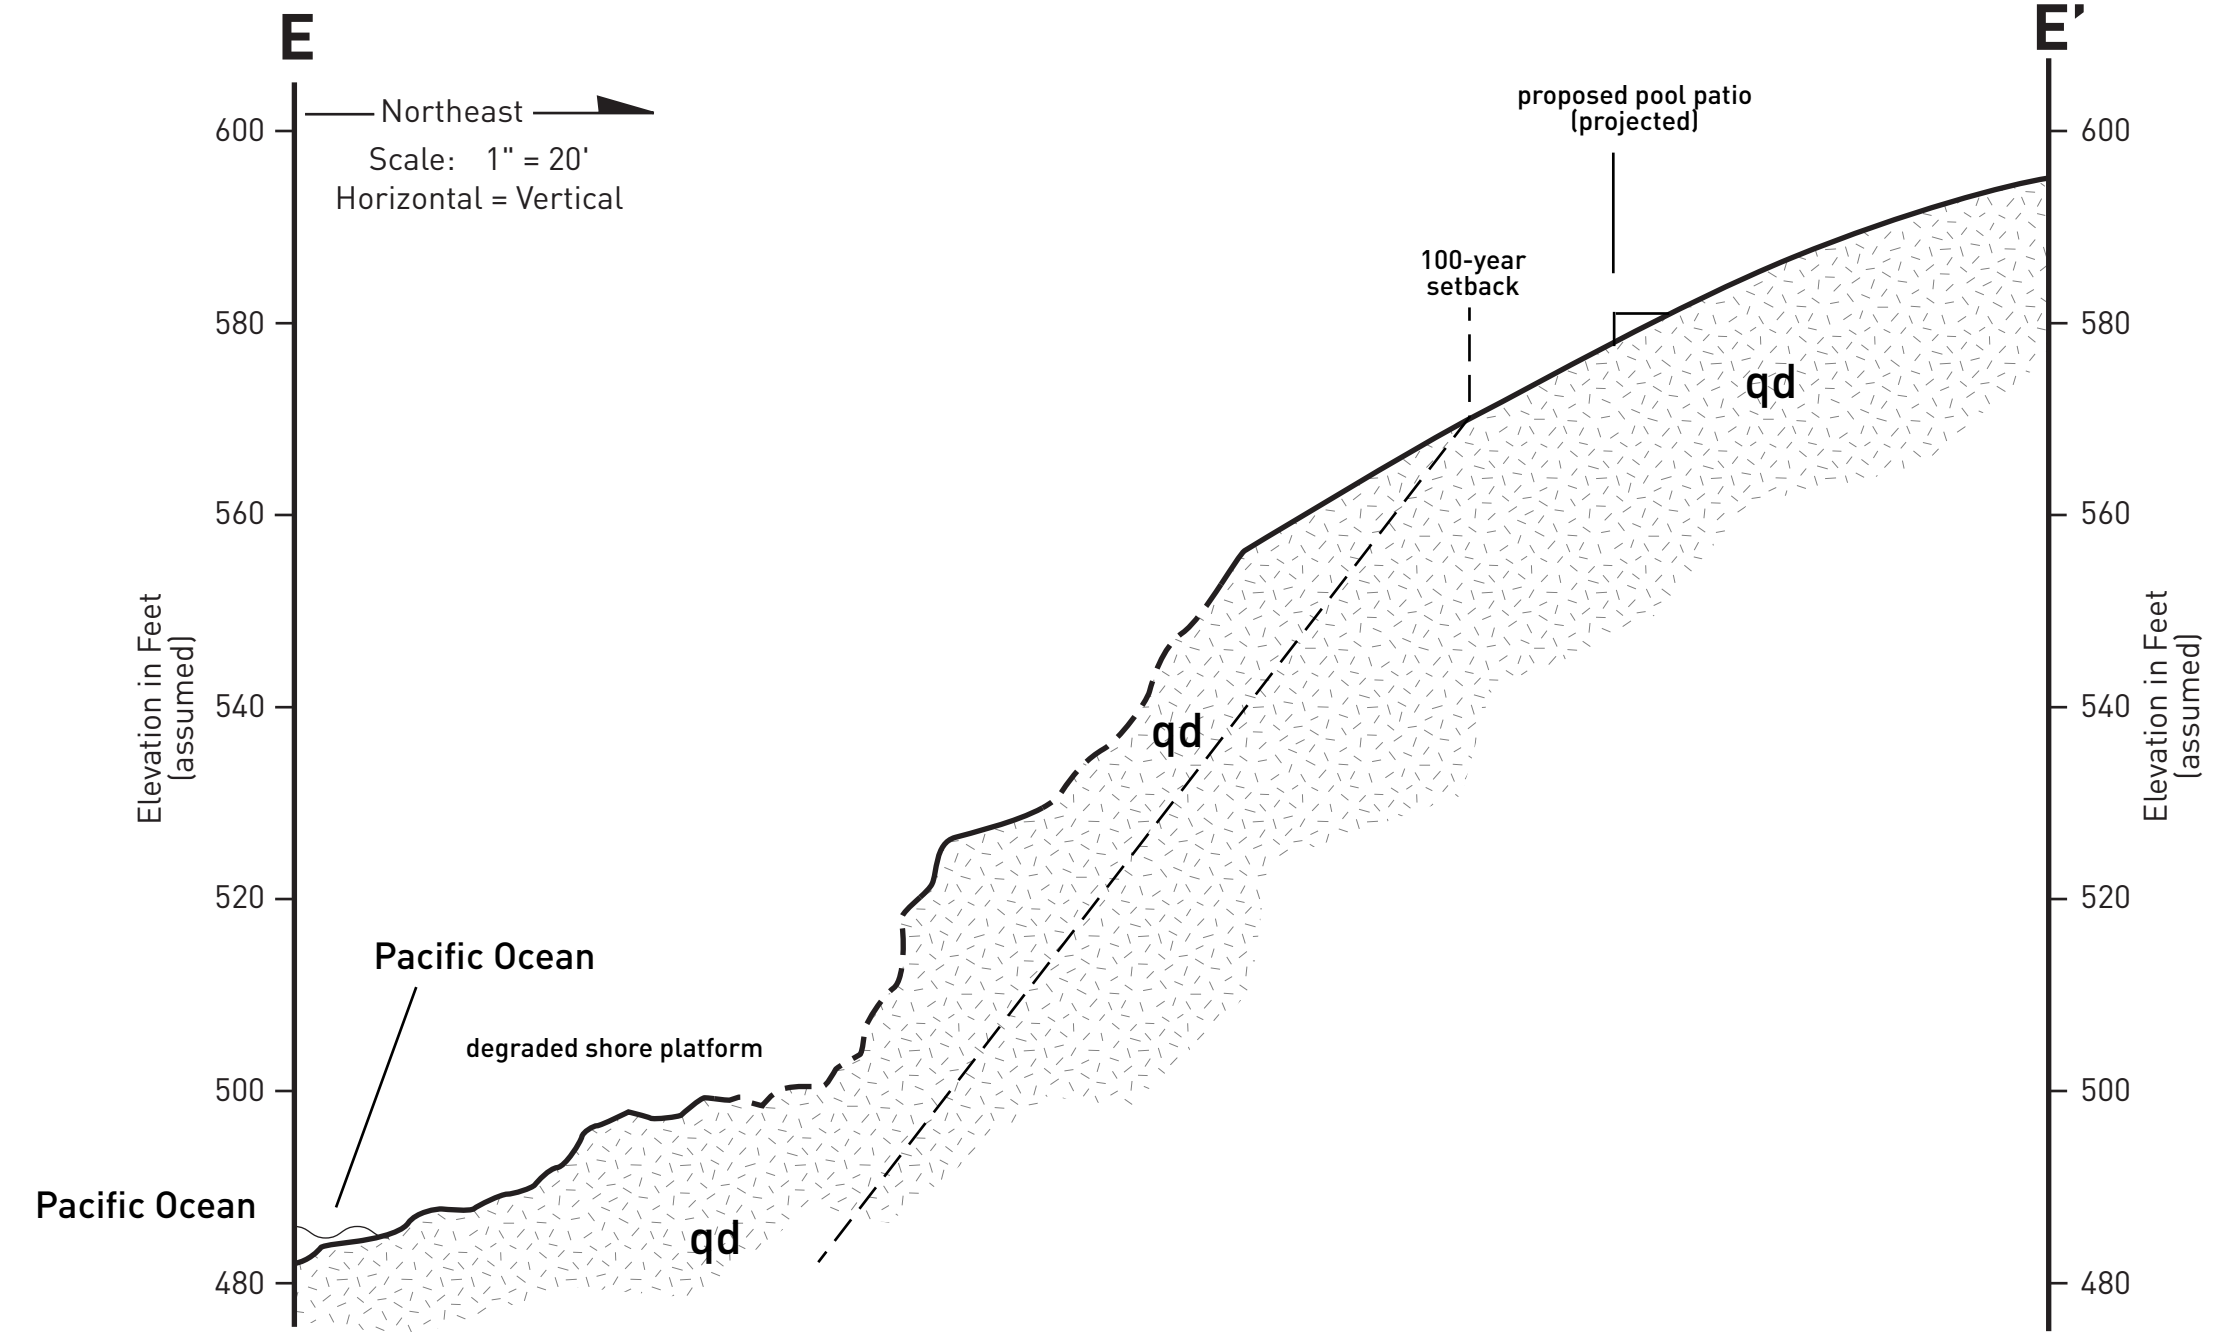
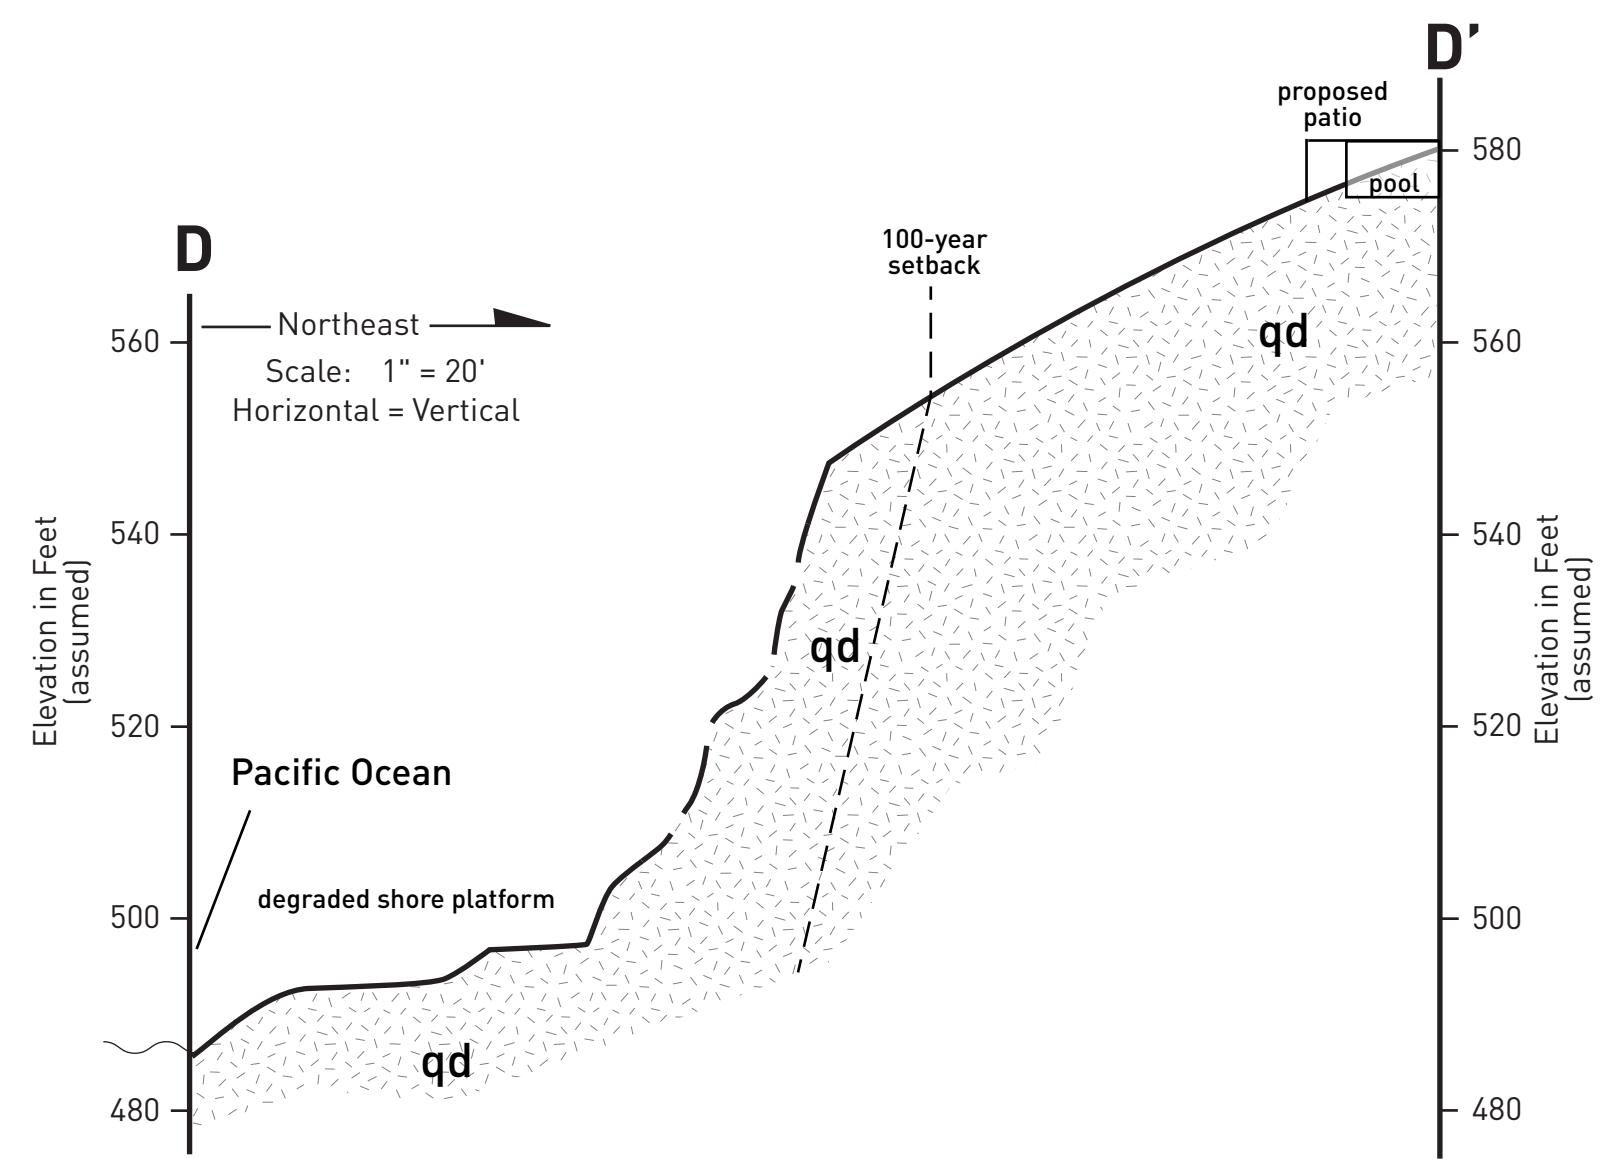
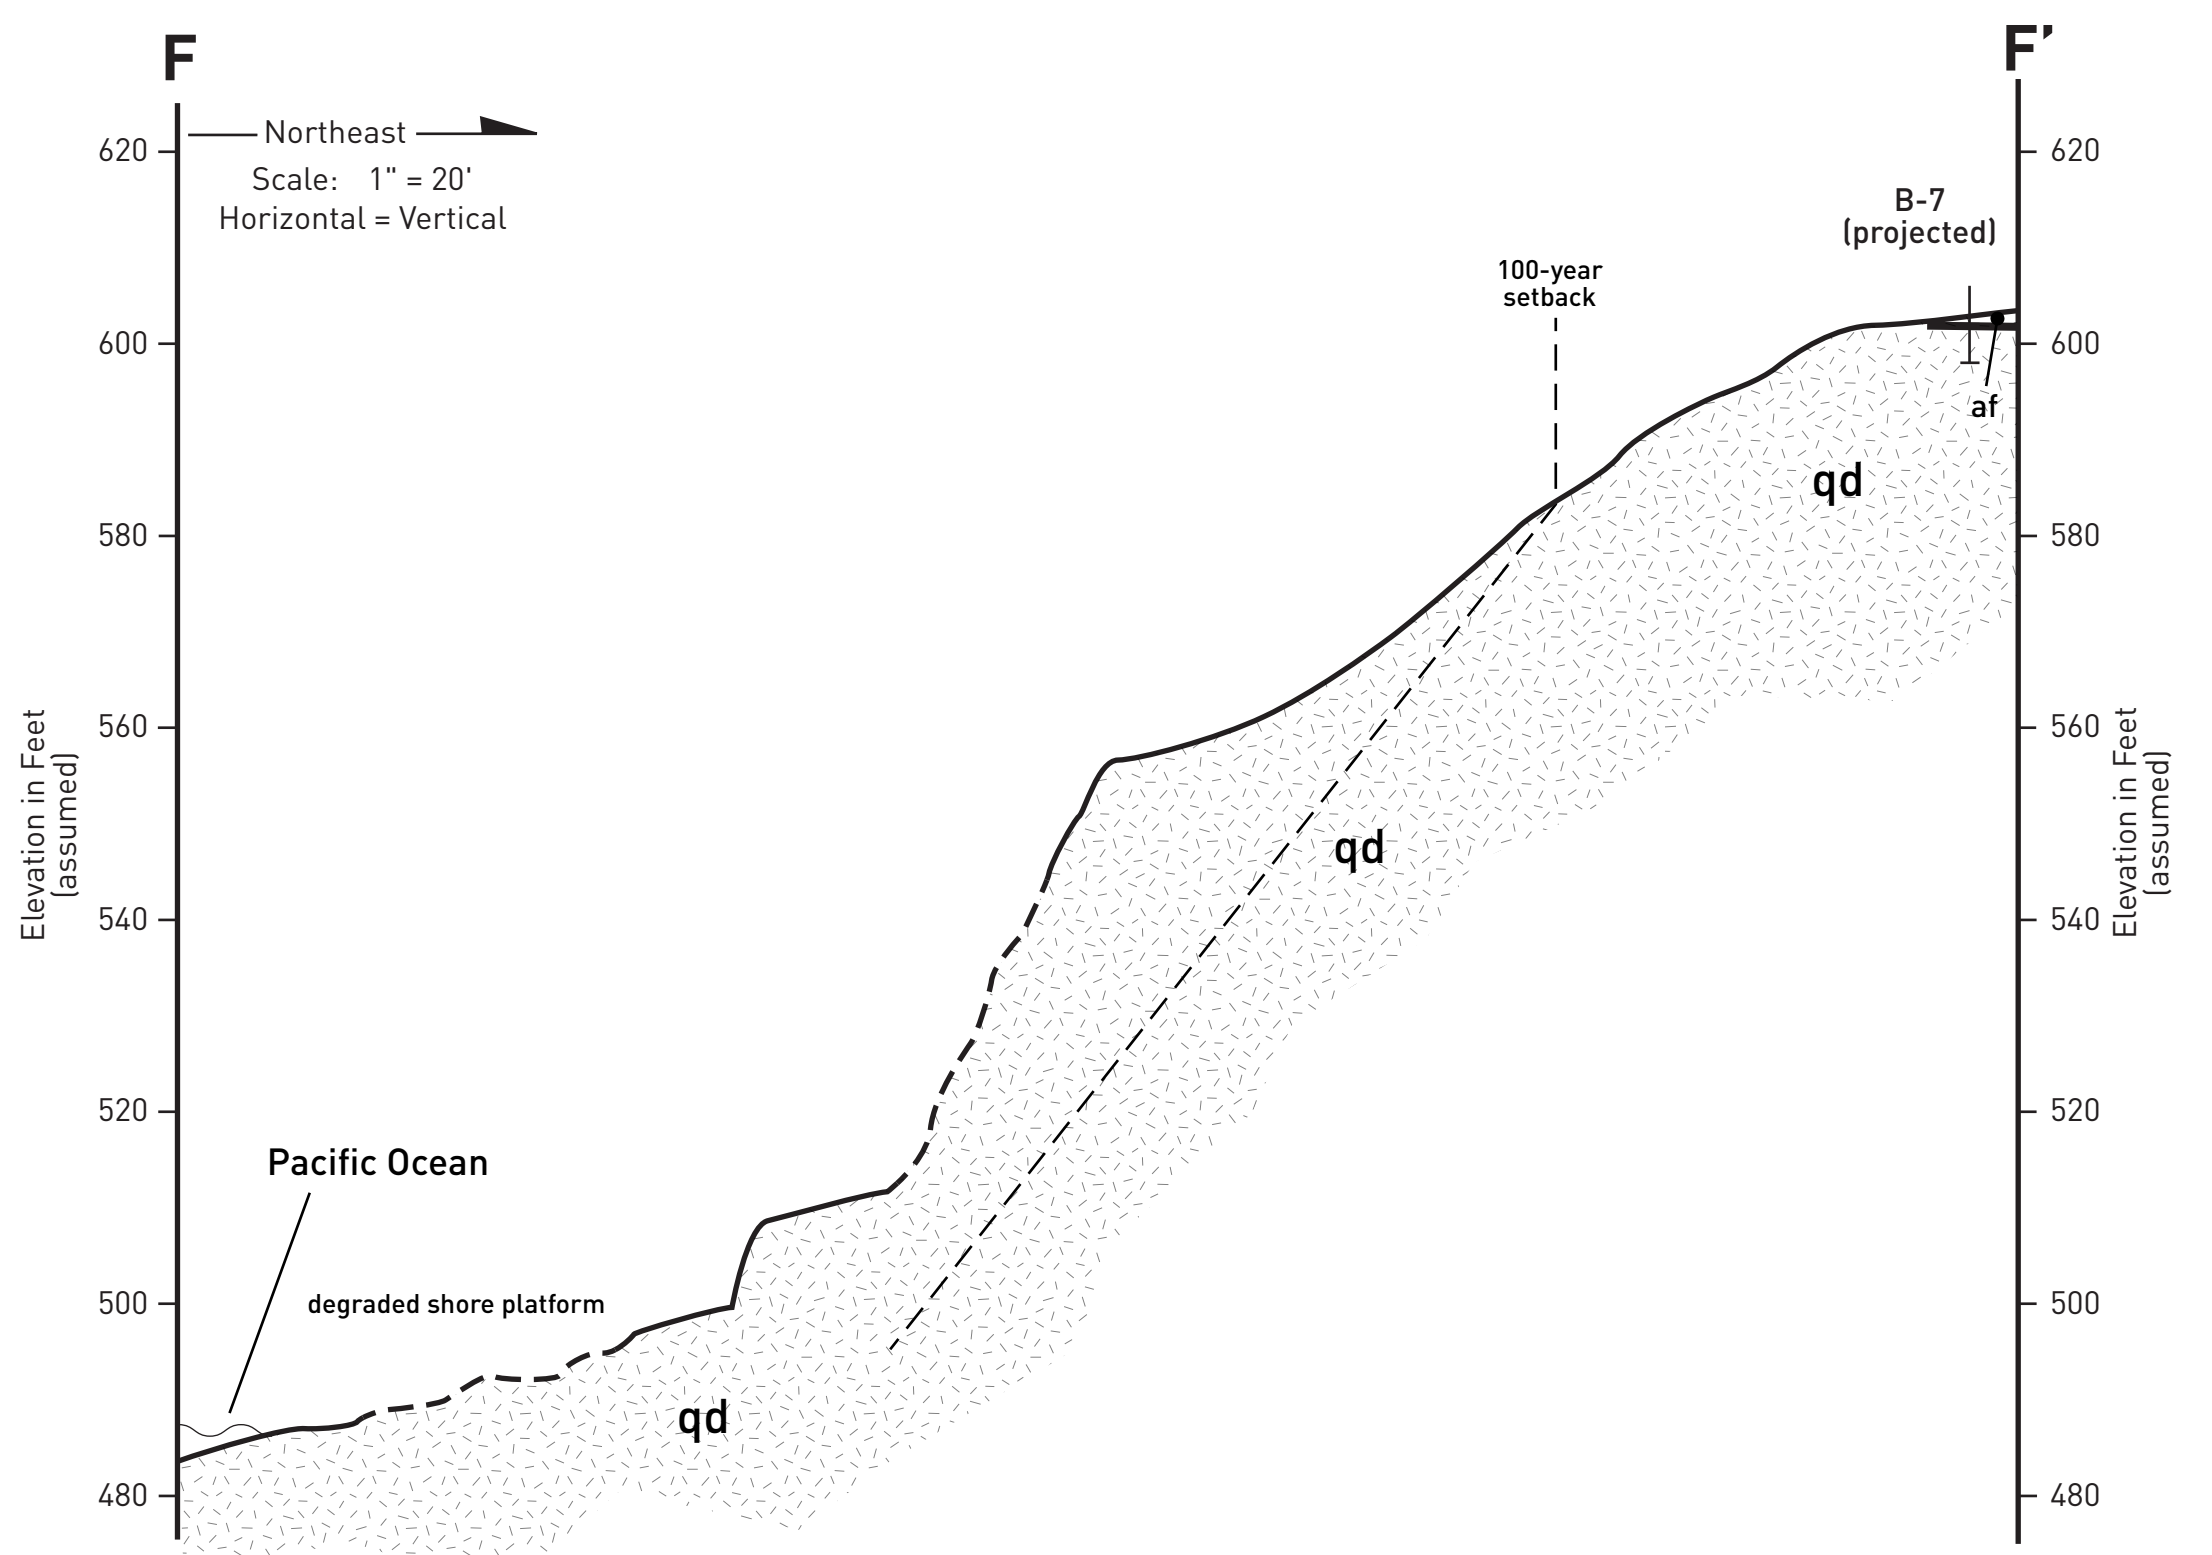
GEOLOGIC CROSS-SECTIONS C, D, E, F
Desai Property
36240 Highway 1
Monterey, California
Monterey County APN 243-251-011

For determining setback and/or foundation recommendations for the proposed new residences, we conducted geologic mapping of the site and surveyed several geologic cross sections through the proposed development areas on the property. We projected collected subsurface data onto our cross sections to analyze the morphology and configuration of the slopes. We utilized the site topographic map and current proposed project plans to assist with our analysis (Plates 1 thru 3). To determine the 100-year bluff setback for the site, we assumed the bluff-face above the degraded shore platform will retreat 10 feet over the next 100-years. The 100-year bluff profile and setback is depicted on Plates 1 thru 3.

1. Foundations for the new residence shall either be set back beyond the surface projection of the 100-year setback line depicted on Plate 1, and/or penetrate below the 100-year setback line depicted in profile view on Plates 2 and 3, and be embedded into competent bedrock. The residence, its basement, and the accessory dwelling unit shall be founded according to the recommendations of the project geotechnical engineer.
