THOMPSON
WILDLAND MANAGEMENT

May 27, 2024

Golden Gate Assets, LP Residence
24656 Guadalupe Street
Carmel, CA 93923
APN: 009-082-004-000

Subject: Pre-construction tree impact assessment & removal report for 24656 Guadalupe Street in Carmel

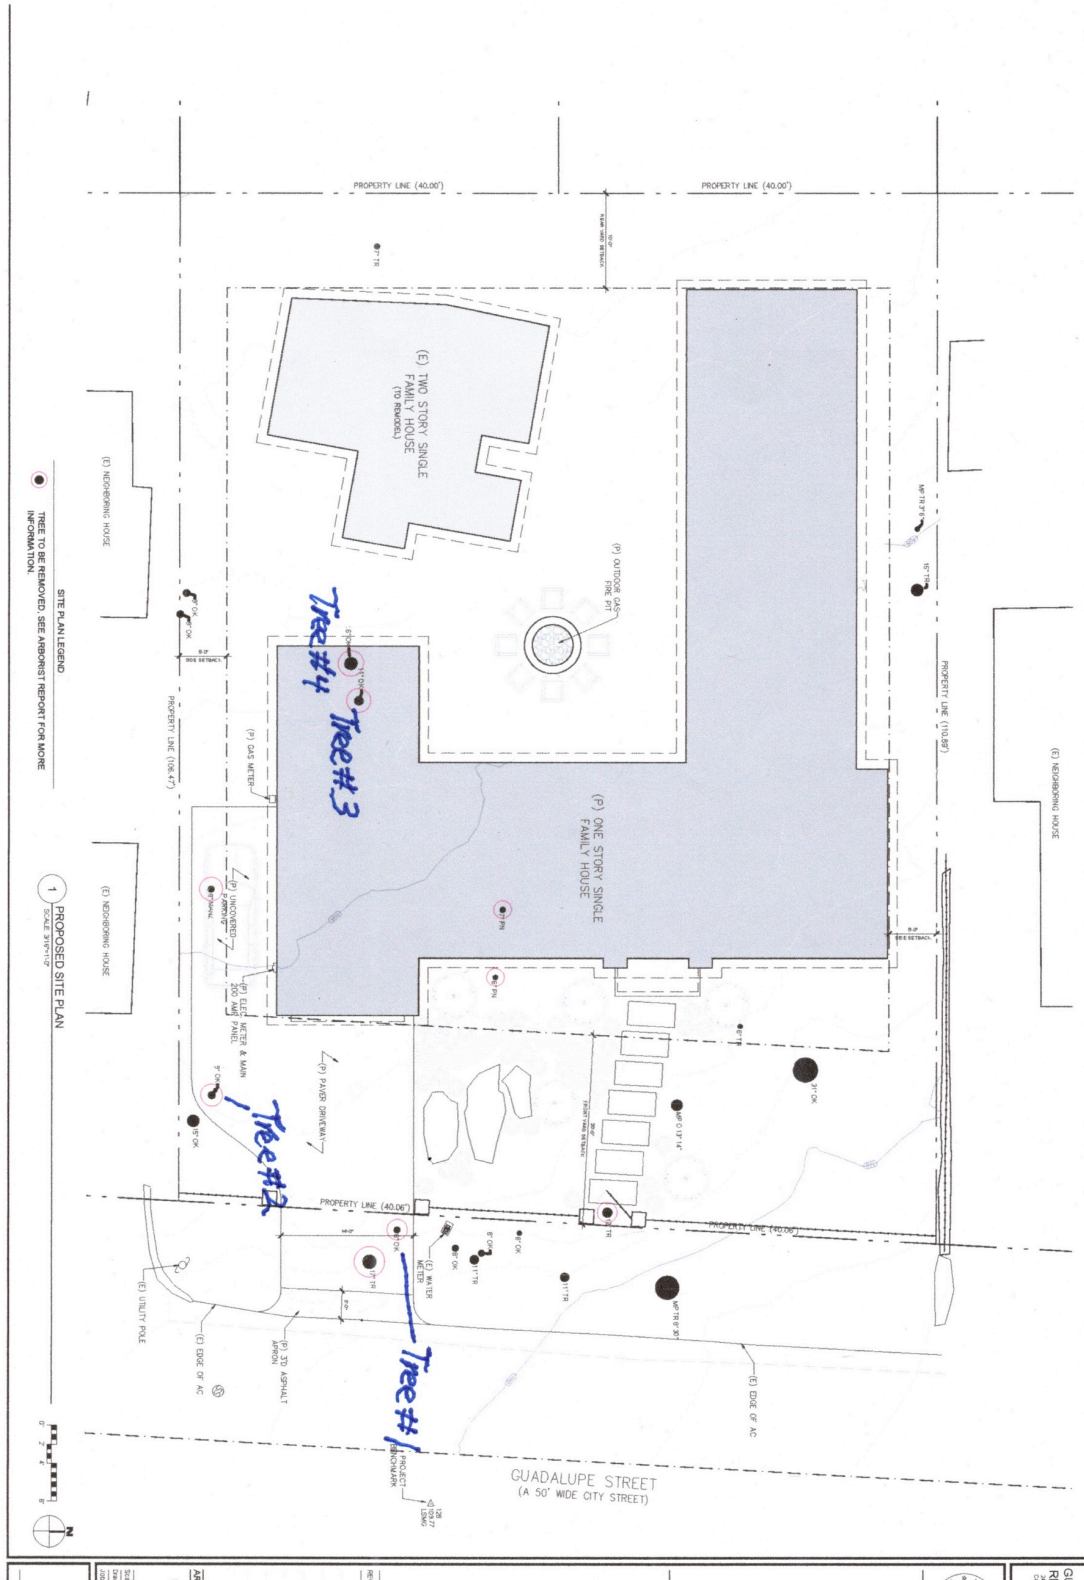
Tree#s 1-4 are native oak trees that are proposed for removal. The 5 other trees proposed for removal are non-native species that do not require a removal permit.

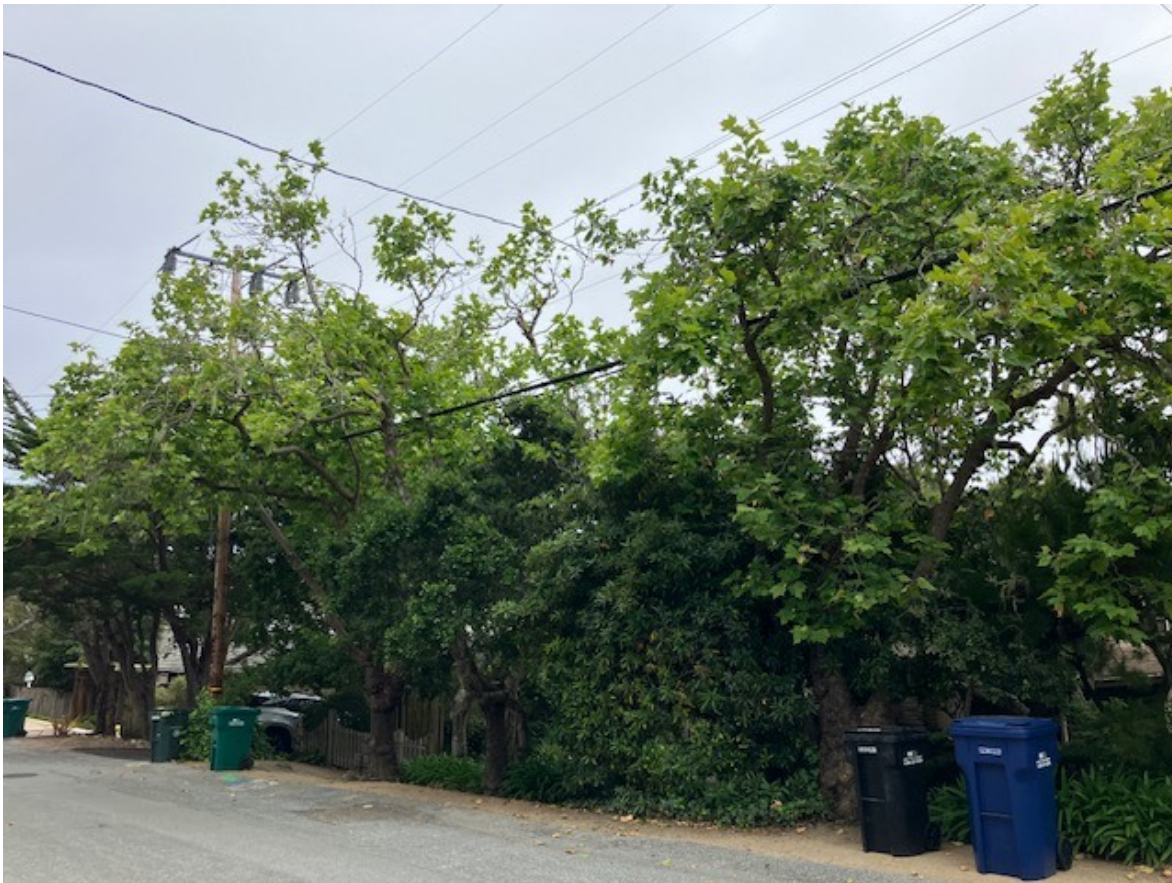
Figure 1. Front area of property along Guadalupe Street is dominated by introduced Liquid Amber and native Coast Live Oak trees.

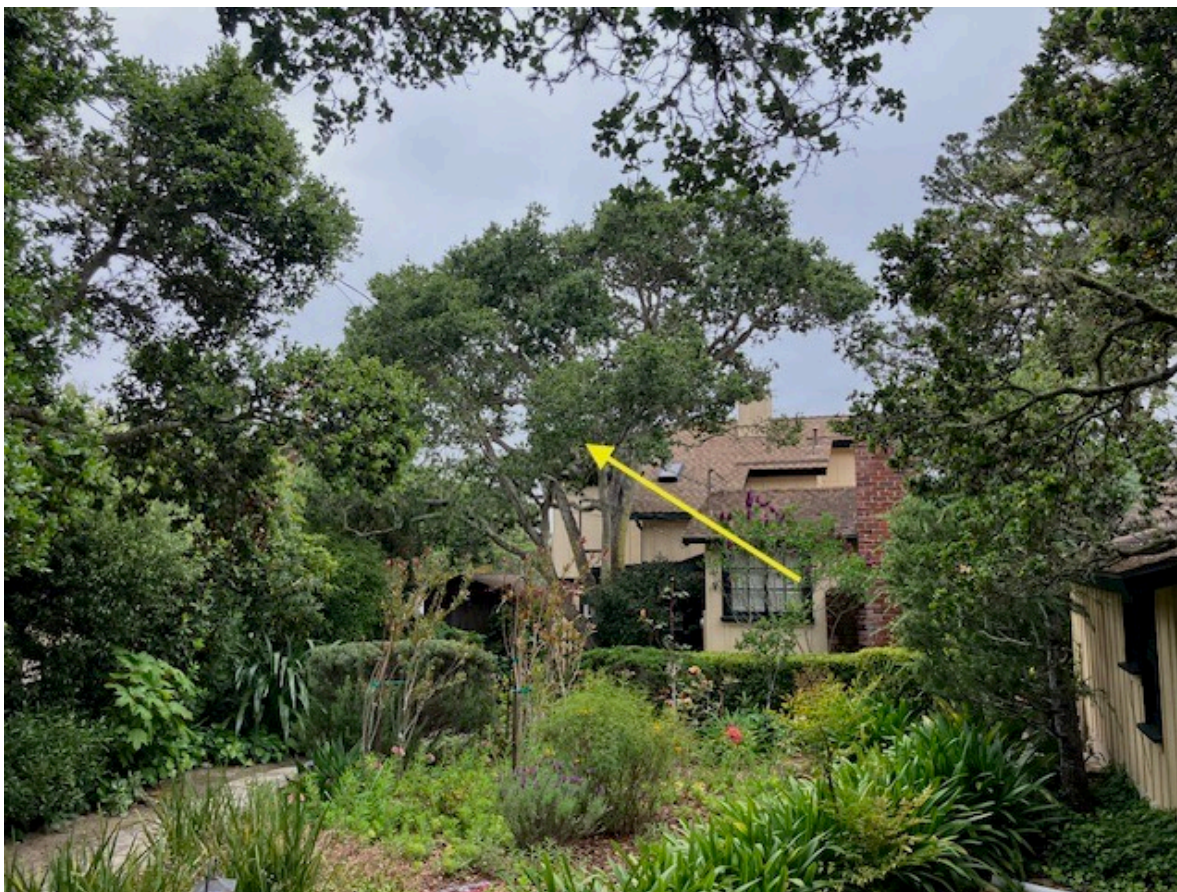
The Coast Live Oak identified as *Tree#3* on the project site plans has a DBH of 10 inches (refer to *Figures 2, 6 & 7*). This oak is located in the construction footprint of the proposed main house site and will need to be removed in order for construction activities to proceed. This oak is in fair physiological health and structural condition. Structural deficiencies include a natural lean, poor canopy balance and symmetry, and multiple co-dominant stem attachments that can be structurally weaker attachments where structural failures are more likely to occur. Currently, this tree appears physiologically and structurally sound. Per County requirements, one 5 to 15-gallon replacement oak will need to be planted on the subject property to satisfy tree removal permit conditions.

The Coast Live Oak identified as *Tree#4* on the project site plans has a DBH of 16 inches (refer to *Figures 2, 6 & 7*) and is located within a few feet of *Tree#3*. This oak is also in the construction footprint of the proposed main house site and will need to be removed in order for construction activities to proceed. This oak is in good physiological health and fair structural condition. Potential structural deficiencies include multiple co-dominant stem attachments, but otherwise this oak currently appears physiologically and structurally sound. Per County requirements, one 5 to 15-gallon replacement oak will need to be planted on the subject property to satisfy tree removal permit conditions.

Figure 2. Front yard of property with existing home where new home will be constructed. Two oaks in center background (Tree#s 3 & 4 identified by yellow arrow) are proposed for removal.

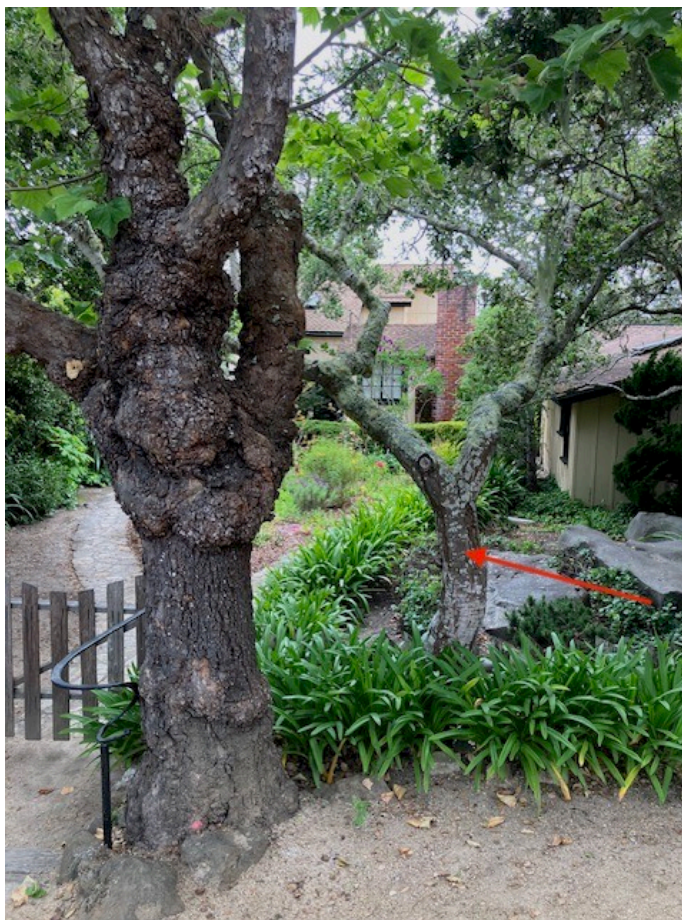
The small Coast Live Oak (*Quercus agrifolia*) identified as *Tree#1* on the project site plans has a DBH (diameter at breast height) of 9 inches (refer to attached photos, *Figures 3 & 4*). This oak is located in the construction footprint of the proposed driveway and will need to be removed in order for construction activities to proceed. This oak is in fair physiological health and condition, but in generally poor structural condition due to visible structural defects and disorders. Structural deficiencies include a suppressed form and structure, poor canopy balance and symmetry, a natural lean in the direction of proposed construction activities, and a co-dominant stem attachment in the main stem. Per County requirements, one 5 to 15-gallon replacement oak will need to be planted on the subject property to satisfy tree removal permit conditions.

Figure 3. The small Coast Live Oak identified as Tree#1 (red arrow) is proposed for removal due to location within construction footprint..

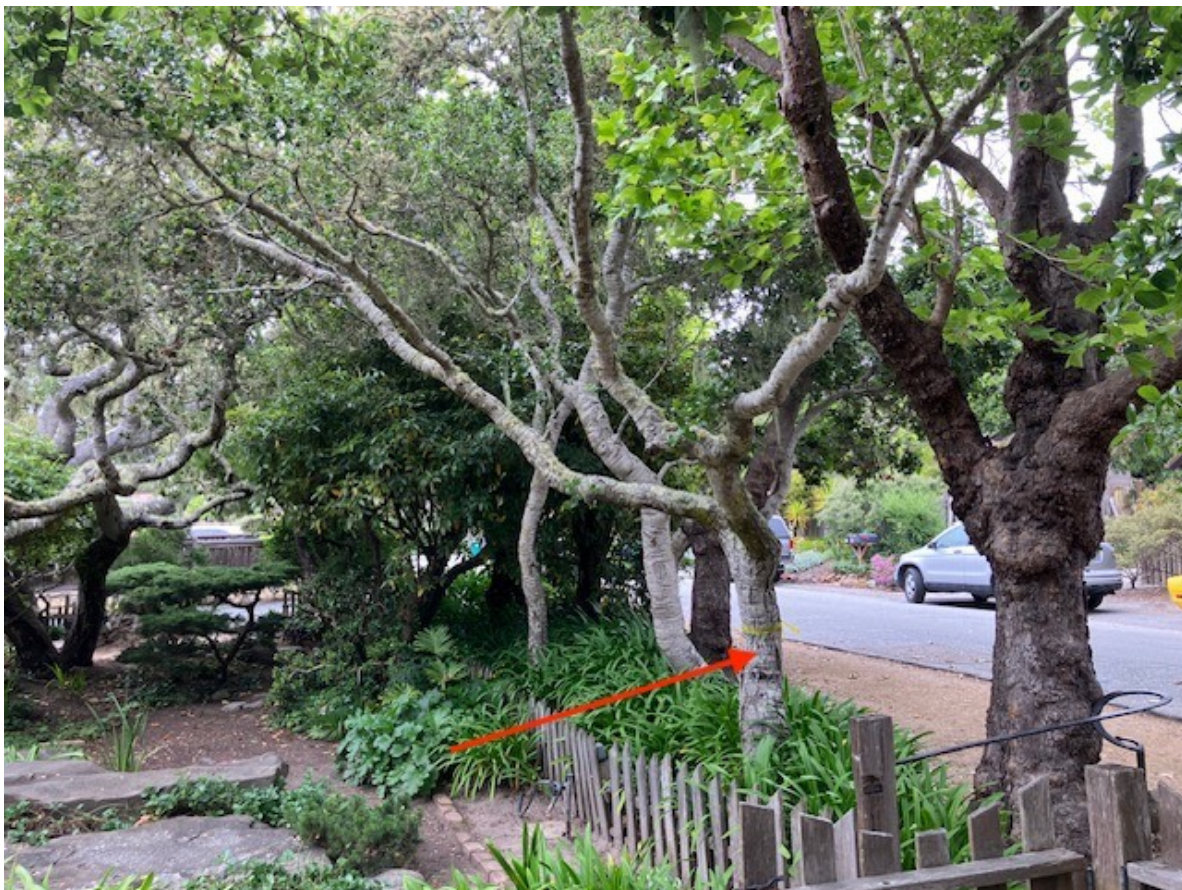
Figure 4. Another view of oak identified as Tree#1 that has suppressed growth and poor canopy balance and symmetry.

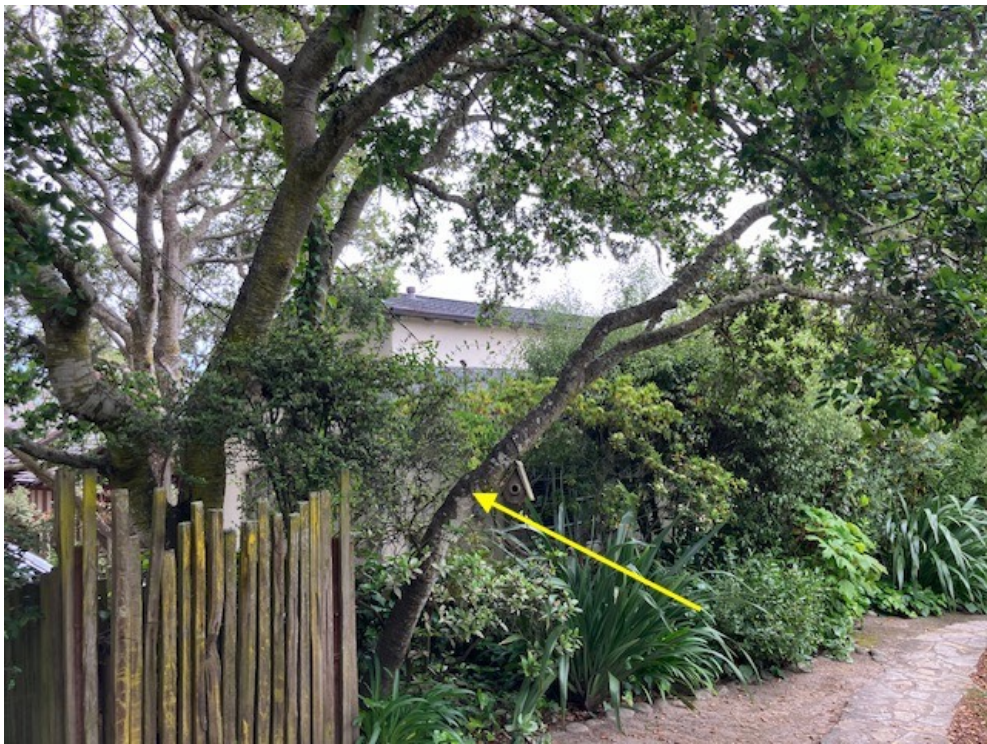
The small Coast Live Oak identified as *Tree#2* on the project site plans has a DBH of 7 inches (refer to *Figure 5*). This oak is also located in the footprint of the proposed driveway construction area and will need to be removed in order for construction activities to proceed. This oak is in fair physiological health and condition, but in poor structural condition due to visible structural defects and disorders. Structural deficiencies include a significant natural lean in the direction of proposed construction activities, a suppressed form and structure, poor canopy balance and symmetry, and a co-dominant stem attachment in the main stem. Per County requirements, one 5 to 15-gallon replacement oak will need to be planted on the subject property to satisfy tree removal permit conditions.

Figure 5. The small and suppressed oak identified as Tree#2 (yellow arrow) has a significant lean and poor structure and is proposed for removal due to construction impacts.

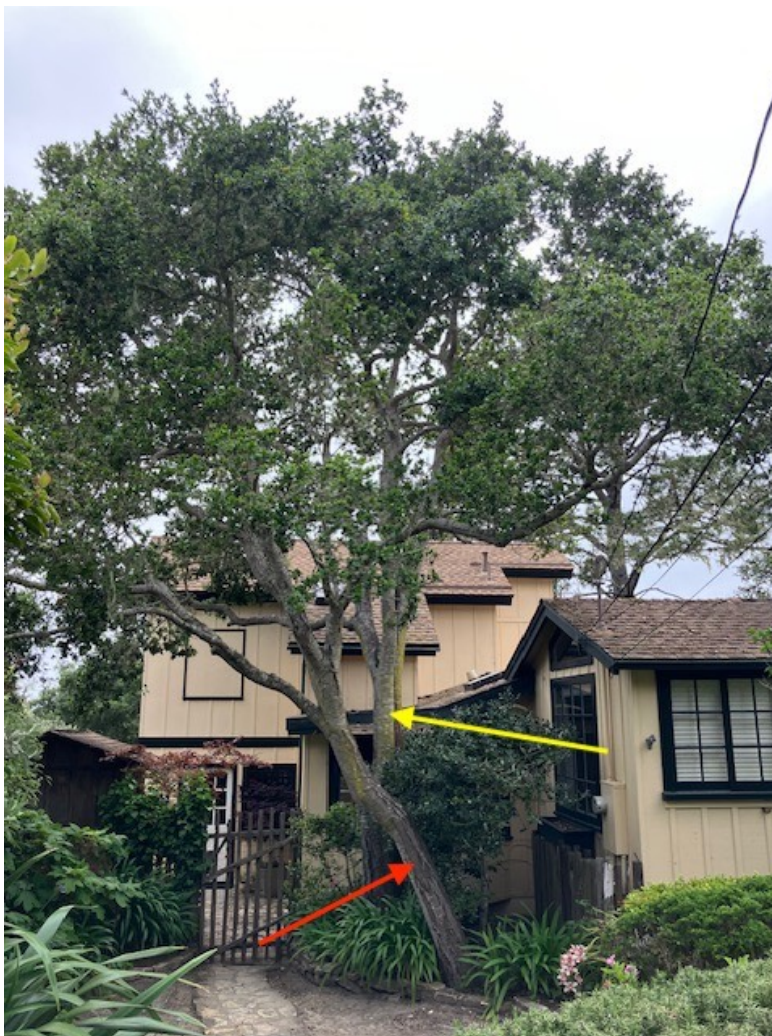
Figure 6. Oaks identified as Tree#s 3 (red arrow) and Tree#4 (yellow arrow) are proposed for removal due to location within construction footprint.

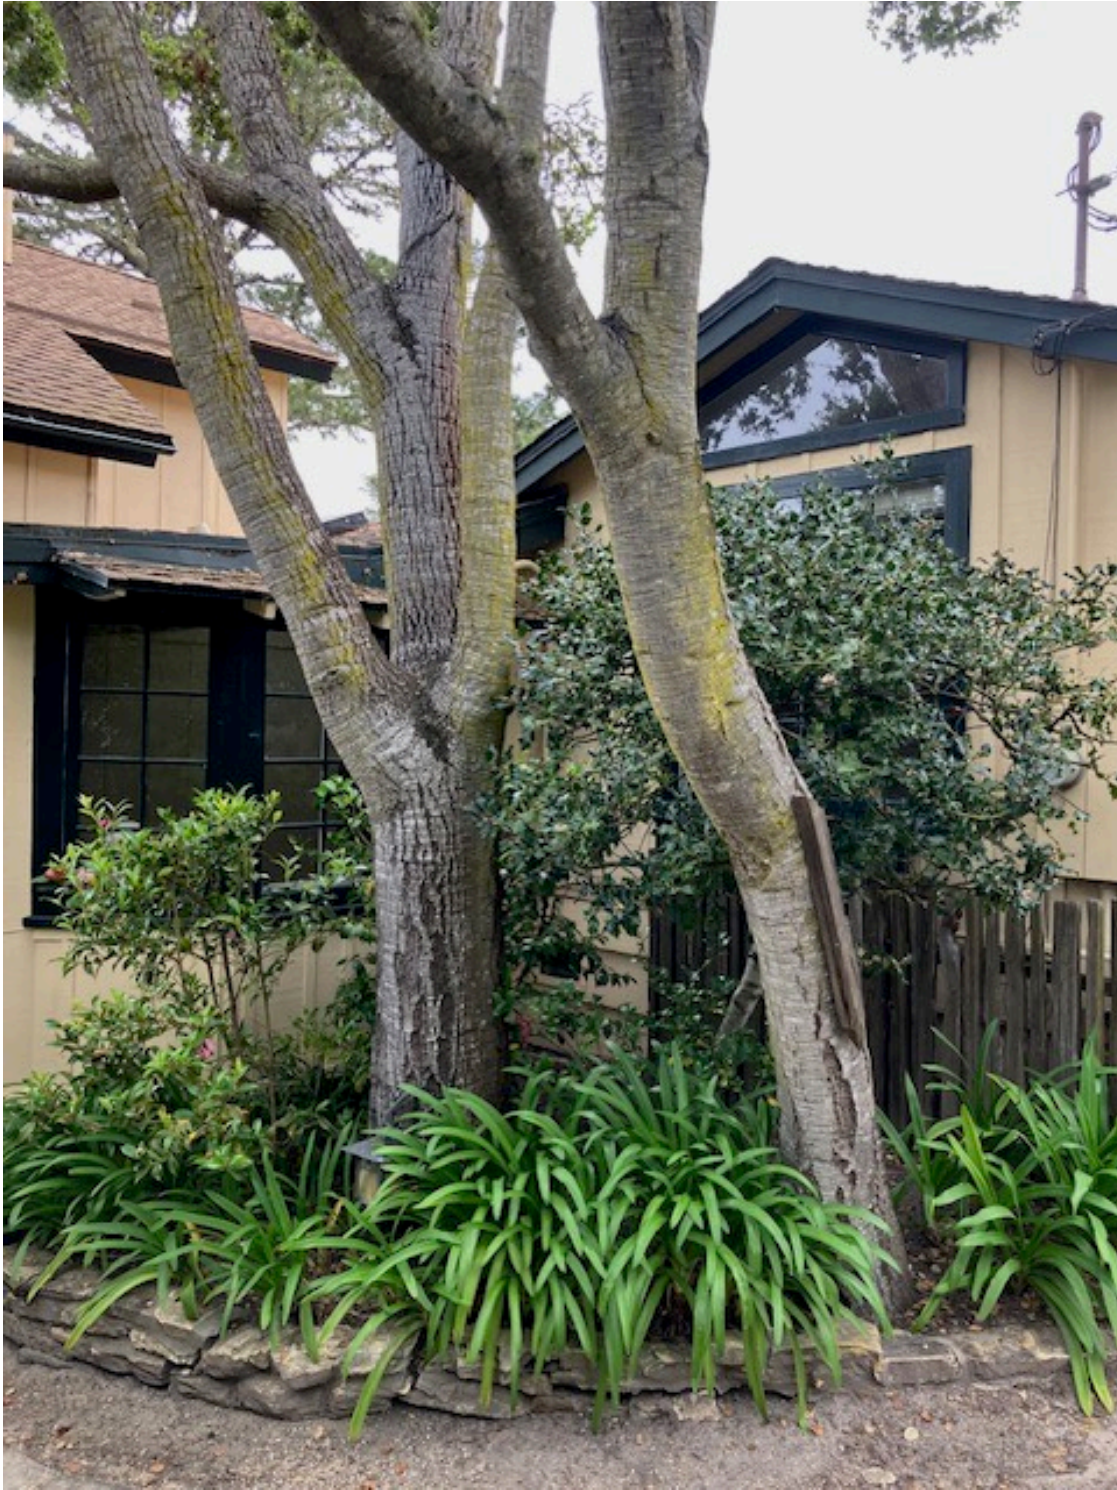
Figure 7. A closer view of oaks identified as Tree#3 (right of center) and Tree#4 (left of center) that are planned for removal due to location within proposed building footprint.

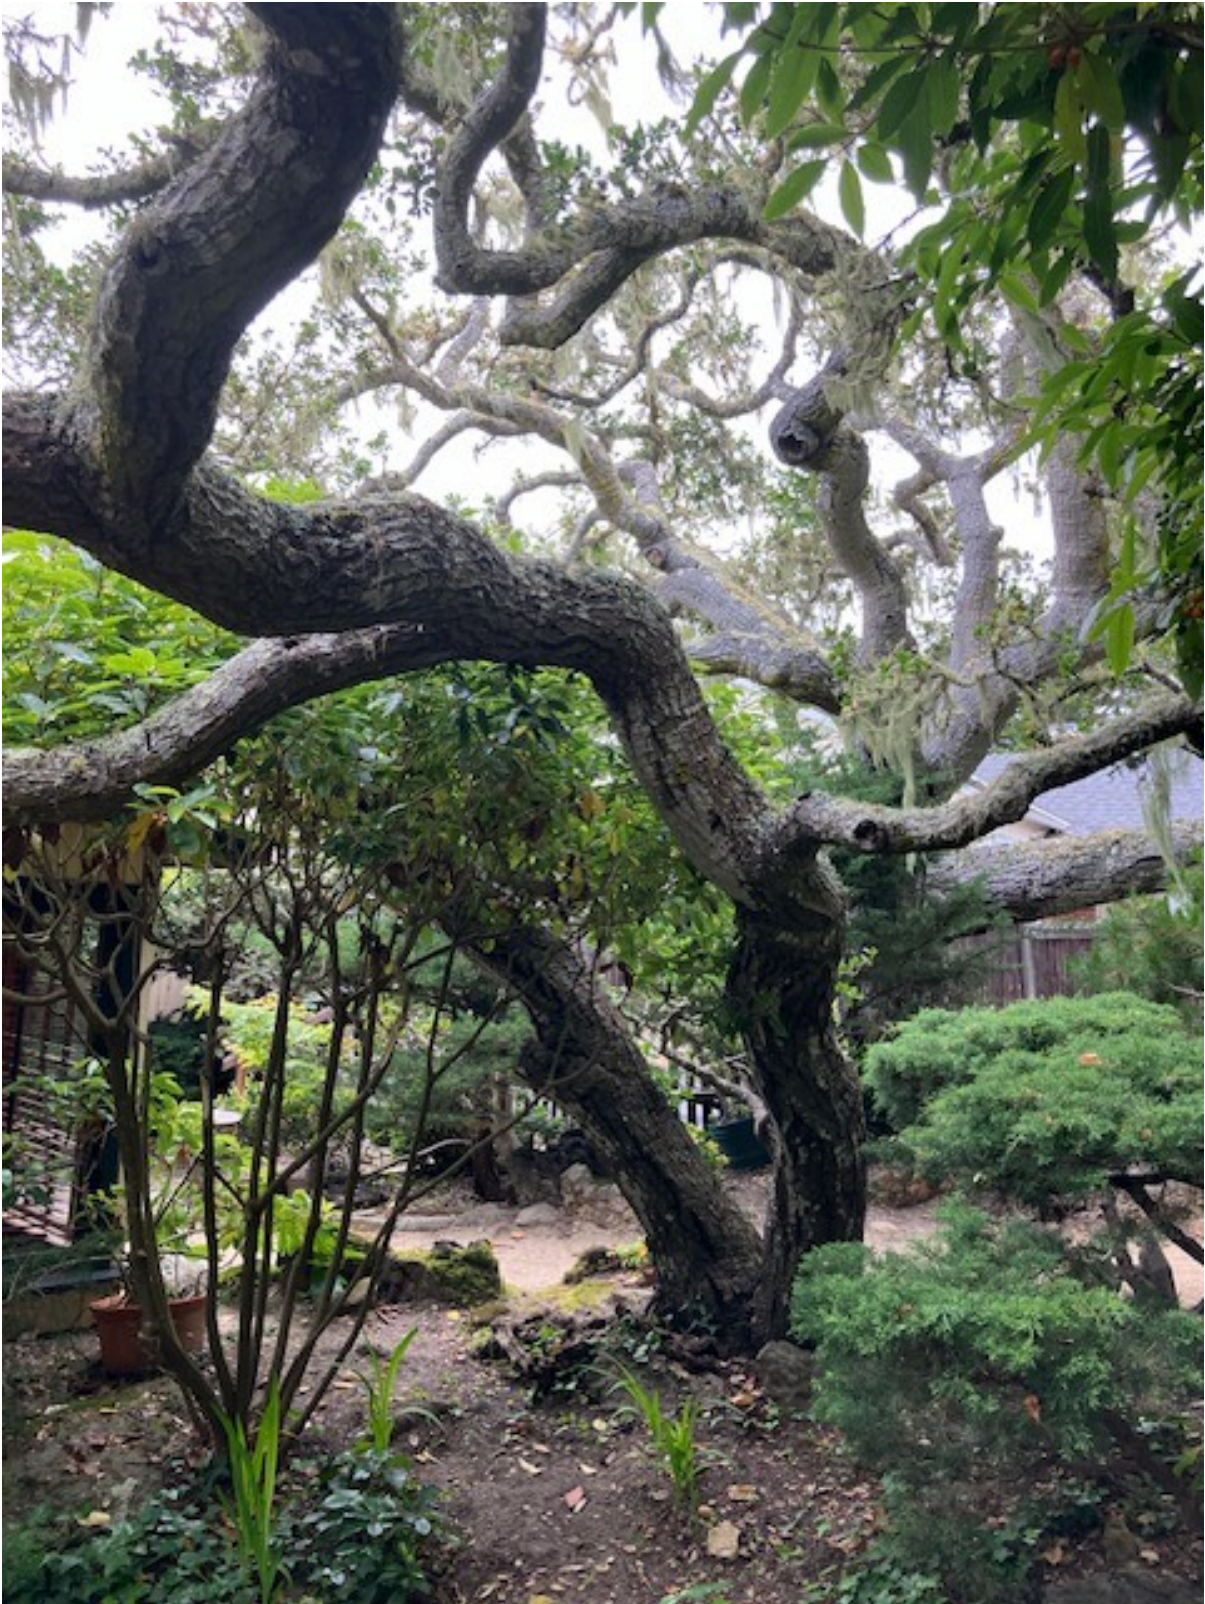
Figure 8. This landmark oak on the property will be retained and protected and is not expected to be significantly impacted by construction activities.
