**RE: Updated January 16, 2025, Tree Assessment and Forest Management Plan for the 2821 Congress Road Residential Project**

2821 Congress Road Residential Project Tree Management Plan

**2821 CONGRESS ROAD RESIDENTIAL PROJECT  
PEBBLE BEACH, CALIFORNIA**

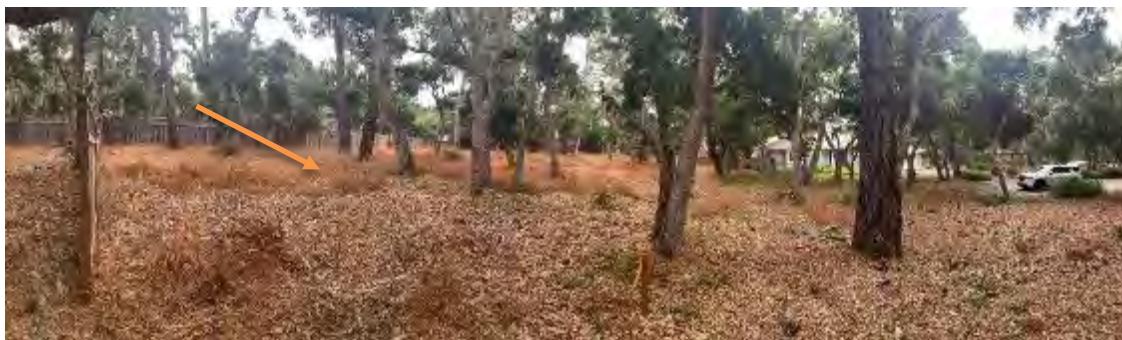
**Figure 3: Vegetation conditions of the site.**

Note the un-mowed grass and herbaceous ground cover (arrow) and the forest vegetation consisting of live oak and Monterey pine. Ladder fuels are largely absent.

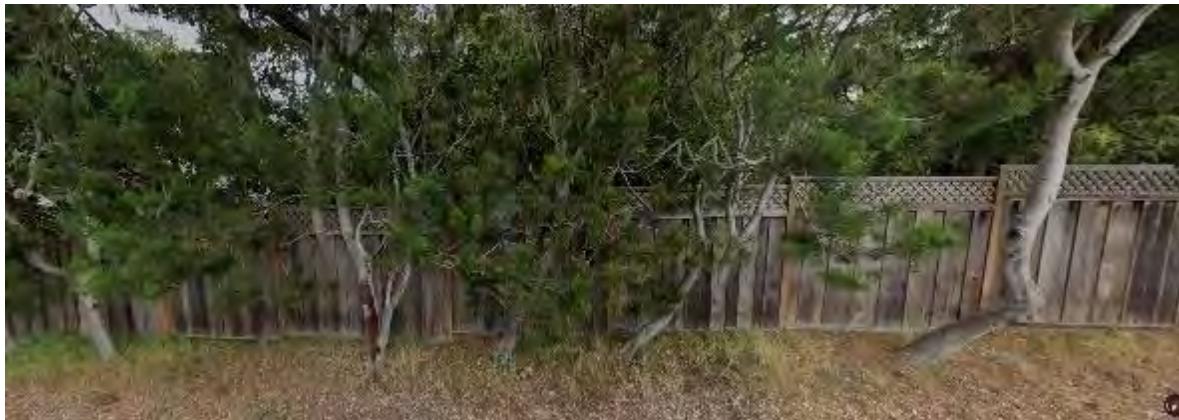
The parcel is surrounded by a wooden good-neighbor fence on three sides (see Figure 5). Wooden fences can contribute to rapid progression of fire through the community and can lead a fire directly to the house, especially if plant debris, dead vegetation, or other flammable material has gathered at the bottom. The existing fences have dense vegetation growing on both sides of the fence. Wood slat fences with gaps can trap burning embers and may cause the fence to catch fire. Vinyl fences, concrete walls, and wrought iron fences are durable and more fire-resistant than wooden fences. They also resist termites and other insects. However, the extreme heat created by a wildfire can cause vinyl fences to melt, potentially spreading the fire. All wooden fences should have a non-combustible gate, or structure, between the fence and the home to keep flames at least 10 feet away from the structure. A small gap at the bottom of the fence keeps fence boards from touching the soil, because direct contact can cause rot and decay, making the wood more flammable. It is important to maintain the fence line clear of plants, dry vegetation, branches, leaves, and combustible materials such as firewood.

**Figure 5: Wood fence on property line.**
