# Exhibit D

#### RE: Updated January 16, 2025, Tree Assessment and Forest Management Plan for the 2821 Congress Road Residential Project

2821 CONGRESS ROAD RESIDENTIAL PROJECT PEBBLE BEACH, CALIFORNIA

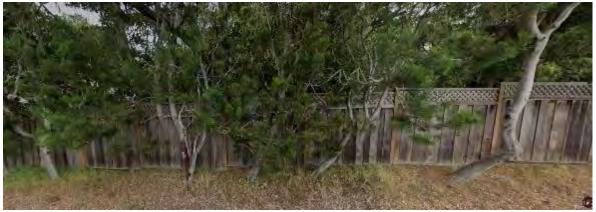
The parcel is surrounded by a wooden good-neighbor fence on three sides (see Figure 5). Wooden fences can contribute to rapid progression of fire through the community and can lead a fire directly to the house, especially if plant debris, dead vegetation, or other flammable material has gathered at the bottom. The existing fences have dense vegetation growing on both sides of the fence. Wood slat fences with gaps can trap burning embers and may cause the fence to catch fire. Vinyl fences, concrete walls, and wrought iron fences are durable and more fire-resistant than wooden fences. They also resist termites and other insects. However, the extreme heat created by a wildfire can cause vinyl fences to melt, potentially spreading the fire. All wooden fences should have a non-combustible gate, or structure, between the fence and the home to keep flames at least 10 feet away from the structure. A small gap at the bottom of the fence keeps fence boards from touching the soil, because direct contact can cause rot and decay, making the wood more flammable. It is important to maintain the fence line clear of plants, dry vegetation, branches, leaves, and combustible materials such as firewood.

Figure 5: Wood fence on property line.

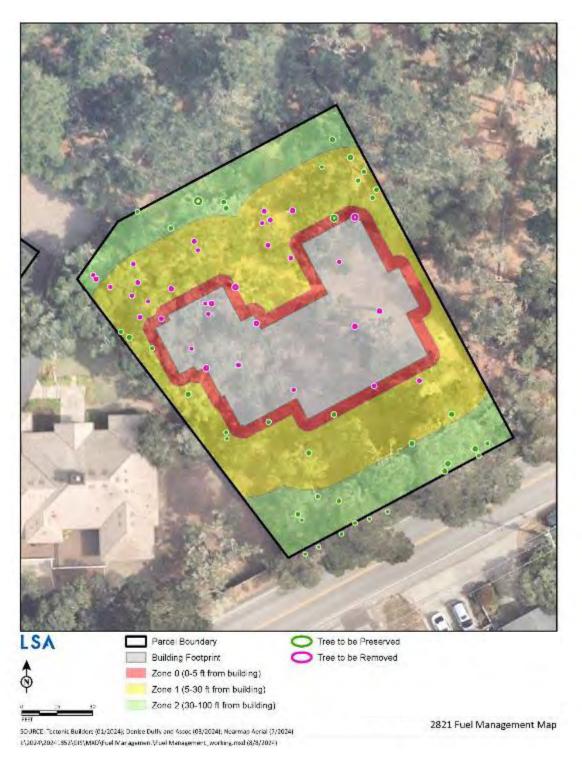
Figure 6: Fuel Management Zones and proposed tree removals
