# THOMPSON WILDLAND MANAGEMENT

July 31, 2024

Allen & Hain Residence 38042 Palo Colorado Road Carmel, CA 93923 APN: 418-132-005-000

Subject: Pre-construction tree impact assessment for 38042 Palo Colorado Road

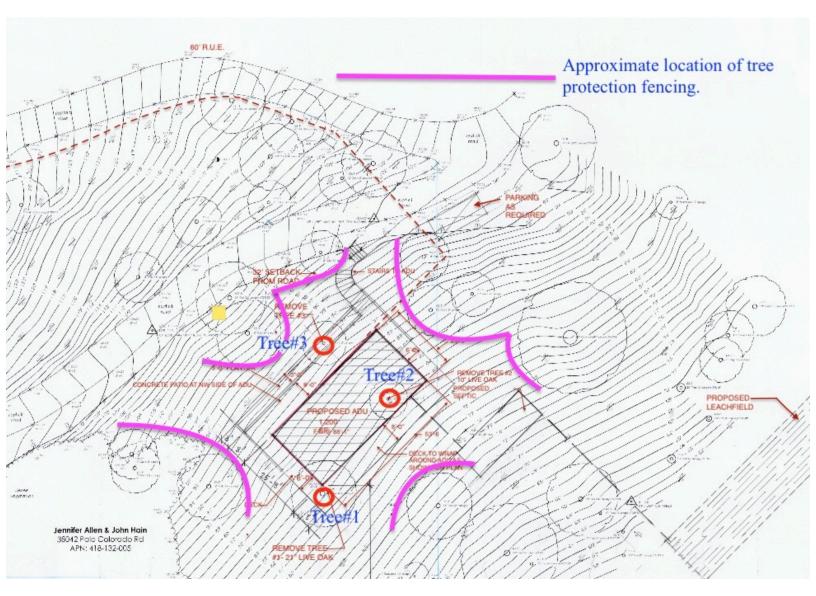
Exhibit A: Tree Location & Tree Protection Fencing Map - 3 Coast Live Oak trees proposed for removal due to construction related impacts are identified as Tree#s 1-3. The purple lines show approximate location of tree protection fencing that shall be properly installed and maintained for the duration of the project.

- 1) Prior to commencing with grading and construction activities install high visibility exclusionary fencing that clearly defines the work area, limits unnecessary disturbance to surrounding areas, and protects the critical root zone (CRZ) of individual trees and/or tree groupings. Generally speaking, the CRZ area is defined by the outermost portion of the canopy dripline 360 degrees around the tree (so basically the entire area under the canopy dripline), or alternatively, but less desirable in terms of tree preservation, installing exclusionary fencing to a distance from the trunk that protects at least half of the interior canopy dripline and CRZ or to a minimum distance of 15 feet from the base of the tree, whichever is greater. For protecting the canopy dripline and CRZ areas of trees use a more durable and heavier duty orange exclusionary fencing (e.g., Resinet Heavy Duty Square Mesh Access Control Barrier Fence) anchored in with steel T-posts, or in some cases consideration should be given to using a much stronger and more durable chain link fencing to protect the most valuable and important trees located in the vicinity of proposed construction activities (refer to the project plans that shows the location of tree protection fencing). Where possible, tree protection fencing will be installed along the outer portion of the canopy dripline (i.e., the CRZ area) or beyond the canopy dripline of trees located within and/or adjacent to the project site to avoid and minimize impacting critical roots. Perform regular monitoring and inspections of tree protection measures, as well as any necessary repairs, modifications and maintenance on a as needed basis for the duration of the project.

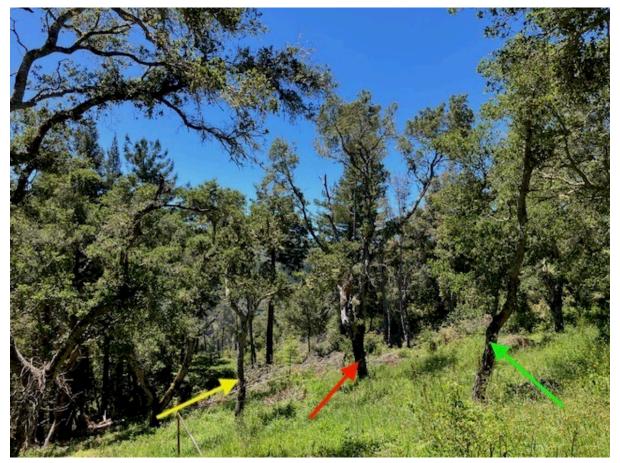
Figure 1. 3 Coast Live Oaks are proposed for removal due to planned ADU construction activities. Tree#1 is red arrow, Tree#2 is yellow arrow and Tree#3 is green arrow.

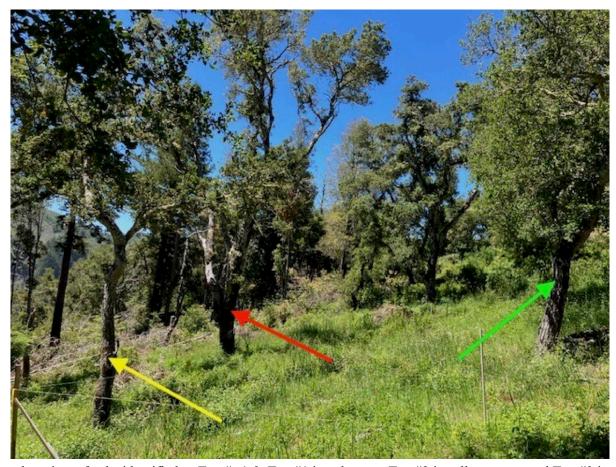
Figure 2. Another view of oaks identified as Tree#s 1-3. Tree#1 is red arrow, Tree#2 is yellow arrow and Tree#3 is green arrow. 13

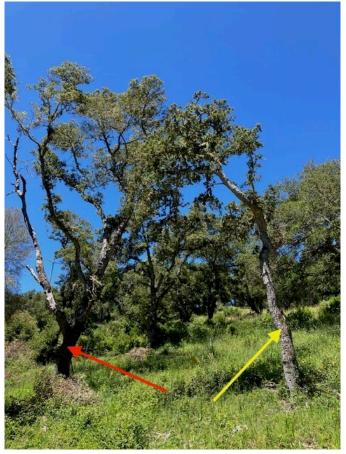
The 10 inch DBH Coast Live Oak identified as *Tree#2* is located within the proposed construction footprint for the ADU and is also in poor physiological health and structural condition (refer to *Figures 1-4*). This insignificant oak has a declining and thinning canopy, a natural lean, poor canopy balance and symmetry, a poorly developed stem and leader, and notable water sprout development, which is a sign of stress and declining health. Consequently, *Tree#2* is recommended for removal due to its location within the proposed building footprint

Figure 3. View of 2 declining oaks identified as Tree#s 1 (red arrow) & 2 (yellow arrow) that are proposed for removal due to construction impacts.

and its poor health and condition, and will be mitigated at a 1:1 replacement ratio to satisfy County permit requirements.

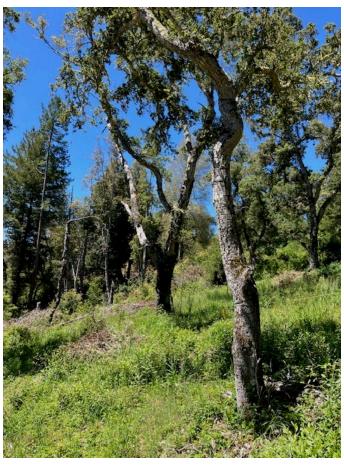
Figure 4. Tree#1 is in center background and Tree#2 is in foreground. 14

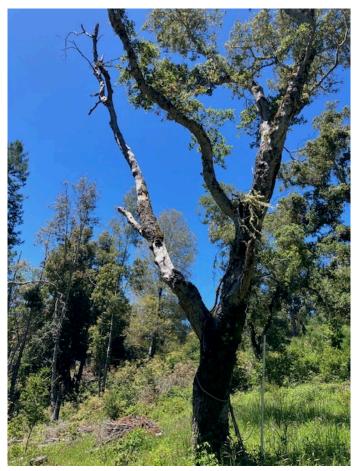
In regards to tree removal, 3 Coast Live Oaks are proposed for removal due to construction related impacts. *Tree#1* is a 21 inch DBH (diameter at breast height) senescing Coast Live Oak that is in poor health and deteriorating structural condition and is located within the proposed building footprint (refer to *Figures 1-6* and the attached *Exhibit A: Tree Location & Tree Protection Fencing Map*). Physiological and structural deficiencies of this aging and declining oak include a thinning and declining canopy with a dead co-dominant stem and other dead canopy material, notable water sprout development (i.e., epicormic shoots), which is a sign of physiological stress and declining health, and significant decay features in the trunk and stem that are compromising structural integrity and potentially increasing hazard concerns. Consequently, *Tree#1* is recommended for removal due to its location within the proposed construction footprint and its poor physiological health and structural condition, and will be replaced at a 1:1 ratio to satisfy Monterey County tree removal permit requirements.

Figure 5. Tree#1 is in poor health and structural condition and should be removed due to construction impacts and hazard concerns.

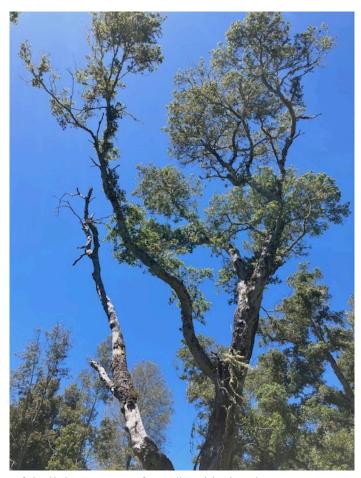
Figure 6. View of declining canopy of Tree#1 with abundant waterspouts and deadwood. 15

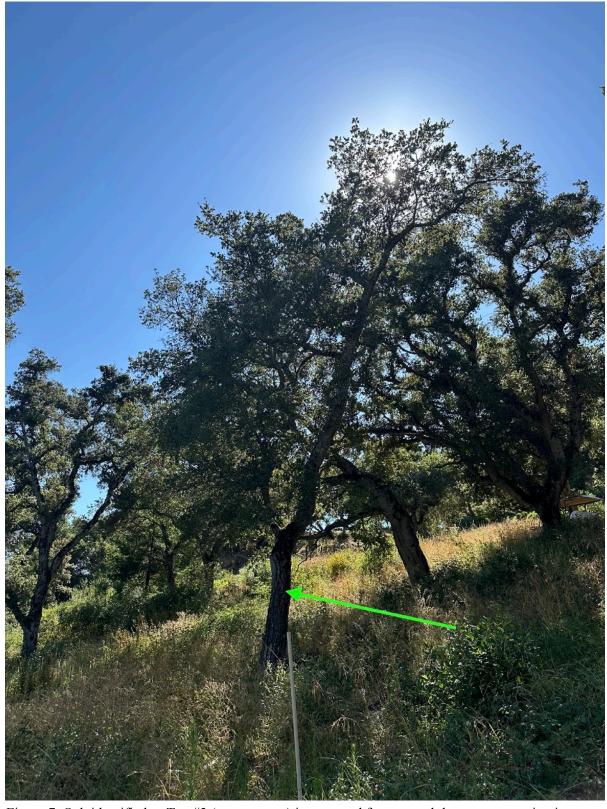
Lastly, the 12 inch DBH Coast Live Oak identified as *Tree#3* is located directly adjacent to the proposed construction footprint for the ADU and is generally in fair physiological health and structural condition (refer to *Figures 1, 2 & 7* and the attached *Exhibit A: Tree Location & Tree Protection Fencing Map*). This fairly insignificant oak has a natural lean away from the proposed ADU, but is located too close to planned grading activities, which would result in significant root loss that would be harmful to the tree's health and structural integrity. Consequently, *Tree#3* is recommended for removal due to its close proximity to planned grading and construction activities, and will be replaced at a 1:1 ratio.

Figure 7. Oak identified as Tree#3 (green arrow) is proposed for removal due to construction impacts.
