## **THOMPSON**

July 31, 2024

Allen & Hain Residence  
38042 Palo Colorado Road  
Carmel, CA 93923  
APN: 418-132-005-000

Subject: Pre-construction tree impact assessment for 38042 Palo Colorado Road

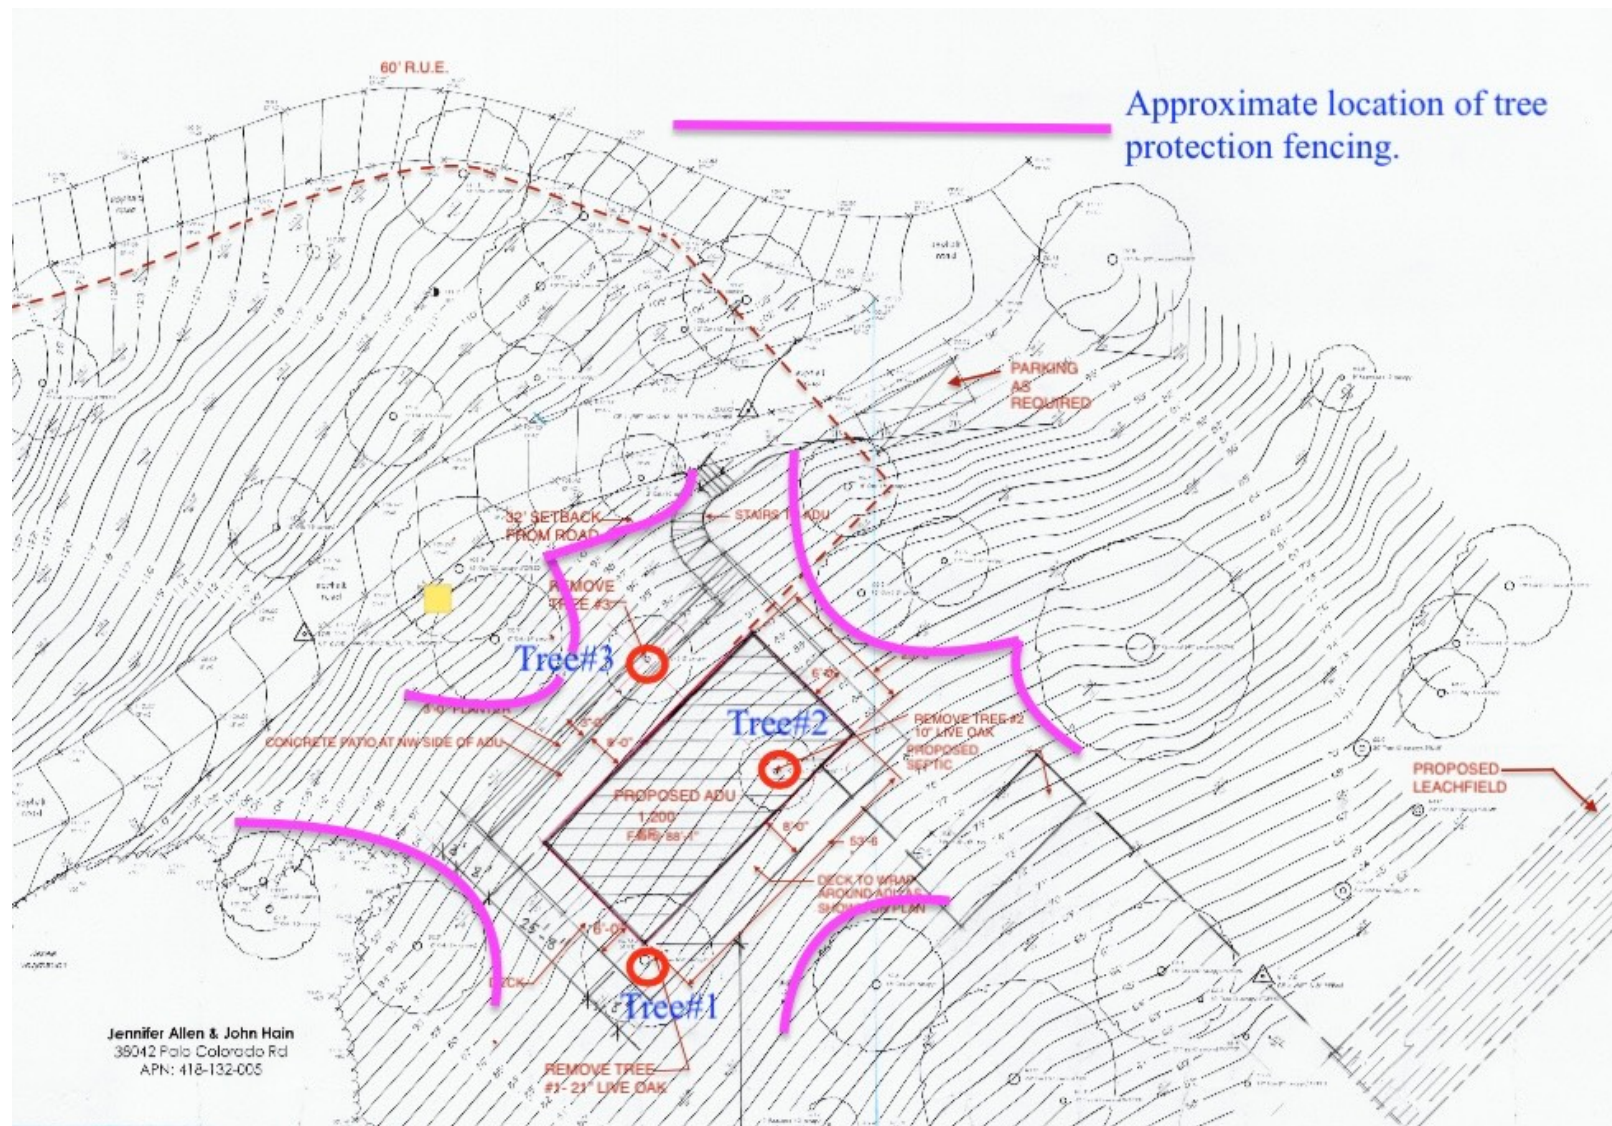
Exhibit A: Tree Location & Tree Protection Fencing Map - 3 Coast Live Oak trees proposed for removal due to construction related impacts are identified as Tree#s 1-3. The purple lines show approximate location of tree protection fencing that shall be properly installed and maintained for the duration of the project.

**1)** Prior to commencing with grading and construction activities install high visibility exclusionary fencing that clearly defines the work area, limits unnecessary disturbance to surrounding areas, and protects the critical root zone (CRZ) of individual trees and/or tree groupings. Generally speaking, the CRZ area is defined by the outermost portion of the canopy dripline 360 degrees around the tree (so basically the entire area under the canopy dripline), or alternatively, but less desirable in terms of tree preservation, installing exclusionary fencing to a distance from the trunk that protects at least half of the interior canopy dripline and CRZ or to a minimum distance of 15 feet from the base of the tree, whichever is greater. For protecting the canopy dripline and CRZ areas of trees use a more durable and heavier duty orange exclusionary fencing (e.g., *Resinet Heavy Duty Square Mesh Access Control Barrier Fence*) anchored in with steel T-posts, or in some cases consideration should be given to using a much stronger and more durable chain link fencing to protect the most valuable and important trees located in the vicinity of proposed construction activities (refer to the project plans that shows the location of tree protection fencing). Where possible, tree protection fencing will be installed along the outer portion of the canopy dripline (i.e., the CRZ area) or beyond the canopy dripline of trees located within and/or adjacent to the project site to avoid and minimize impacting critical roots. Perform regular monitoring and inspections of tree protection measures, as well as any necessary repairs, modifications and maintenance on a as needed basis for the duration of the project.

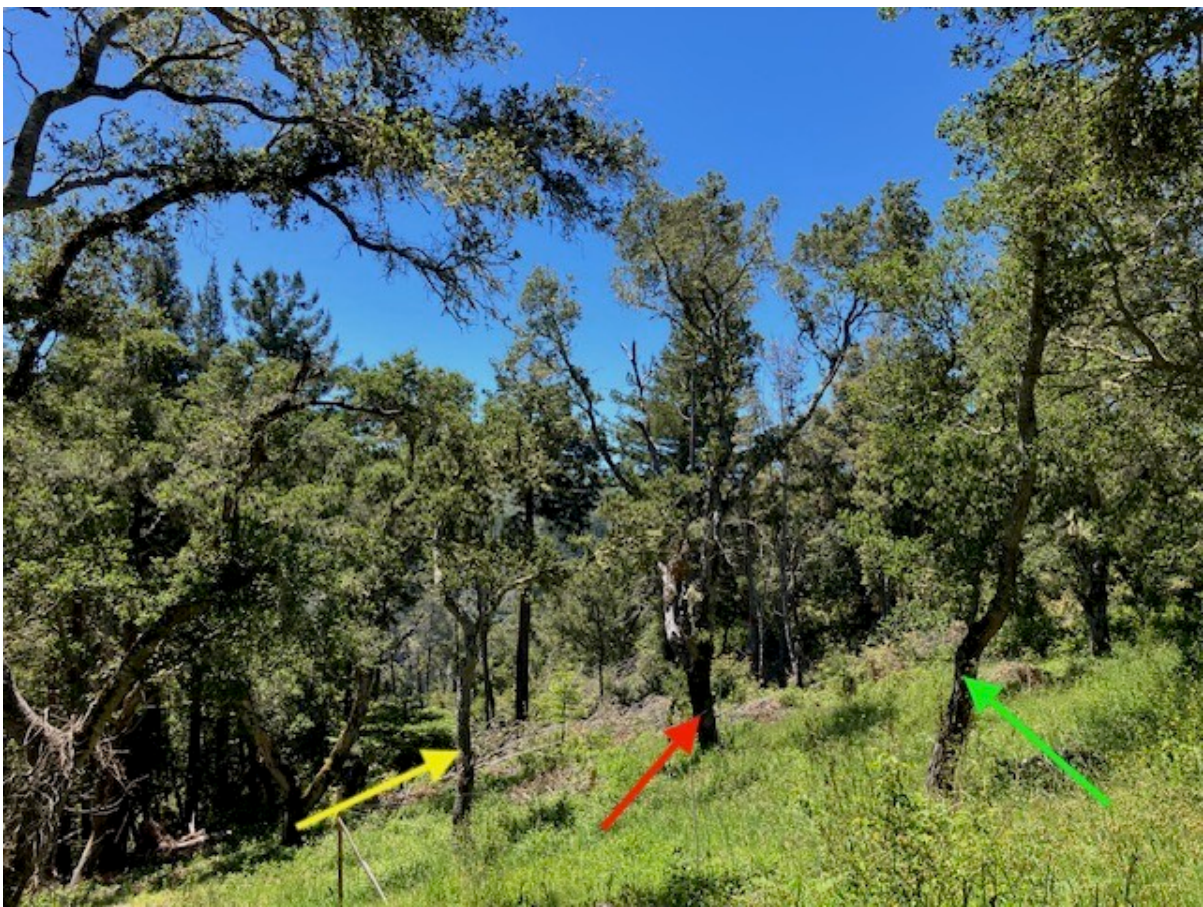
Figure 1. 3 Coast Live Oaks are proposed for removal due to planned ADU construction activities. Tree#1 is red arrow, Tree#2 is yellow arrow and Tree#3 is green arrow.

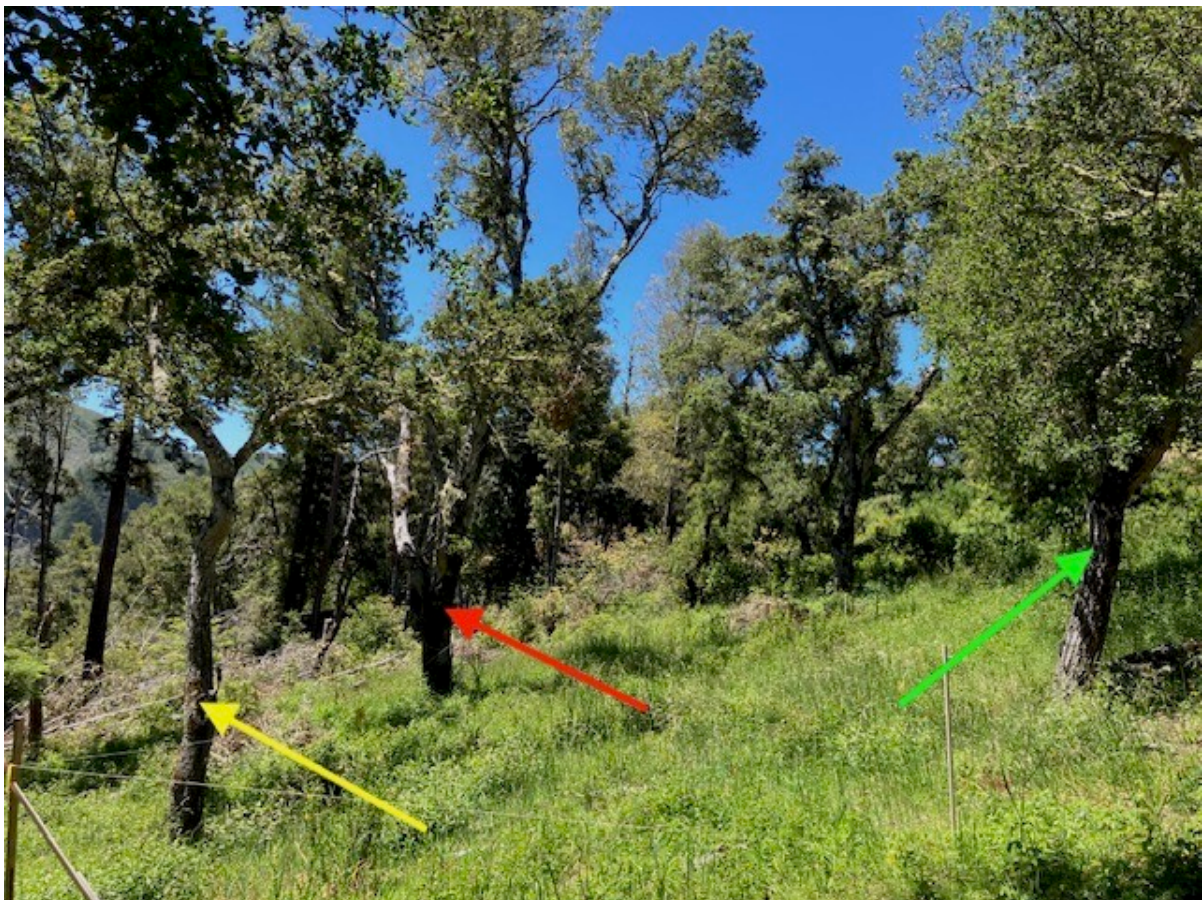
Figure 2. Another view of oaks identified as Tree#s 1-3. Tree#1 is red arrow, Tree#2 is yellow arrow and Tree#3 is green arrow.

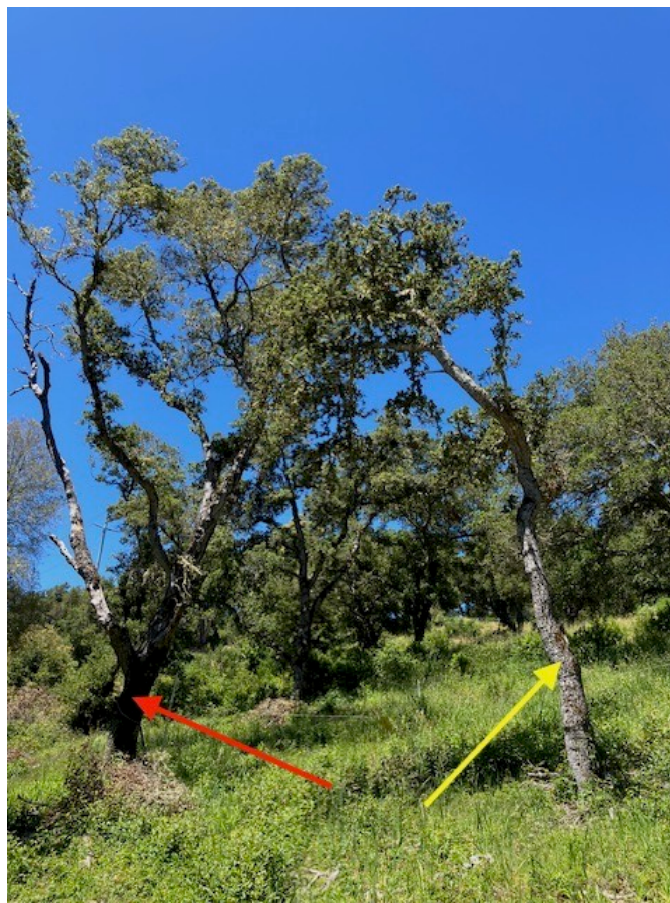
The 10 inch DBH Coast Live Oak identified as *Tree#2* is located within the proposed construction footprint for the ADU and is also in poor physiological health and structural condition (refer to *Figures 1-4*). This insignificant oak has a declining and thinning canopy, a natural lean, poor canopy balance and symmetry, a poorly developed stem and leader, and notable water sprout development, which is a sign of stress and declining health. Consequently, *Tree#2* is recommended for removal due to its location within the proposed building footprint

Figure 3. View of 2 declining oaks identified as Tree#s 1 (red arrow) & 2 (yellow arrow) that are proposed for removal due to construction impacts.

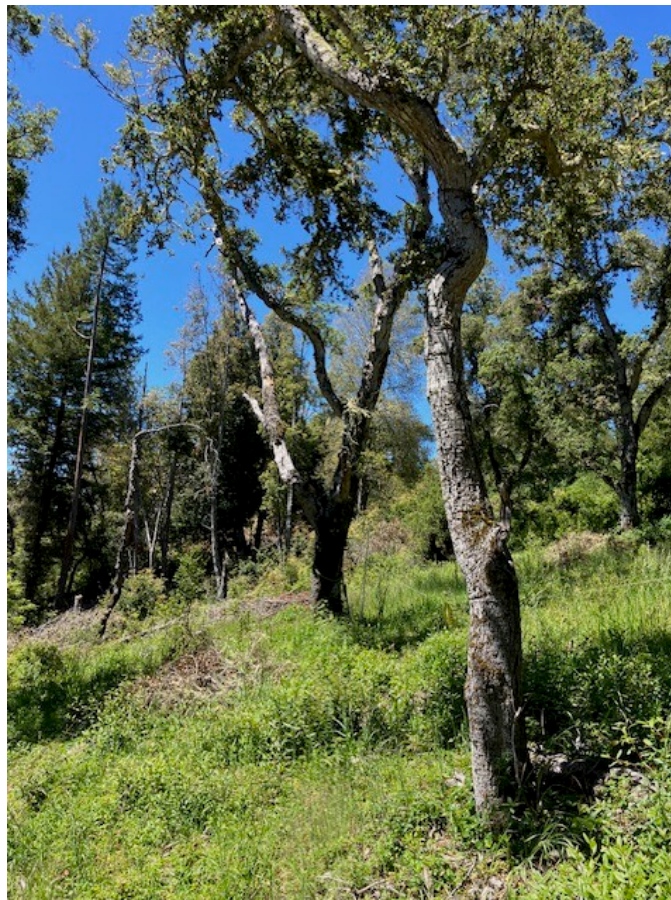
Figure 4. Tree#1 is in center background and Tree#2 is in foreground.

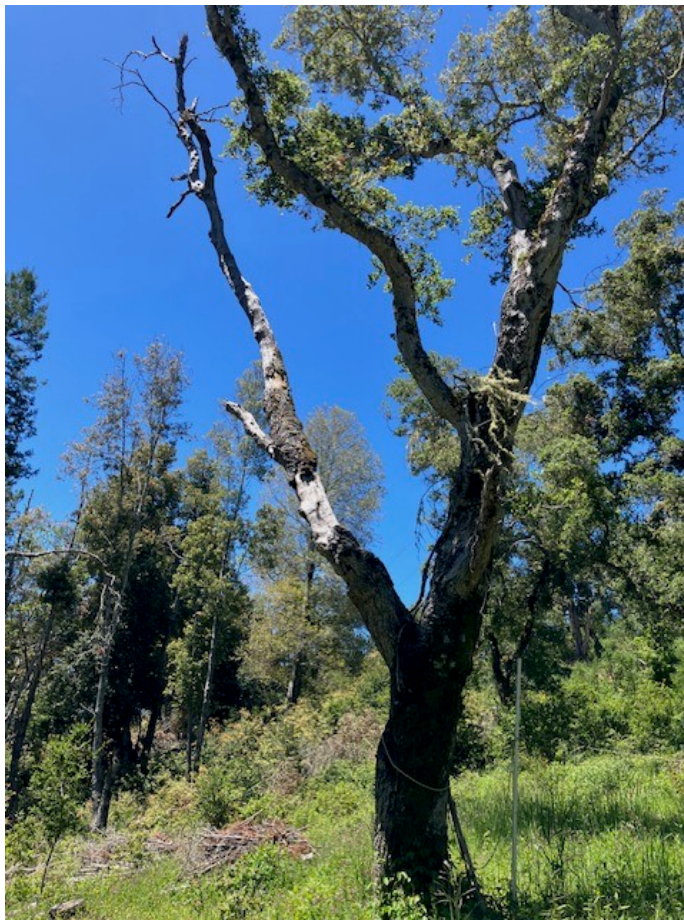
In regards to tree removal, 3 Coast Live Oaks are proposed for removal due to construction related impacts. *Tree#1* is a 21 inch DBH (diameter at breast height) senescing Coast Live Oak that is in poor health and deteriorating structural condition and is located within the proposed building footprint (refer to *Figures 1-6* and the attached *Exhibit A: Tree Location & Tree Protection Fencing Map*). Physiological and structural deficiencies of this aging and declining oak include a thinning and declining canopy with a dead co-dominant stem and other dead canopy material, notable water sprout development (i.e., epicormic shoots), which is a sign of physiological stress and declining health, and significant decay features in the trunk and stem that are compromising structural integrity and potentially increasing hazard concerns. Consequently, *Tree#1* is recommended for removal due to its location within the proposed construction footprint and its poor physiological health and structural condition, and will be replaced at a 1:1 ratio to satisfy Monterey County tree removal permit requirements.

Figure 5. Tree#1 is in poor health and structural condition and should be removed due to construction impacts and hazard concerns.

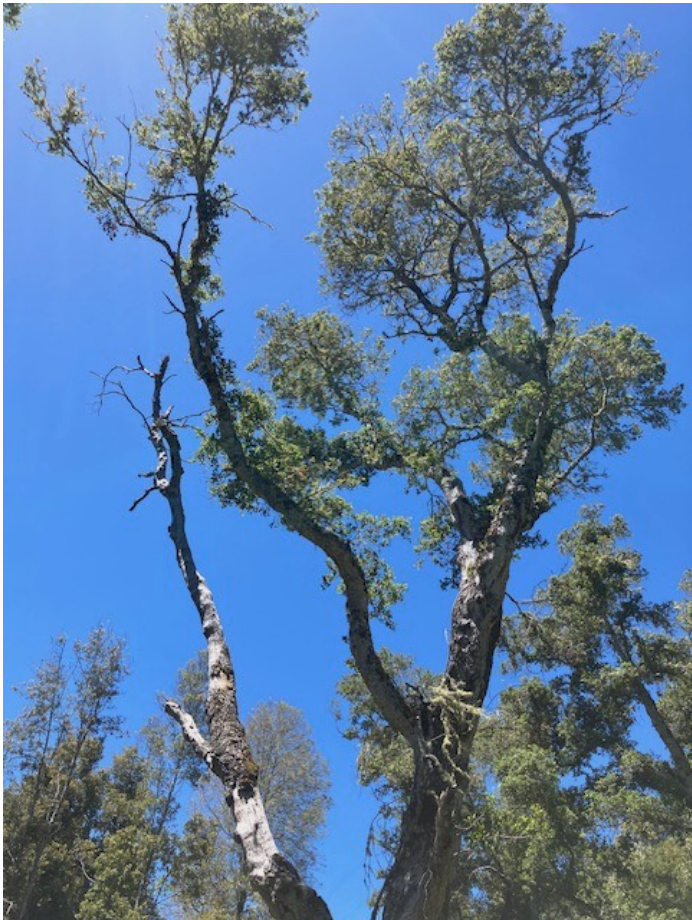
Figure 6. View of declining canopy of Tree#1 with abundant waterspouts and deadwood.

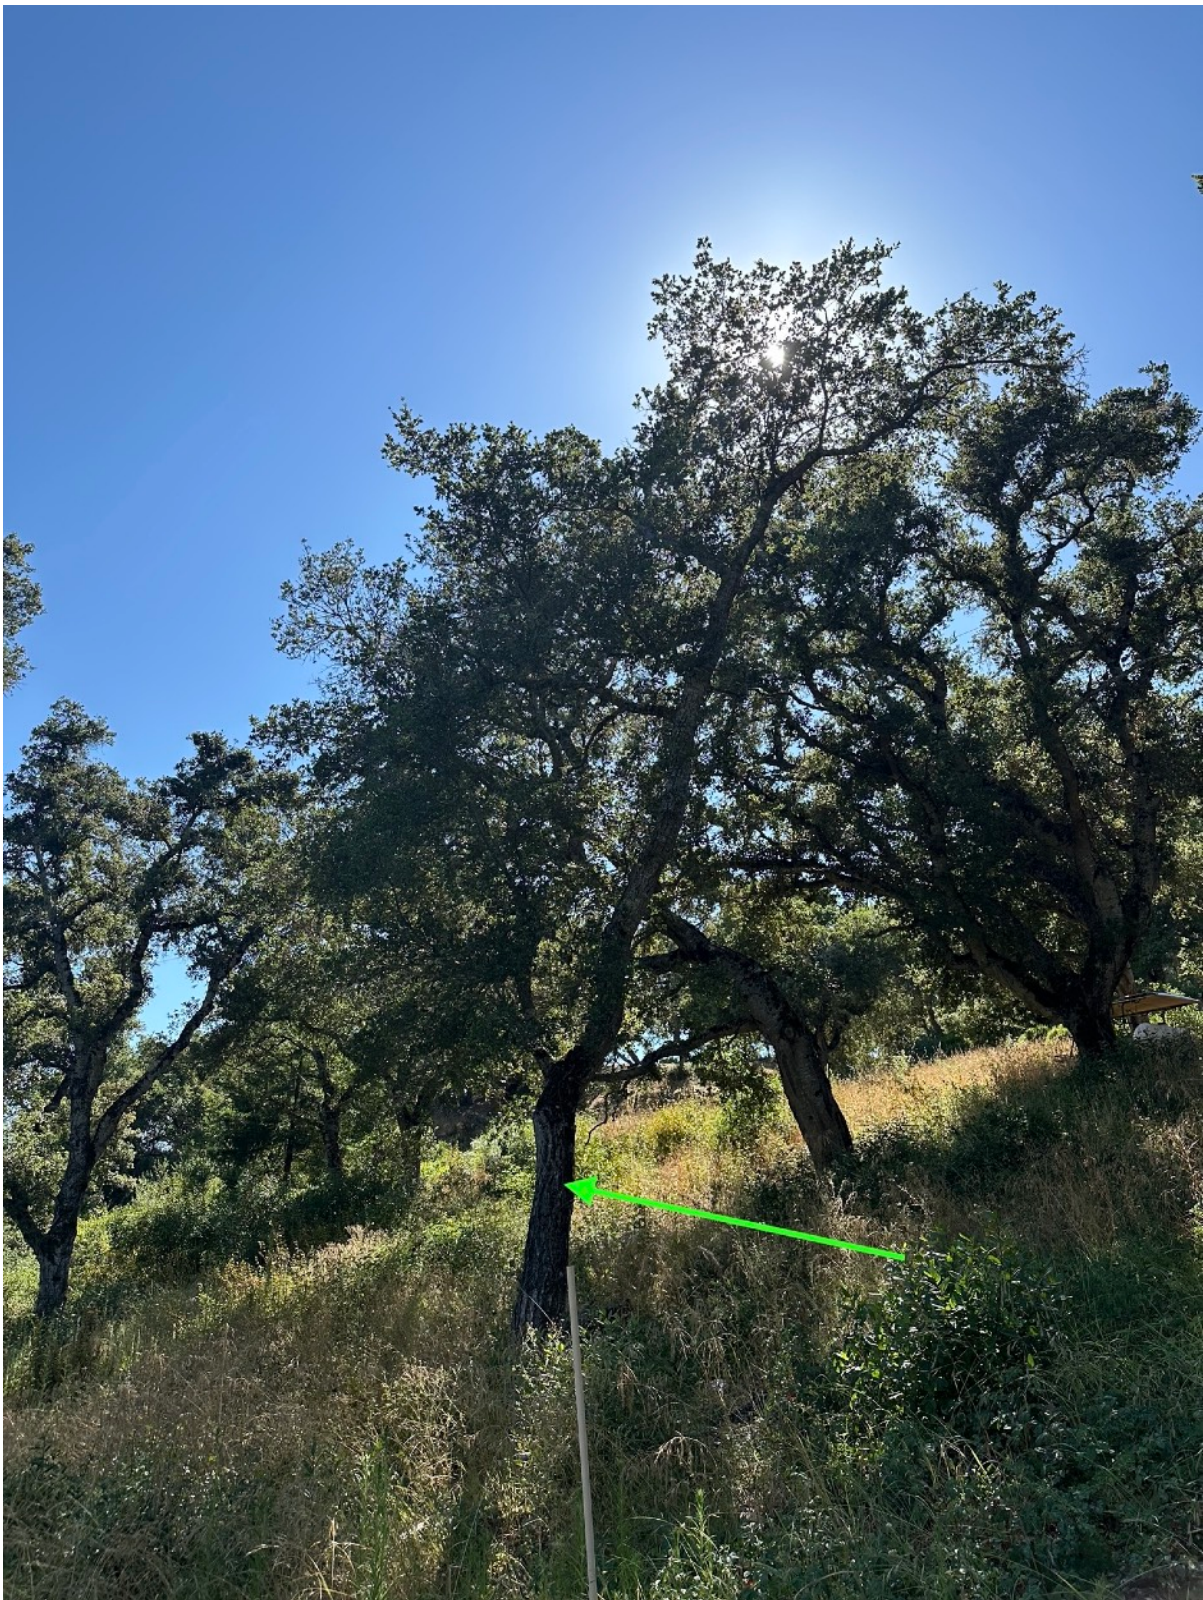
Lastly, the 12 inch DBH Coast Live Oak identified as *Tree#3* is located directly adjacent to the proposed construction footprint for the ADU and is generally in fair physiological health and structural condition (refer to *Figures 1, 2 & 7* and the attached *Exhibit A: Tree Location & Tree Protection Fencing Map*). This fairly insignificant oak has a natural lean away from the proposed ADU, but is located too close to planned grading activities, which would result in significant root loss that would be harmful to the tree's health and structural integrity. Consequently, *Tree#3* is recommended for removal due to its close proximity to planned grading and construction activities, and will be replaced at a 1:1 ratio.

Figure 7. Oak identified as Tree#3 (green arrow) is proposed for removal due to construction impacts.
