Murrer Certified Inspections

Property Inspection Report

62 Yankee Point Drive, Carmel Highlands, CA 93923
Inspection prepared for: Studio Schicketanz
Real Estate Agent: Haley Lundquist -

Date of Inspection: 9/9/2024 Time: 9:00 am Size: Limited Inspection
Weather: Cool and clear

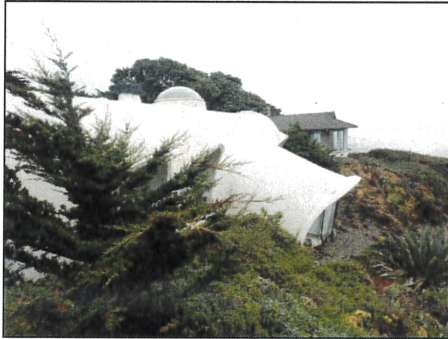
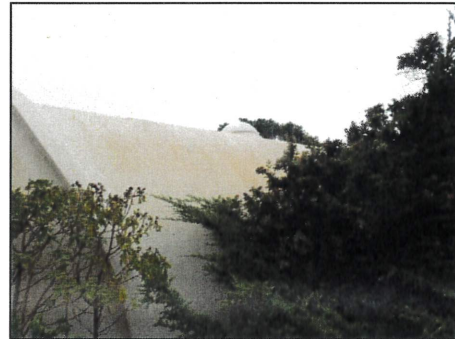
1. Roof Condition

- **Fungus and/or moss on roof. This can lead to the premature failure of the roof and subsequent leaks. Recommend power washing the stucco systems and repainting.**

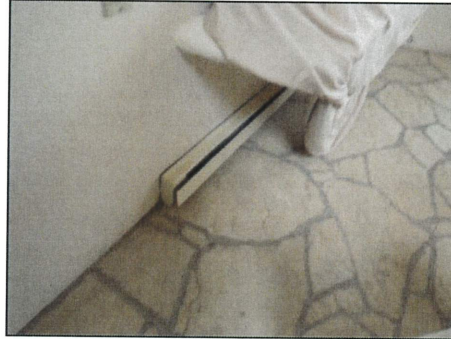
1. Heater Condition

- **Many of the electrical heaters were found rusted and not longer in operation. Several of the units found incorrectly wired and could present a fire hazard.**

Heater found rusted. Most did not operate when tested.

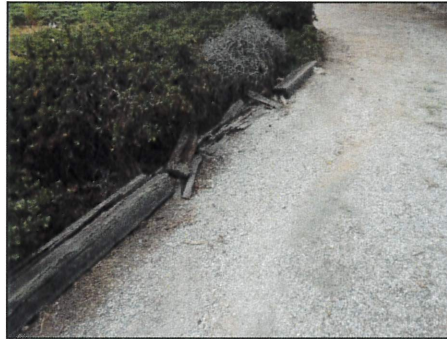
1. Driveway and Walkway Condition

- Areas of cracking at base of walkway concrete structure.
- **Moderate cracks in walkway. Repair and / or monitor for expansion and development of trip hazards.**

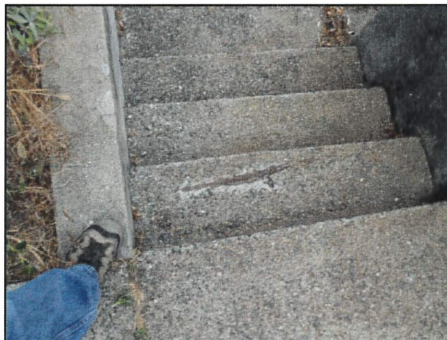
4. Stairs, Handrail and Guardrail

- Recommend installing emergency egress light.
- **There were no railings installed at the steps. This is a potential tripping hazard. Recommend installing handrail.**
- **Handrail not graspable. By today's standards, rails should be configured so that a hand may grasp around a rail for safety.**

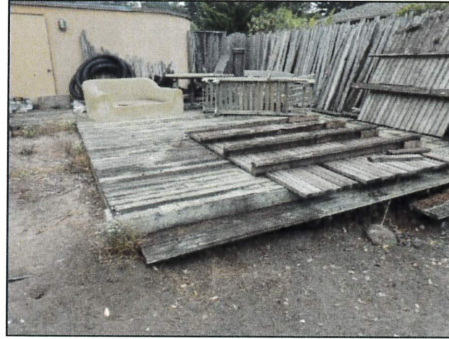
5. Deck Framing

- **Deck has reached it's life expectancy and should be repaired, replaced or removed.**

Deck found in poor condition.

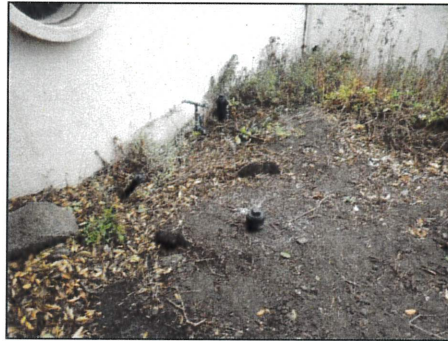
7. Plumbing

- Visible areas appeared to have under gone repairs.

Areas of repairs noted.

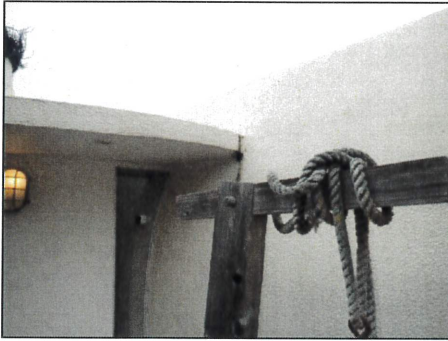
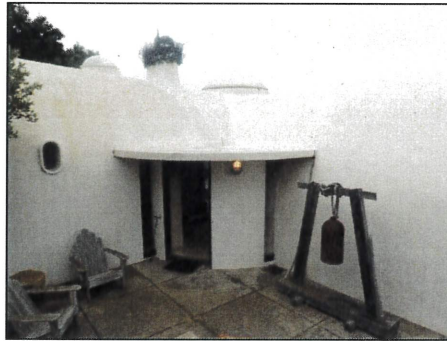
1. Entrance Condition

- **Indications of past or present water leaks, seeps, or condensation at eaves.**

Pooling and bubbling at entrance roof.

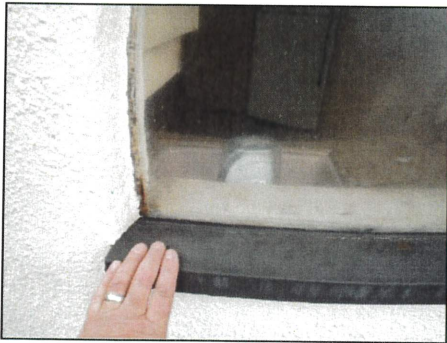
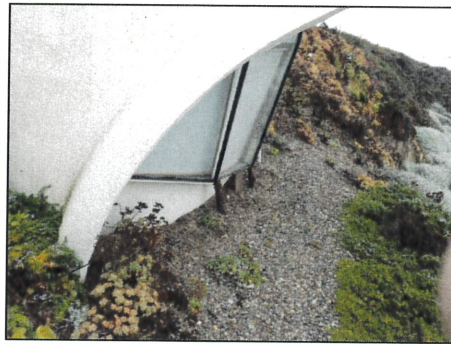
4. Window Condition

- **Single glazed windows noted. Single glazed widows can present a condensation issue.**
- **Makeshift seal at plexiglass glazing noted to be leaking into the wall system.**

Plexi glass windows are leaking. Windows are failing. Makeshift support noted.

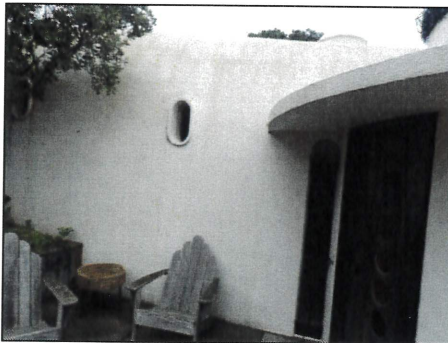
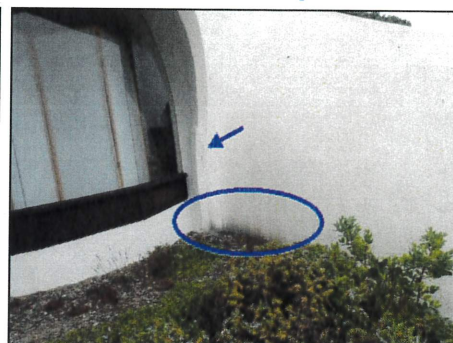
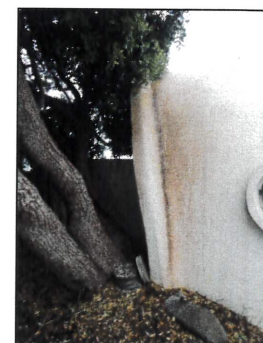
6. Stucco

- Structural defects may be hidden behind dense foliage, vines, stored items, debris or finishes and cannot be included with this inspection.
- **Areas of fungus staining and detachment to substructure noted.** Recommend removal and replacement of damaged areas.

Areas of cracking and water infiltration.

Areas of heavy fungus growth noted.

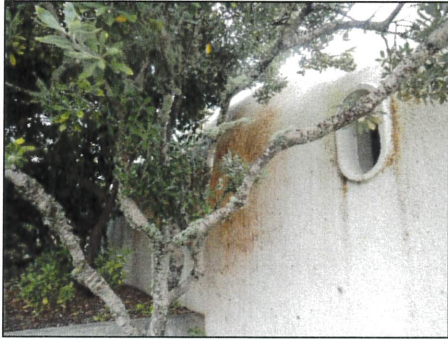
Areas of hollow sounding and potentially detached stucco noted.

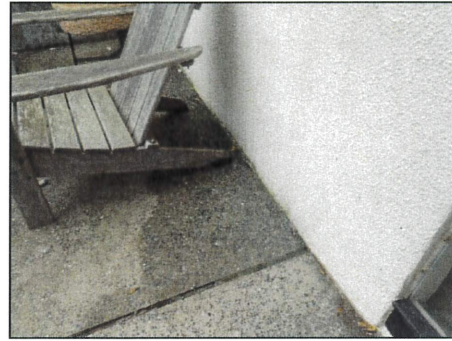
- **Without a means of water migration to leave the stucco wall structures. Moisture becomes locked in above exterior doors and windows. Recommend proper means of drainage though the installation of weep screed(s).**

No weep screed was found.

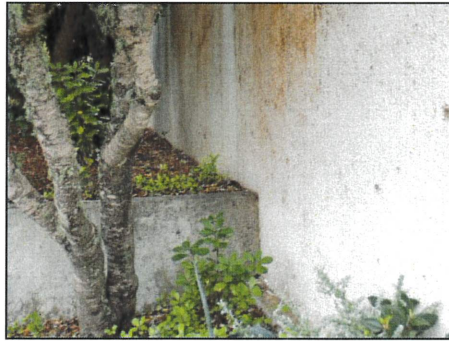
7. Planter Box

- Areas of staining and minor cracking noted. Recommend further investigation.
- **Wall to planter waterproofing could not be determined. Recommend further investigation.**

Potential areas of water damage at planter.

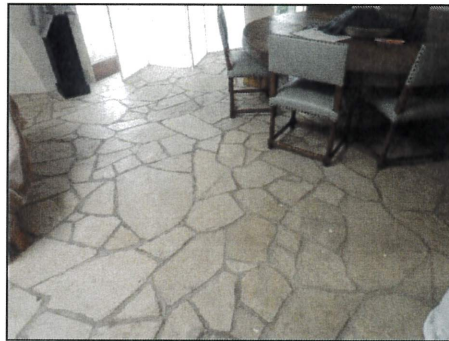
3. Floor Condition

- **Floor is not level. Suggest further evaluation by a licensed contractor.**

Floors are uneven and present a tripping hazard.

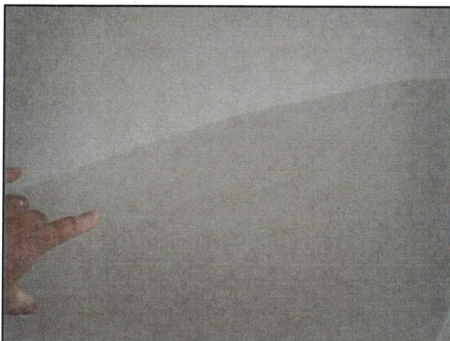
5. Wall Condition

- **Mold-like bio growth observed. Professional testing and evaluation advised.**
- **There were signs of past water damage. Peeling stucco, water staining and fungus growth. Recommend opening walls system to determine the extent on internal damage.**

Water stains noted throughout the home.

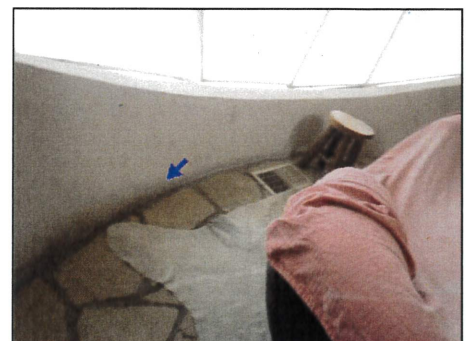
Extensive water staining at floor line.

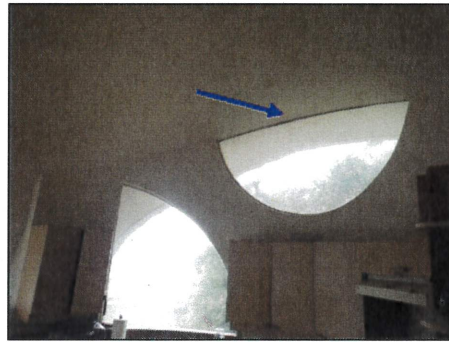
Staining at top window line noted.

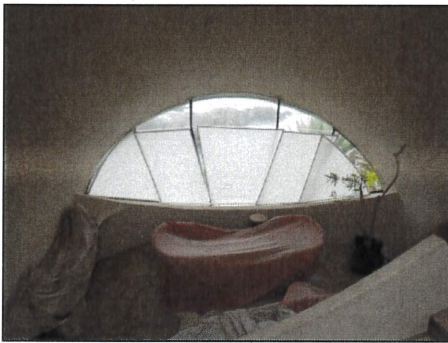
6. Window Condition

- Tempered glass is required within 18" of the finished floor. In some areas tempered glass could not be determined.
- Wood rot and deterioration noted.

Lower area window found in poor condition.

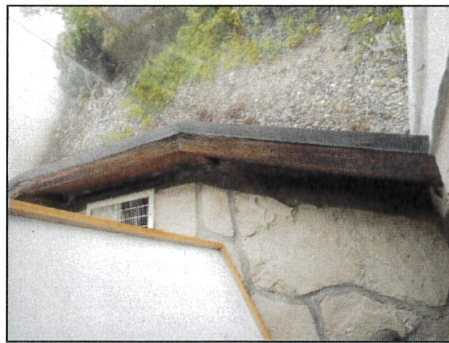
Tempered glass could not be verified.

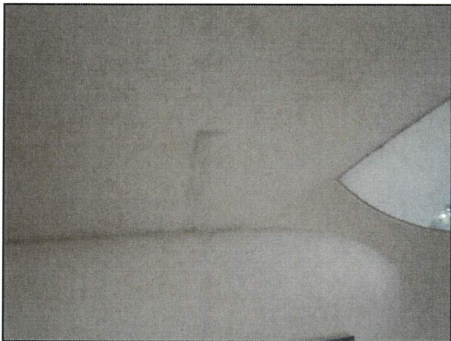
7. Ceiling Condition

- Mold like stains present on the ceiling. Recommend having a mold sample taken and lab tested, also monitor the area for water intrusion.

Notable Water and fungus staining on ceilings

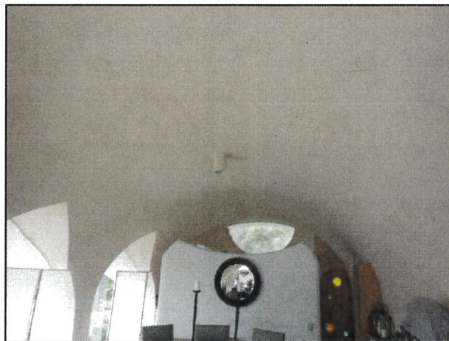
Areas of water staining noted.

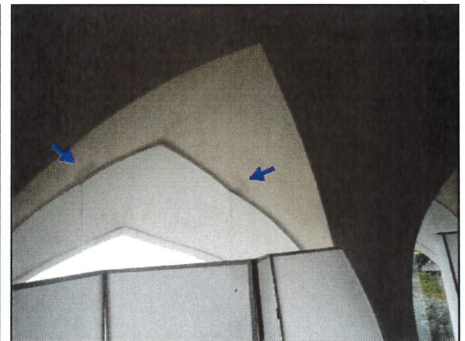
Moisture travel noted.

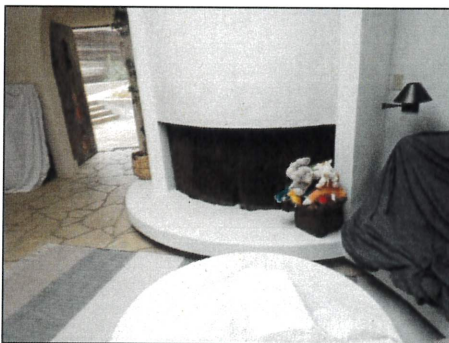
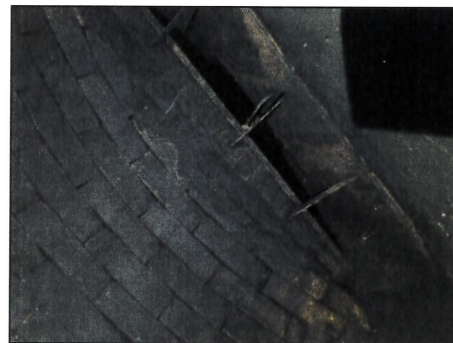
9. Fireplace

- **Recommend a fireplace professional service/evaluate fireplace before operating.**
- **It was observed that some of the mortar around the firebox was failing; have a qualified individual evaluate and repair to avoid possible safety issue.**
- **Damper deterioration was observed.**

Deteriorated damper noted.

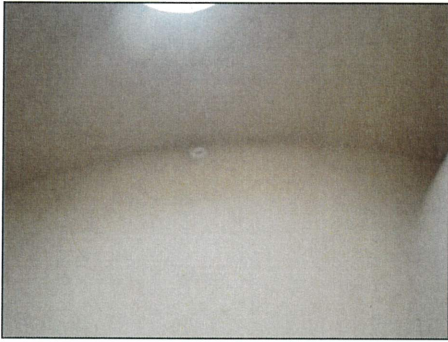
10. Smoke and CO2 Detectors

- Detector(s) are present.
- **The smoke detector missing and do not provide adequate protection.**
- **The International Association of Fire Chiefs recommend a carbon monoxide detector on every floor of your home, including the basement. A detector should be located within 10 feet of each bedroom door and there should be one near or over any attached garage. Each detector should be replaced every five to six years.**
- **Carbon monoxide is roughly the same weight as air and over time distributes throughout a room, so a detector can be placed at any height in any acceptable location. Preferably at eye level and definitely where the alarm can be easily heard.**

Some smoke detectors noted.

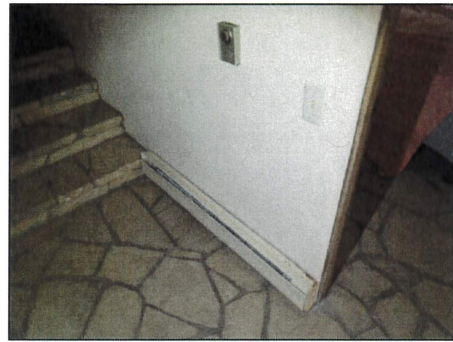
Thermostat found above heater.

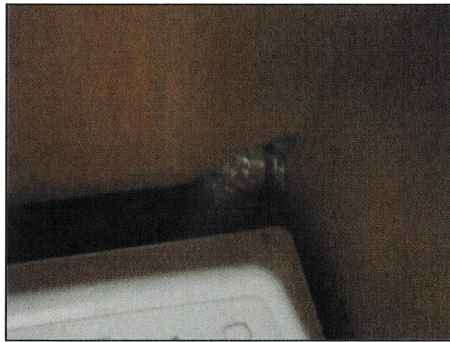
5. Dryer Vent

- **Vertical dryer vents are easily clogged and can present a fire hazard.**

Vertical dryer vents present a fire hazard.

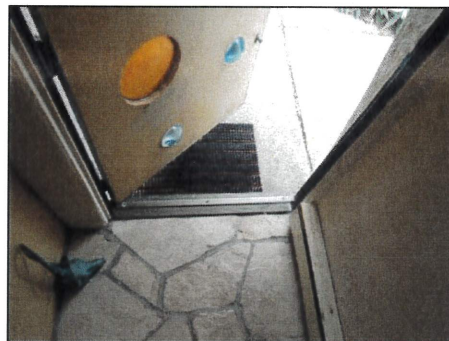
2. Patio Doors

- Damaged weatherstripping noted.

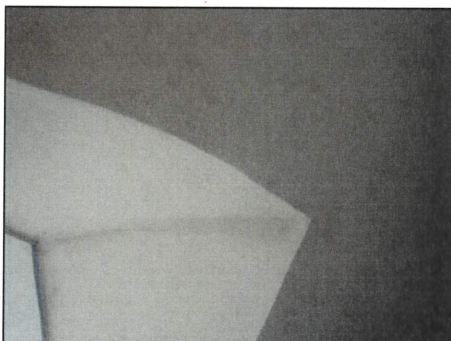
4. Window Condition

- Deterioration noted due to contact with moisture.
- **Deterioration and water staining on window enclosure noted.**

Water staining at windows noted.

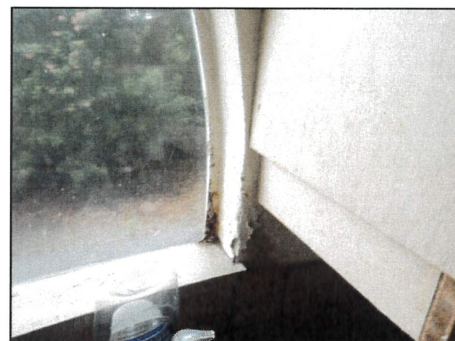
Water damage at failed windows noted.

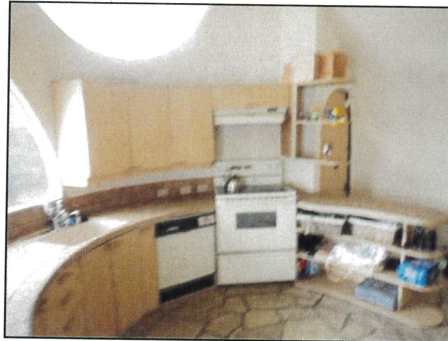
5. Cabinets

- Found to be functional.
- **Deterioration noted at cabinet finishes.**

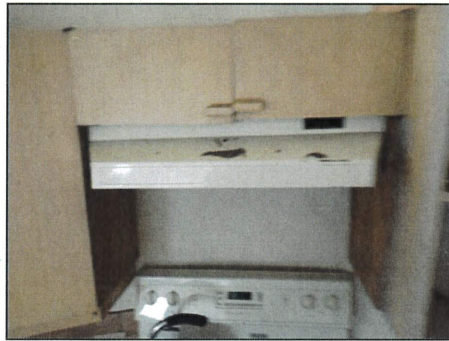
8. Vent Condition

Damaged vent noted.

- **Recommend review for repair or replacement as necessary.**

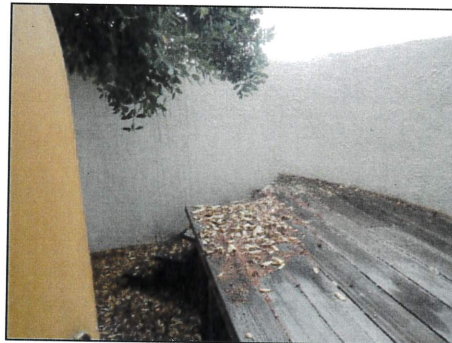
- **Water damage at wall to deck connection. Recommend further investigation of substructure.**

Areas of water damage at wall to deck connection.

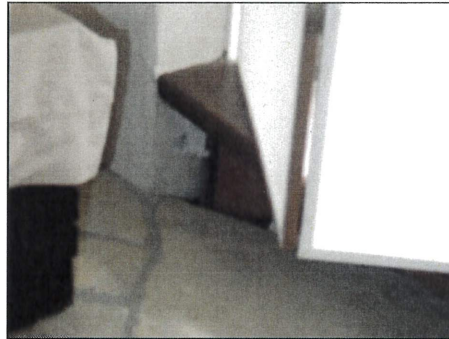
2. Wall Condition

- Areas of minor cracking. Recommend complete repair.
- **Mold like stains are present under windows. We recommend having a mold sample taken and lab tested.**

Areas of water damage noted.

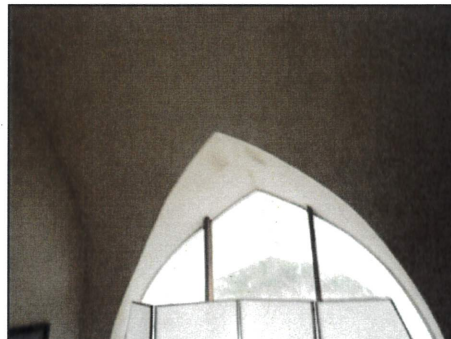
3. Ceiling Condition

- Evidence of past leaking was noted.
- **Mold like stains present on the ceiling. We recommend having a mold sample taken and lab tested, also monitor the area for water intrusion.**

Fungus growth noted. Recommend further investigation.

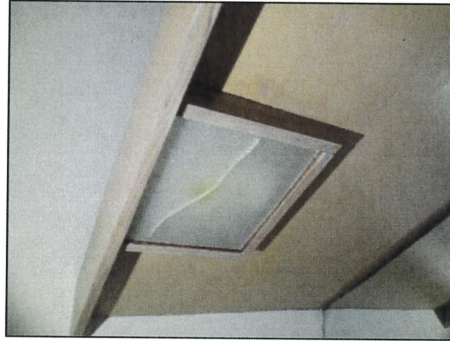
- Closet light found with a damaged cover.

Broken cover plate.

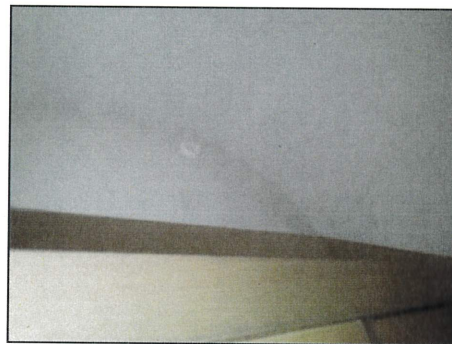
6. Smoke Detectors

- There were no visible smoke detectors.

Missing detector noted.

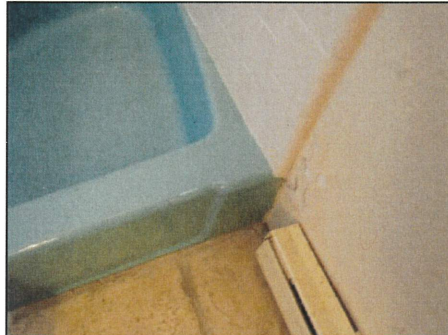
1. Wall Condition

- **Water damage and bio-growth noted at the edge of the shower area.**

Water damage noted

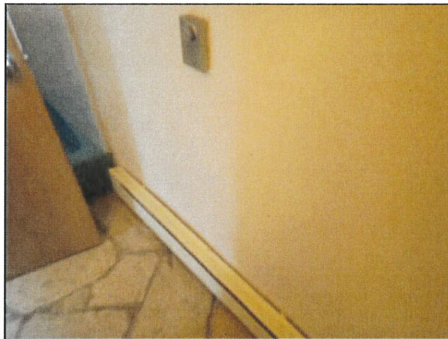
2. Heating

System did not appear to operate.

- **The inspector recommends removal of the electric wall heating unit. Most units did not operate.**

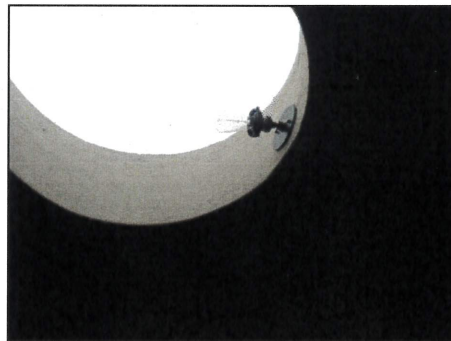
- **Light fixture(s) missing cover(s).**

Exposed light bulb now requires a cover.

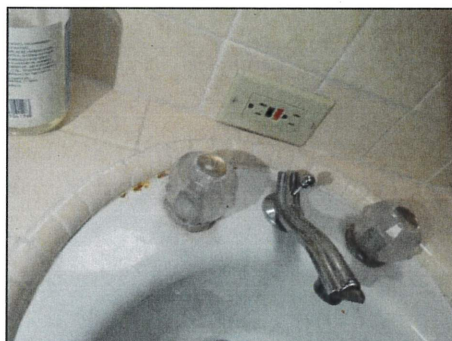
- **Sink rusted. Monitor for developing leaks (none found during inspection).**

Rusted surfaces noted.

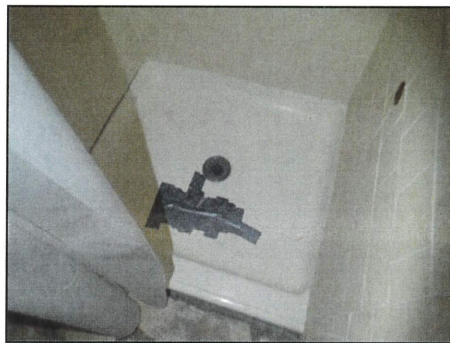
- Cracked shower pan with duct tape repair noted. This present a high liklihood of water damage.

Large cracked shower pan noted.

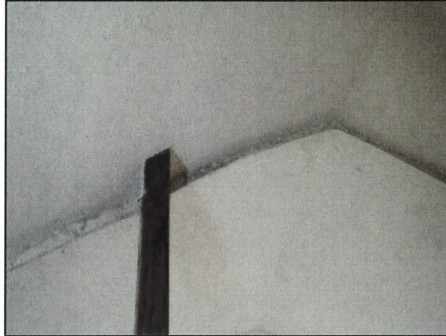
1. Floor Condition

- **Indication of water migration noted. Recommend further investigation.**

Indications of moisture and fungus growth,

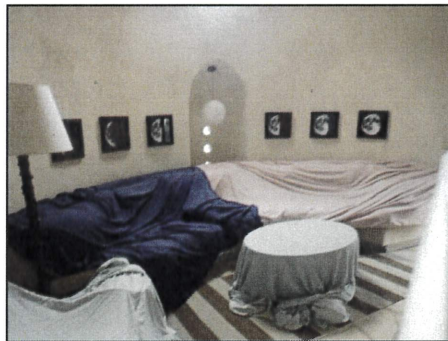
3. Wall Condition

- Area of unknown staining noted. Area tested dry.
- **Mold-like bio growth observed. Professional testing & evaluation advised.**

Extensive discoloration noted.

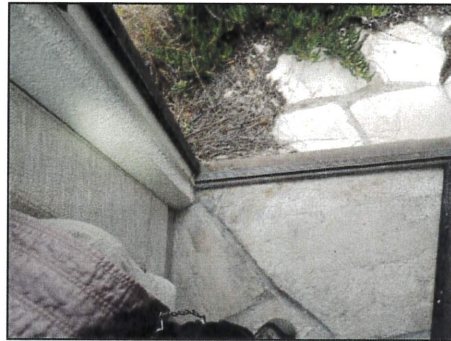
- The patio door was functional during the inspection.
- **Noted deterioration at threshold.**

Areas of water migration noted.
