Tree Resource Assessment
26141 Rinconada Drive
Carmel Valley, CA

Frank Ono
Urban Forester
Member Society of American Foresters #48004
ISA Certified Arborist #536
1213 Miles Avenue
Pacific Grove, CA 93950

January 7, 2025

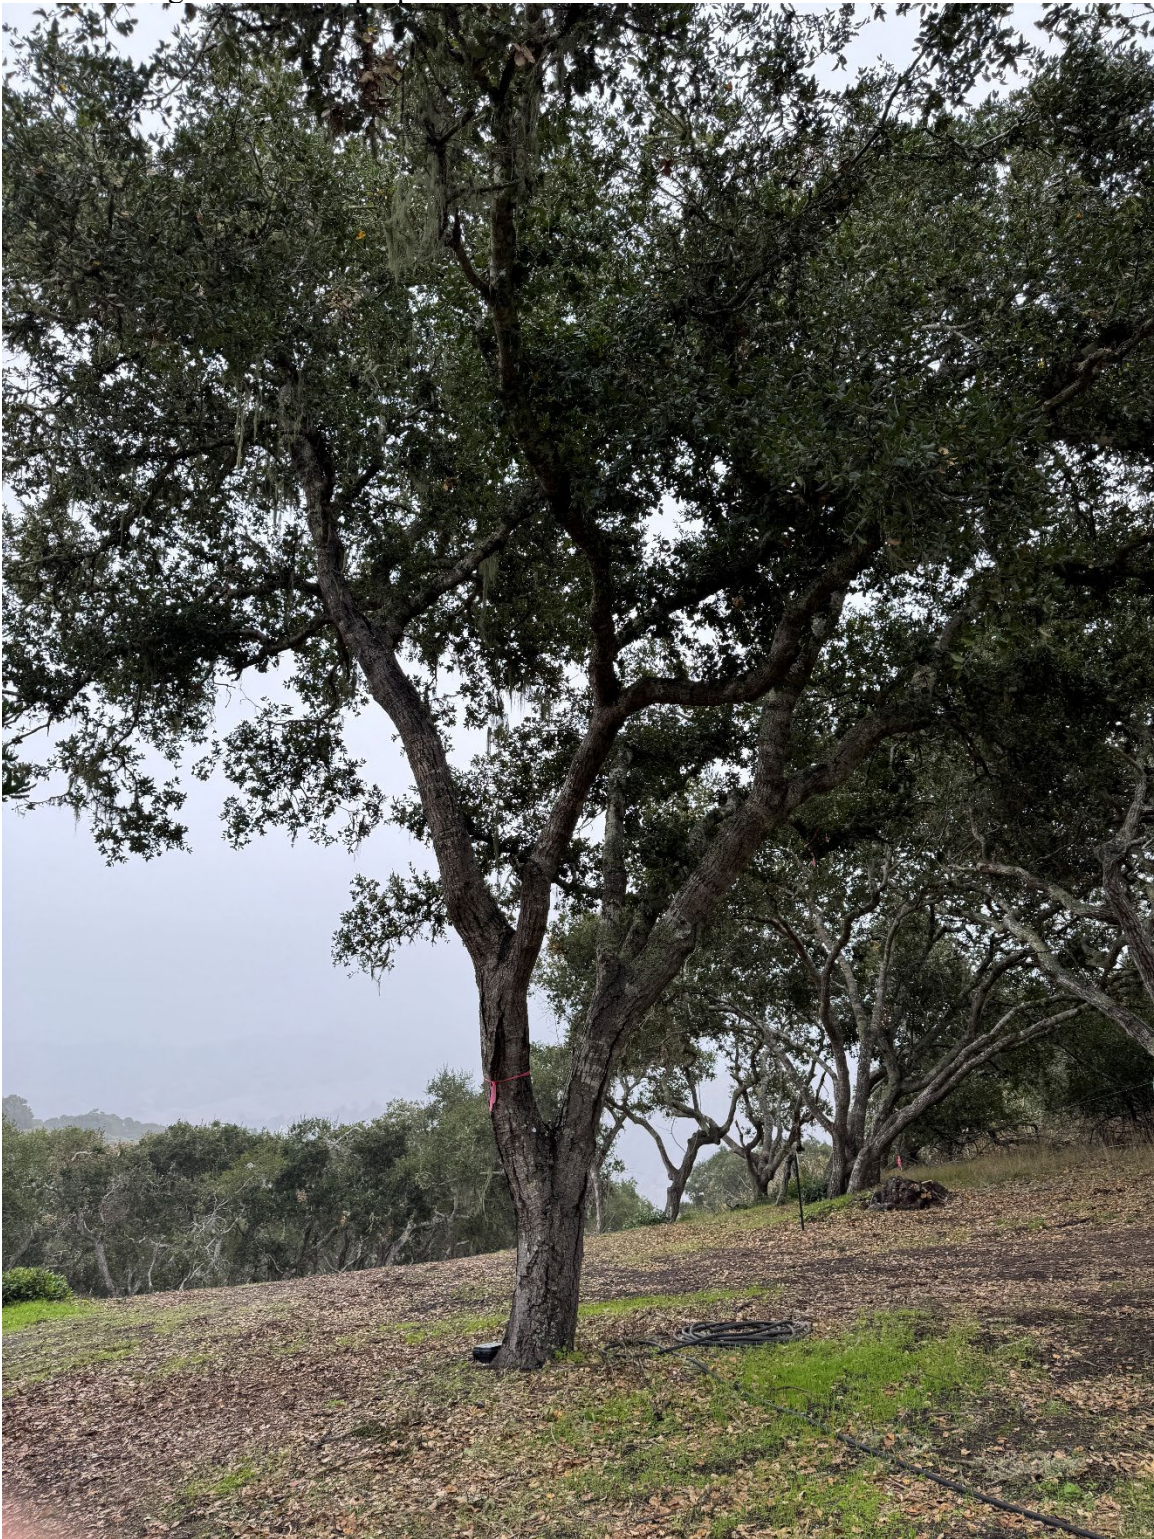
- Three oaks are tagged and are located within or adjacent to the building footprint that must be removed for the design as proposed.
 - Tree #965 stands approximately 30 feet tall with a crown spread of 35 feet. It exhibits fungal activity at the base bark with bark bleeding on the southeast side of the trunk. The canopy exhibits previous branch breakage. It is rated as fair overall.

The removal of three oaks (#965, #966, and #967) is proposed for this project; The remaining trees are to remain and be protected from construction impacts.

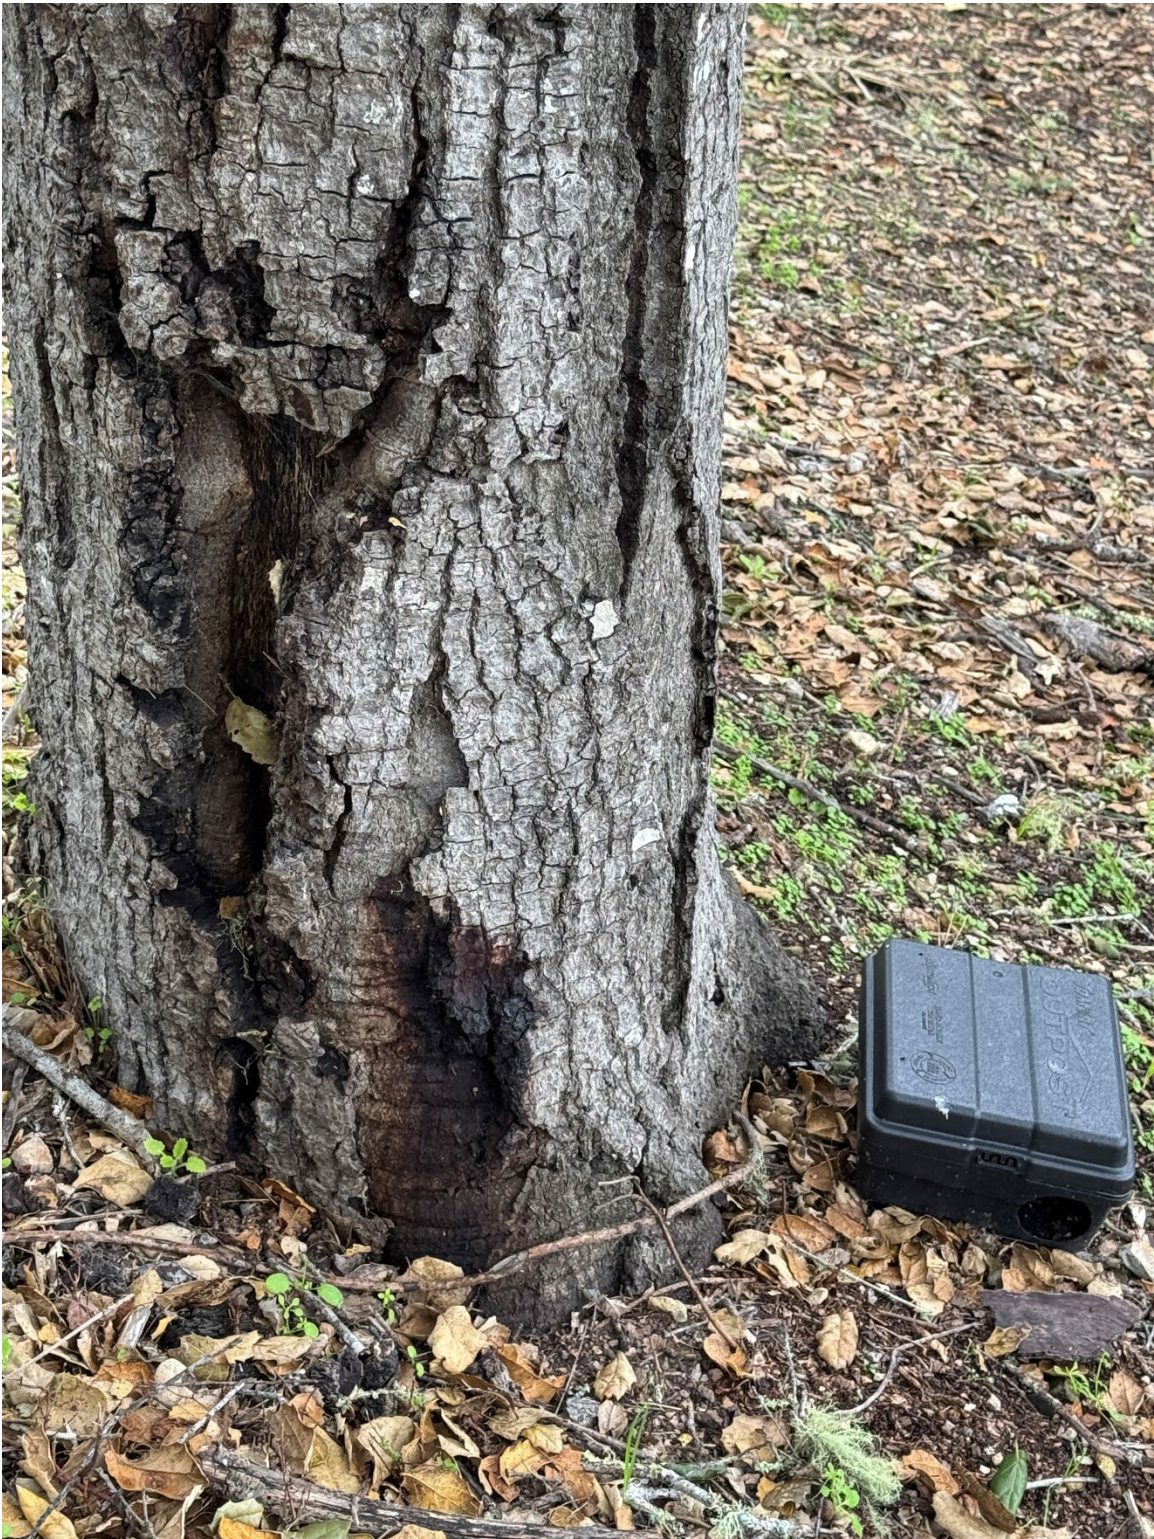
The base of tree #965 with wounding and bleeding.

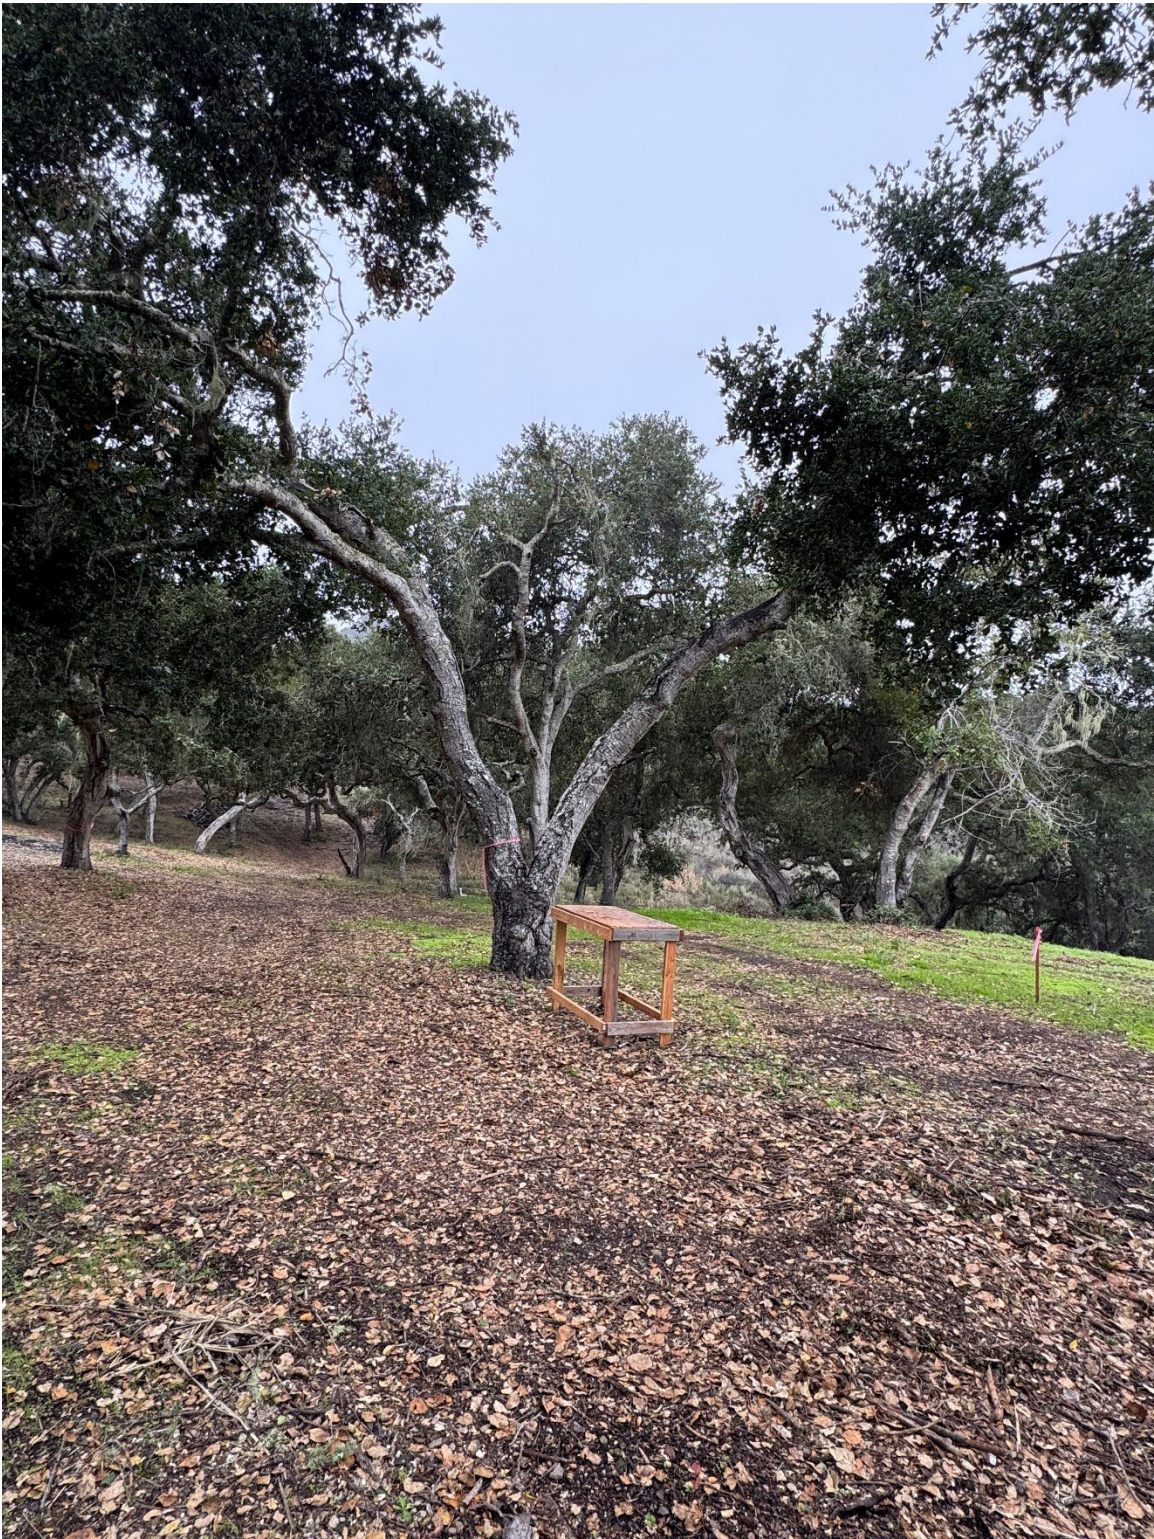
- Tree #966 consists of two major stems with a sparsely foliated crown. The tree stands approximately 25 feet tall with an overall crown spread of approximately 50 feet. The tree has poor architecture and is rated as fair to poor condition. It is missing a center stem and most of the crown mass is heavily weighted to the south side of the tree.

Tree #966 , a disfigured tree

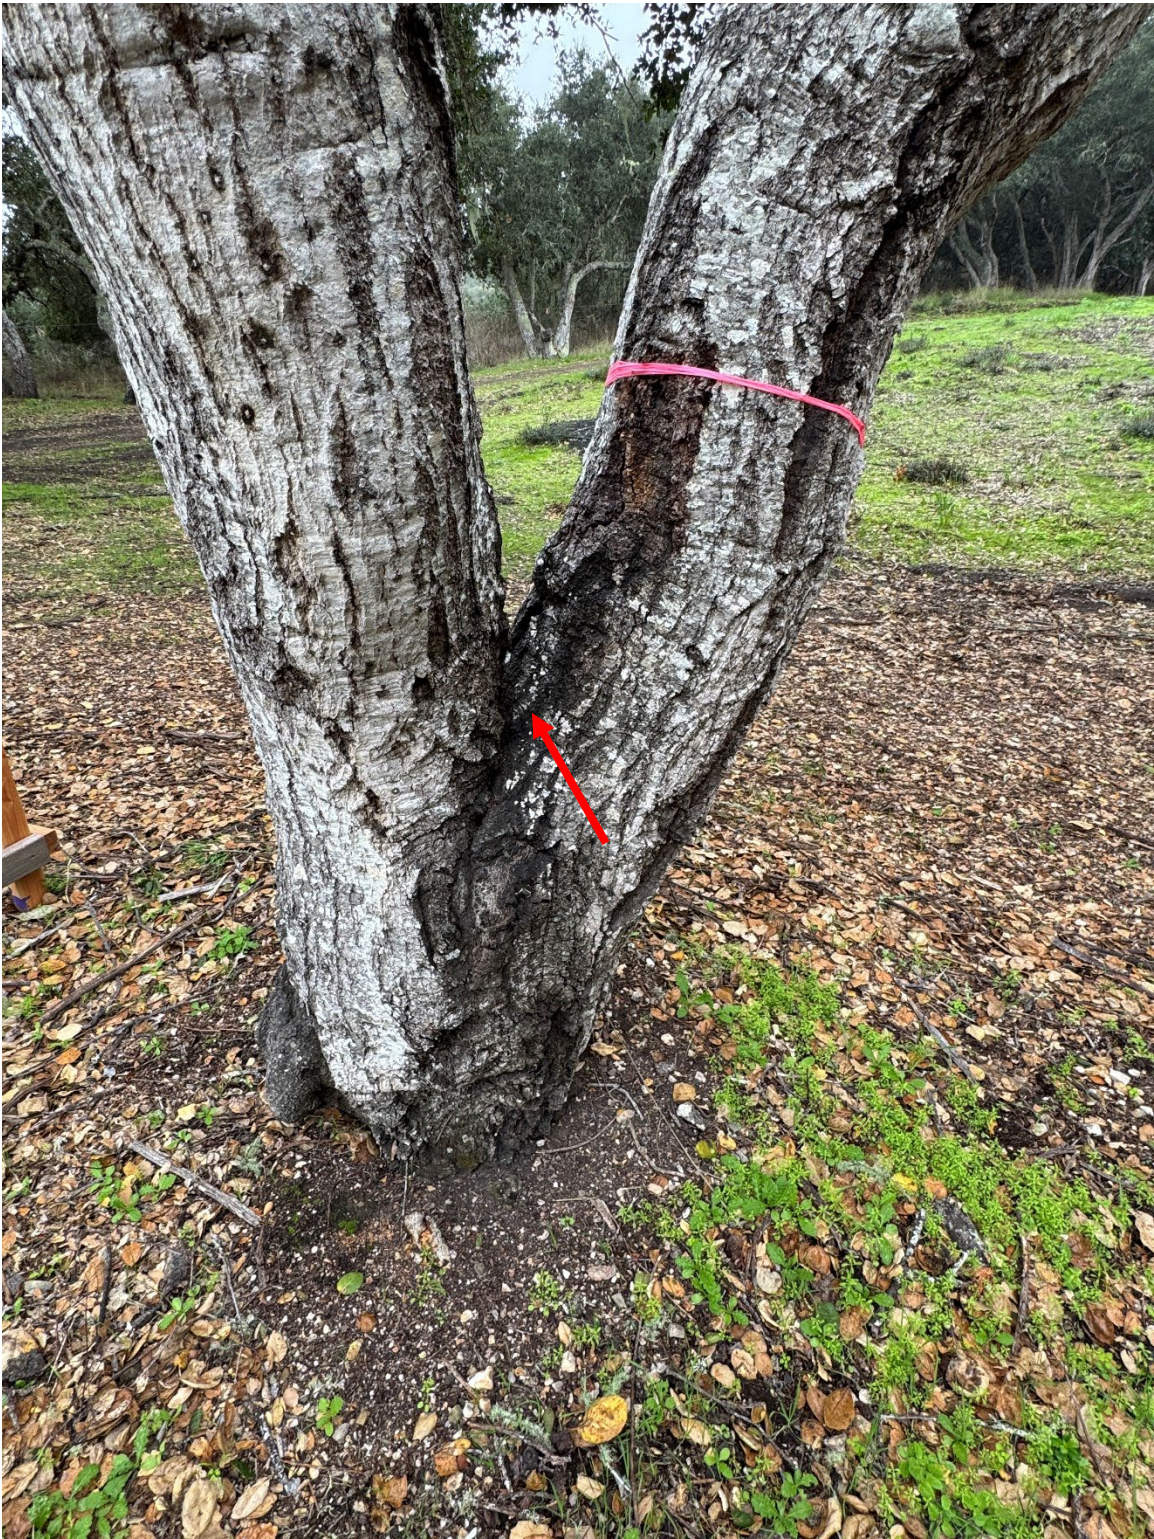
Tree #966 with structurally weak branch attachments, decay in stem, and multiple beetle attacks.

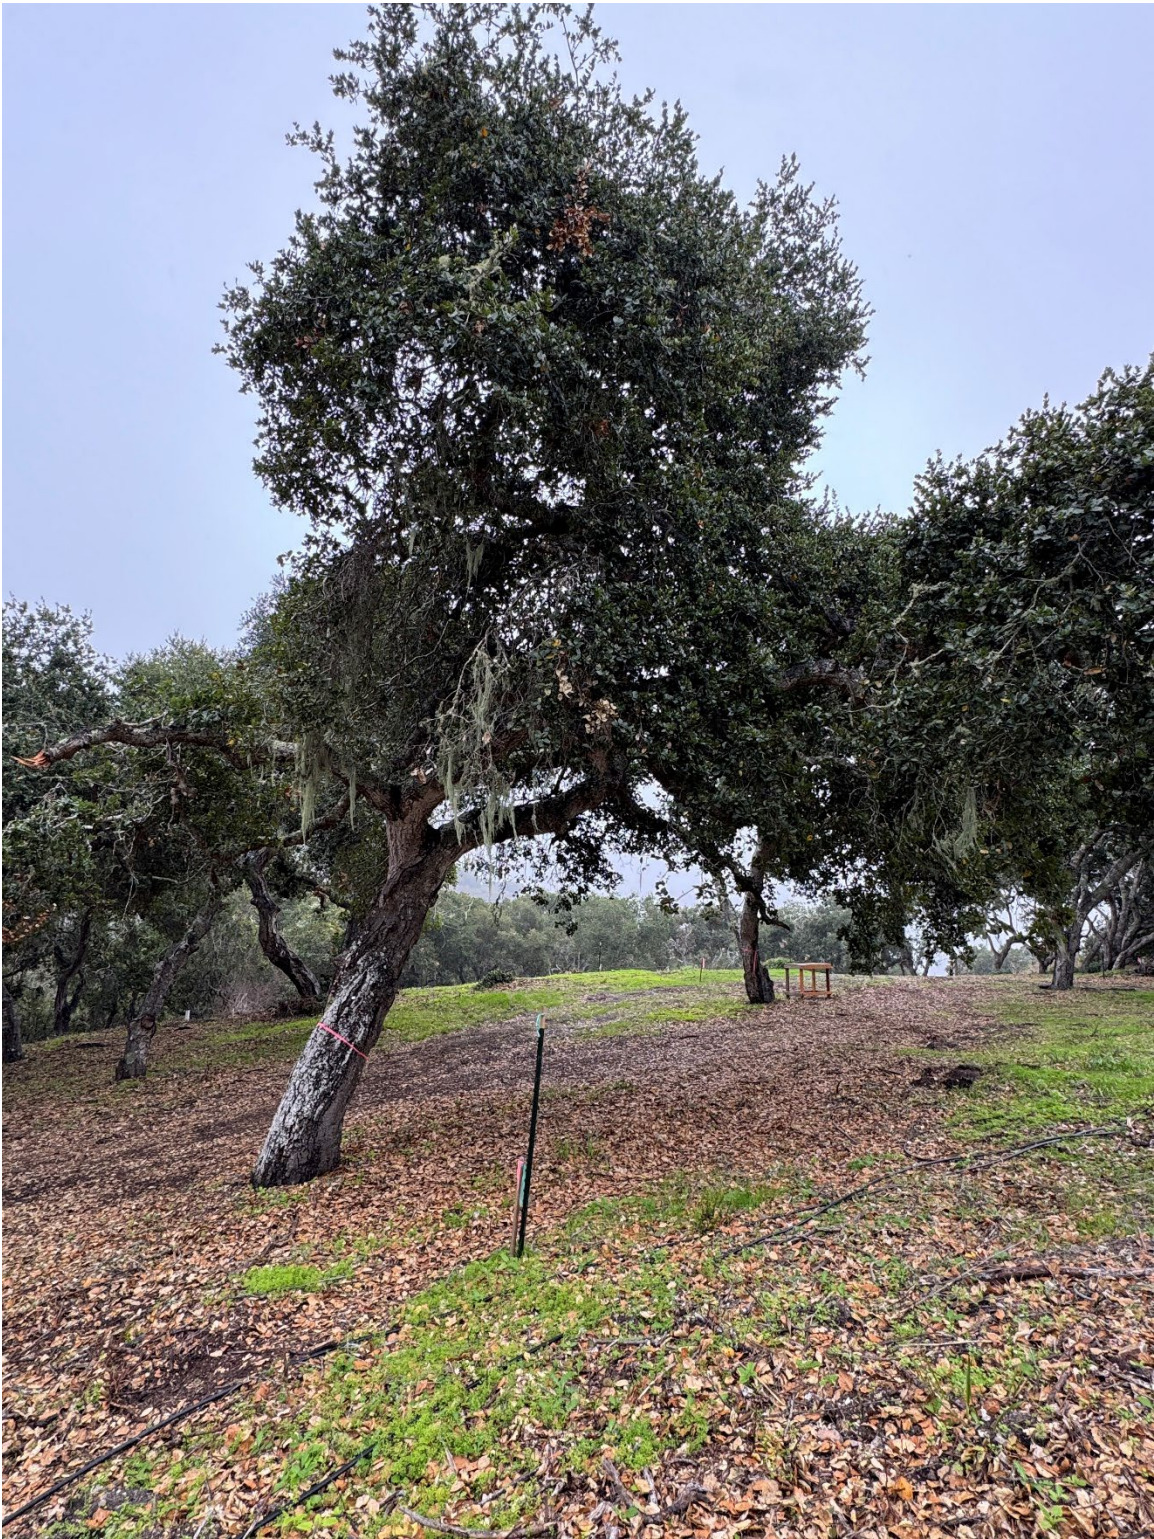
- Tree # 967 stands approximately 35 feet tall with a 35-foot crown spread. The stem is visibly twisted and its bark spread and cracked. The tree is outside the building footprint but due to its poor condition will be impacted by grading.

Tree #967 with severe lean and fracturing of stem

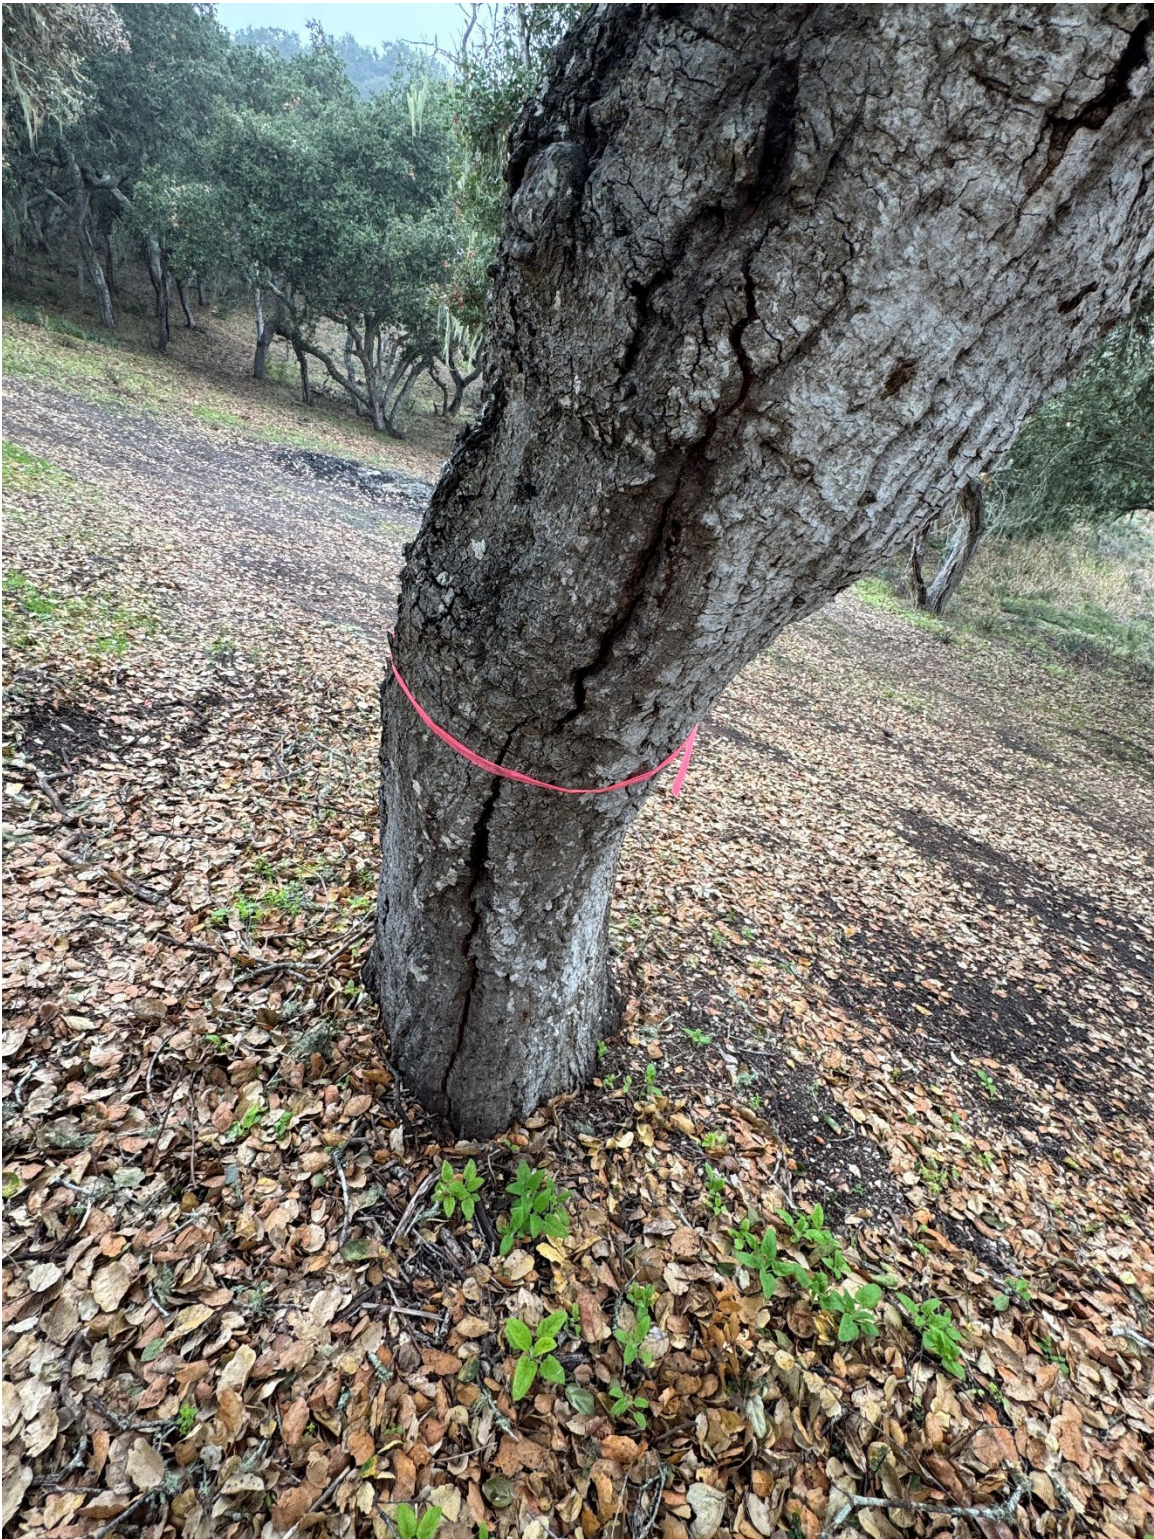
Fractured stem on the compression side of the trunk

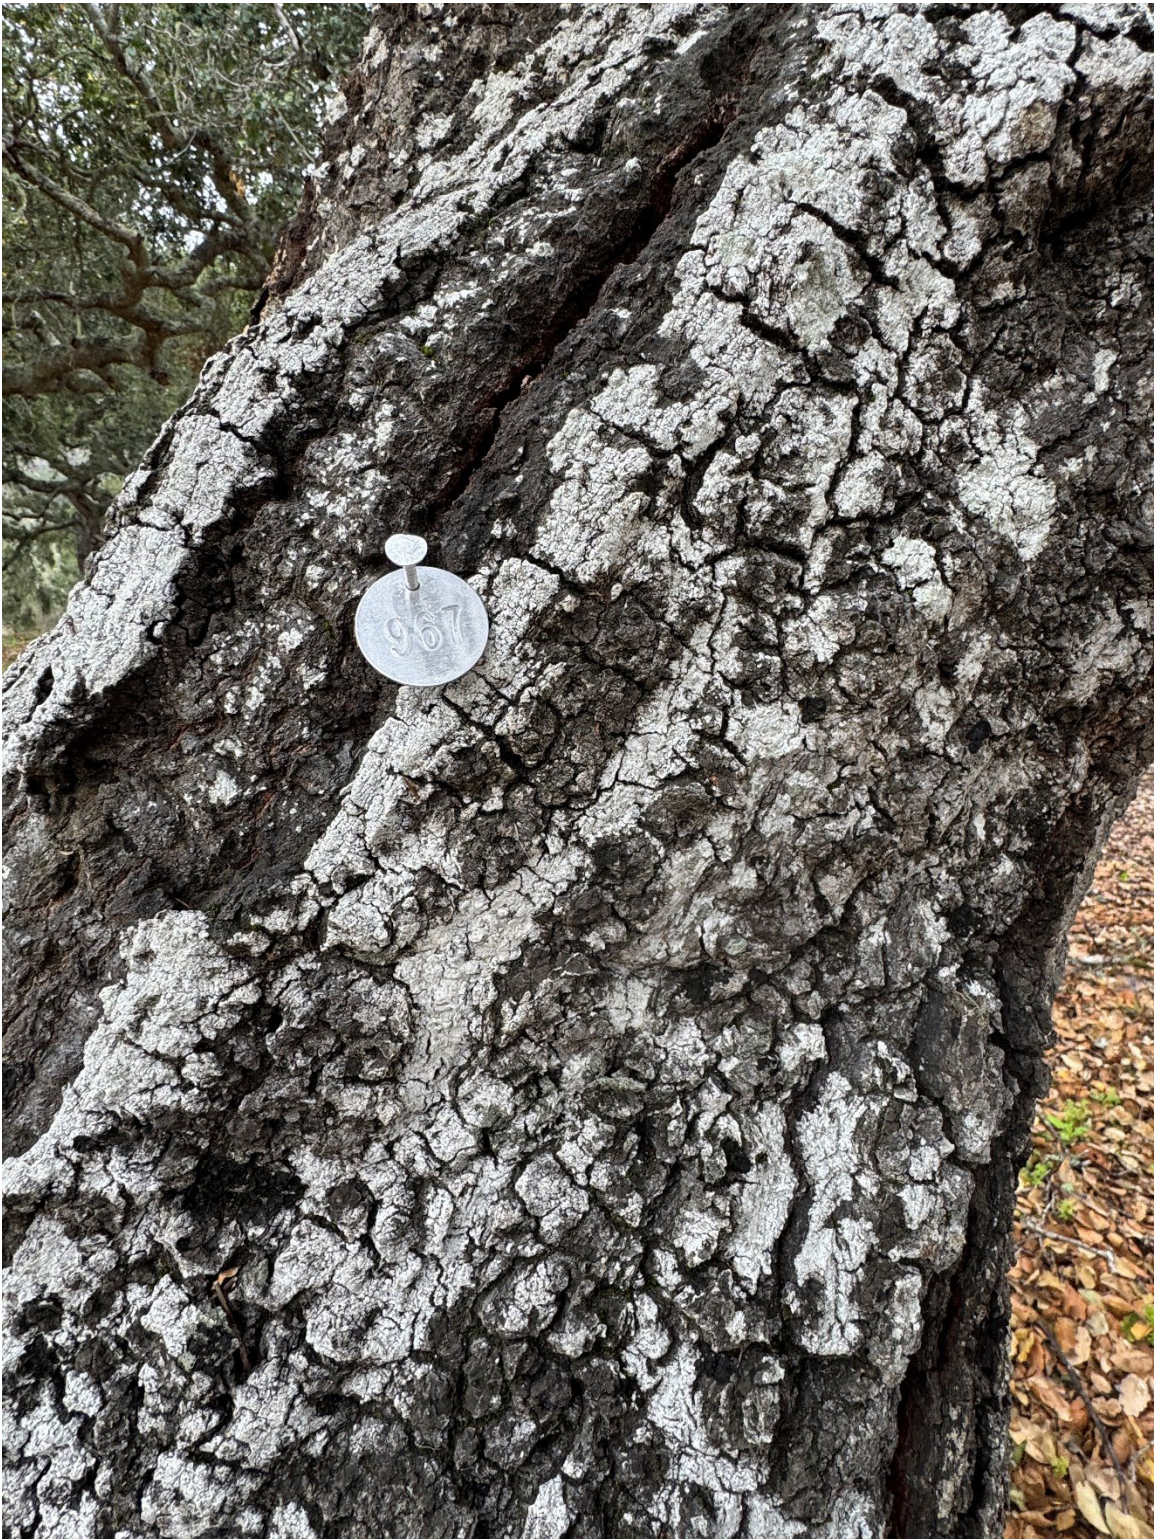
Fractured stem on tension side of the trunk.
