THOMPSON
WILDLAND MANAGEMENT

May 15, 2023

Peterson Residence
25600 Via Mal Paso
Carmel, CA 93923
APN: 259-092-023-000

Subject: Pre-construction tree removal report for 25600 Via Mal Paso

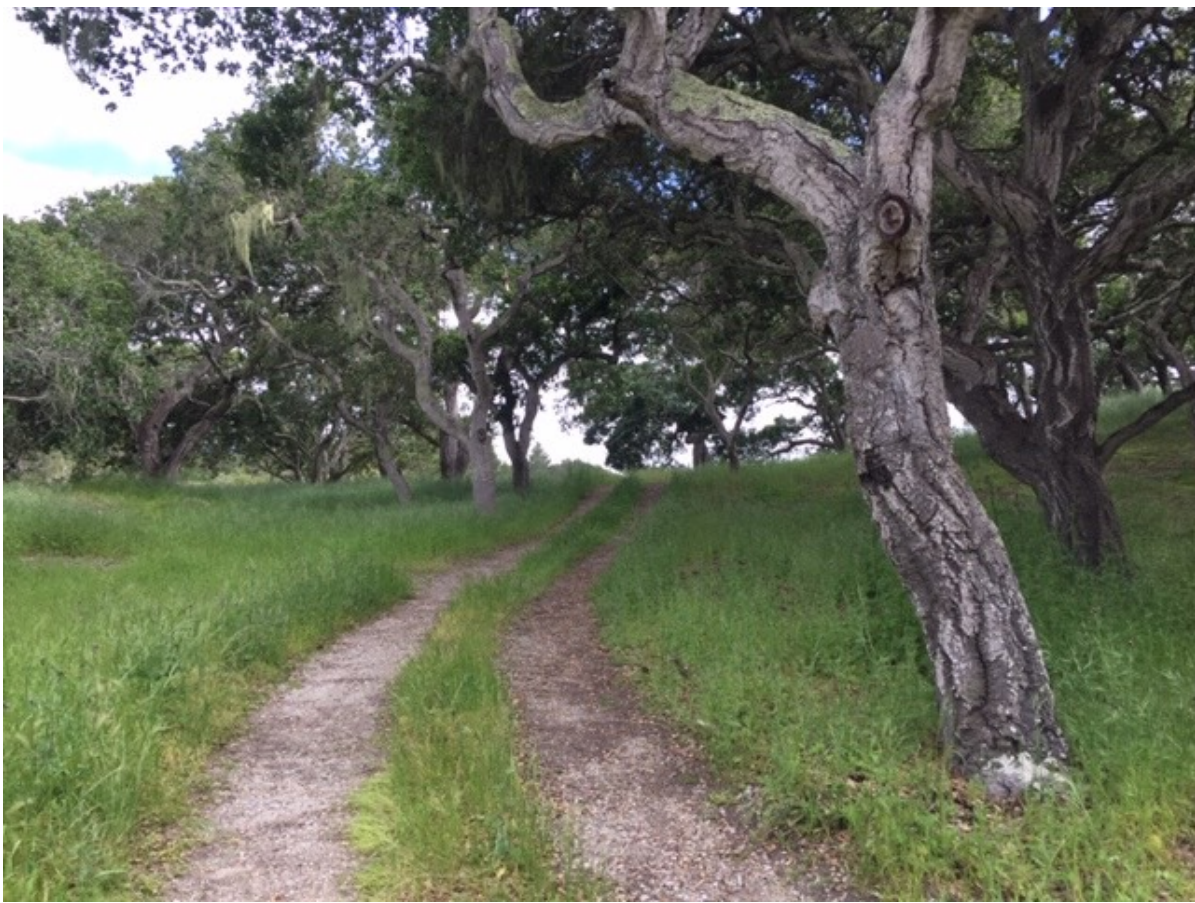
Figure 1. Tree protection measures and fencing will be properly installed and maintained for several oaks located along the proposed driveway.

The numerous remaining trees on the property will be retained and protected from construction activities for the duration of the property development project. Tree and resource protection measures will be properly monitored and maintained during the project to assist in preserving and protecting ecological resources and minimizing impacts to trees and woodland habitat.

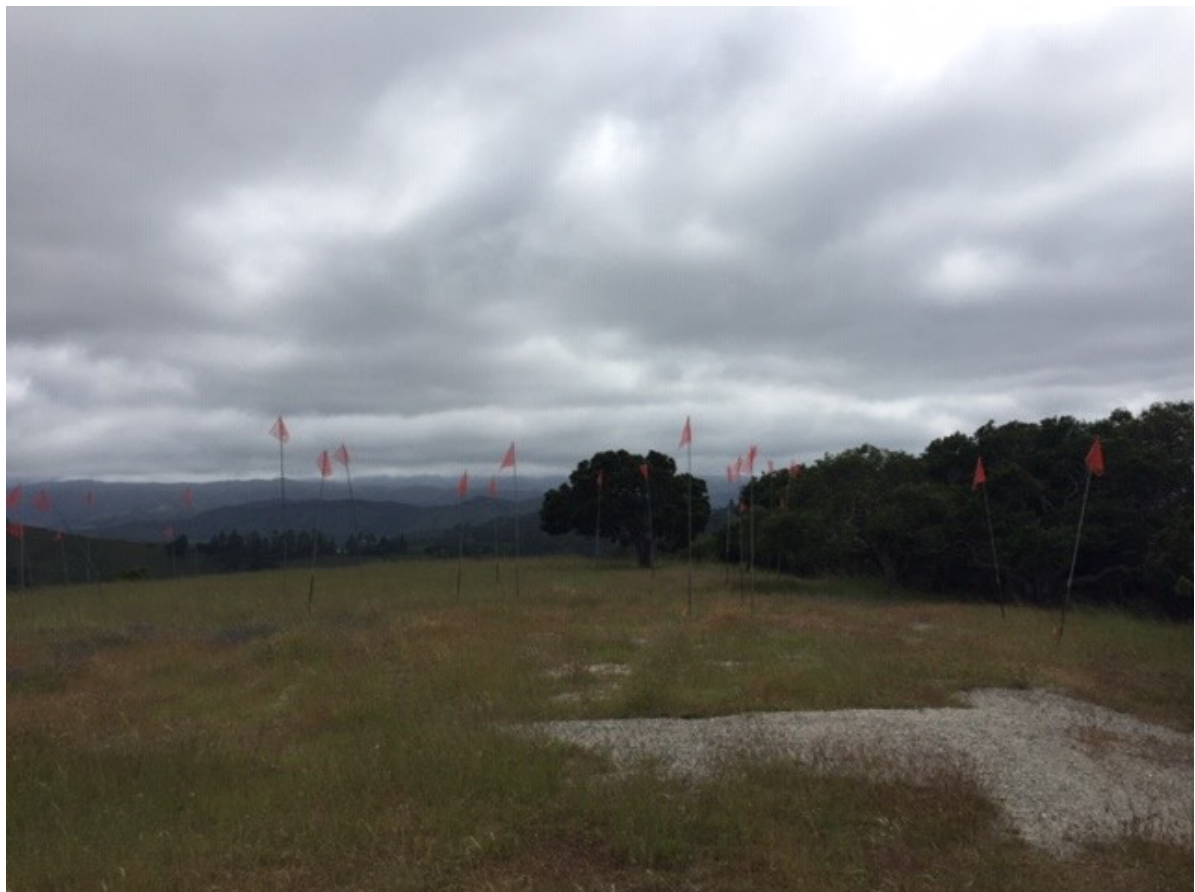
The proposed homesite is located in a grassland clearing with a few oaks located towards the southwest end of the clearing, including the two oaks that are proposed for removal. In preparation for home construction activities it will be necessary to remove the two Coast Live Oak trees addressed in this report due to their location within the proposed building footprint. The remaining trees in the construction site area will be protected

Figure 2. The homesite is located in a grassland clearing with a few oaks located towards the southwest end of the site.

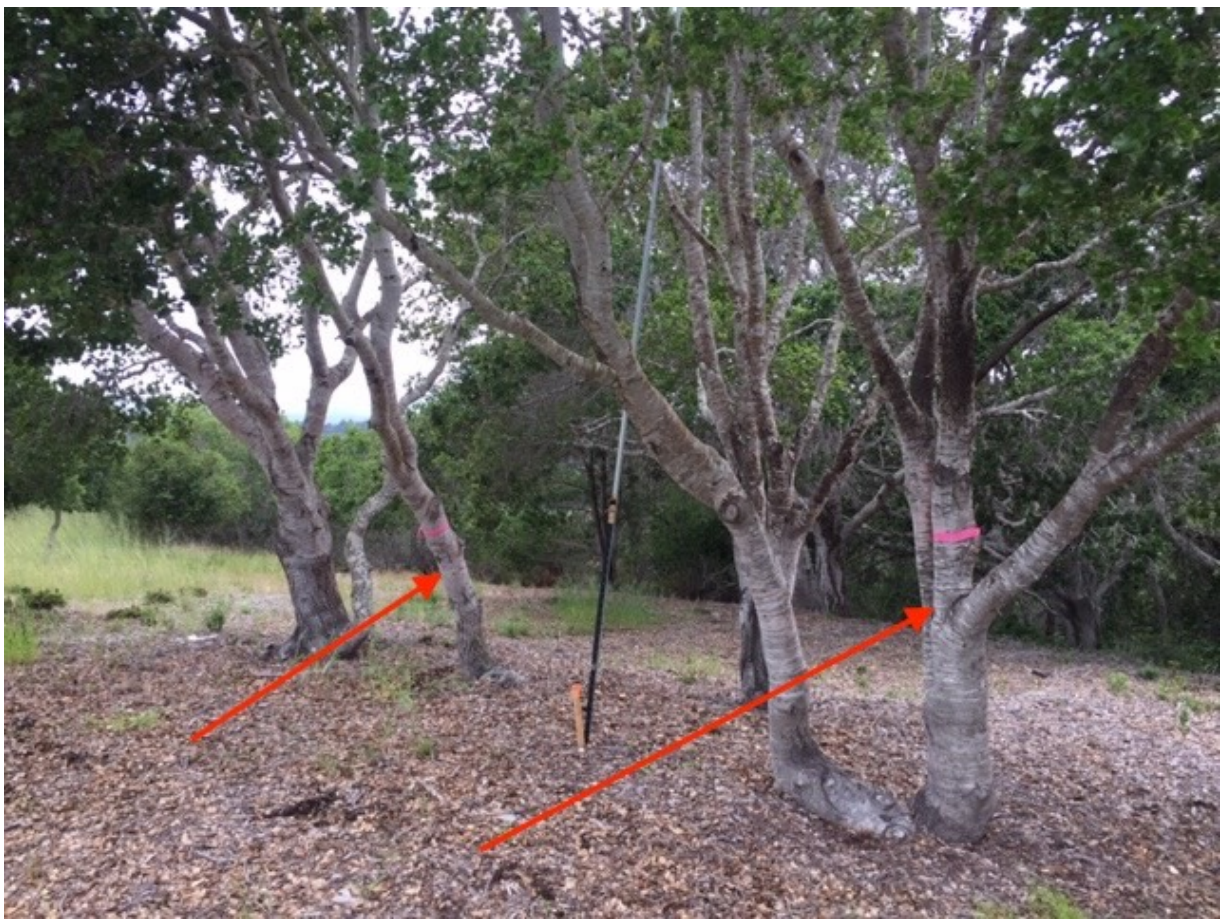
The relatively small in stature 16 inch DBH double trunk Coast Live Oak identified as *Tree#1* on the construction plans will need to be removed due to its location within the proposed building footprint (refer to *Figures 3-5*). This oak has a height of approximately 15 feet and is in fair physiological health and structural condition. Notable structural deficiencies include a co-dominant trunk and multiple co-dominant stem attachments in the mid and upper sections of the tree.

The small 7 inch DBH single stem Coast Live Oak identified as *Tree#2* on the construction plans is located in close proximity to *Tree#1* and will also need to be removed due to its location within the building footprint (refer to *Figures 3-5*). This oak also has a height of approximately 15 feet and is in fair physiological health and structural condition. Structural deficiencies include a significant natural lean and co-dominant stem attachments in the mid and upper sections of the tree.

It should be noted that at this time biotic disorders (e.g., disease, insect pests, decay) and/or significant structural defects appear to be absent in levels that are detrimental to the health and welfare of the subject oaks. These two oaks, as well as many of the other oaks on the property, have fairly dense and healthy canopies primarily consisting of green foliage. Significant chlorosis or necrosis in the crowns (e.g., limb or branch dieback) was not observed during the assessment.

Figure 3. The 2 oaks proposed for removal are identified with red arrows. Tree#1 is in right foreground and Tree#2 is in left background.

When tree removal operations commence, removal should be performed by licensed and insured tree workers trained in accordance with ANSI Z133.1 safety regulations, as required by OSHA. If necessary, tree protection measures should be installed to nearby trees that could potentially be damaged during removal operations. Additionally, if substantial soil disturbance occurs at the removal site it may be necessary to install erosion and sedimentation control measures to effectively stabilize exposed soil surfaces and contain sediment runoff. Furthermore, BMP's involved with tree removal, disposal, and the cleaning and sterilization of tools and equipment should be implemented to minimize the chance of biotic disorders (that may be present) spreading to other areas.

In regards to tree replacement, two (2) 5 to 15 gallon container size Coast Live Oak replacement trees of good physiological health and structural condition shall be planted on the subject property to replace the two removed oak trees and to help preserve and sustain the long-term health, viability and character of this mixed oak woodland environment. The two replacement trees should be acquired from a local plant nursery that has a good selection of specimens that are free from harmful pathogens, insect pests and/or significant structural disorders. Furthermore, the replacement plantings should be planted during the appropriate time of year (preferably fall or winter) using proper tree planting techniques and best management practices, and should be planted in suitable locations that will support healthy establishment and maturation. The replacement plantings shall be provided the necessary irrigation, mulching and protection (i.e., welded wire fence secured with T-posts around the plantings to protect from wildlife) until they are successfully established. Successful completion of this *Monterey County RMA-Planning Department* tree removal permit compliance action shall be achieved when the two replacement plantings survive a one-year monitoring period.

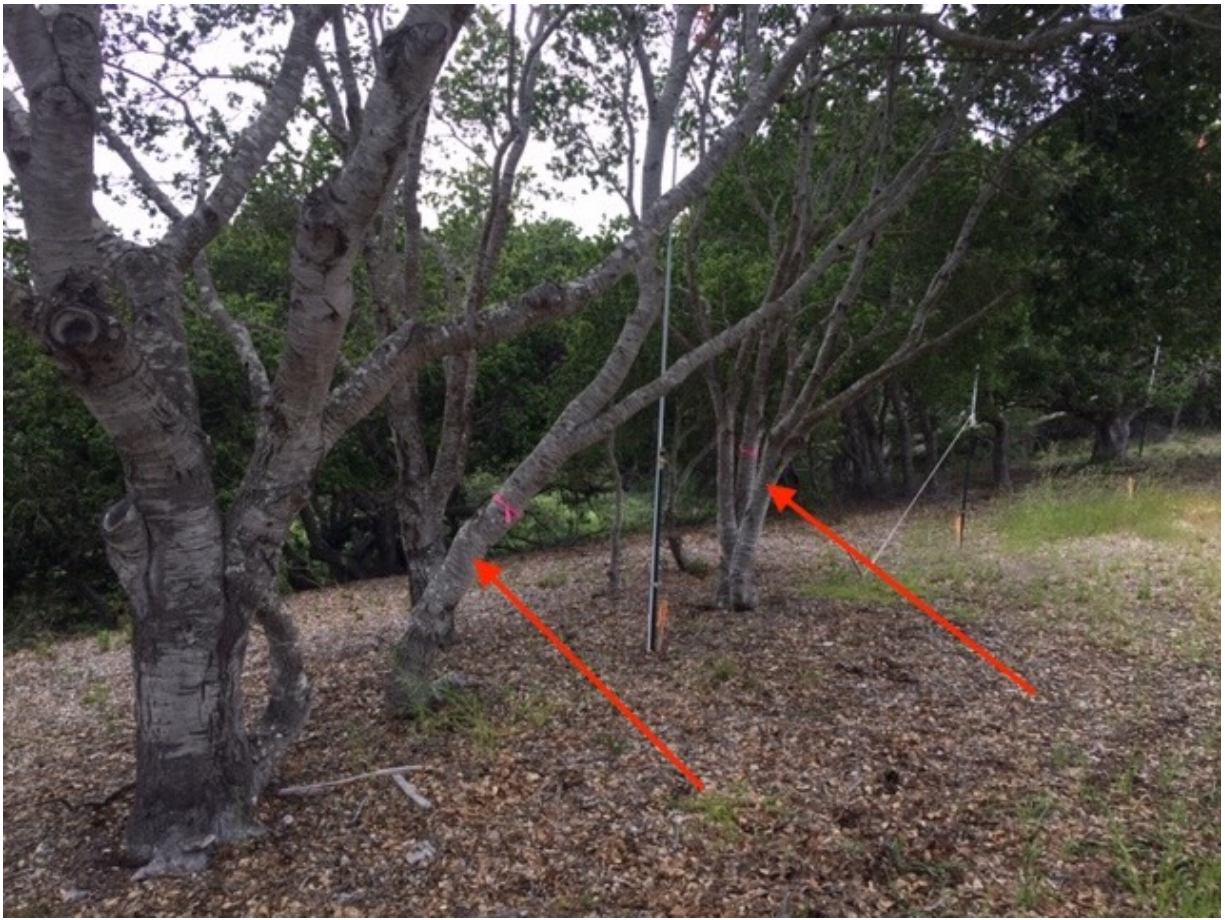
Figure 4. Another view of 2 oaks proposed for removal. The oak identified as Tree#1 is in right background and Tree#2 is in left foreground.

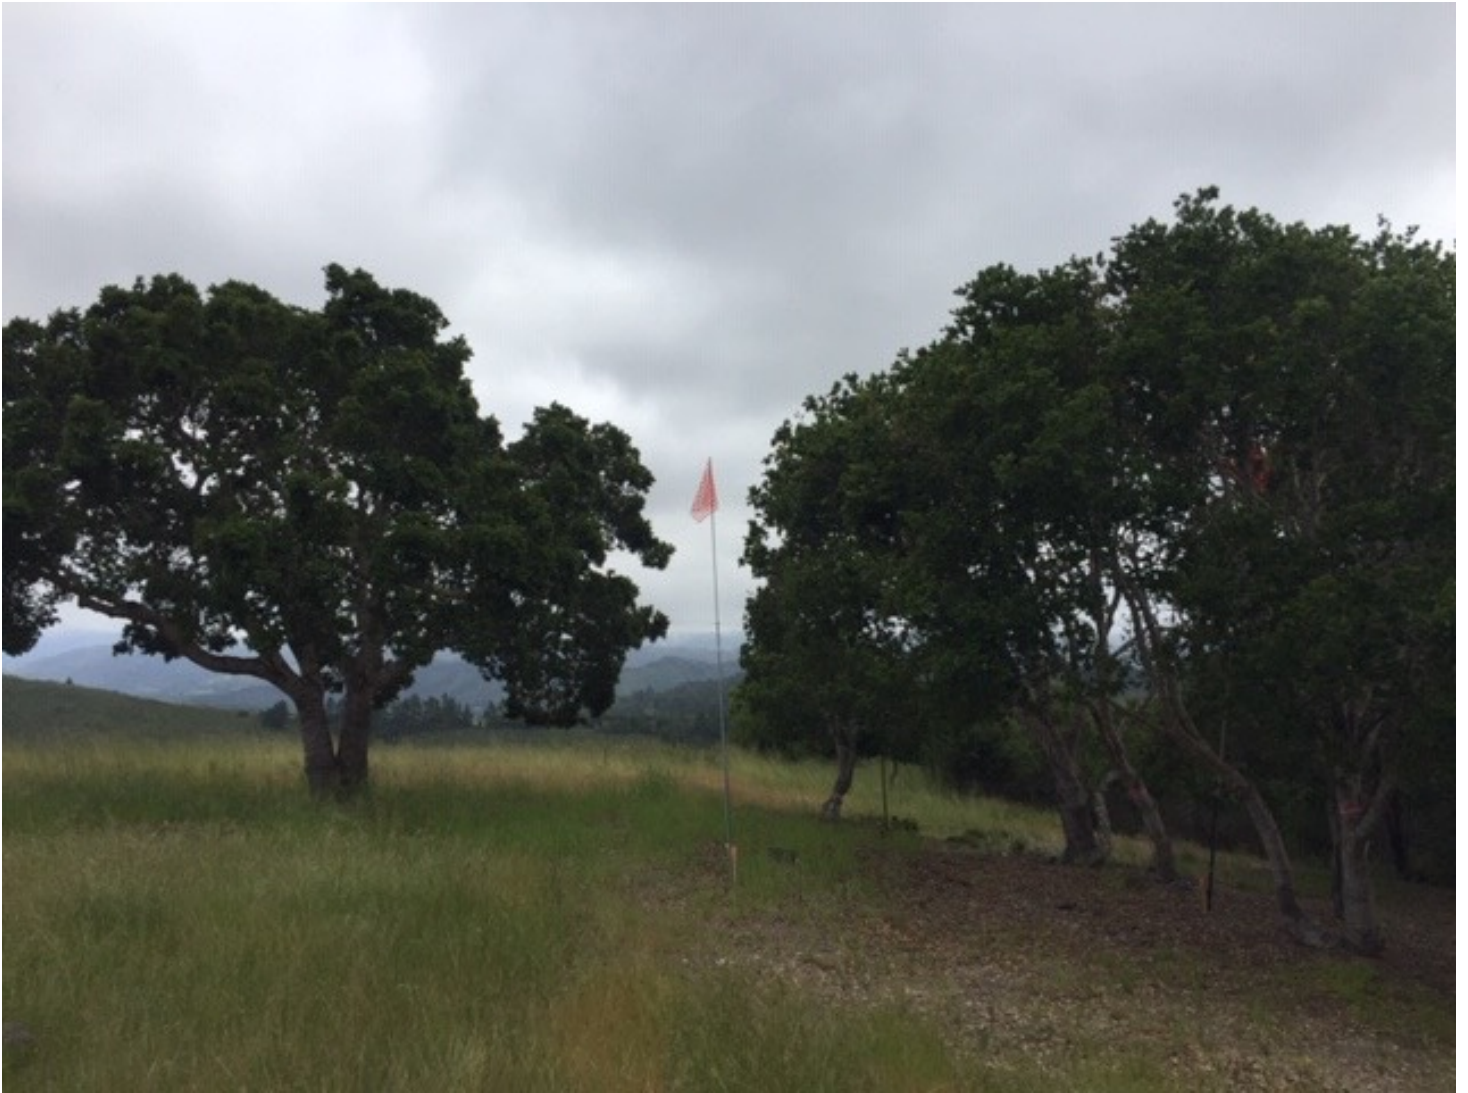
Figure 5. The 2 relatively small oaks proposed for removal are in the oak grouping to the right. The remaining oaks will be retained and protected for the duration of the home construction project.
