## ARBORIST REPORT

May 4, 2025

**Project:** New Construction

**Project Location:** 24744 Dolores Street, Carmel, CA 93923

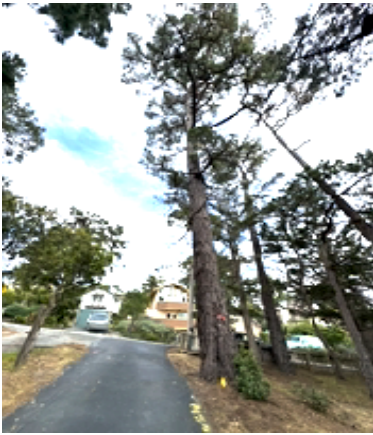
Pine 216 is within the new proposed driveway.

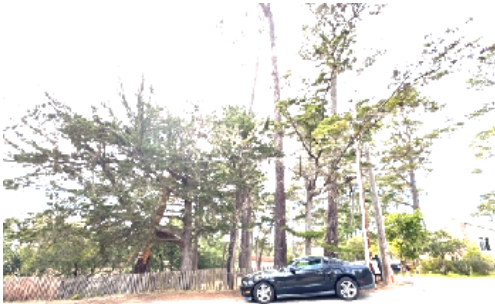
Trees 217 through 221 are located beneath utility lines. Due to their positioning, the utility company performs ongoing canopy reductions to maintain clearance. It is recommended that these trees be re-assessed to determine if a more suitable species—better adapted to grow under utility lines—should be planted in their place.

Re-assess the suitability of retaining these trees. Consider phased removal and replacement with utility-compatible species that naturally maintain a smaller mature height, reducing the need for frequent pruning.

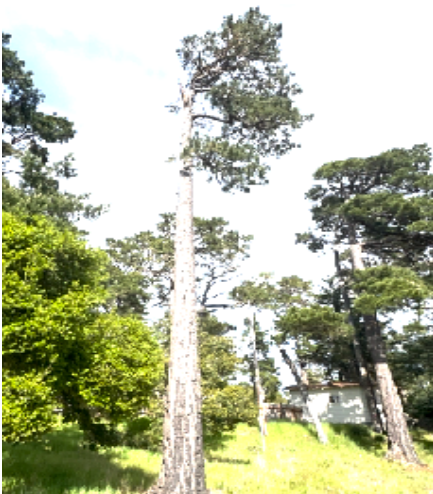
Tree 238 – Monterey Pine (*Pinus radiata*)

Tree 238 is located outside the building envelope. It is a mature specimen currently exhibiting signs of senescence. The tree recently experienced a structural failure involving a large lateral limb, resulting in a significantly uneven canopy and further compromising its form and structural stability.

Additionally, it is noted that a whole-tree failure involving another Monterey Pine occurred nearby during the past winter storm events. Given the species' known decline in urban and coastal environments at maturity, and the recent history of failure, the structural condition and long-term viability of Tree 238 should be carefully evaluated.

Due to its declining condition, recent limb failure, and potential risk to nearby structures or use areas, removal or risk mitigation pruning should be considered. Ongoing monitoring is advised if the tree is to be retained in the short term.

- **Phased Removal of Senescing Trees:** Mature pines such as Tree 238, which are in decline or structurally compromised, may be candidates for phased removal to reduce risk and open canopy space for younger trees.

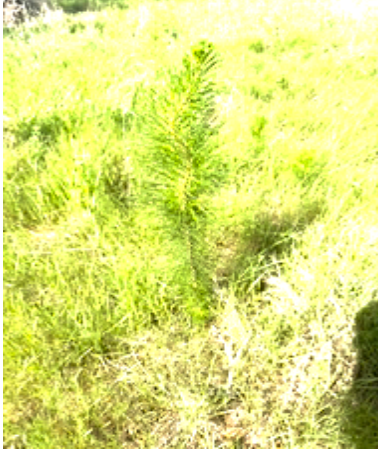
Several young Monterey Pine seedlings were observed onsite, indicating active natural regeneration within the existing stand. These individuals may represent valuable local genetics, particularly well-adapted to the site-specific conditions. Preservation and support of this regeneration is recommended as part of the long-term stewardship of the native Monterey Pine population on the property.

Protect existing seedlings where feasible from mechanical damage, competition from invasive species, and soil compaction. These naturally regenerating trees may serve as a resilient and site-adapted foundation for the future stand structure.
