Arborist Report

Prepared for:
Paul Donovan
2819 Congress Rd.
Pebble Beach, CA 93953
APN# 007-103-012

Prepared by:
Topes Environmental inc.
CA Lic. # 1082285
ISA Certified Arborist WE-7621A
ISA Board Certified Master Arborist
ISA Tree Risk Assessment Qualified
P.O. Box 223436
Carmel, CA 93922

RE: Tree Assessment

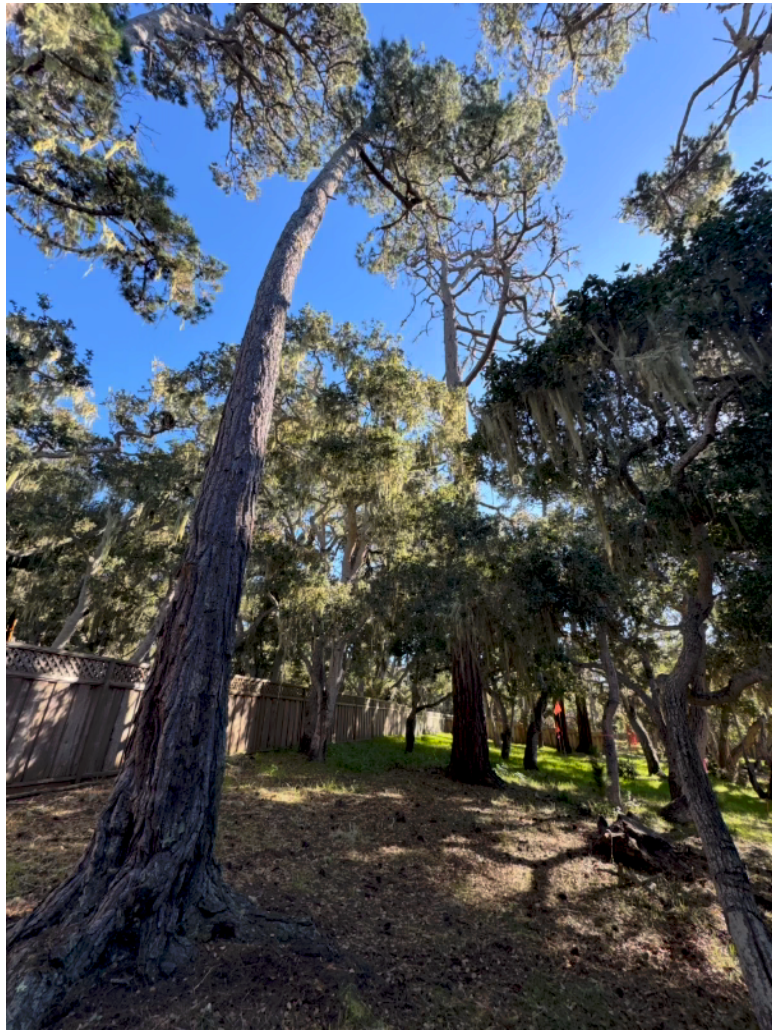
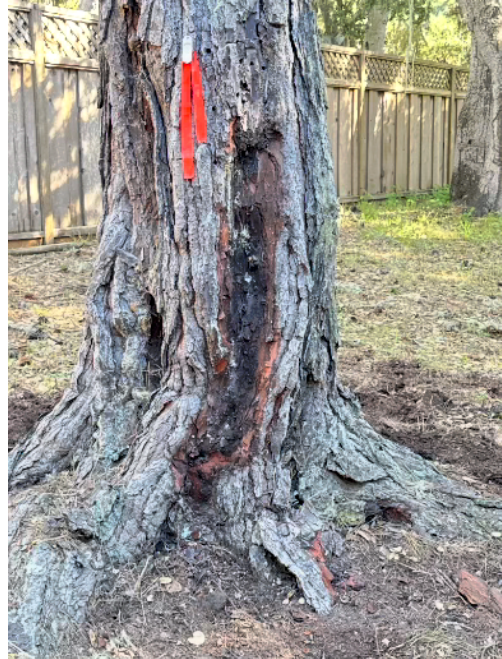
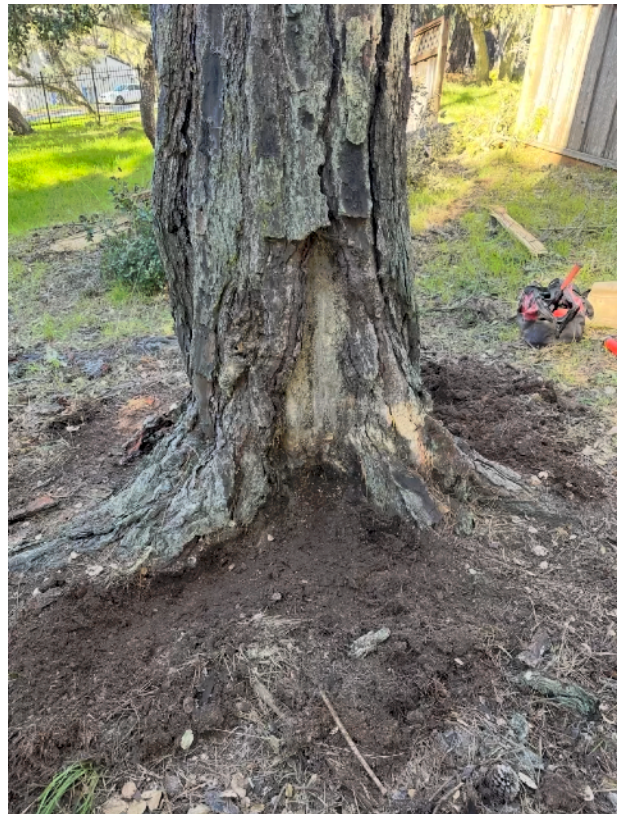
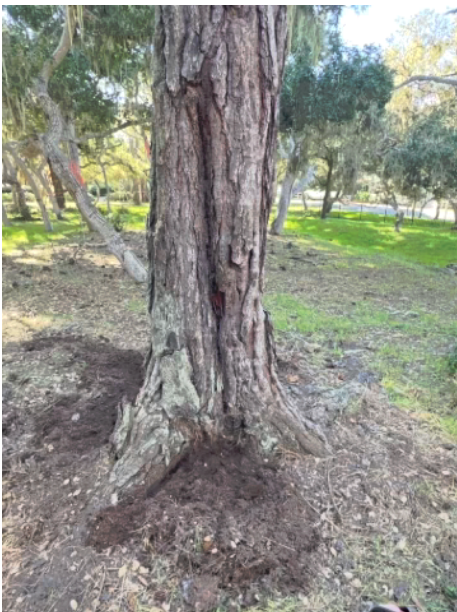
Subject tree *Pinus radiata*, #889, is ~70. Ft in height with a diameter of 26". The canopy has an ~30 ft. spread. Vigor is noted as low, growing slowly, and/or under stress for its species and site conditions. Foliage size and color indicate poor tree health. Pests noted are *Dendroctonus valens* (Red turpentine beetle) on the lower trunk and root system. The tree develops with a significant lean and a noticeable bend in the trunk. Decay, inclusions /defects to the lower trunk entering into the root-crown are present.

Subject tree 889 - Advanced decay is present throughout the lower portion of this tree with a severe lean.

All three trees display advanced stages of structural defects that compromise the health and stability of the tree. Considering that the trees will have detrimental impacts to the current stand of trees or people and structures if development were to take place, It is recommended that these trees be removed for canopy preservation or prior to any development that might take place onsite for safety reasons.

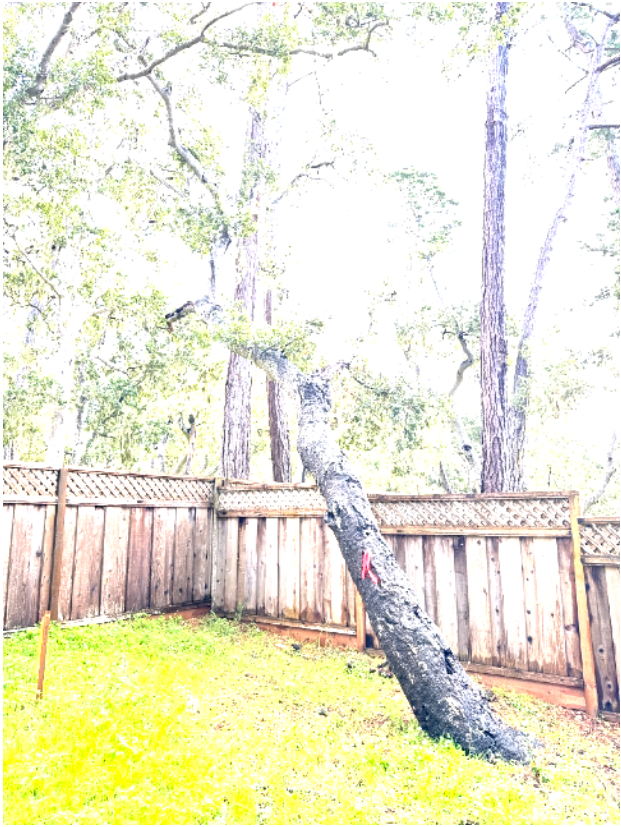
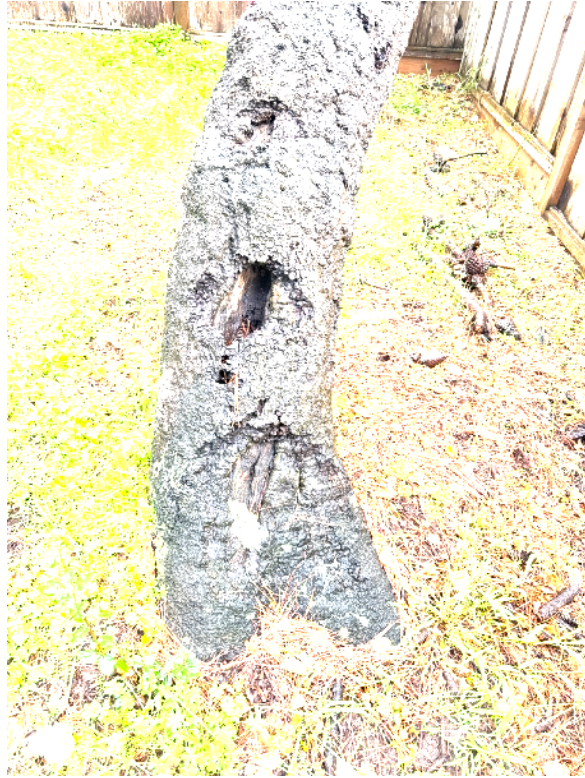
Subject tree *Quercus agrifolia* #891, is ~25. Ft in height with a diameter of 16". The canopy has an ~20 ft. spread. Vigor is noted as low, growing slowly, and/or under stress for its species and site conditions. Foliage size and color indicate poor tree health. Decay, inclusions /defects to the lower trunk entering into the root-crown are present. Cavities with decay noted at the base.

Subject tree 891 -
Is in decline with advanced decay and cavities. The canopy develops beyond the critical root zone increasing the likelihood of failure.

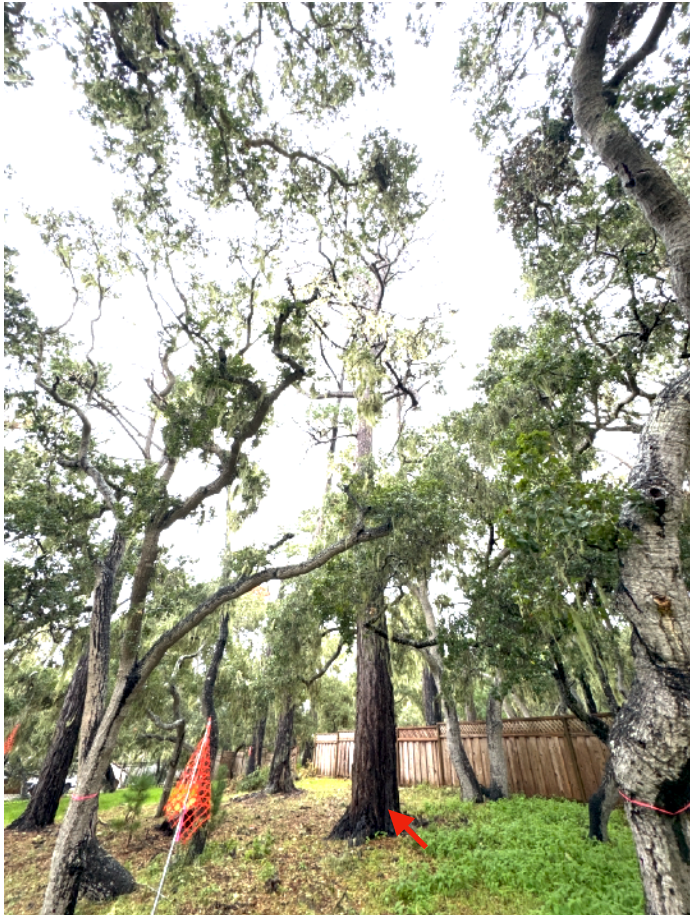
Subject tree *Pinus radiata*, #892, is ~80. Ft in height with a diameter of 40". The canopy has an ~25 ft. spread. The subject tree is dead with no living foliage.

Subject tree 892 is dead with no living foliage
