Arborist Report

*Santa Lucia Preserve Lot #38
1 Rumsen Trace
Carmel, CA 93923
APN# 239-051-007*

*Inspection Date:
April 11, 2023
Revised: September 21, 2023*

Prepared by: Chris Stewart
Project Arborist: Michael Young/Chris Stewart
contractors license # 755989
certified arborist WC ISA #WE-13682A

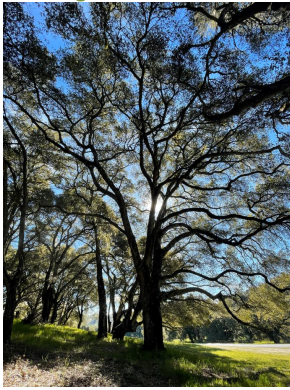
Tree #1

TAG NO.	COMMON NAME	DIAMETER AT BREAST HEIGHT"	H'/W'	HEALTH	STRUCTURE	Critical Root Zone 8 x DBH"	PROTECTED (X)	TREE DISPOSITION	NOTES, RECOMMENDATIONS
1	Coast live oak	52.4	80'/60'	fg	fp	419.2	x	B	EWR, DWR, SP, RCE, large CD @ 8', cable
2	Coast live oak	38.0	40'/40'	fg	fp	304	x	B	EWR, DWR, SP, RCE, CD @ 5', leaning
3	Coast live oak	30.5	70'/35'	fg	fp	244	x	B	EWR, DWR, SP, RCE, CD @ 18', slight lean
4	Coast live oak	24.8	70'/30'	fg	f	198.4	x	B	EWR, DWR, SP, RCE, slight lean
5	Coast live oak	19.5	65'/30'	fg	f	156	x	B	EWR, DWR, SP, RCE, slight lean
6	Coast live oak	41.5	75'/60'	fg	fp	332	x	B	EWR, DWR, SP, RCE, large CD @ 8', cable
7	Coast live oak	8.0	20'/10'	fg	fp	64	x	C	EWR, DWR, SP, RCE, leaning
8	Coast live oak	56.5	65'/70'	fg	fp	452	x	B	EWR, DWR, SP, RCE, multiple CD @ 8', cable
9	Coast live oak	17.6	35'/15'	fg	fp	140.8	x	C	EWR, DWR, SP, RCE, heavy lean
10	Coast live oak	19.6	40'/30'	fg	fp	156.8	x	C	EWR, DWR, SP, RCE, heavy lean, CD @ 8'

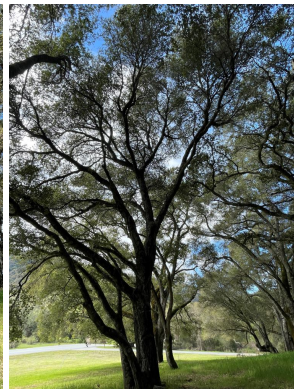
Tree #12

11	Coast live oak	18.5	35'/18'	fg	fp	148	x	C	EWR, DWR, SP, RCE, heavy lean, CD @ 7'
12	Coast live oak	32.7	65'/60'	fg	fp	261.6	x	B	EWR, DWR, SP, RCE, CD @ 15', cable
13	Coast live oak	20.5	60'/30'	fg	fp	164	x	B	EWR, DWR, SP, RCE, slight lean, CD @ 9'
14	Coast live oak	22.5	60'/30'	fg	f	180	x	A	EWR, DWR, SP, RCE
15	Coast live oak	22.0	60'/35'	fg	fp	176	x	B	EWR, DWR, SP, RCE, CD @ 12', cable
16	Coast live oak	26.5	30'/35'	fg	fp	212.4	x	C	EWR, DWR, SP, RCE, heavy lean
17	Coast live oak	34.0	70'/60'	fg	fp	272	x	B	EWR, DWR, SP, RCE, CD @ 12', cable
18	Coast live oak	23.7	25'/30'	fg	fp	189.6	x	C	EWR, DWR, SP, RCE, heavy lean, prop
19	Coast live oak	34.0	65'/40'	fg	fp	272	x	B	EWR, DWR, SP, RCE, CD @ 12', cable
20	Coast live oak	40.0	40'/45'	f	fp	320	x	C	EWR, DWR, SP, RCE, CD @ 3'
21	Coast live oak	16.4	30'/15'	f	fp	131.2	x	C	EWR, DWR, SP, RCE, leaning
22	Coast live oak	8.6	20'/1'	p	p	68.8	x	D	RR, tree is dead

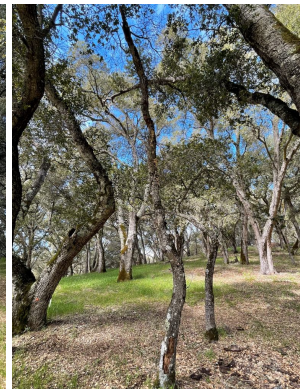
Tree #22 is a Coast live oak (*Quercus agrifolia*) with a DBH of 8.6"

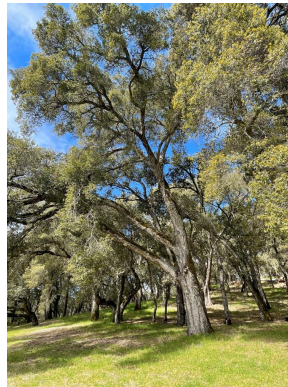
Tree #25

23	Coast live oak	28.7	70'/28'	f	fp	229.6	x	C	EWR, DWR, SP, RCE, leaning, dead limb
24	Coast live oak	9.6	25'/6'	f	fp	76.8	x	C	EWR, DWR, SP, RCE, heavy lean
25	Coast live oak	46.5	75'/40'	fg	f	372	x	B	EWR, DWR, SP, RCE
26	Coast live oak	28.0	60'/25'	fg	f	224	x	B	EWR, DWR, SP, RCE, slight lean in upper canopy
27	Coast live oak	72.0	60'/55'	f	fp	576	x	C	EWR, DWR, SP, RCE, CD at base, large tear in trunk from limb failure
28	Valley oak	28.0	55'/50'	f	f	224	x	B	EWR, DWR, SP, RCE
29	Coast live oak	32.0	45'/30'	f	f	256	x	C	EWR, DWR, SP, RCE, over shadowed by Valley oaks
30	Valley oak	48.0	70'/65'	f	fp	384	x	C	EWR, DWR, SP, RCE, CD @ 7', rotten limbs, heavy pruning needed, cable
31	Valley oak	48.0	75'/70'	f	fp	384	x	C	EWR, DWR, SP, RCE, CD @ 12', heavy pruning needed, cable
32	Valley oak	48.0	55'/45'	fg	fp	384	x	C	EWR, DWR, SP, RCE, CD @ 10', heavy pruning needed, cable
33	Coast live oak	22.0	30'/30'	fg	fp	176	x	B	EWR, DWR, SP, RCE, CD @ base
