ALBERT WEISFUSS
ISA CERTIFIED ARBORIST #1388
ISA TREE RISK ASSESSOR QUALIFIED
(831) 869-2767
albertweisfuss@gmail.com
montereybaytreeworks.com

TYPE OF CONSTRUCTION: TYPE V-B NEW RESIDENCE

PROJECT LOCATION: 62 MARGUERITE, CARMEL CA 93923

SUMMARY

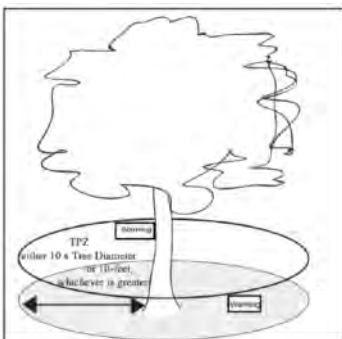
Tree Protection Zone (TPZ) shown in grey
(radius of TPZ equals 10-times the diameter of the tree or 10-feet, whichever is greater).

- Keep the foliage canopy and branching structure clear from contact by equipment, materials and activities.
- Preserve roots and soil conditions in an intact and non-compacted state.
- Identify the Tree Protection Zone (TPZ) in which no soil disturbance is permitted and activities are restricted, unless otherwise approved.
- The Tree Protection Zone (TPZ) is a restricted area around the base of the tree with a radius of ten-times the diameter of the tree's trunk or ten feet; whichever is greater, enclosed by fencing.

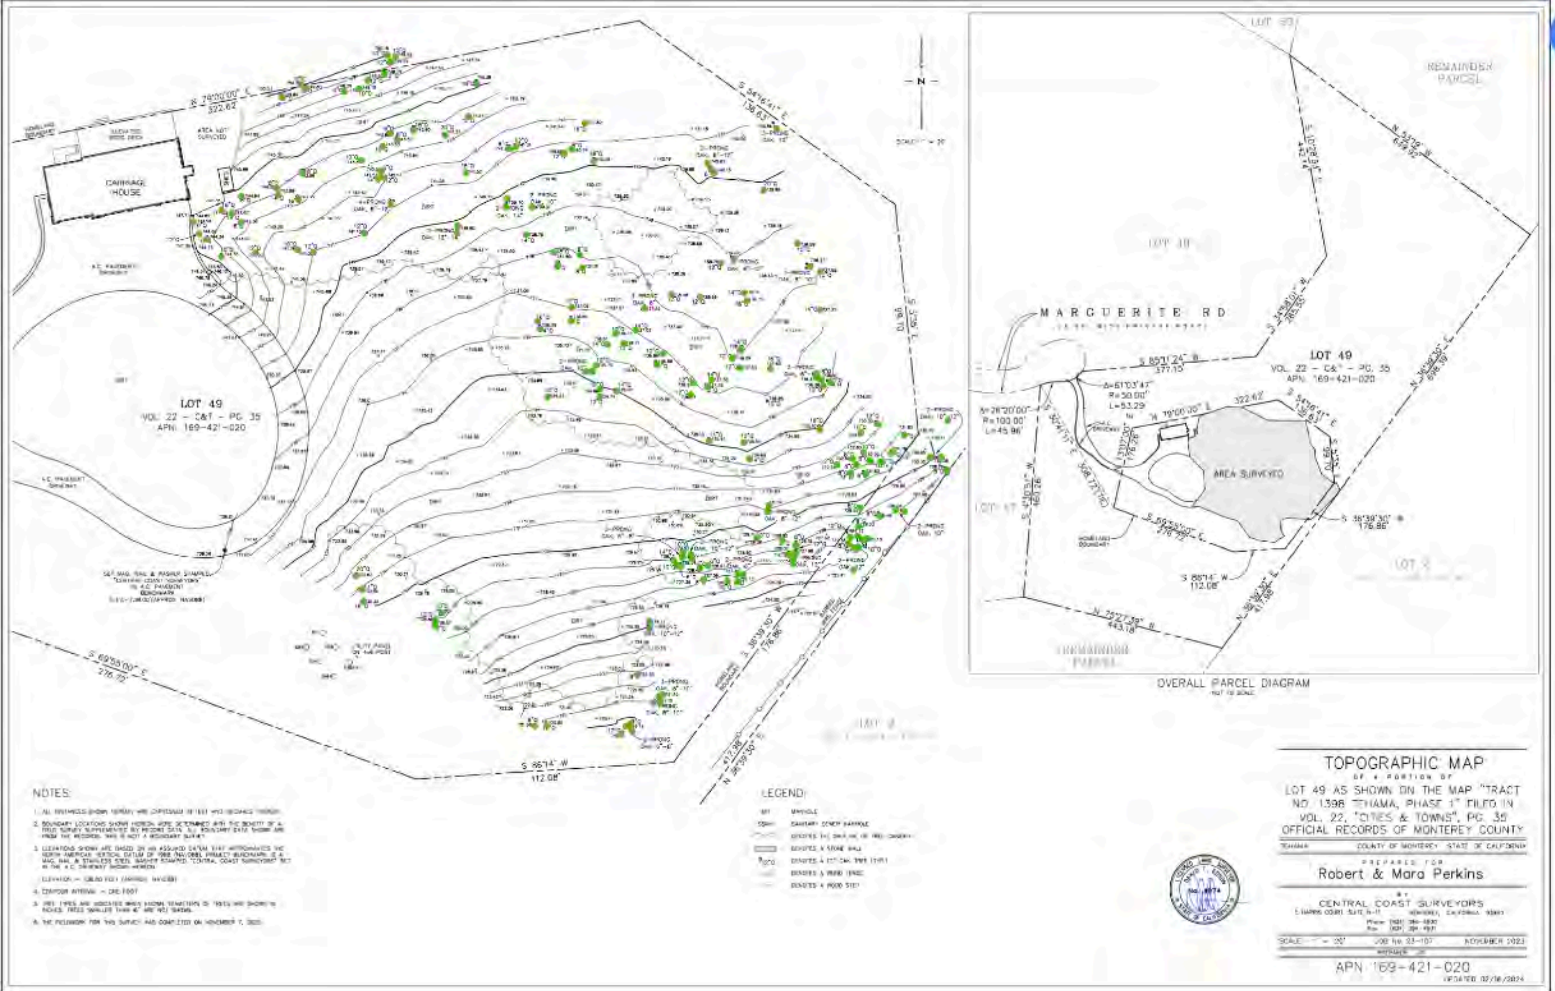
Provided topo map of documented 177 Quercus agrifolia.
