# 2025 Boat Dock Survey: Data Collection and Findings

The Monterey County Water Resources Agency (“Agency”) administers a boat dock licensing and inspection program at Nacimiento Reservoir, which oversees the operation of recreational boat docks in accordance with Ordinance Nos. 5033 and 4065.<sup>1</sup> This program has been active since 1972 and now includes a total of 386 recreational docks.

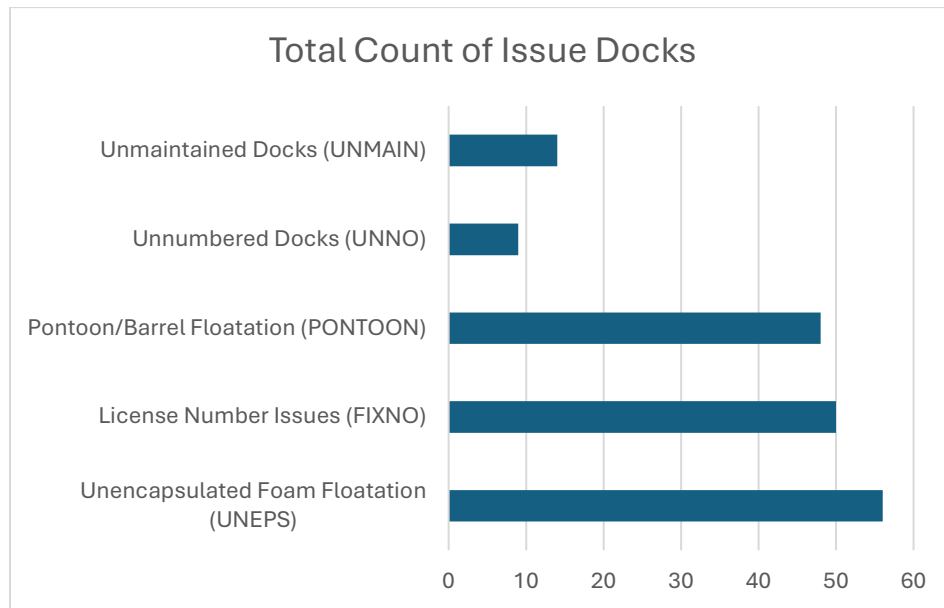
*Figure 3 – Number of docks with licensing violations in the year 2025.*

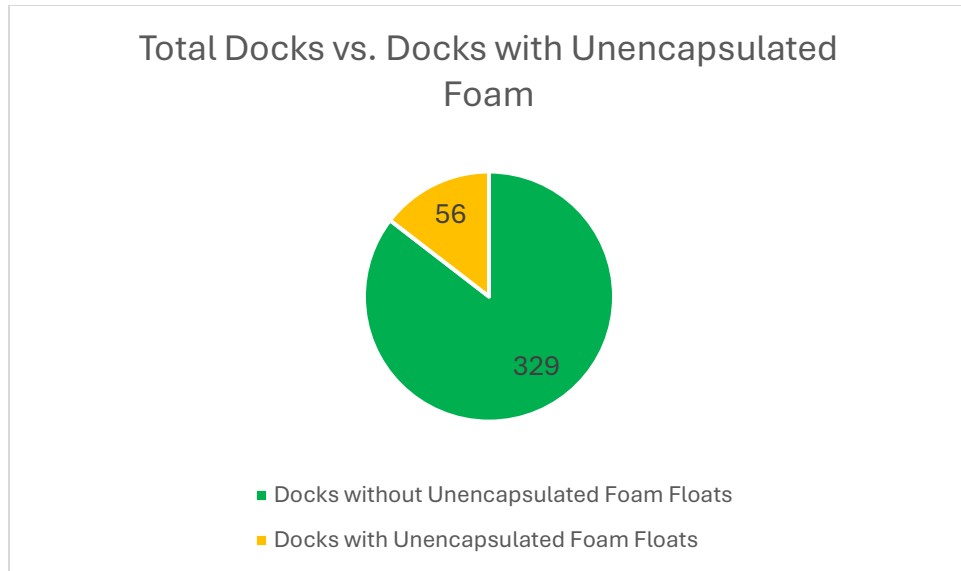
The inspection results have been compiled to summarize all findings, including the observation that 56 docks (14.5%) on the reservoir are equipped with unencapsulated foam floats. These floats disintegrate over time, releasing microplastics into the reservoir. The detailed totals are presented below:

*Figure 4 - Total number of docks containing encapsulated Styrofoam, which is prohibited by ordinance 4065 enacted in 2000.*

1. UNEPS: Unencapsulated foam floating dock structures should be retrieved and disposed of in accordance with appropriate environmental and safety protocols.

Based on a thorough review of the photographs, all docks featuring unencapsulated foam are observed to be in poor condition and are not suitable for straightforward retrofitting. Consequently, the full removal of these docks from the reservoir will be necessary.

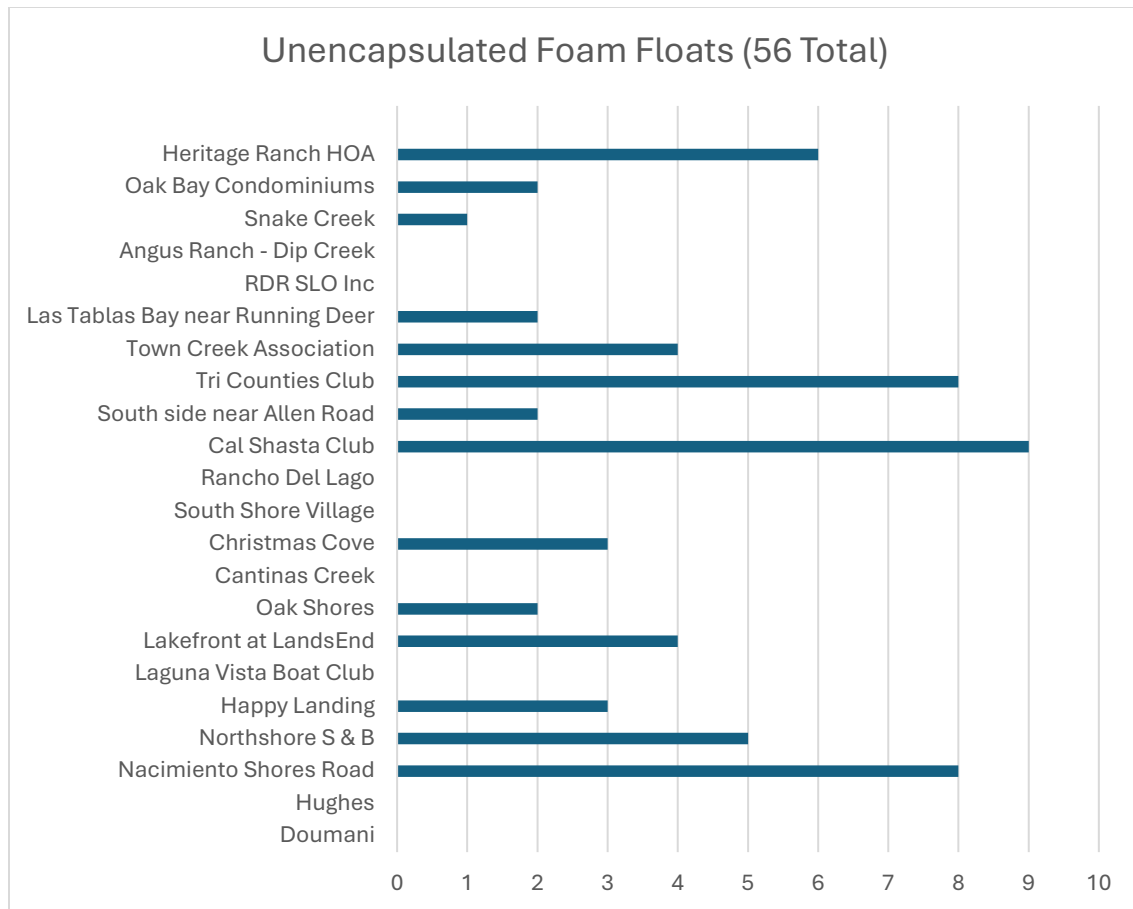
These docks were observed in multiple regions along the reservoir, with the highest concentrations in Cal Shasta Club, Tri Counties Club, and Nacimiento Shores Road.

Figure 5 – Identify locations on Nacimiento Reservoir to efficiently address all instances of exposed Styrofoam.

The detailed totals per each region are provided below, and these locations will be required to undertake appropriate corrective actions.

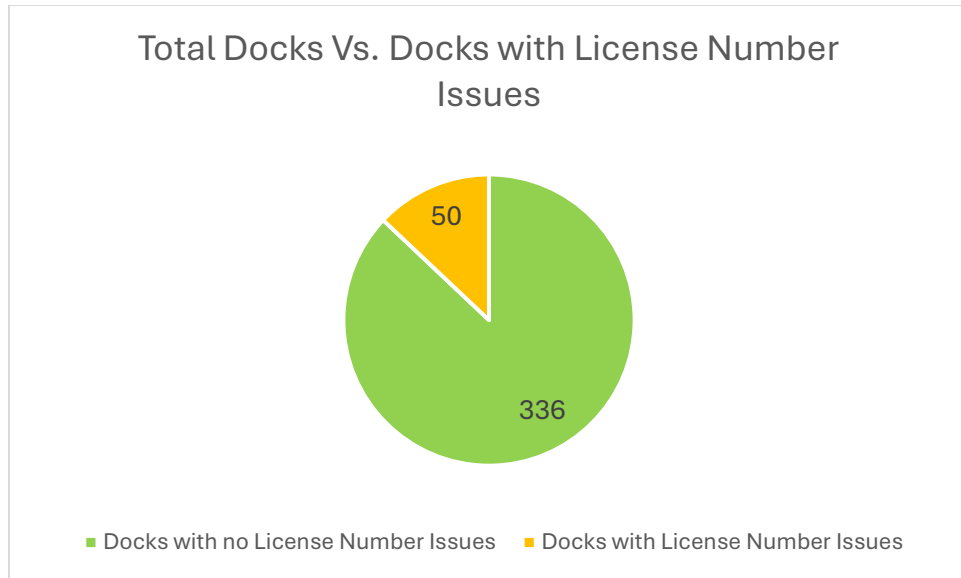
The second most common issue observed at the reservoir involved license number compliance. A total of 50 docks (13%) exhibited license number issues, including missing numbers (entirely or partially), multiple license numbers posted at a single dock, numbers that are too small, or numbers that are difficult to read due numbers to placement, color, sinking, shadowing, or other factors. Docks are required to display numerals at least 3 inches in height, clearly visible from the water. The following summary provides an overview of these docks, with inspection audit results indicating specific management concerns related to identification numbering.

*Figure 6 – There are discrepancies with dock numbering. Please utilize the findings to enhance the management of docks by ensuring that all docks display the correct license identification numbers, including the use of agency-issued plates or signs with proper ID numbers.*

2. FIXNO/UNNO. Docks owners whose docks do not clearly display their license number should be informed of this issue and advised to take the necessary corrective action.

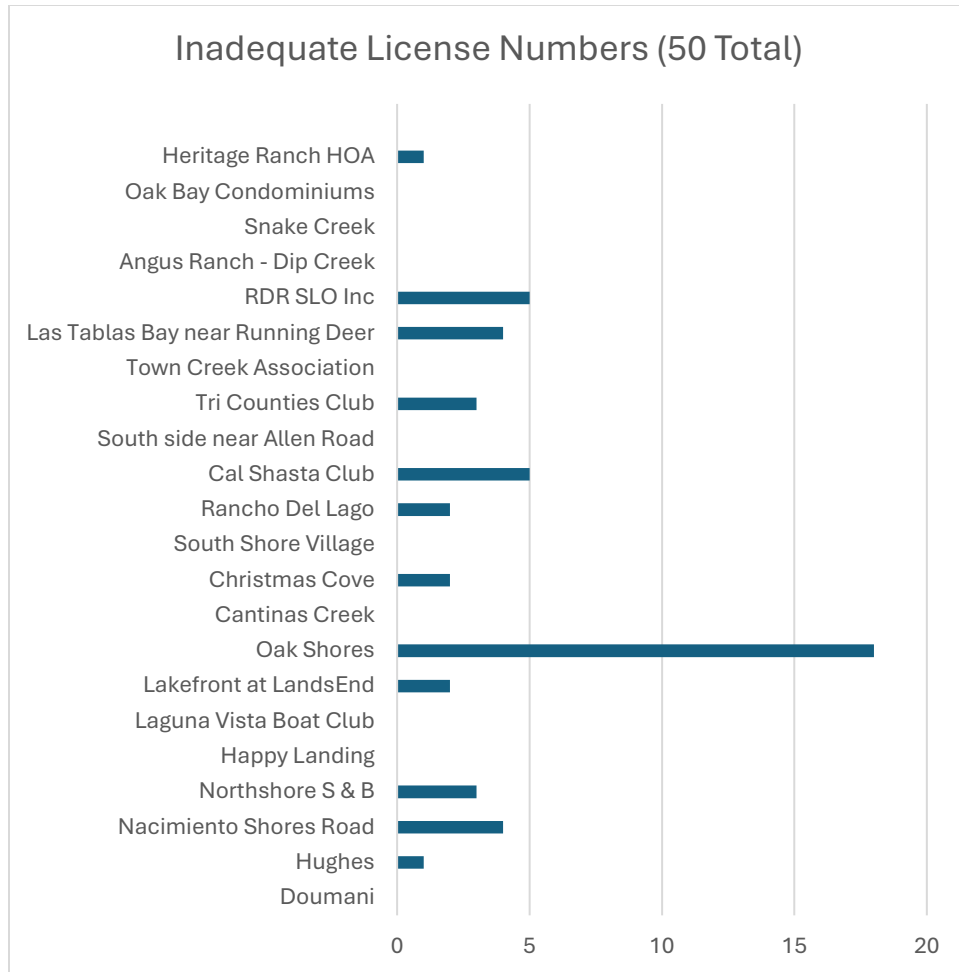
This issue was identified across nearly all the 22 geographic regions, with the highest totals being in Oak Shores, Cal Shasta Club, and RDR SLO Inc. It is important to note that these clubs also have the largest total number of docks. Detailed totals are provided below. Moving forward, the objective is to achieve 100 % accuracy in future inspection audits.

Figure 7 - Results of license identification numbering issues for each location.

The absence of properly posted boat dock license numbers significantly hampers our ability to accurately identify docks during on-site inspections. This often results in extensive efforts to review historical, cataloged photographs to establish a match, which can be time-consuming. Following the 2025 inspection, considerable time was dedicated to identifying docks with insufficient license number postings. It is essential to implement corrective measures to resolve the issue.

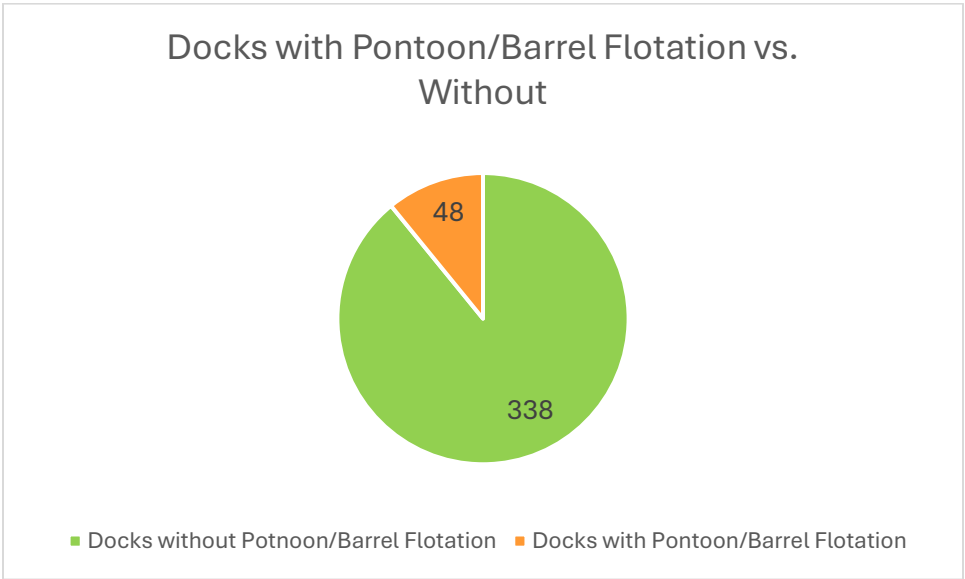
Approximately 12% (48) docks utilize pontoon or barrel-style floatation, which the Agency aims to phase out due to potential safety concerns related to dock and reservoir integrity. The following table compares these figures to the total docks on the reservoir:

*Figure 8 - Results of pontoon and barrel flotation at each location.*

3. PONTOON. Dock owners utilizing pontoon or barrel flotation are advised that the Agency will be gradually discontinuing this flotation method in the future., Please proactively plan and arrange for the replacement of such flotation systems accordingly.

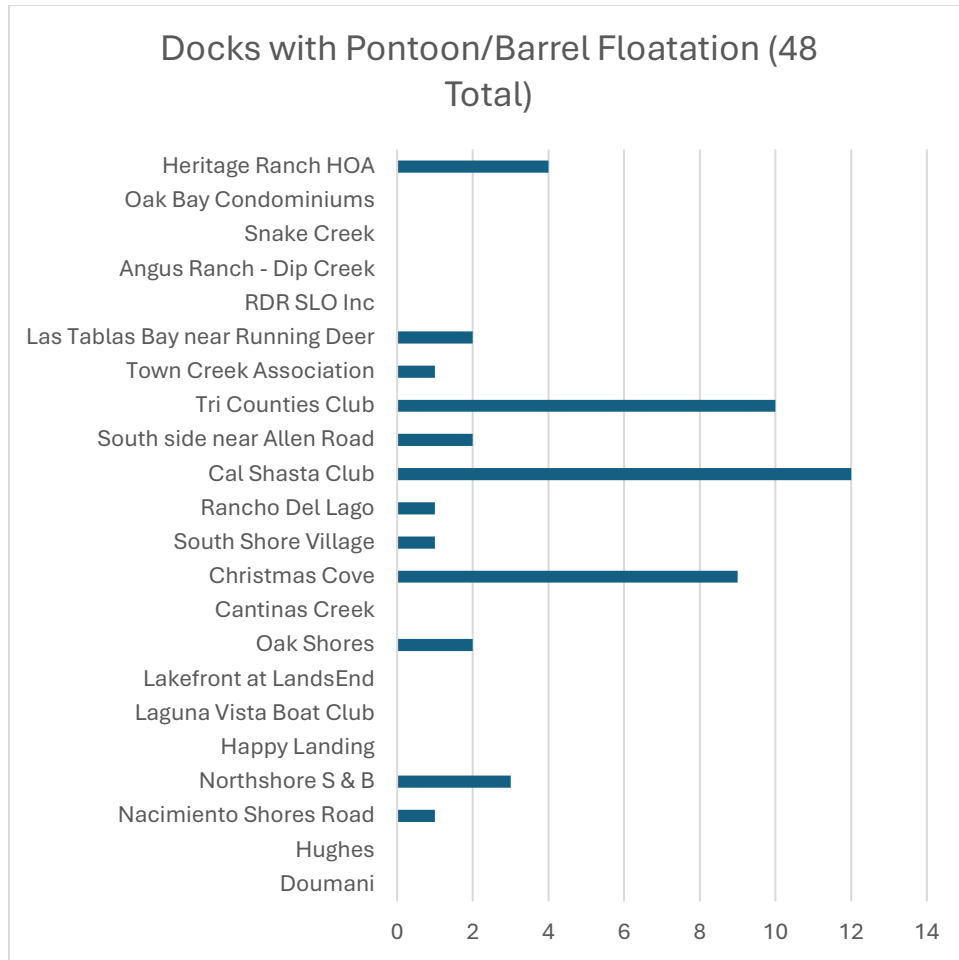
*Figure 9 - Results of pontoon and barrel flotation for each location.*

The highest concentrations of this type of flotation were observed at Cal Shasta Club, Tri Counties Club, and Christmas Cove. Although these locations feature some of the larger number of total docks, many of their docks are among the oldest and are in relatively poor condition, with some utilizing pontoon or barrel flotation. For example, Christmas Cove, has a total of 19 docks, of which 9 (47%) of them have pontoon or barrel floatation. In areas most affected by low reservoir levels, the docks generally tend to be of an older design, as they experience less frequent movement and therefore are not prioritized for upgrades by owners.

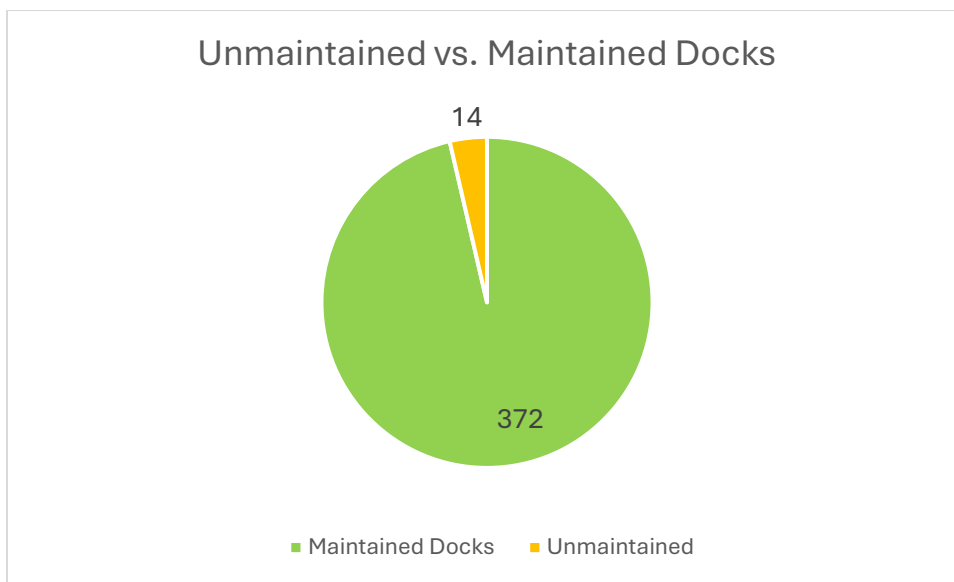
Additionally, this category encompasses docks that are deemed abandoned. At total of 14 docks, representing 3.5% of those that were surveyed, were classified within this category. The detailed totals are provided below.

Figure 10 – Comparison of maintained and unmaintained docks.

4. UNMAIN. Dock structures exhibiting compromised structural integrity should be retrieved and securely dismantled. Identified issues include inadequate mooring, deteriorated decking conditions, and decayed or disintegrated materials.

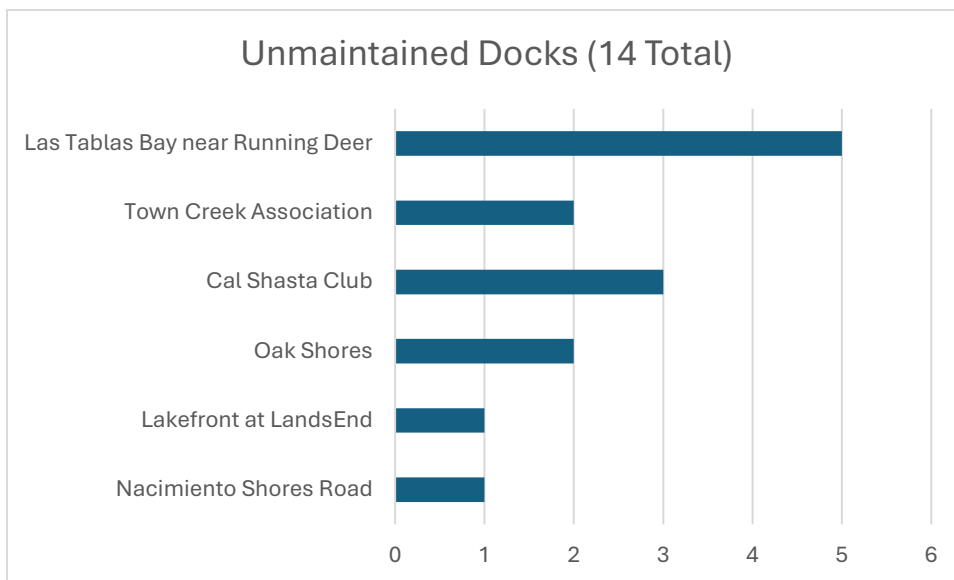
Figure 11 - Results of pontoon and barrel flotation for each location.

The highest concentration of unmaintained docks was identified in Las Tablas Bay near Running Deer, where 18.5% of the total 27 docks are unmaintained. Although this issue area has the lowest number of docks compared to locations with unencapsulated foam, insufficient licensing, or pontoon and barrel floats, these unmaintained docks still present potential risks to reservoir resources and users. Implementing corrective measures is recommended to address these concerns.

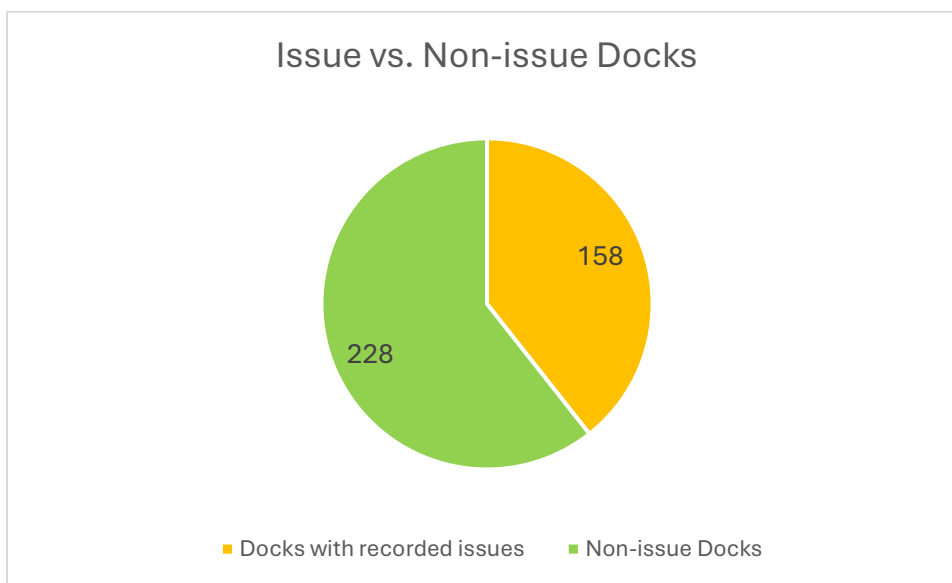
*Figure 12 - Results of docks with reported issues compared to those without.*

A total of 158 docks (41%) were identified as having at least one notable issue during inspection or subsequent photo review. These concerns placed the docks into one or more of the four identified issue categories. As anticipated, several docks with structural deficiencies also exhibited difficulties with, or absence of, proper license number posting, resulting in multiple category classifications. As shown in the table below, 41% of docks were identified having issues in one or more of the four categories discussed. Specifically, 28% exhibited structural concerns, while 15% had inadequate license number postings. Some docks were affected by both structural issues and license posting deficiencies, which accounts for the combined percentage 41%.
