# Krimson Coast Holdings Residence

# 36240 Highway One Forest Management Plan

September 27, 2023

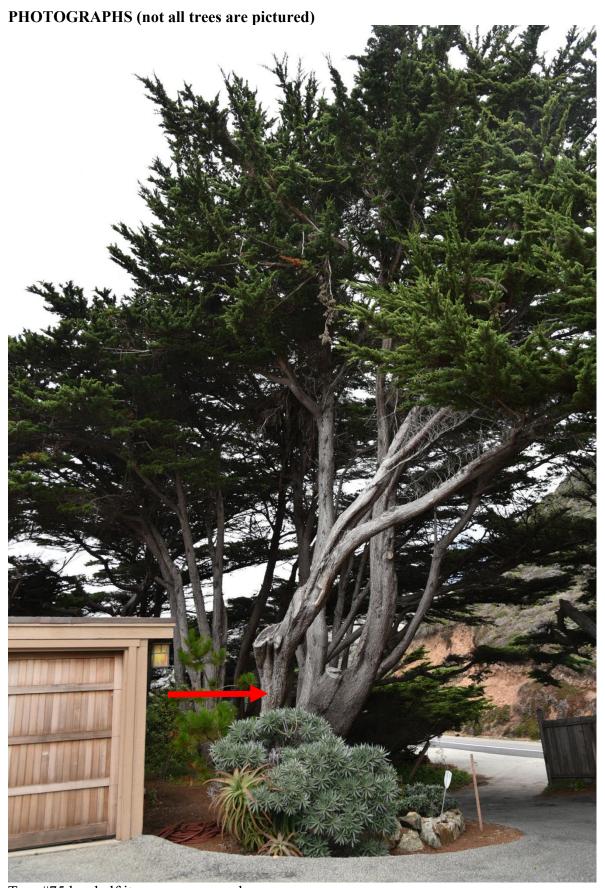
- Six trees are proposed for removal to accommodate construction:
  - #75 is a 43" diameter cypress tree within the new footprint, this tree is in fair health but has poor structure and has half its crown already removed.

Tree #75 has half its crown removed

Trees #75, #78, #82, #85, #86, and #87 will need to be removed for the new structure and the driveway.

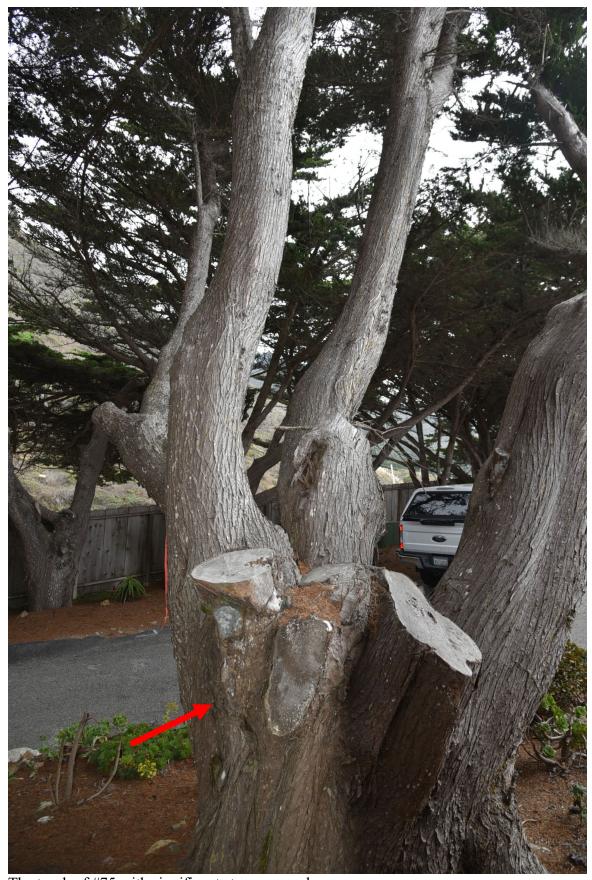
The trunk of #75 with significant stem removal

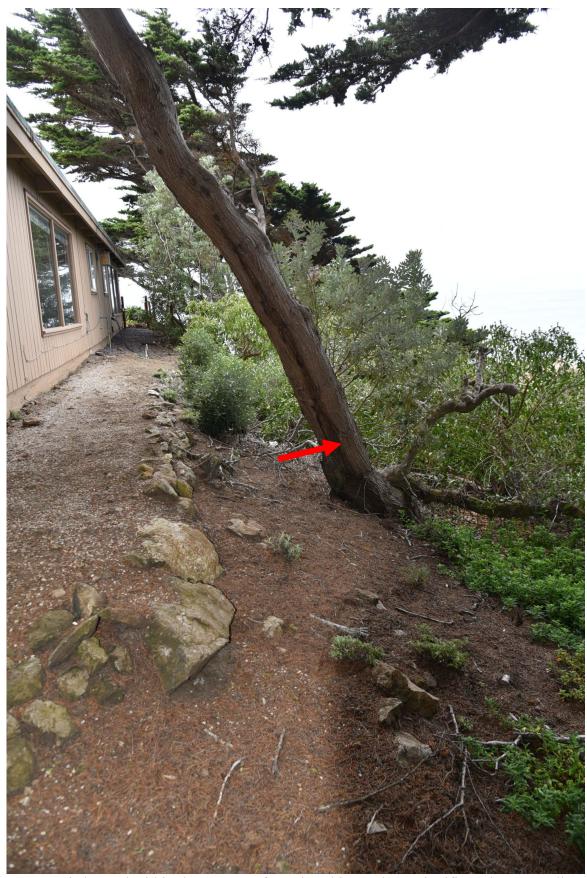
- #85 is a 15" diameter cypress tree within the new footprint. It has a severe lean and poor structure.
  - #86 is a 32" diameter cypress tree within the footprint and also has poor structure and well-developed lean.

Tree #85 is located within the structure footprint; this tree has a significant lean as well as other adjacent trees.

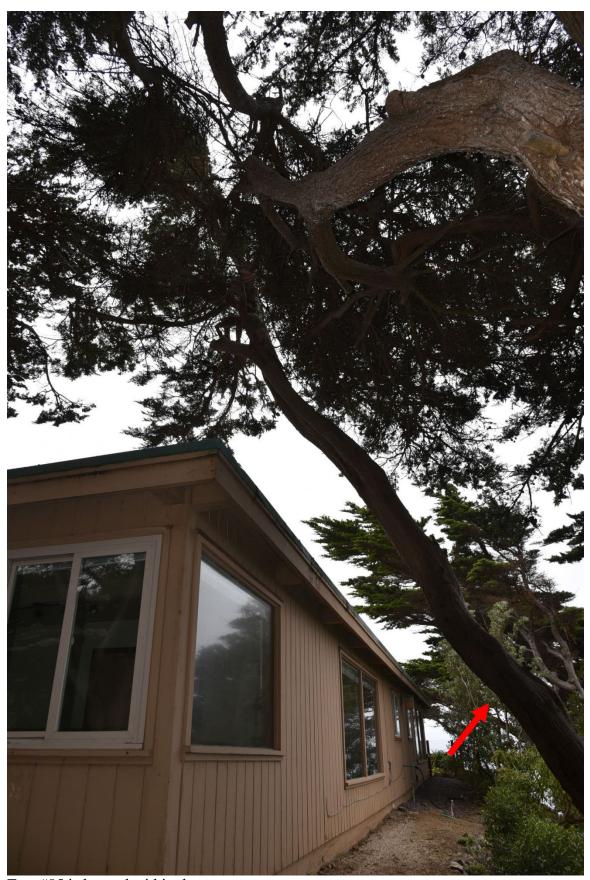
Tree #85 is located within the structure

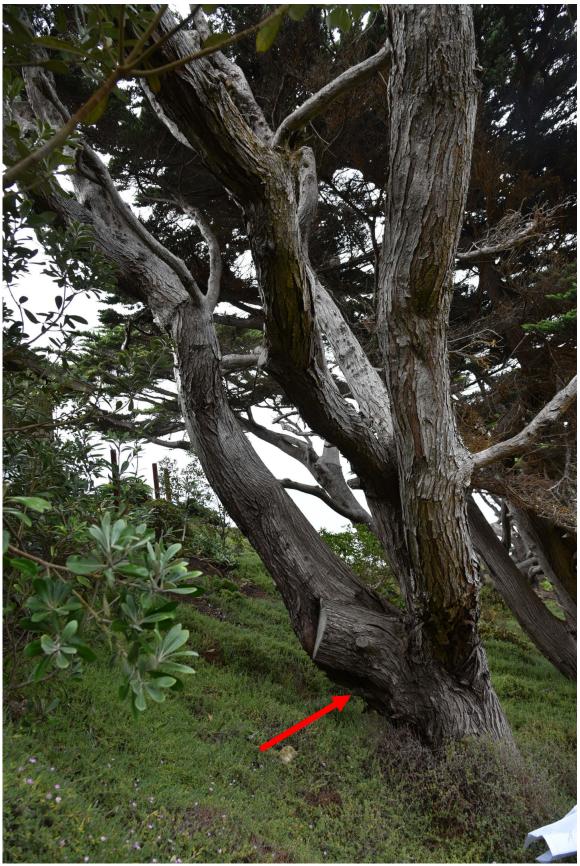
Tree #86 is a 32" diameter cypress. The tree is in the footprint as well as tree #87. Both trees have significant leans and are already recipients of large limb removal.

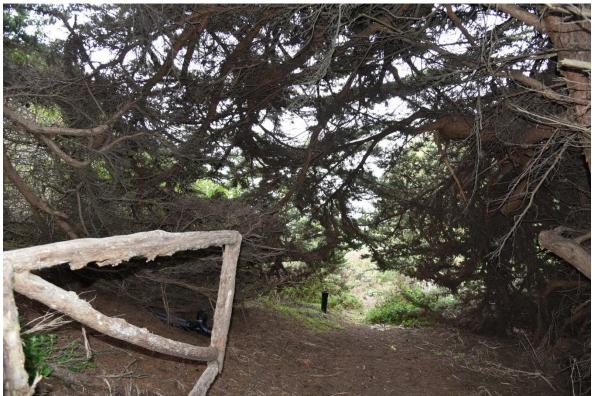
The footpath where the ADU driveway is to be constructed will require pruning of dead wood and over-extended limbs.

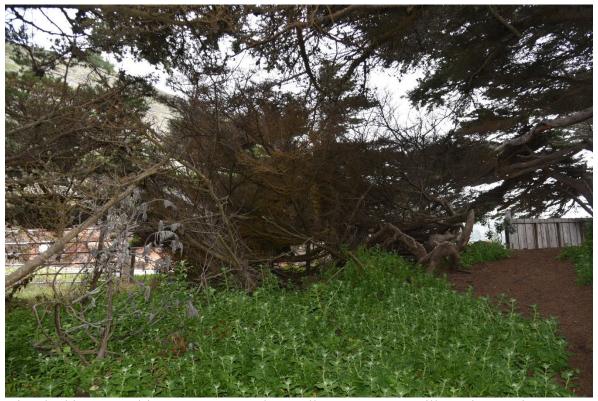
View looking up to driveway entrance, the small cypress grove will require pruning

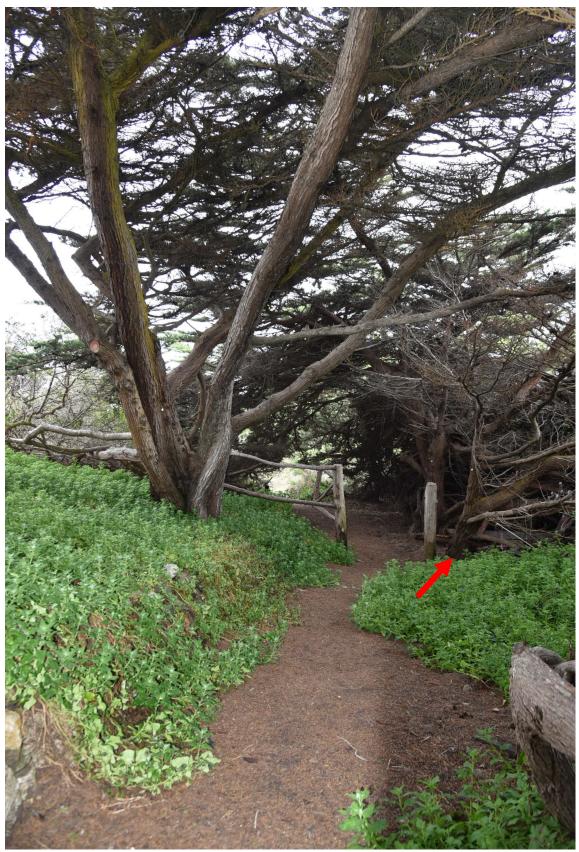
View looking down from the driveway entrance toward the proposed ADU site. This will require pruning of several larger diameter limbs for access on the right. Trees #78 and #82 are to the left of the pathway and will need to be removed to accommodate the driveway.

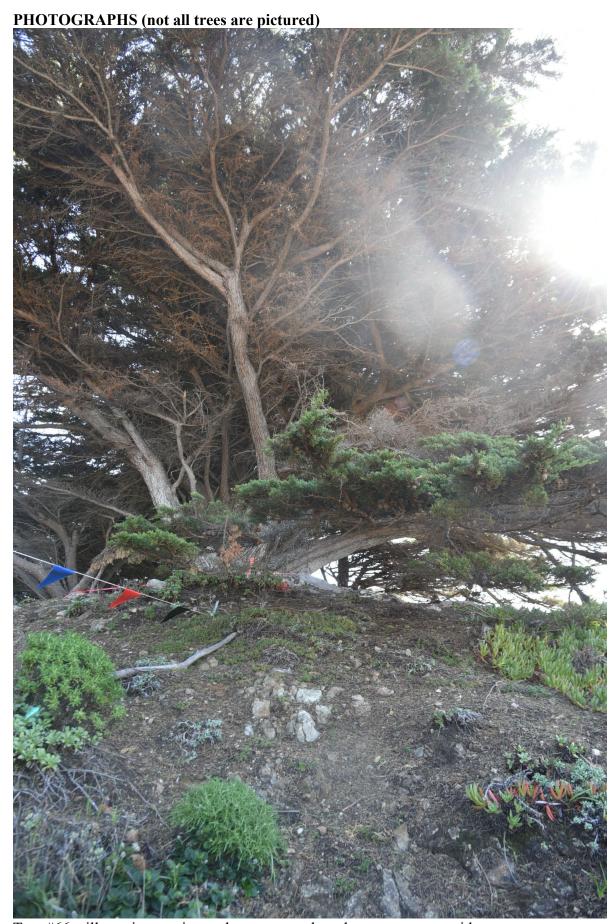
Tree #66 will require pruning and root removal on the new structure side.

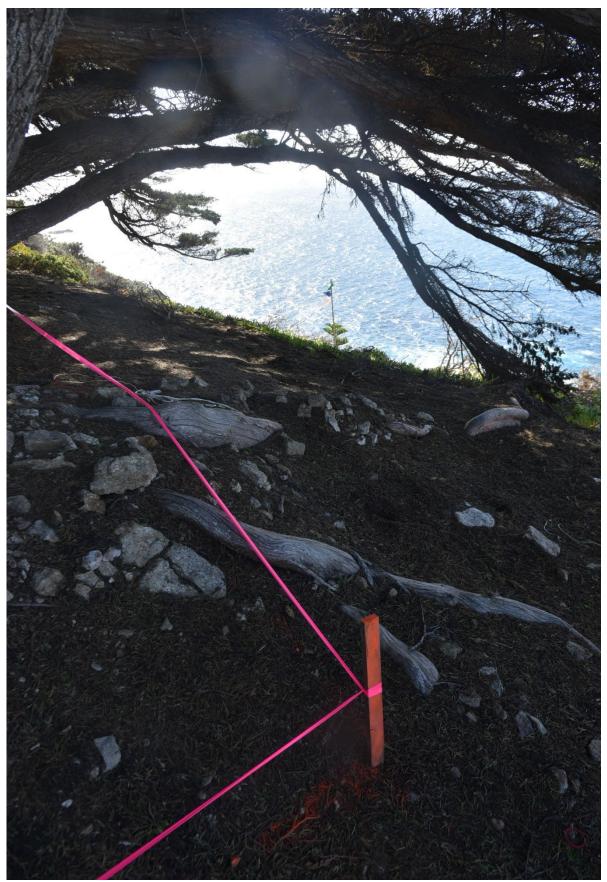
#66. Significant surface roots will need to be severed to accomplish grading for the structure. The tree will require monitoring during excavation.

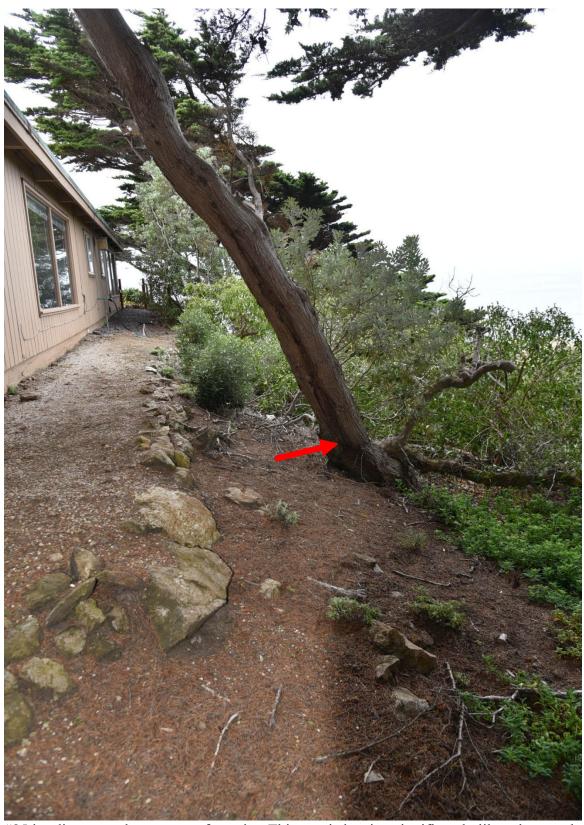
#85 is adjacent to the structure footprint. This tree is leaning significantly like other nearby trees. This tree is to be retained, however, because grading will be close to its roots, it will require judicious root pruning and monitoring.

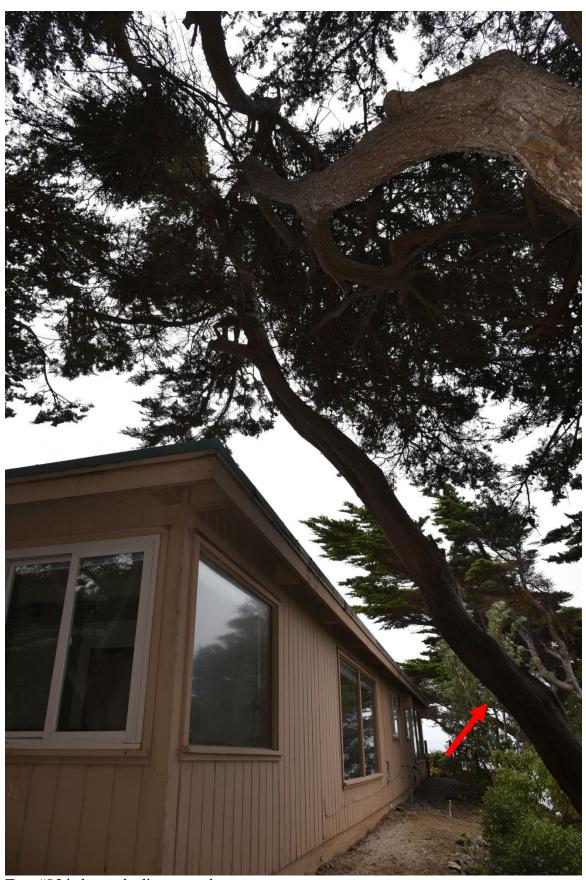
Tree #85 is located adjacent to the new structure

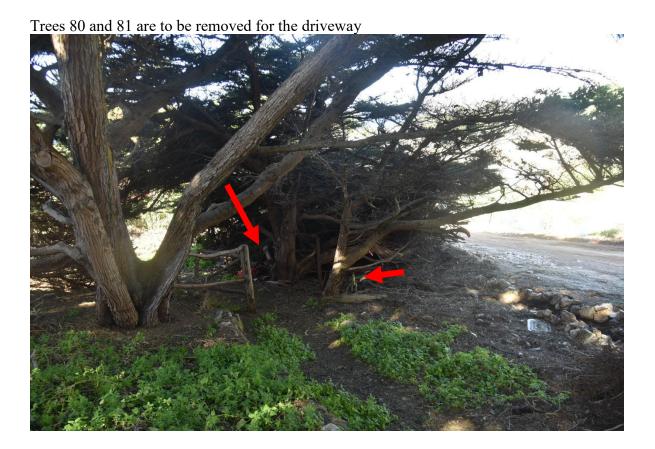
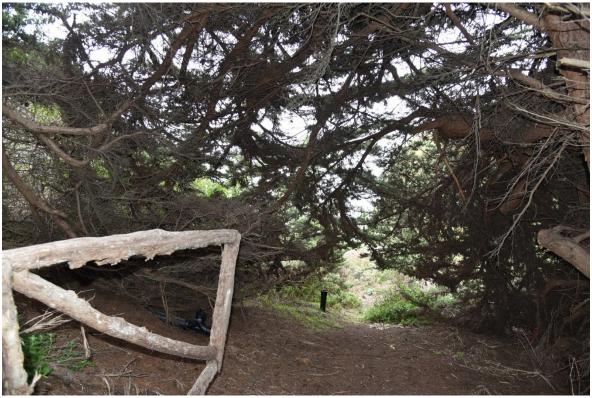
The footpath where the driveway will be constructed. It requires pruning of dead wood and over-extended limbs.
