GEOLOGIC EVALUATION OF COASTAL BLUFF EROSION
at 62 YANKEE POINT DRIVE
CARMEL, CALIFORNIA

File No. G-907.1

Project: **Proposed Studio, New Detached Garage, New Bathroom Addition by Enclosing an Existing Patio, New Solar Array and Improvements**
62 Yankee Point Drive
Carmel By-The-Sea
Monterey County, California

Subject: **Geologic Evaluation of Coastal Bluff Erosion**

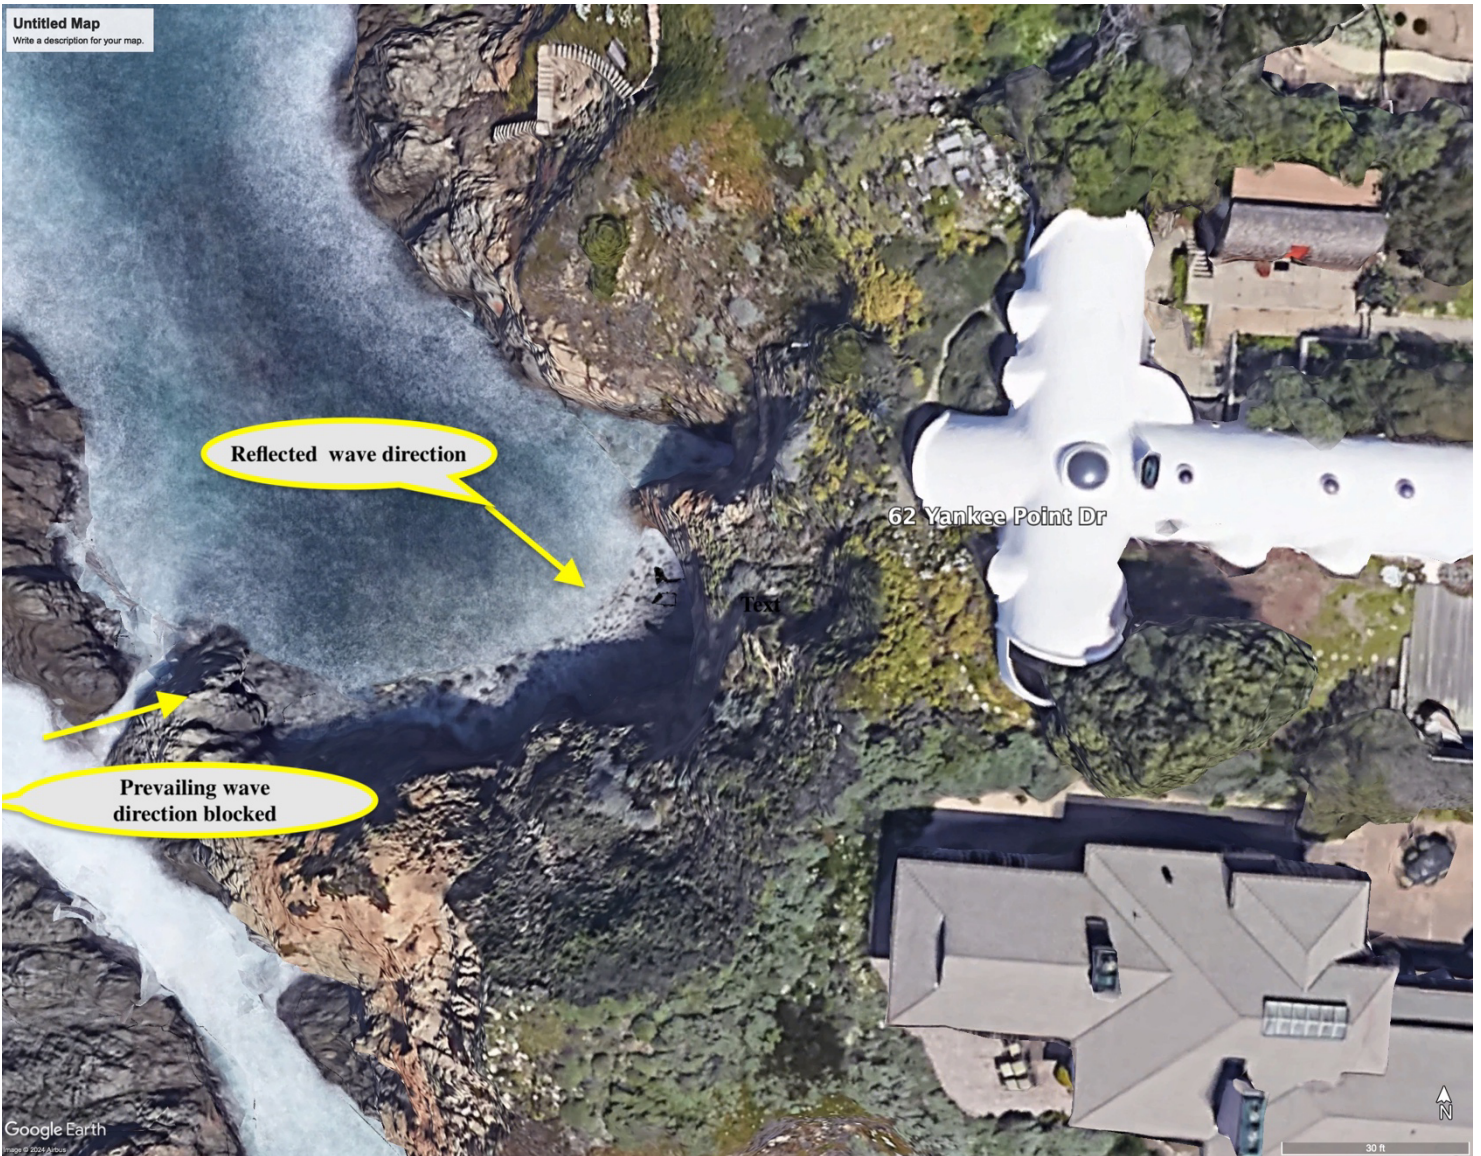
Photo Plate 2

Granodiorite bedrock is exposed extensively throughout the cove at the west property line where it forms a platform which extends about 30 feet up from the high tide line near the base of the bluff in the cove. The bedrock is overlain by a 28 to 35 foot thick layer of terrace deposits, with the terrace deposits becoming thicker toward the east. Where exposed the bedrock is typically of a hard condition (competent) but contains northerly trending, steeply inclined joint sets with medium to close spacing. The orientation of these through-going joint sets is generally favorable in terms of bluff stability. The bedrock is moderately-severely weathered. Surf action over thousands of years has produced a series of westerly and northwesterly trending, small alcoves along the granitic cliff face. The bedrock has spalled along these joint sets due to this surf action and these alcoves most likely took thousands of years to form. There is an extensive, northwesterly trending granitic outcrop extending out into the ocean directly in front of the pocket cove and bluff that borders the west property line (see Photo Plate 1). This outcrop provides a barrier between the bluff face and the more energetic waves coming from the southwest and west. In fact, waves that extend into the small pocket cove receive waves that “feel bottom” and curve around the resistant outcrop or occasional waves that come from the northwest (see Photo Plate 2).

In the immediate area of the site, large outcrops (ledges and “haystack rocks”) of granitic bedrock form a partial barrier to surf action along the oceanside of the small pocket cove located in front of the bluff face. This bedrock barrier tends to dissipate the energy of incoming waves, which must wrap around the outcrop in order to enter the small cove. In storm surge the waves crash over the bedrock platform which also dissipates some of the wave energy. Because of these localized conditions, it is our opinion that the estimates of coastal erosion quoted above (“PWA,” 2009) are unrealistic for the immediate area of the subject site. A site-specific evaluation is relevant and instructive in this scenario. Available historic aerial photos extending over a period between 1929 and 2023 were reviewed as part of our work. Although these photos are of a resolution that makes precise determinations difficult, we note that pre-development photos (1929 through mid 1960’s) and post development photos (post late 1960’s) suggest a bluff retreat of approximately 3 to 4 feet at the bluff face over the period covered by the photos (94 years). This suggests an erosion rate of between 3 feet per hundred years to 4 feet per hundred years. Although sea level rise would be expected to increase the wave runup at the coast, we note the large barrier outcrops, and the height and resistant nature of the bedrock platform underlying the bluff is such that the wave runup would not be expected to increase the risk of coastal erosion at the site during the design life of improvements (typically 50 years).

Aerial imagery (2023) showing the pattern of prevailing wind driven surf (toward the east and northeast) and large bedrock outcrops which provide a buffer between the waves and the bluff. Surf within the alcove is largely from reflection of waves off of nearby outcrops. Source: Google Earth

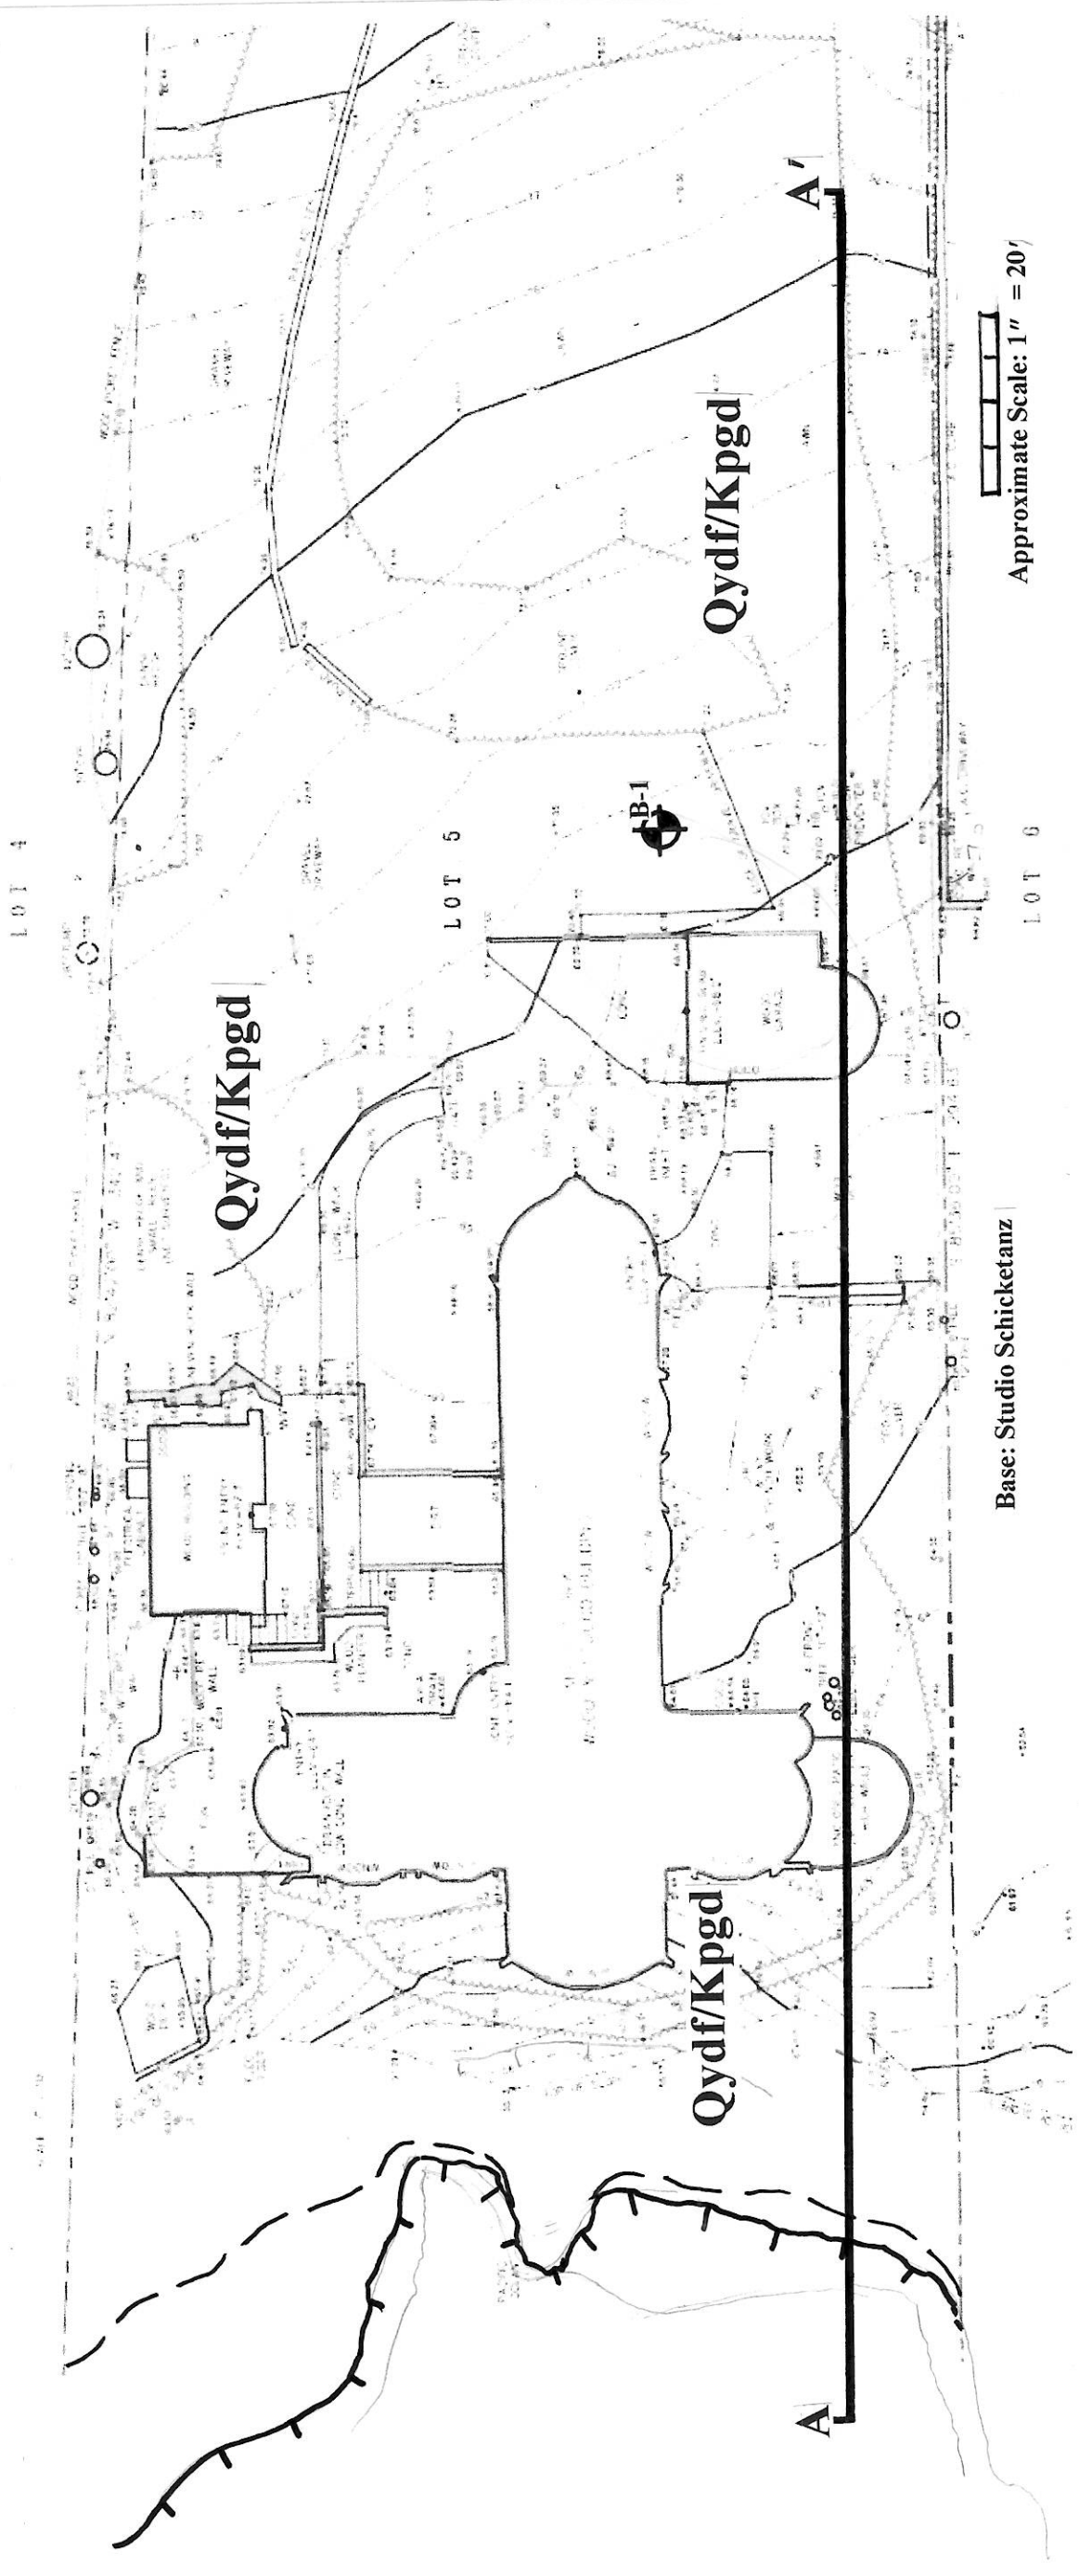
The project site is located within the Yankee Point coastal area, approximately 4 miles south of Carmel, Monterey County, California (see Site Location Map). The site is located on the west side of Yankee Point Drive and is accessed by a gravel driveway which extends directly into the property from the east property line. The site contains an existing residence, a small detached guest house, a detached garage, and miscellaneous landscaping, wood fences and decks, all of which were constructed some decades ago beginning in the late 1960's. As the residence was built in 1968 (Calif. Dept. of Parks and Rec, 2021) there are geotechnical or geologic reports available for the establishment of the original residence. The site occupies a very gently inclined (westerly dipping) marine terrace surface and is bordered on the west by a nearly vertical coastal bluff. A small marine "pocket cove" exists at the base of the cliff. The overall topographic relief between the bluff crest and the base (at 4 feet MSL) is about 58 feet. The Site Geologic Map (Appendix A) shows some of these described features.

The attached Site Geologic Map and Geologic Cross Section shows these geologic features and inferred geologic relationships.
