THOMPSON
WILDLAND MANAGEMENT

February 14, 2024

Subject: 12 Arroyo Sequoia (Lot 96) Pre-construction Tree Impact Assessment

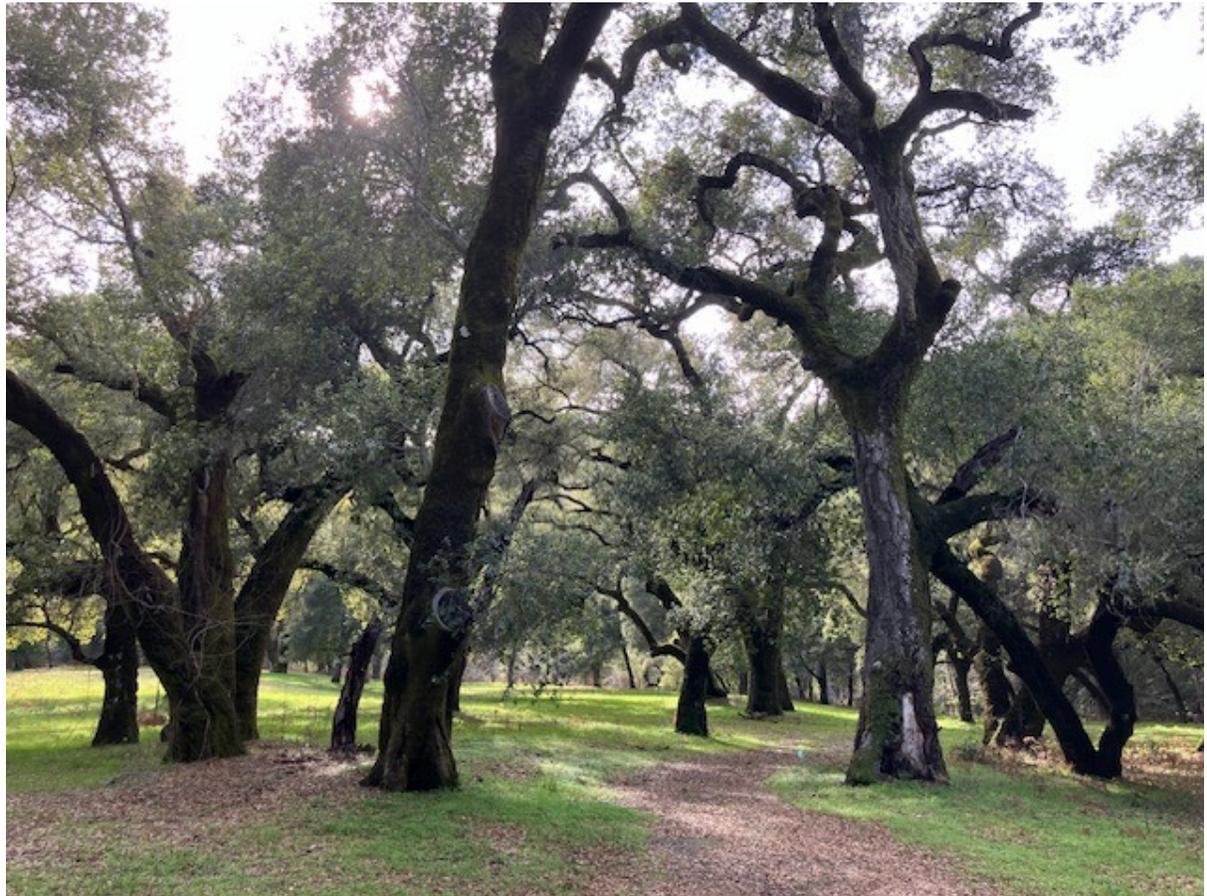
Figure 2. Photo taken from existing paved driveway heading into Homeland past several large and aging oaks. Trees will be retained and protected.

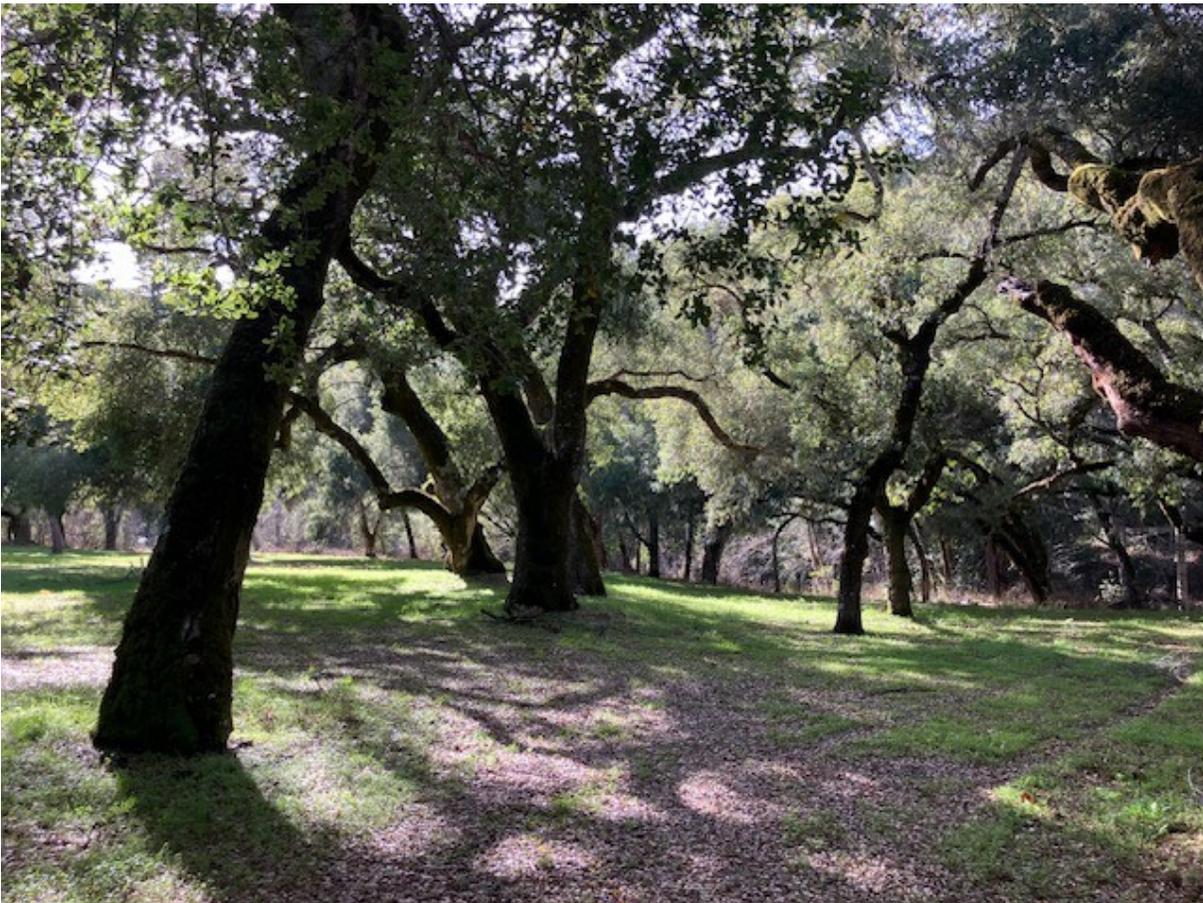
Figure 4. View of proposed looped driveway area entering Homeland. Oaks visible in photo are Tree# 403 (left foreground) and Tree#s 408-412 in center background. Trees will be retained and protected.

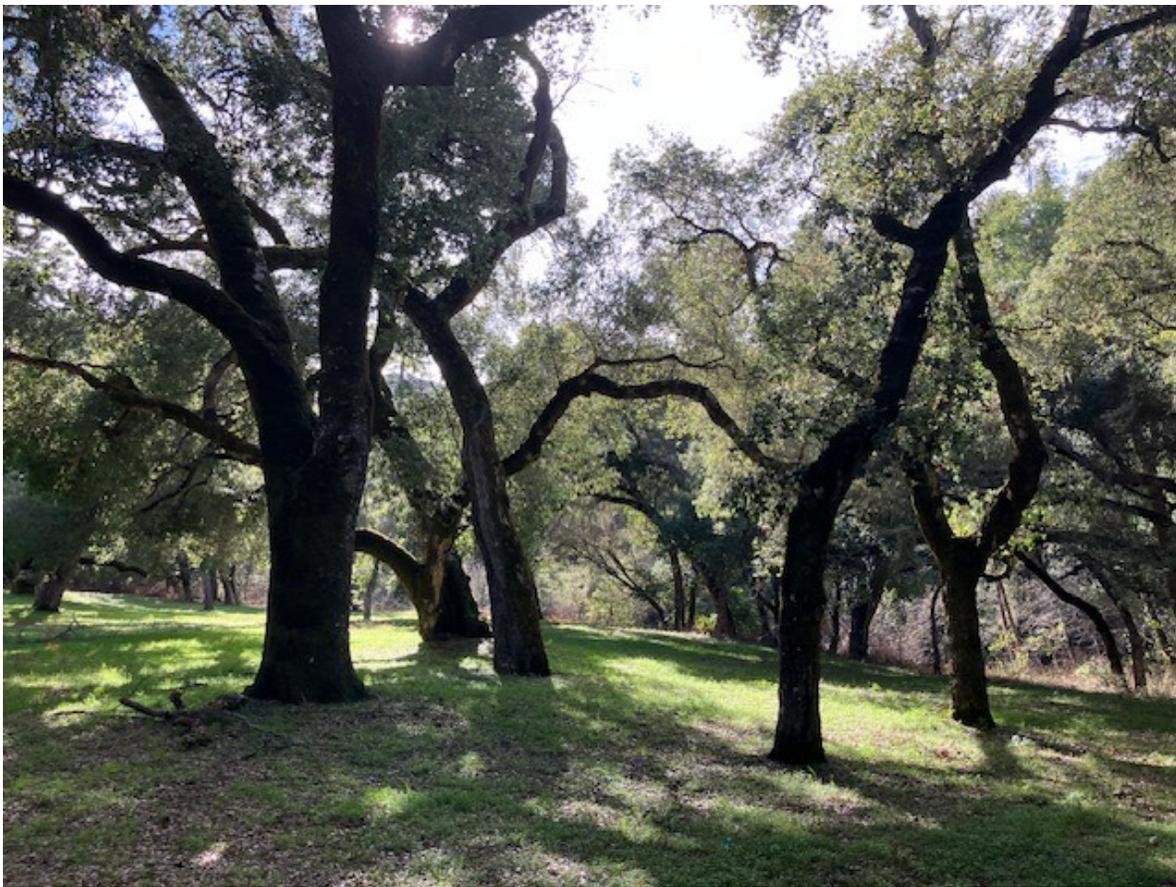
Figure 5. Another view of oak grouping (right to left Tree#s 408-412) that will be located in center of proposed circular permeable surfaced driveway. Trees will be retained and protected.

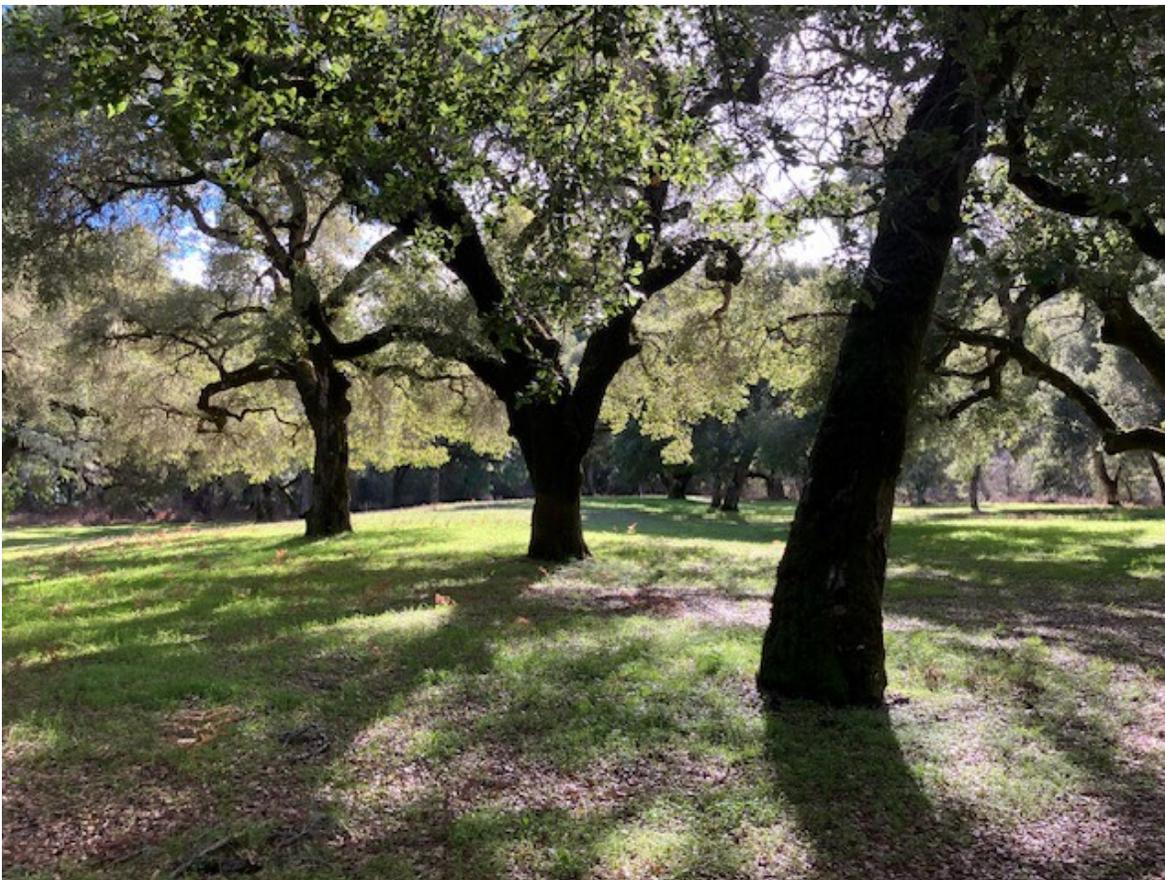
Figure 7. Entering oak savanna Homeland looking towards proposed homesite. Tree#s 403 (foreground), 413 & 414 are primary oaks seen in photos. Trees will be retained and protected.

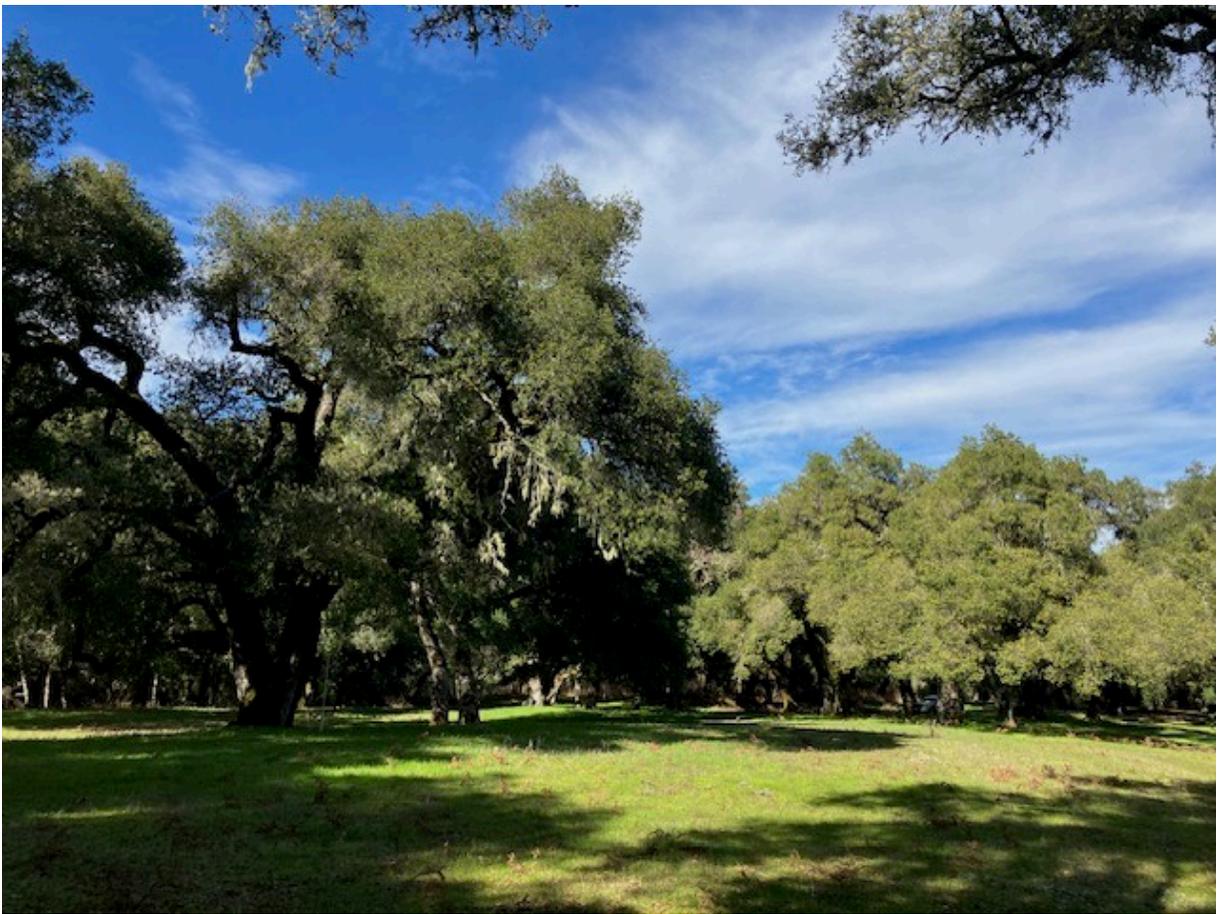
Figure 11. Oaks identified as Tree#s 428-430 are visible to the left of proposed homesite. Trees will be retained and protected.

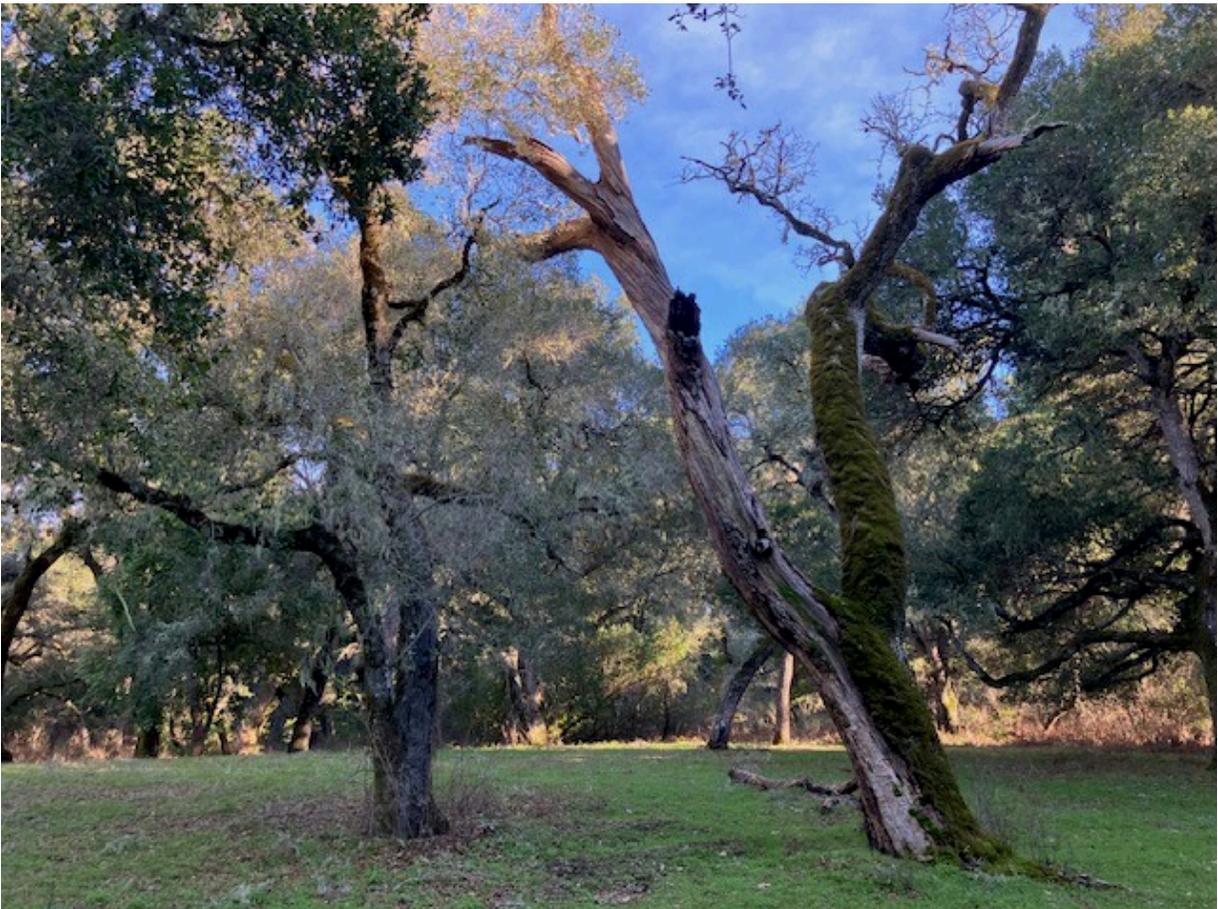
Figure 14. Dead valley oak snag to the right (next to Tree#435 to the left) is not a hazard concern and should be retained for habitat.

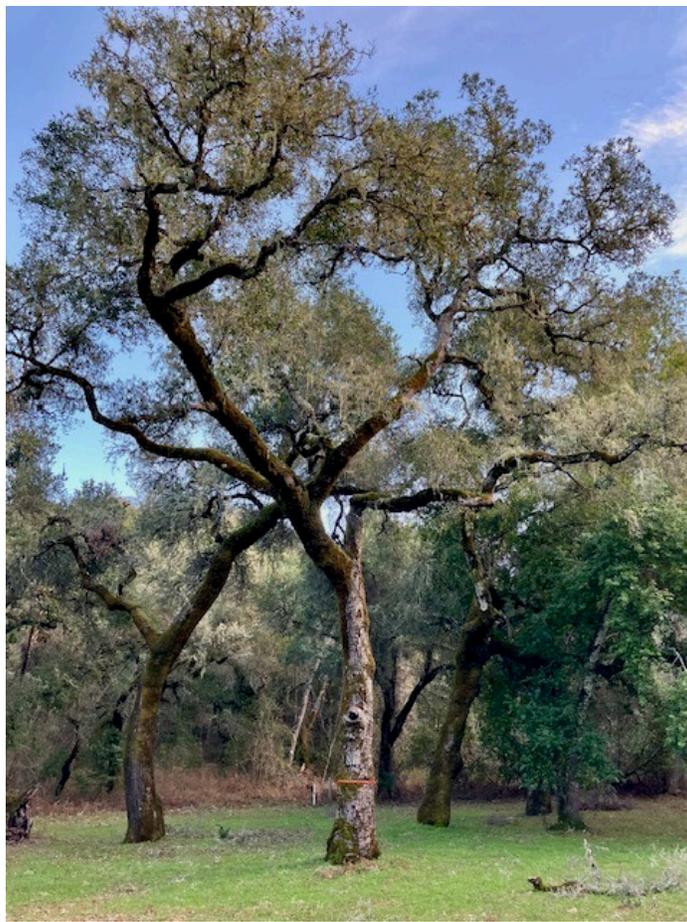
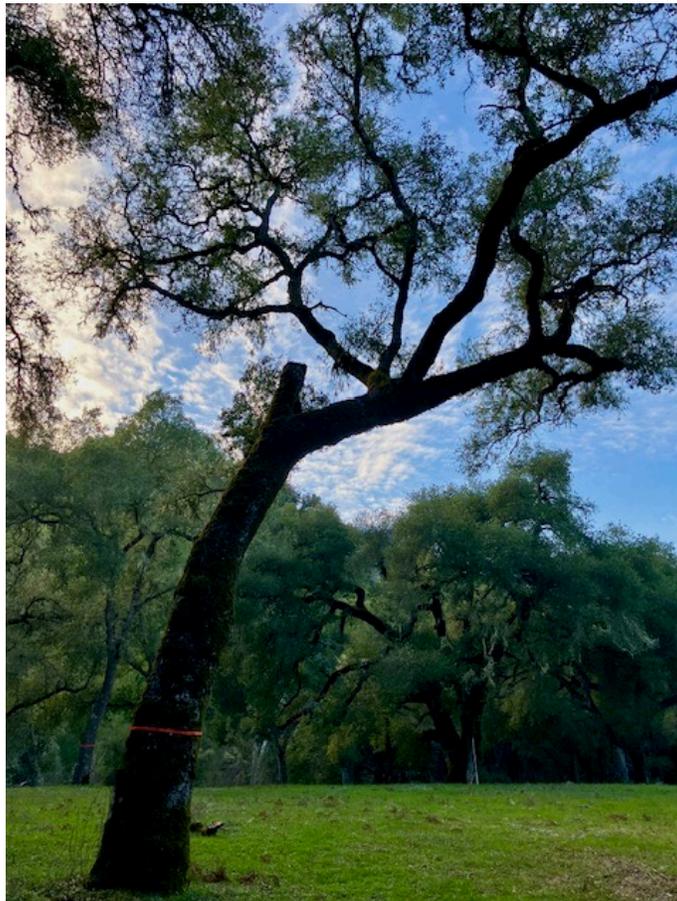
- 1) *Tree#421* is a 34 inch DBH coast live oak that is located directly adjacent to the building footprint for the main house and will need to be removed due to construction impacts (refer to *Figures 15 & 16*). This tree is in fair physiological health and poor structural condition. Structural deficiencies include a significant natural lean, poor canopy balance and symmetry, a co-dominant stem attachment in the upper stem and visible decay features. Plant 5 replacement trees to support and sustain woodland health and character and to satisfy County tree removal permit requirements.

Figure 15. The declining coast live oak identified as Tree#421 is proposed for removal due to construction impacts.

Figure 16. Another view of the declining and leaning Tree#421 that has visible decay and poor balance and symmetry.

For the reasons provided in this report, permission is being requested to remove a total of 3 coast live oak trees (identified as *Tree#s 421, 426 & 427*) in preparation for proposed property development activities (refer to *Figures 15-19* and the corresponding *Exhibit A: Tree Location Map* and *Exhibit B: Tree Impact Assessment Spreadsheet*). In regards to tree replacement, 11 coast live oak mitigation replacement trees will need to be planted in the Homeland and survive a 5-year monitoring period to comply with Monterey County tree removal permit conditions for the 3 oaks proposed for removal.

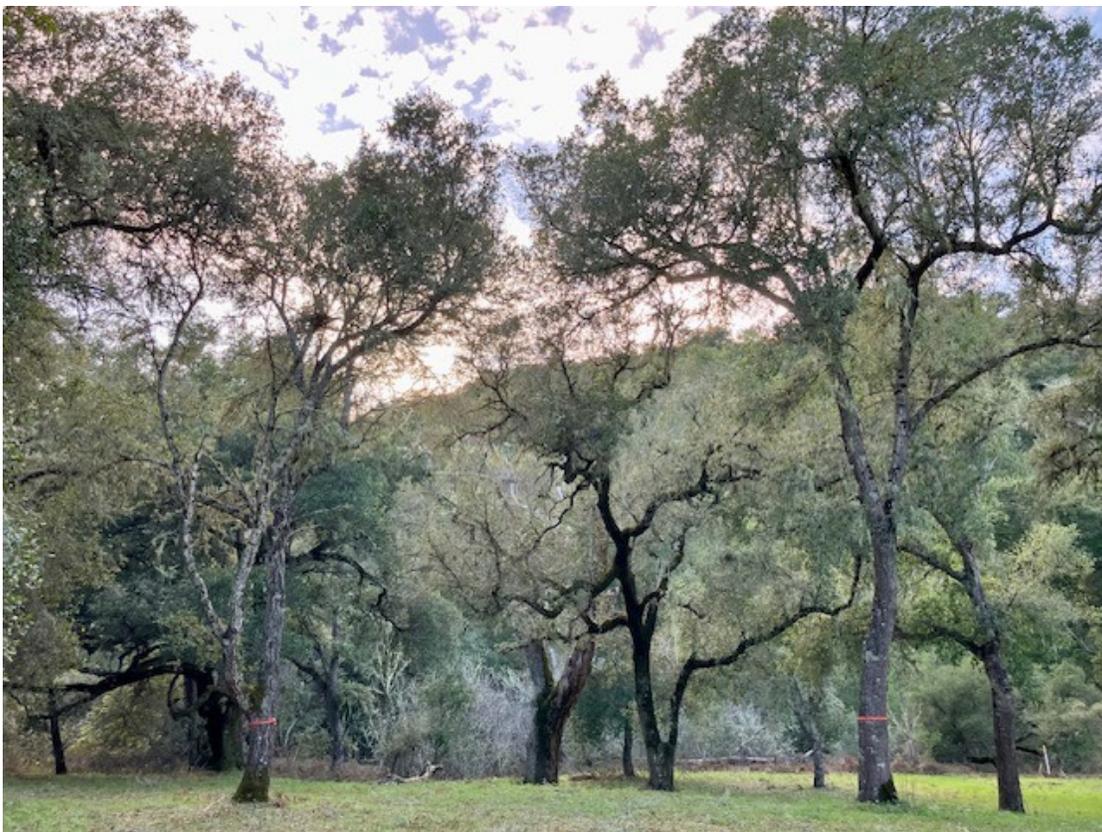
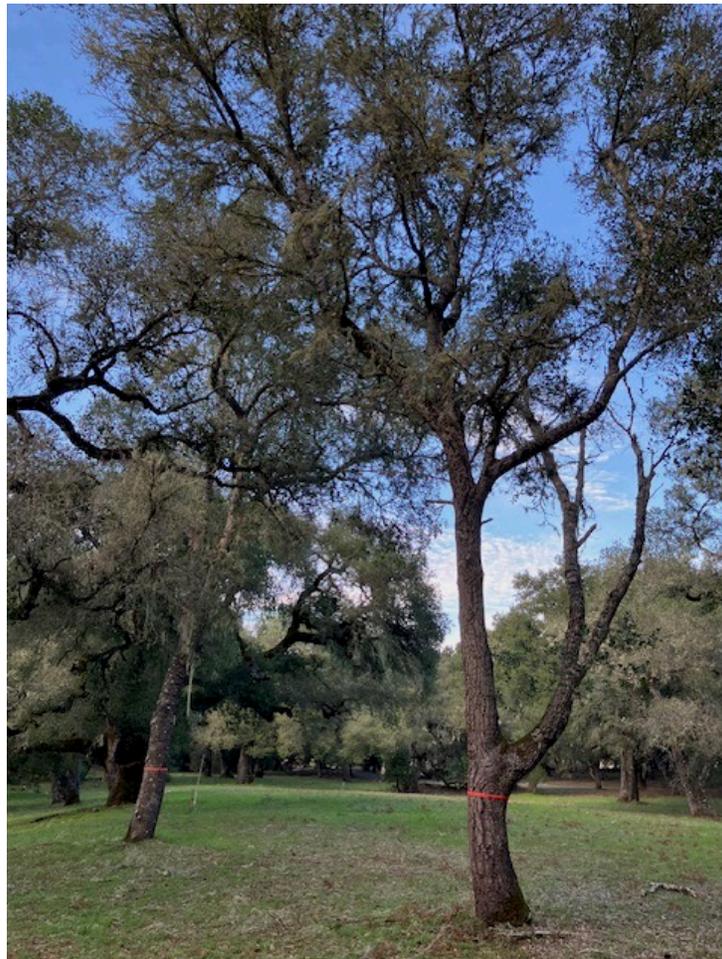
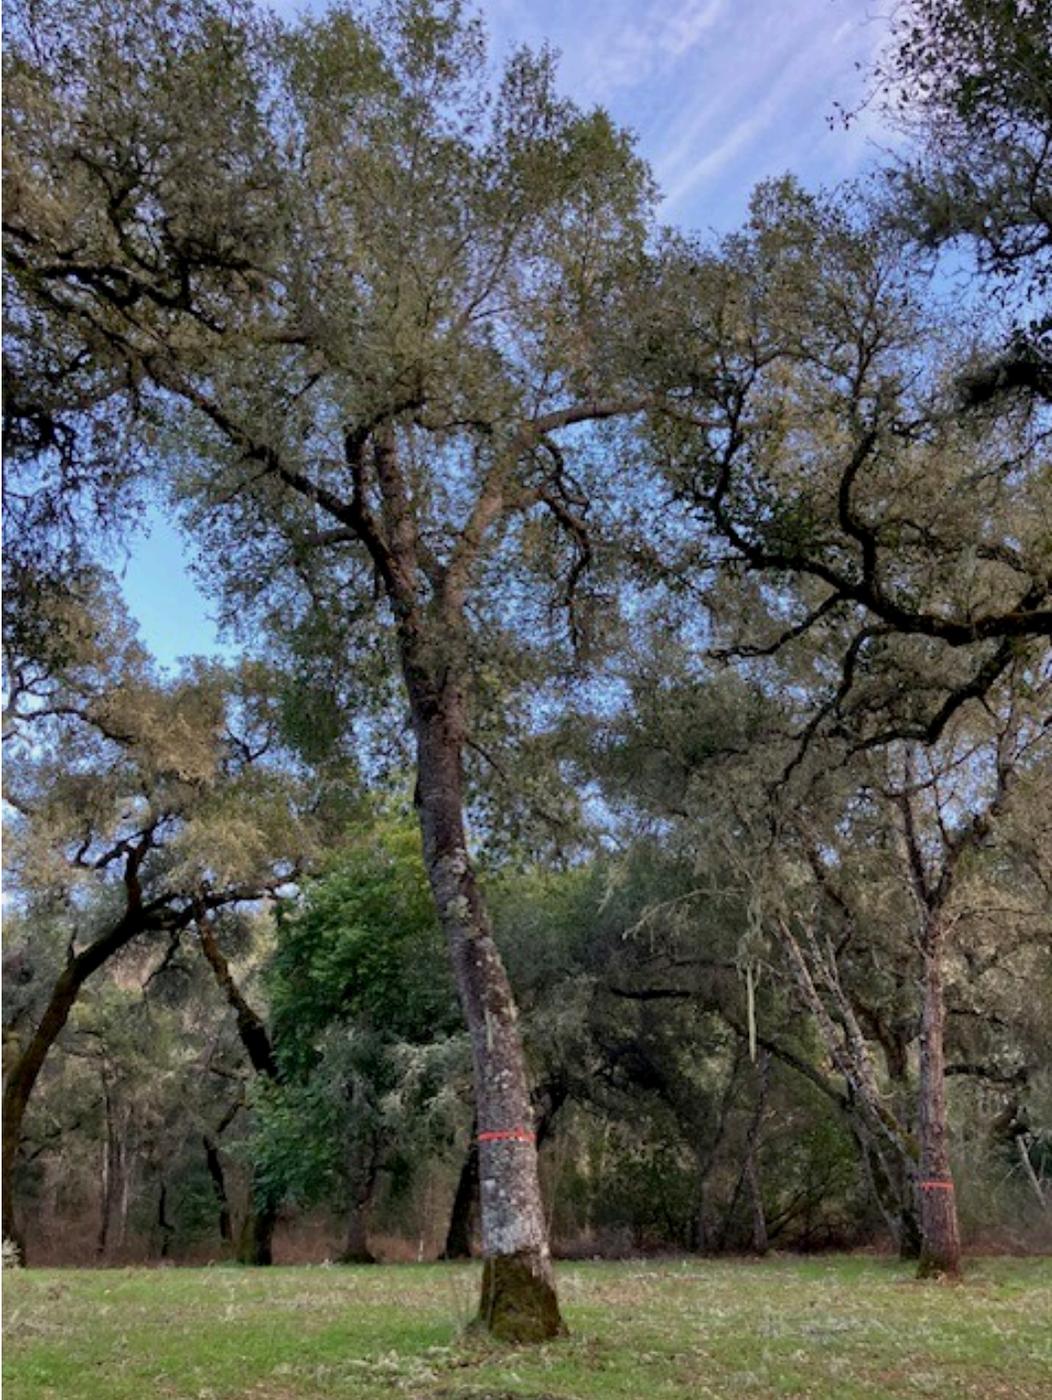
- 2) *Tree#426* is a 19 inch DBH coast live oak that is also located directly adjacent to the building footprint for the main house and will need to be removed due to construction impacts (refer to *Figures 17-19*). This oak tree is generally in fair physiological health and structural condition with no significant health disorders and/or structural defects observed. If there is interest, this tree may be a good candidate for transplanting using proper equipment, such as a tree spade. Plant 3 replacement oak trees to support and sustain woodland health and character and to satisfy County tree removal permit requirements.

- 3) *Tree#427* is a 18 inch DBH coast live oak that is located within the construction footprint for the main house (refer to *Figures 17-19*). This oak tree is generally in fair physiological health and structural condition with no significant health disorders and/or structural defects observed. Plant 3 replacement trees to support and sustain woodland health and character and to satisfy County tree removal permit requirements.

Figure 17. Two coast live oaks identified as Tree#s 426 (to the left marked with orange flagging tape) and #427 (to the right marked with orange tape) are proposed for removal due to construction impacts.

Figure 18. Tree#426 is right of center in foreground and #427 is in left background. Both trees are proposed for removal.

Figure 19. Tree#427 is in center foreground and #426 is in right background. Both oaks are in fair to good health and are proposed for removal due to construction impacts.
