# Tree Assessment/ Construction Impact Analysis 3 Wild Turkey Run

Ono Consulting  
International Society of Arboriculture  
Certified Arborist Municipal Specialist  
Board Certified Master Arborist #WE-9388BM  
ASCA Registered Consulting Arborist #744  
Society of American Foresters Professional Member  
PO Box 508  
Pacific Grove CA, 93950

November 25, 2022

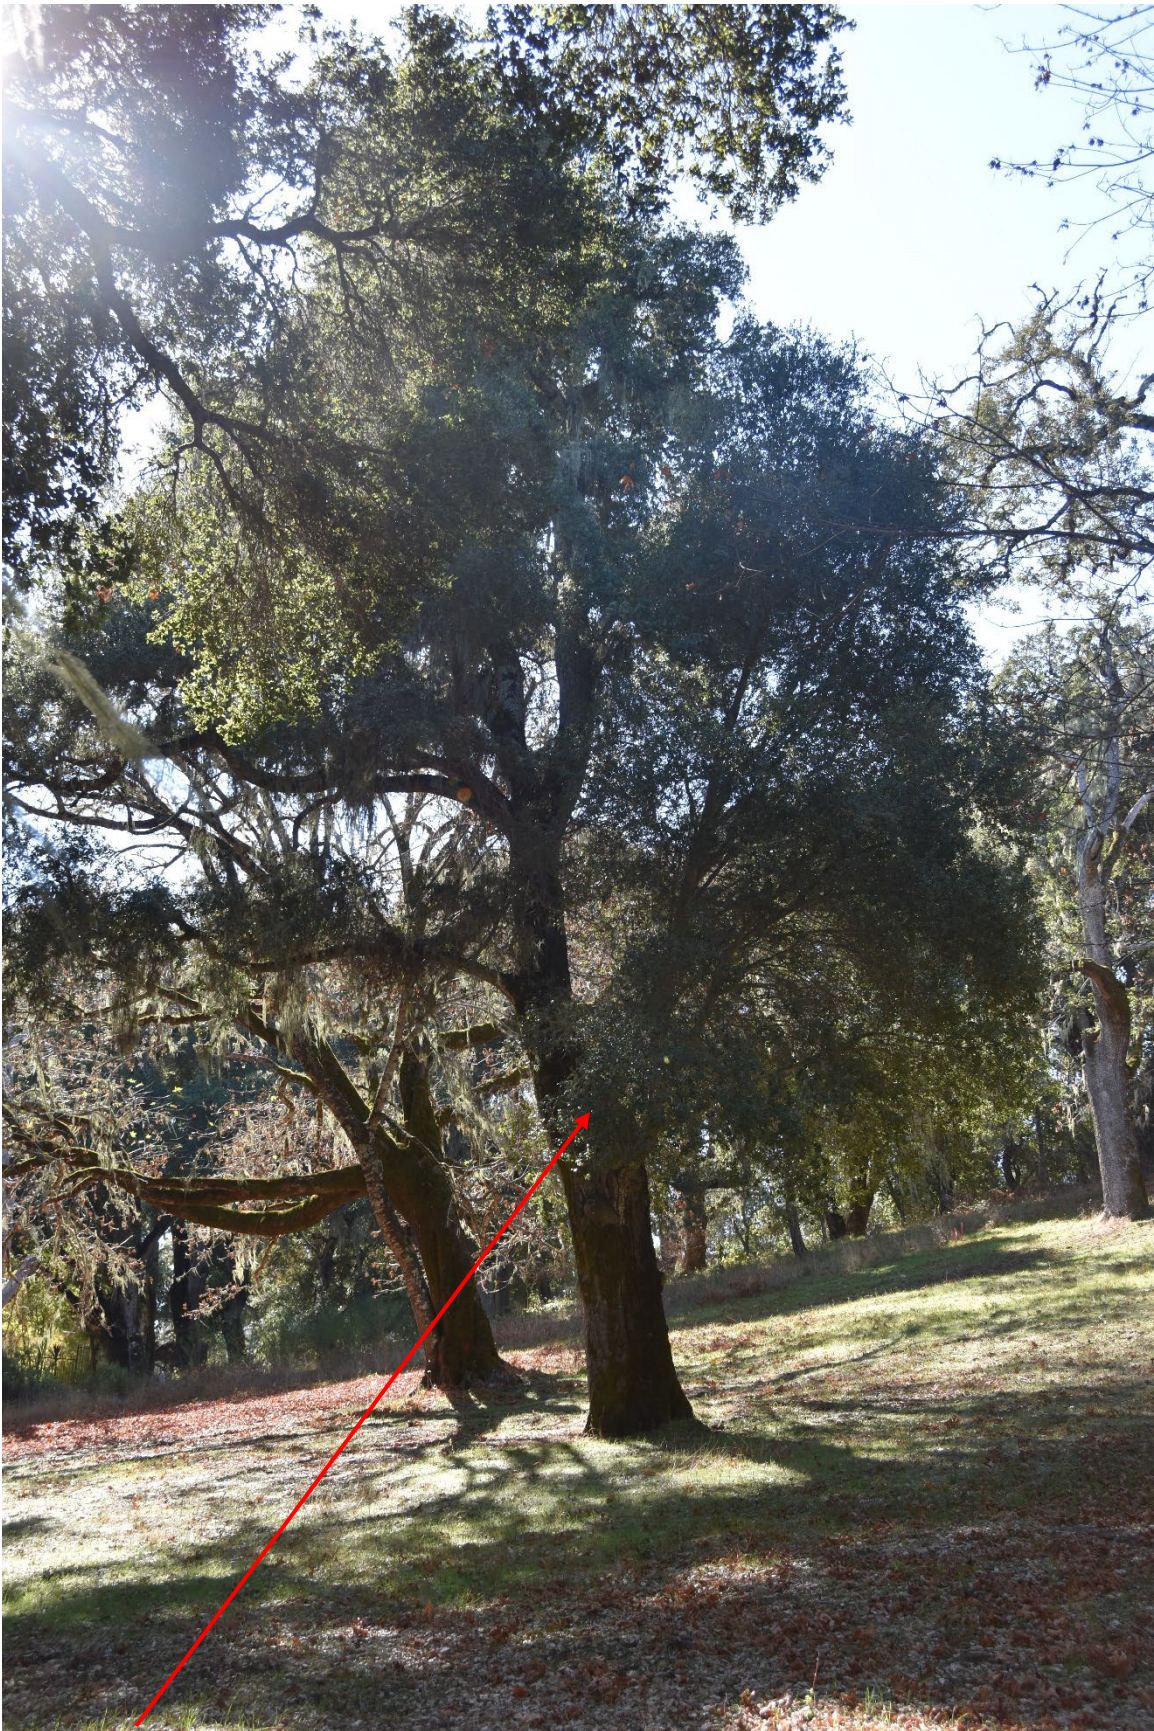
Tree #	Species	DBH	Health	Structure	Remove	Impacted	Height	Crown	CRZ	Comments
1021	Coast live oak	15	Fair	Fair		x	40	20	10	
1022	Coast live oak	20	Fair	Fair		x	40	30	15	
1023	Coast live oak	20	Fair	Fair		x	50	25	15	
1024	Coast live oak	15	Poor	Fair		x	40	20	10	Beetles
1025	Coast live oak	13	Fair	Fair			40	15	8	
1026	Coast live oak	19	Fair	Fair			40	20	10	
1027	Coast live oak	7	Fair	Fair			25	15	8	
1028	Coast live oak	6	Fair	Fair			25	15	8	
1029	Coast live oak	7	Fair	Fair			45	20	10	
1030	Coast live oak	24	Fair	Fair		x	50	40	20	
1031	Coast live oak	24	Fair	Fair		x	50	40	20	
1032	Maple	8	Fair	Fair			50	20	10	
1033	Madrone	6	Fair	Fair			35	12	10	
1034	Coast live oak	23	Fair	Fair			50	40	20	
1035	Valley oak	24	Fair	Fair			50	20	20	
1036	Black oak	40	Fair	Fair			40	40	20	wound at base
1037	Maple	20	Fair	Fair			35	20	10	
1038	Valley oak	42	Fair	Poor			50	40	20	
1039	Valley oak	19	Fair	Fair			40	20	15	
1040	Coast live oak	42	Fair	Fair	x		75	40	20	Grading

Tree #1040 is proposed for removal.
