Tree Assessment/
Construction Impact Analysis
31 Potrero Trail

Ono Consulting
International Society of Arboriculture
Board Certified Master Arborist #WE-9388B
ASCA Registered Consulting Arborist #744
Society of American Foresters Professional Member
311 Forest Ave, Box 14
Pacific Grove CA, 93950

January 26, 2022

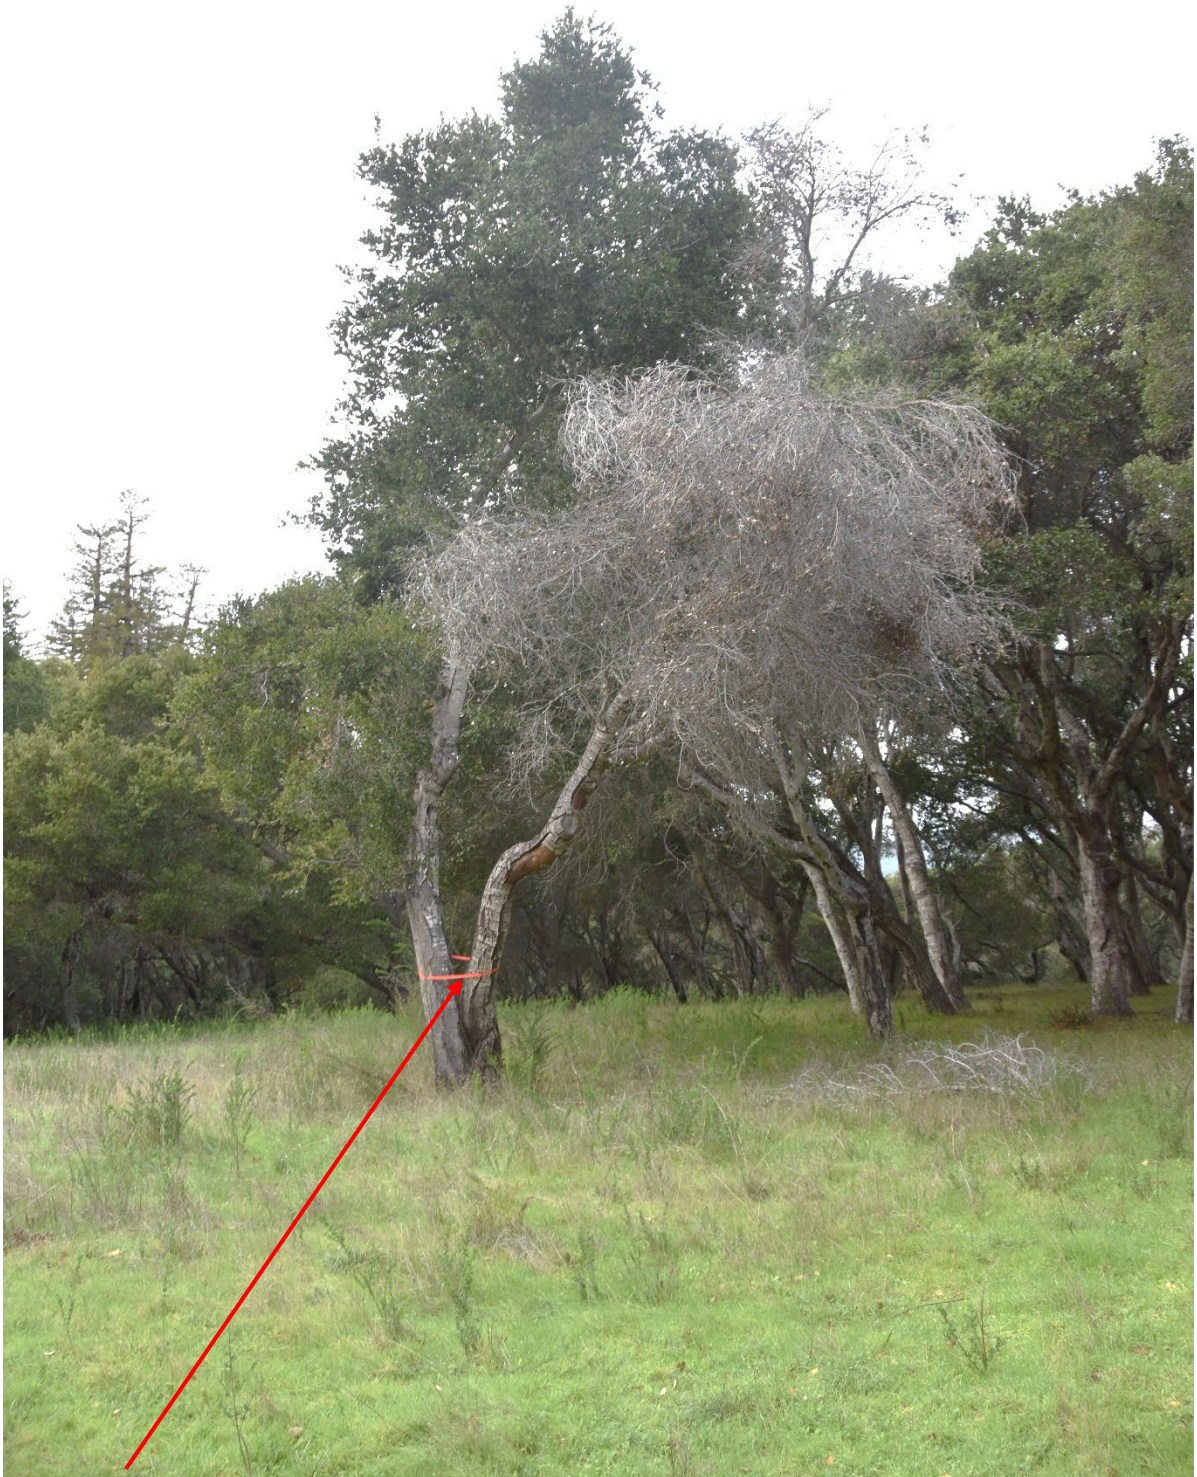
- The site is forested mainly with a mixture of Coast live oak and Coast redwood trees.
- One (1) tree is proposed for removal with the current design. This tree (#465) is a dual 14-inch diameter stemmed tree in poor condition. The tree has fungus in its stem and one of the trunks is dead.

Tree #465 is proposed for removal.

There is one (1) tree to be removed with the design. The tree removal contractor shall verify the absence of active animal or bird nesting sites before any tree removal. If any active animal or bird nesting sites are found before tree removal, work shall be stopped until a qualified biologist is consulted for further recommendations.

Because it is recommended that replacement of removed trees be undertaken replacement planting is necessary. Per the Santa Lucia Preserve Development Guidelines replacement shall be at a ratio of 3:1 for a total of three (3) five-gallon Coast live oaks. Trees should be planted in the areas with the greatest opening in the stand to allow for a minimum of competition and maximum sunlight. Spacing between trees should be at least 8 feet. Occasional deep watering (more than two weeks apart) during the late spring, summer, and fall is recommended during the first two years after establishment.

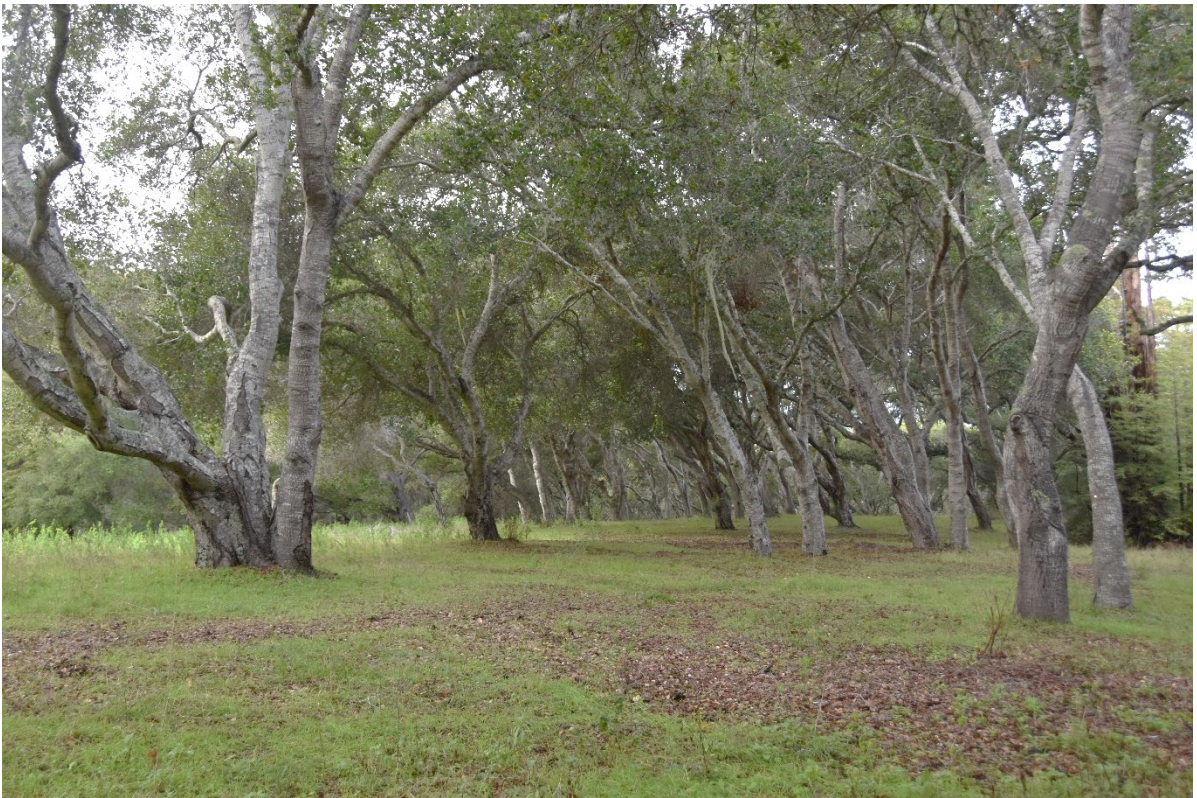
- Six (6) trees will need encroachment into root zones for the proposed driveway and fire turnaround. The proposed driveway will be slightly elevated for proper grade and should not impact the trees if significant excavation is not required, and soil is not accumulated at the base of the trees.

A view down the proposed driveway.

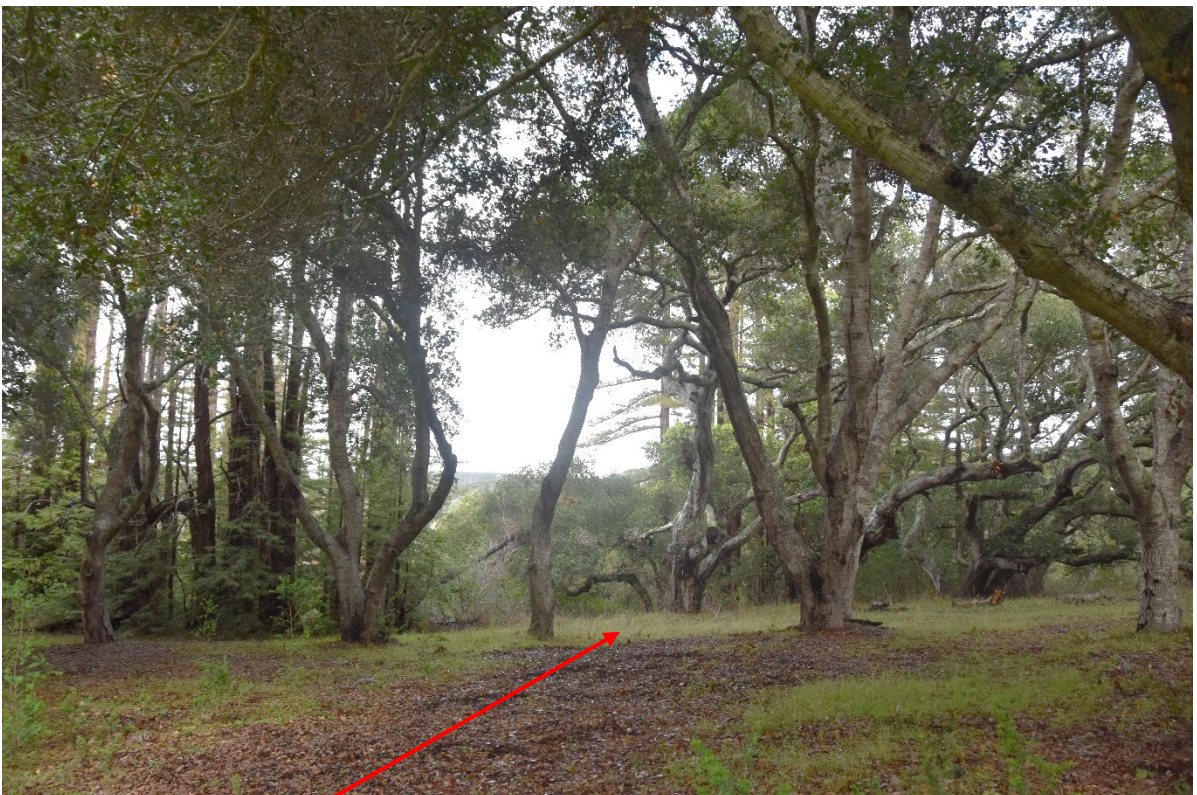
A view of the proposed fire turnaround.

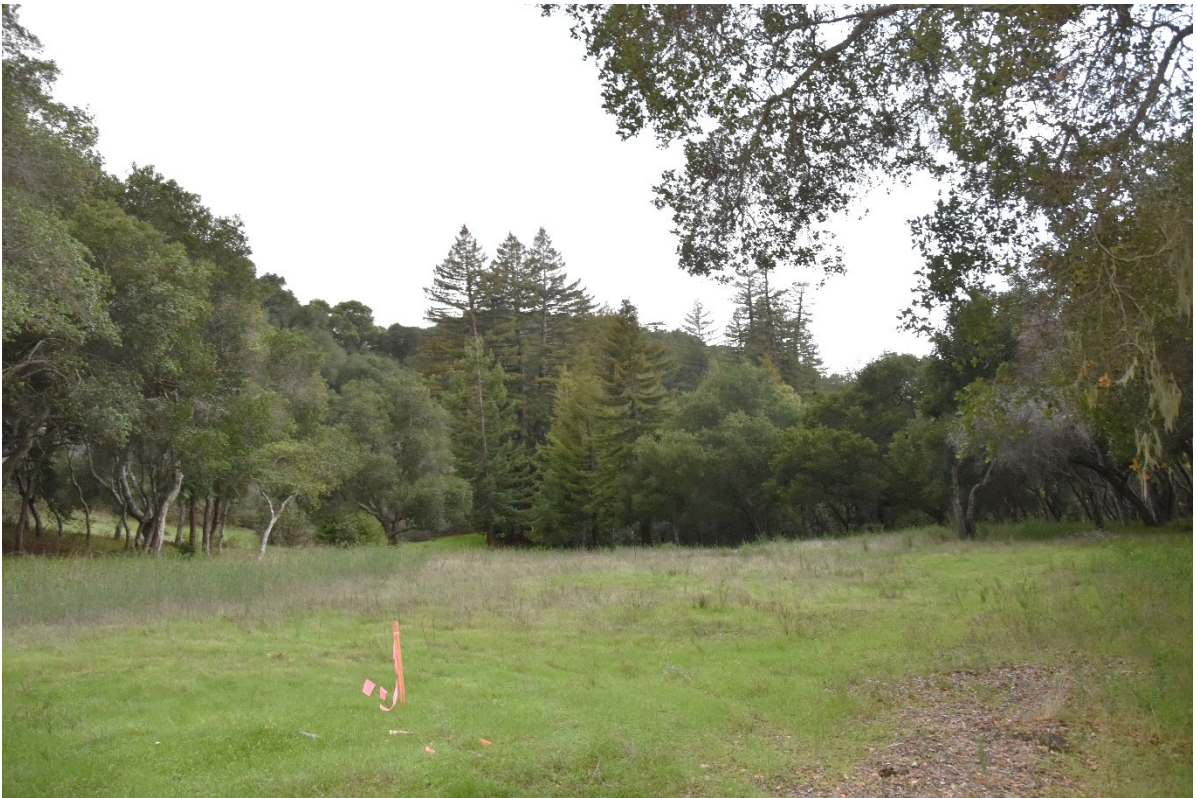
A view of the proposed building site.

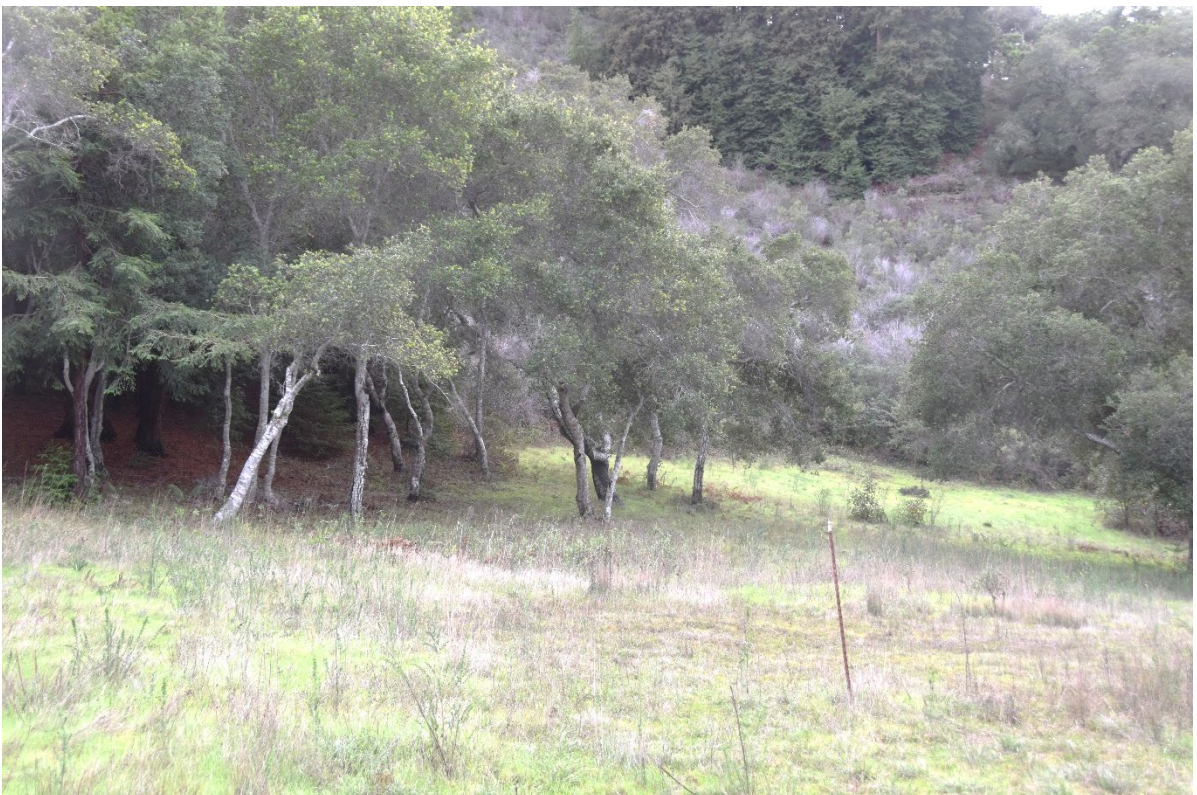
A view of the proposed ADU site.
