THOMPSON
WILDLAND MANAGEMENT

Bliss Residence
9 Mesa Trail
Carmel, CA. 93923
APN: 239-101-022-000

Subject: 9 Mesa Trail Pre-construction Tree Impact Assessment

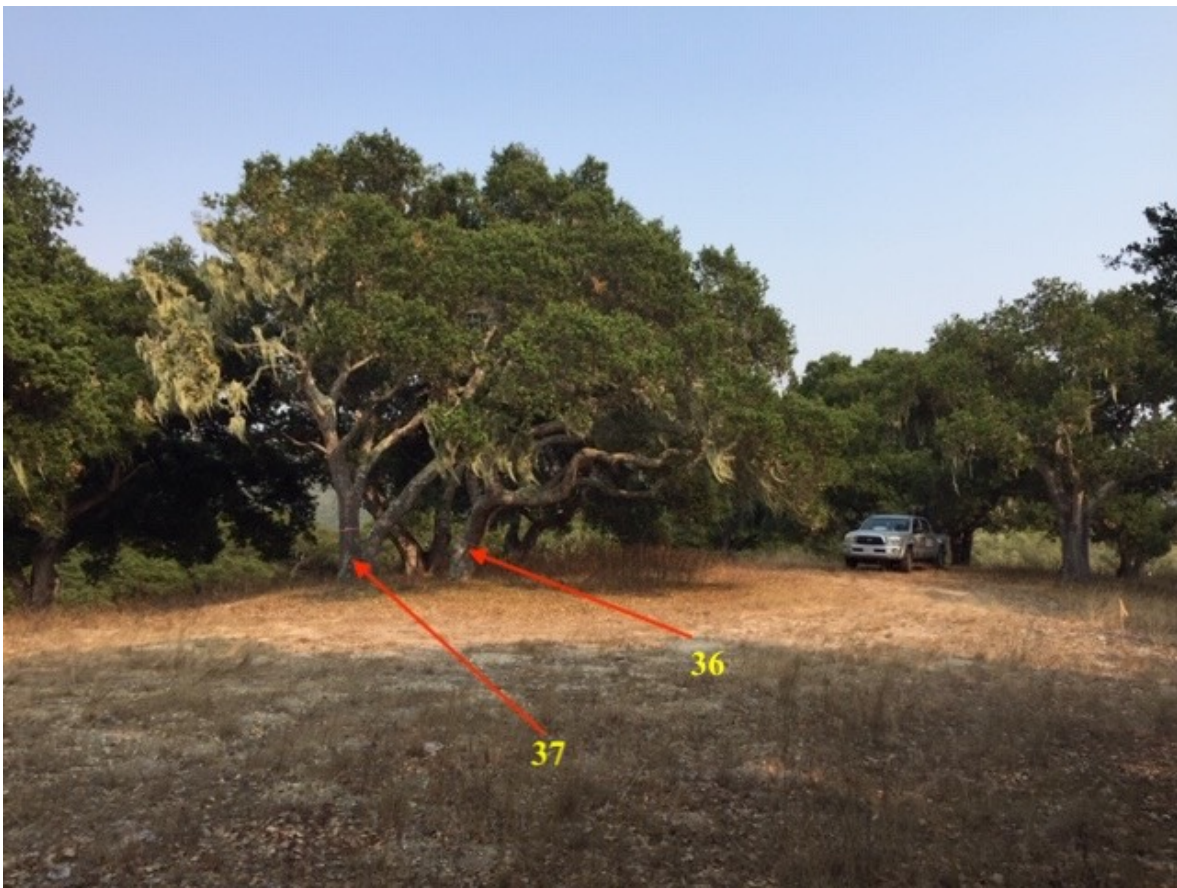
Figure 3. Another view of proposed main house construction site. *Tree#36* seen in photo is proposed for removal and *Tree#37* will now be retained and protected.

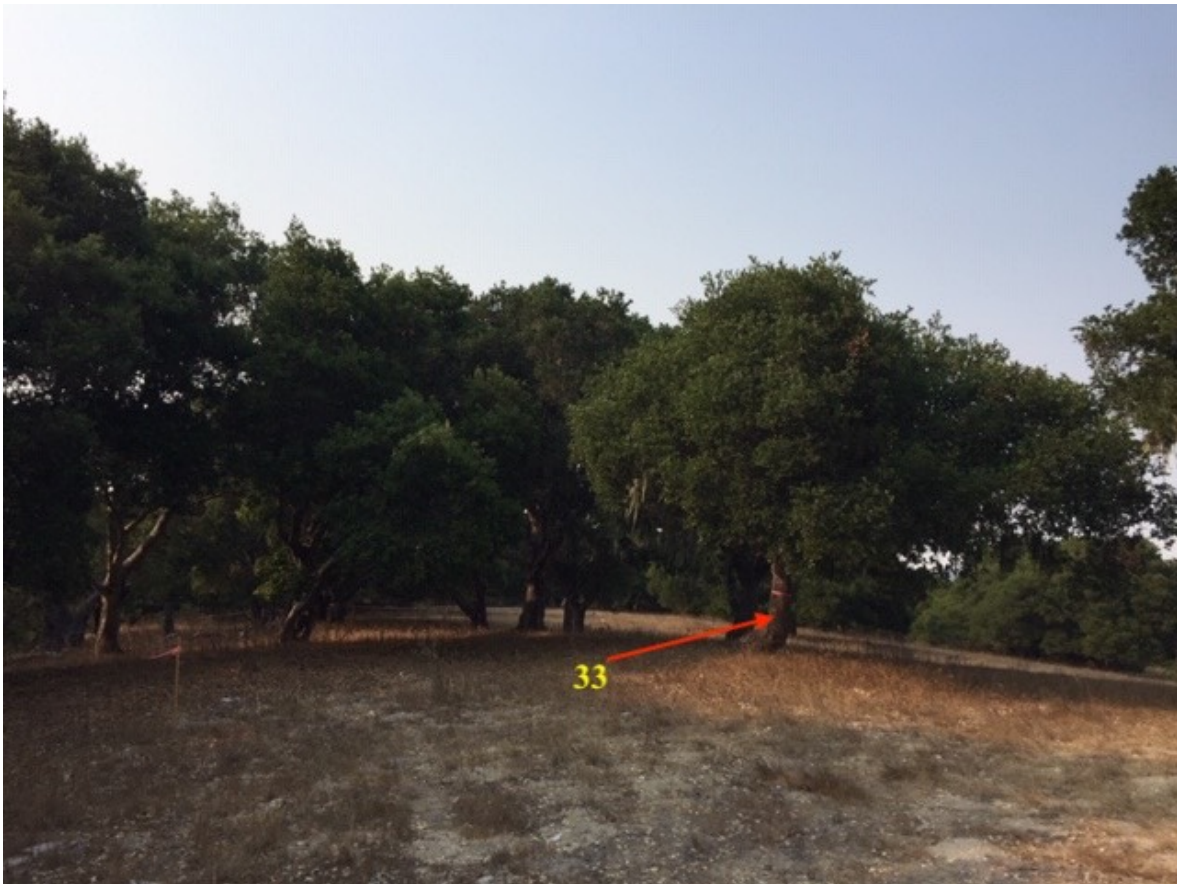
Figure 4. Another view of proposed main house construction site. *Tree#33* is proposed for removal due to location within construction footprint.

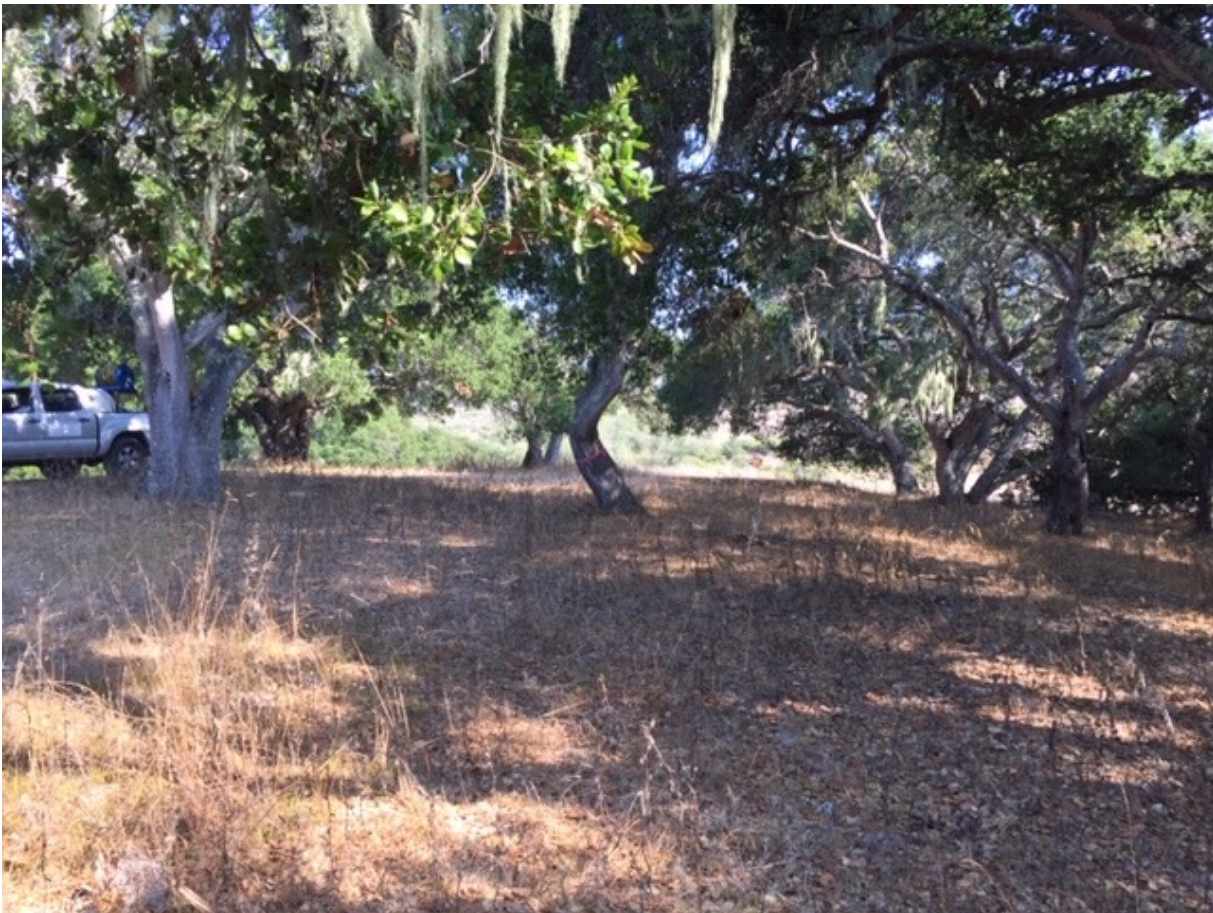
Figure 9. Proposed driveway route. *Tree#7* in center of photo is proposed for removal due to location in driveway.

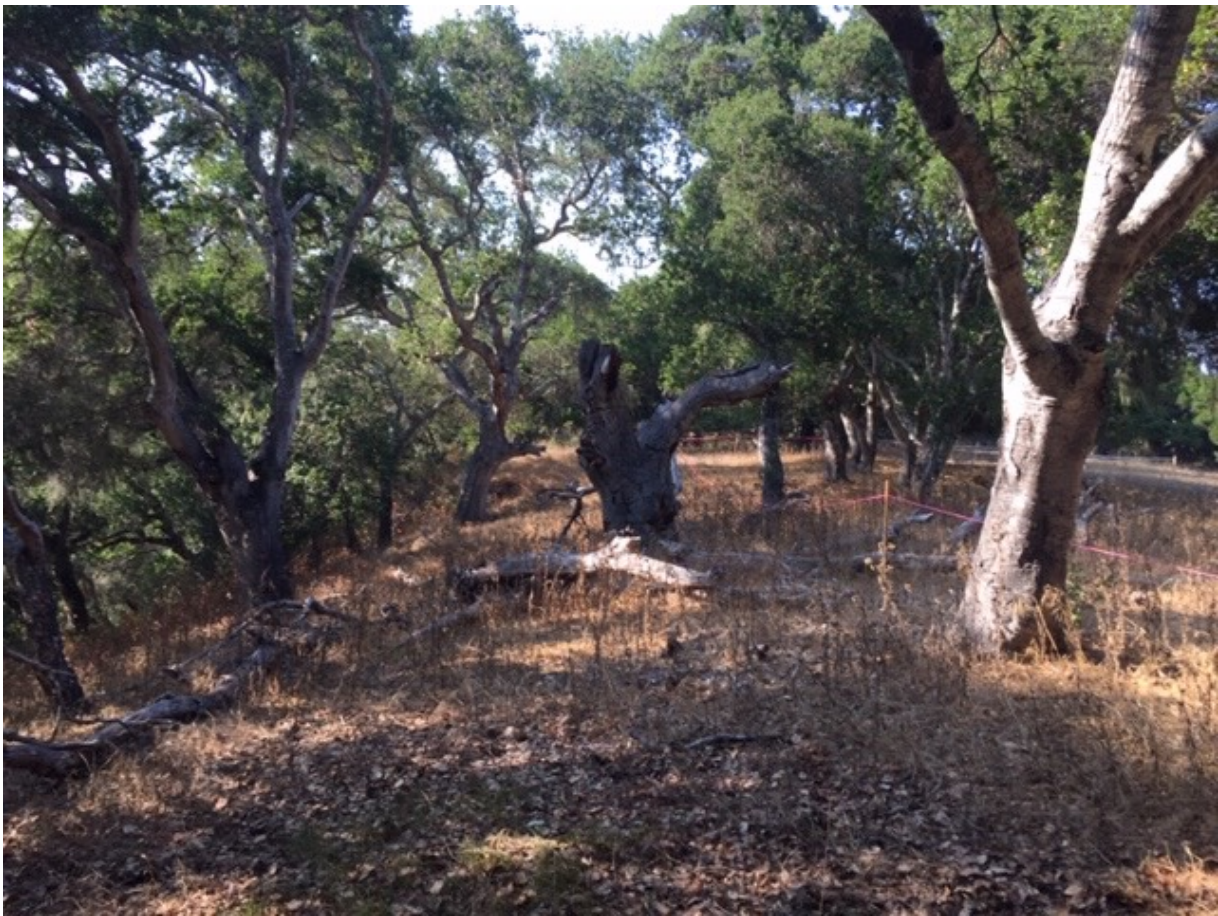
Figure 11. Proposed driveway route through oak woodland. Dead snag in center of photo will need to be removed.

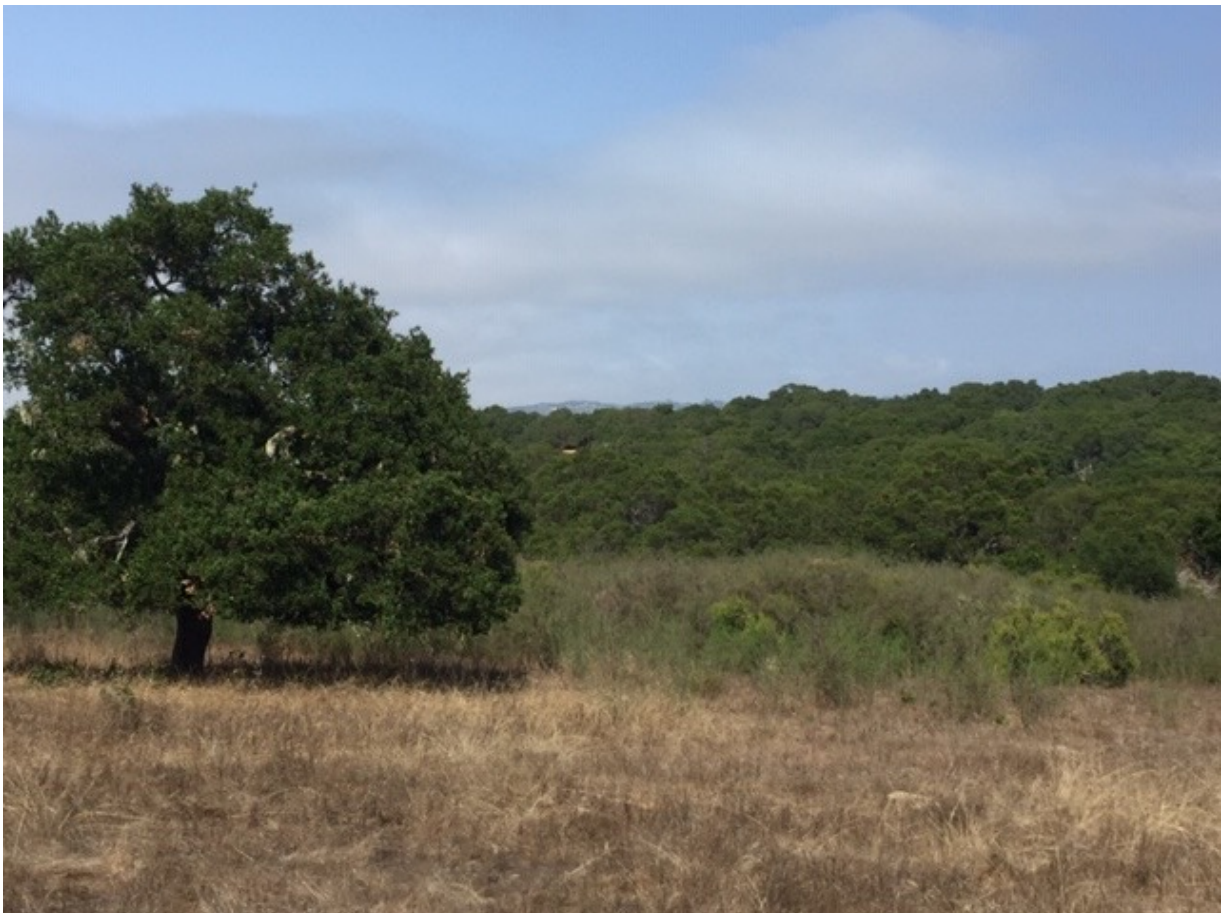
Figure 12. Large population of non-native invasive French broom in adjacent Openlands. Several stands are occurring on lot.

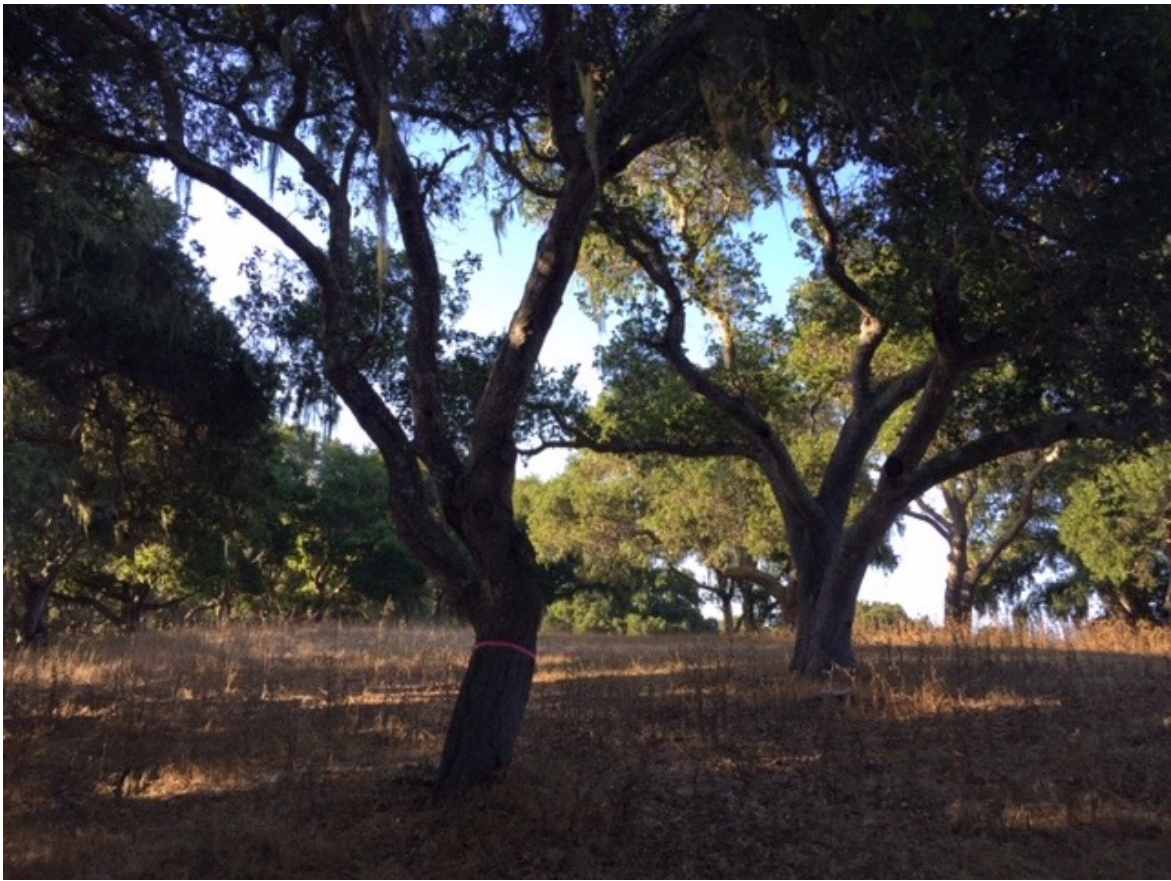
Figure 13. *Tree#7* in center foreground is proposed for removal due to driveway location.

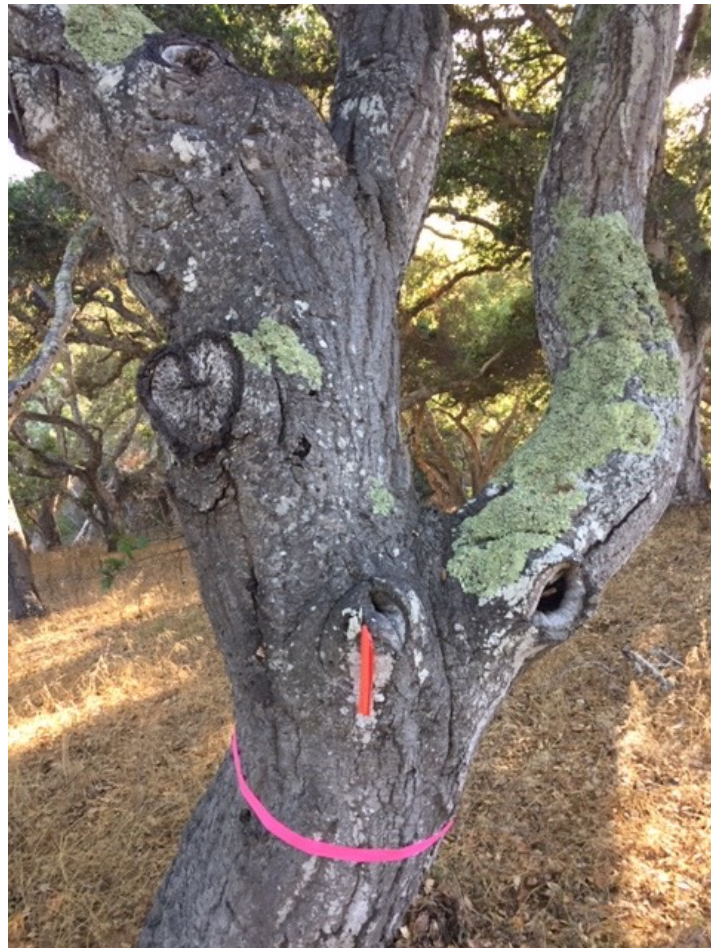
Figure 14. Closer view of *Tree#7*.

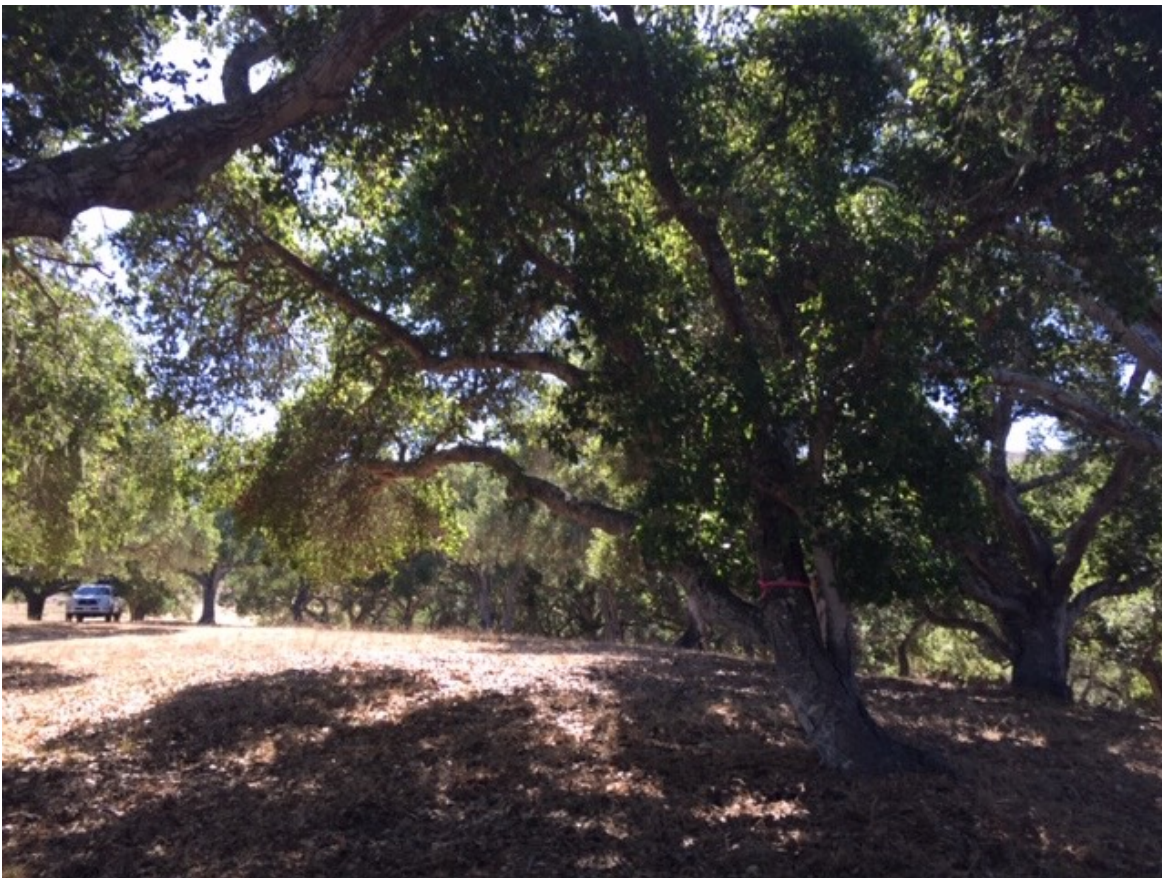
Figure 15. *Tree#19* (right of center in foreground) is recommended for removal due to close proximity to proposed bunk house.

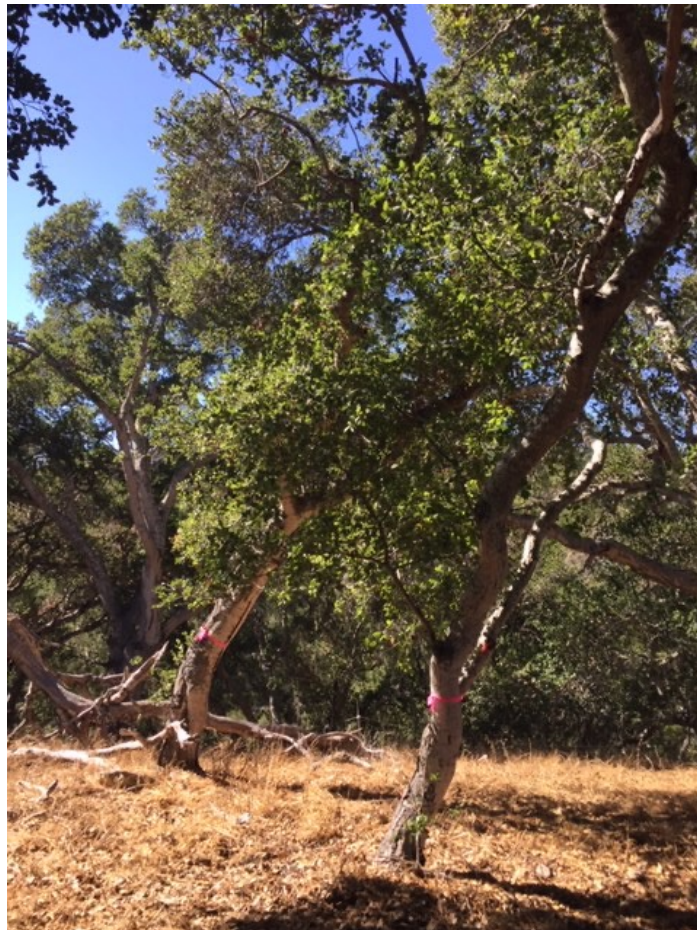
Figure 16. *Tree#s 20* (background left) & *21* (center foreground) are no longer proposed for removal and will be retained and protected.

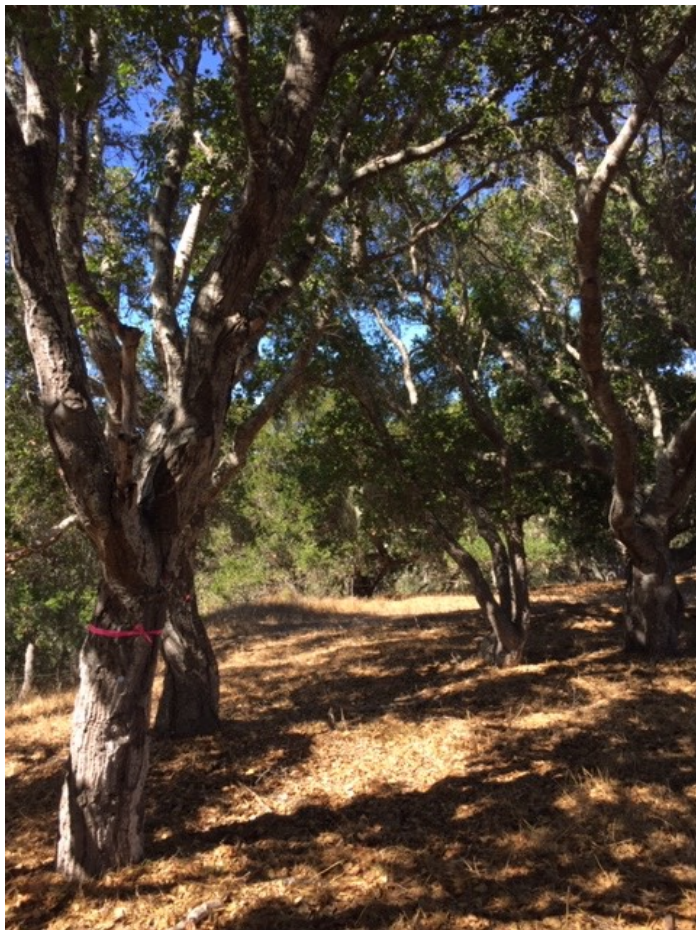
Figure 17. *Tree# 22* is no longer proposed for removal and will be retained and protected.

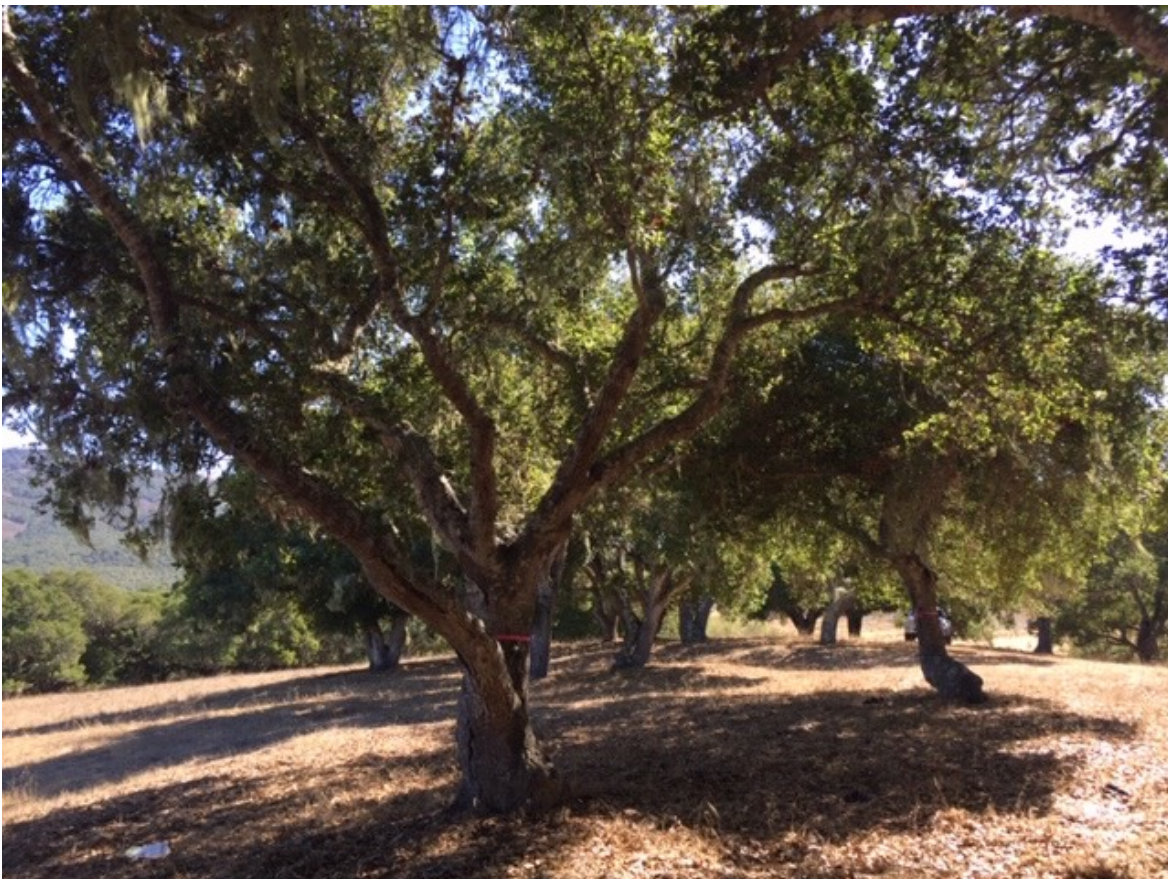
Figure 18. *Tree#s 32* (center foreground) & *33* (right background) are recommended for removal due to location within proposed homesite.

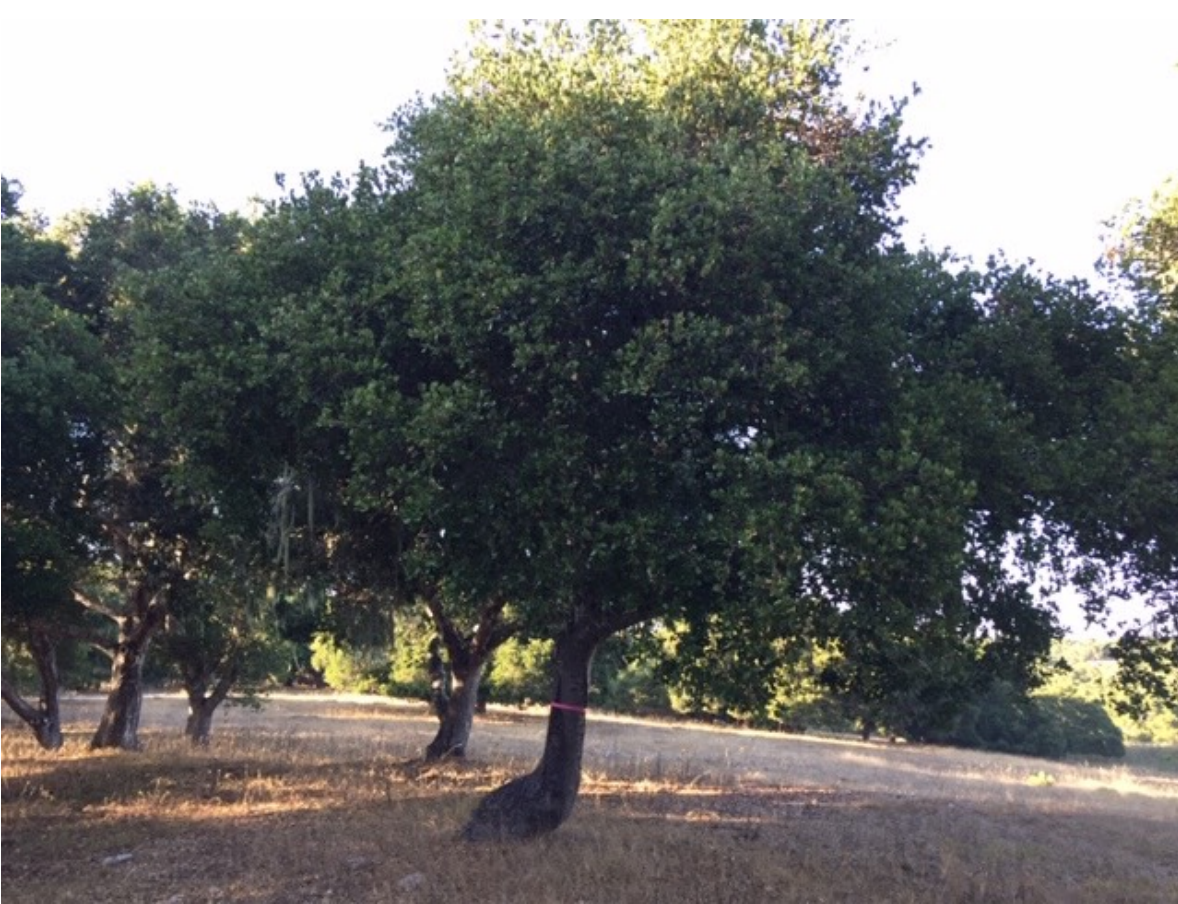
Figure 19. *Tree#s* 32 (background left of center) & 33 (center foreground) are proposed for removal due to location within building footprint of main house.

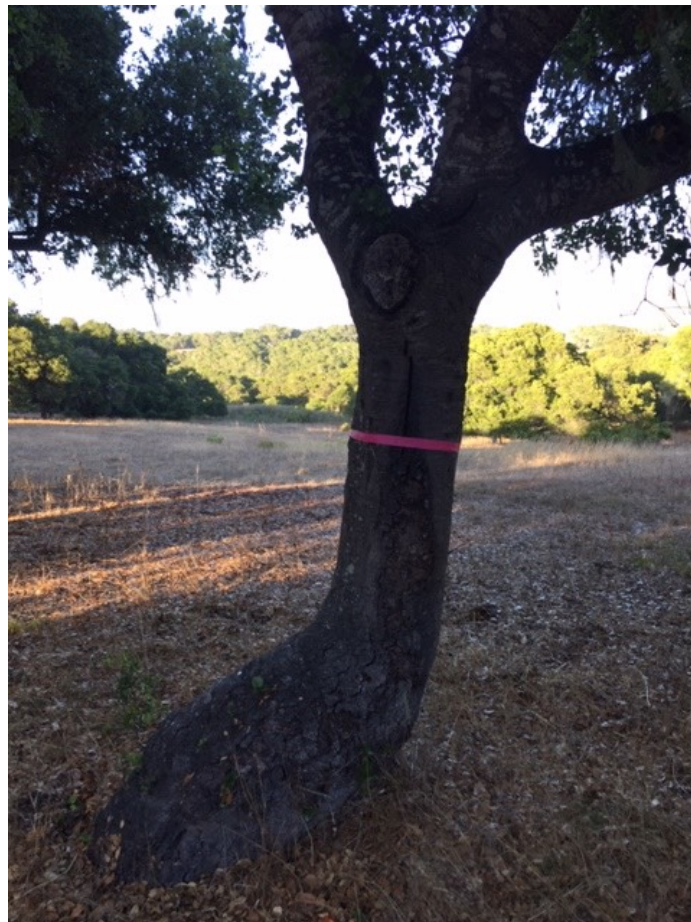
Figure 20. Closer view of *Tree#33*.

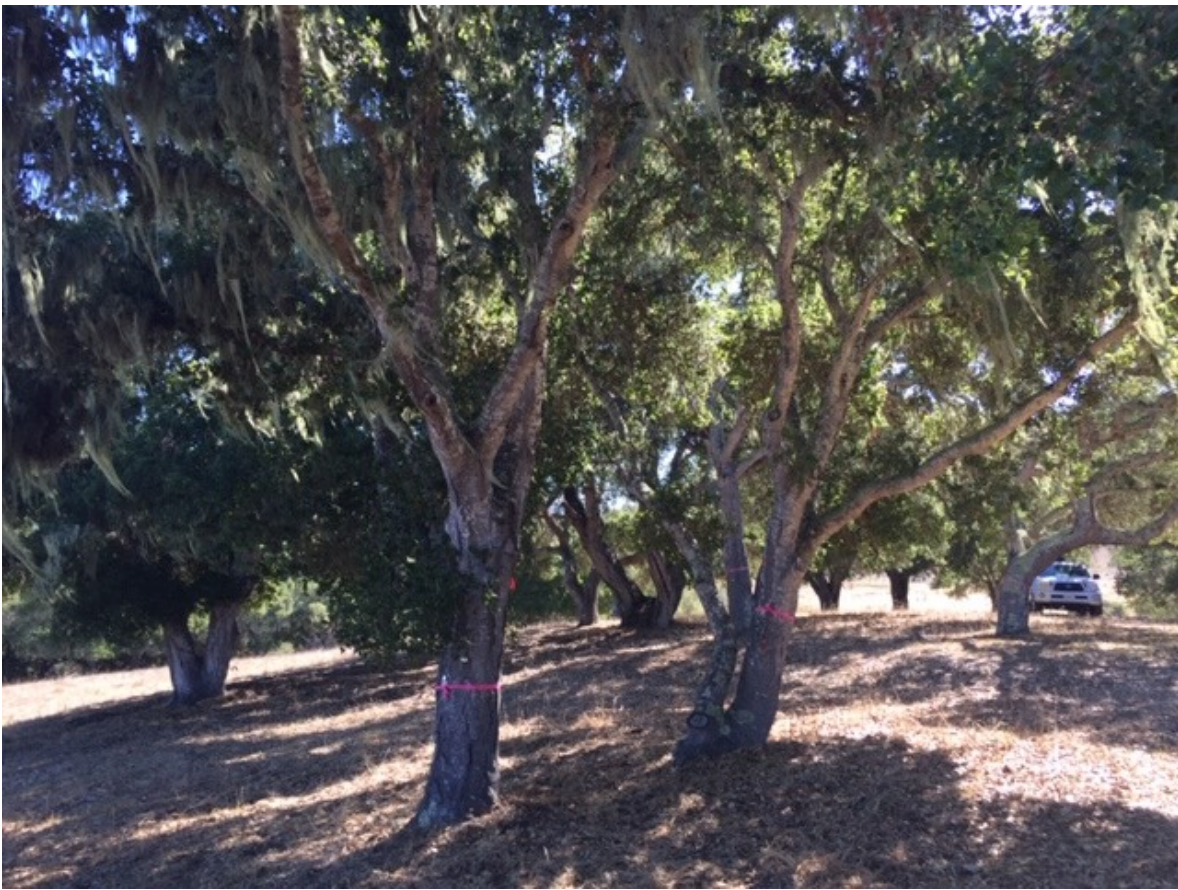
Figure 21. *Tree#s* 34 (left of center) & 35 (right of center) are proposed for removal due to location within building footprint of main house.

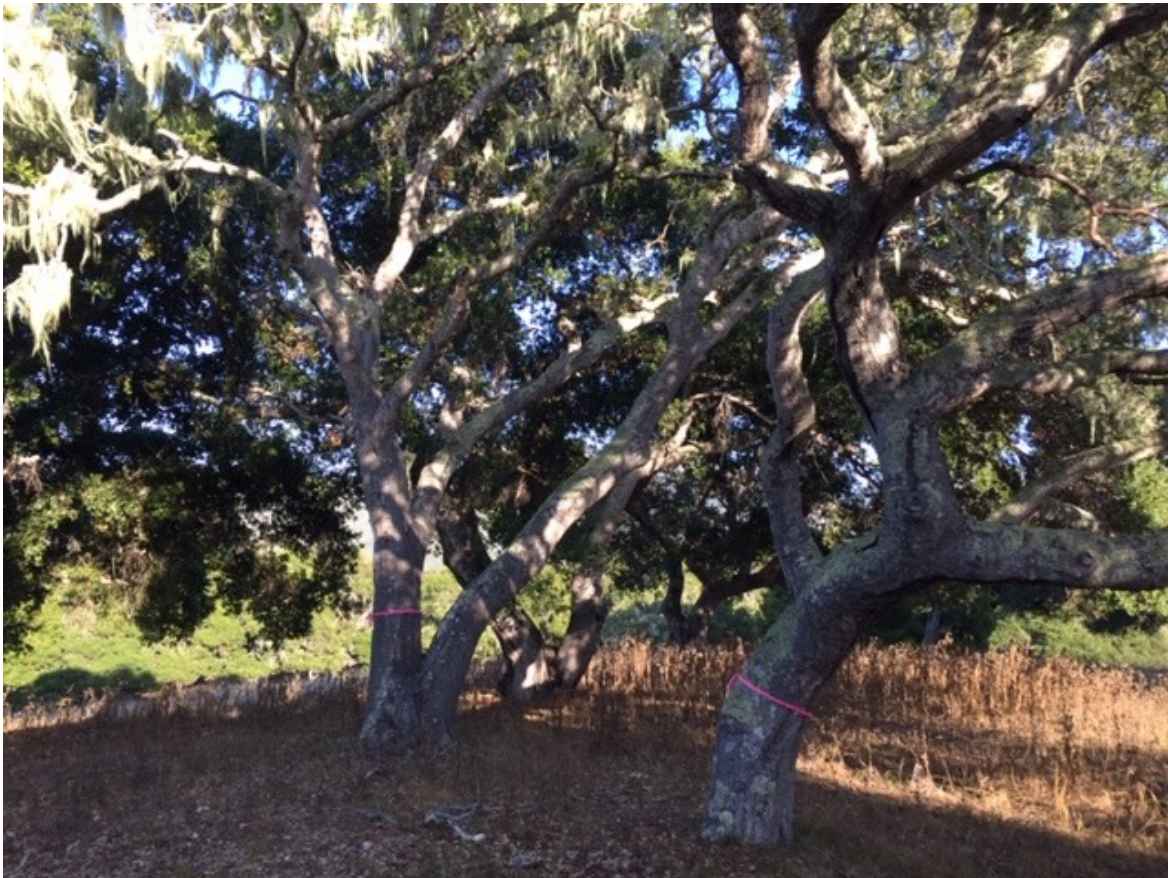
Figure 22. *Tree#36* (right of center) is proposed for removal due to location within building footprint of main house and *Tree#37* (left of center) will be retained and protected.

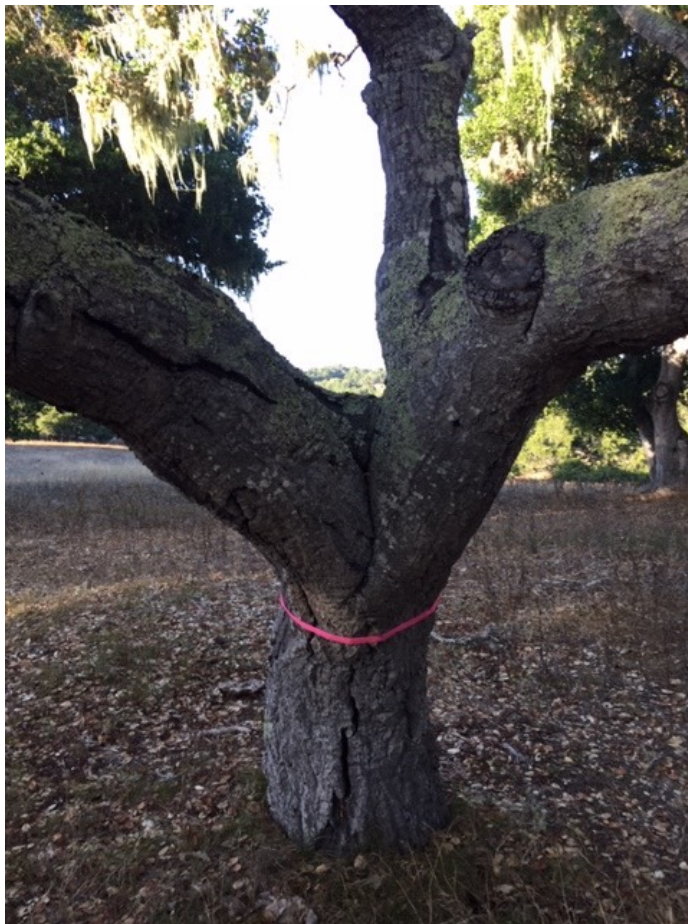
Figure 23. Closer view of *Tree#36* that is proposed for removal.

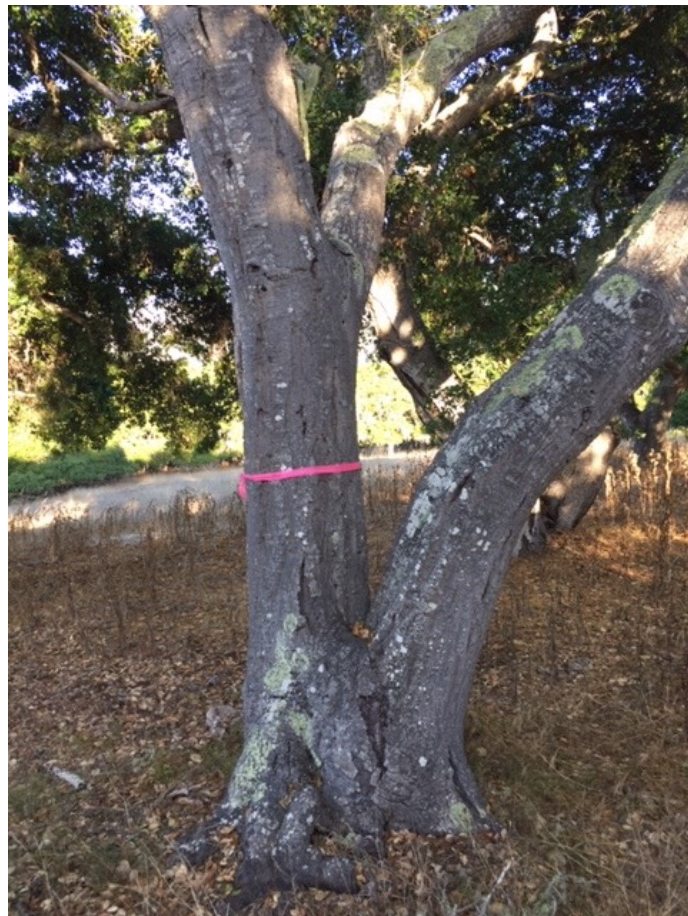
Figure 24. Closer view of *Tree#37* that will now be retained and protected.
