THOMPSON
WILDLAND MANAGEMENT

January 17, 2022

Subject: 9 Wild Boar Run Pre-construction Tree Impact Assessment

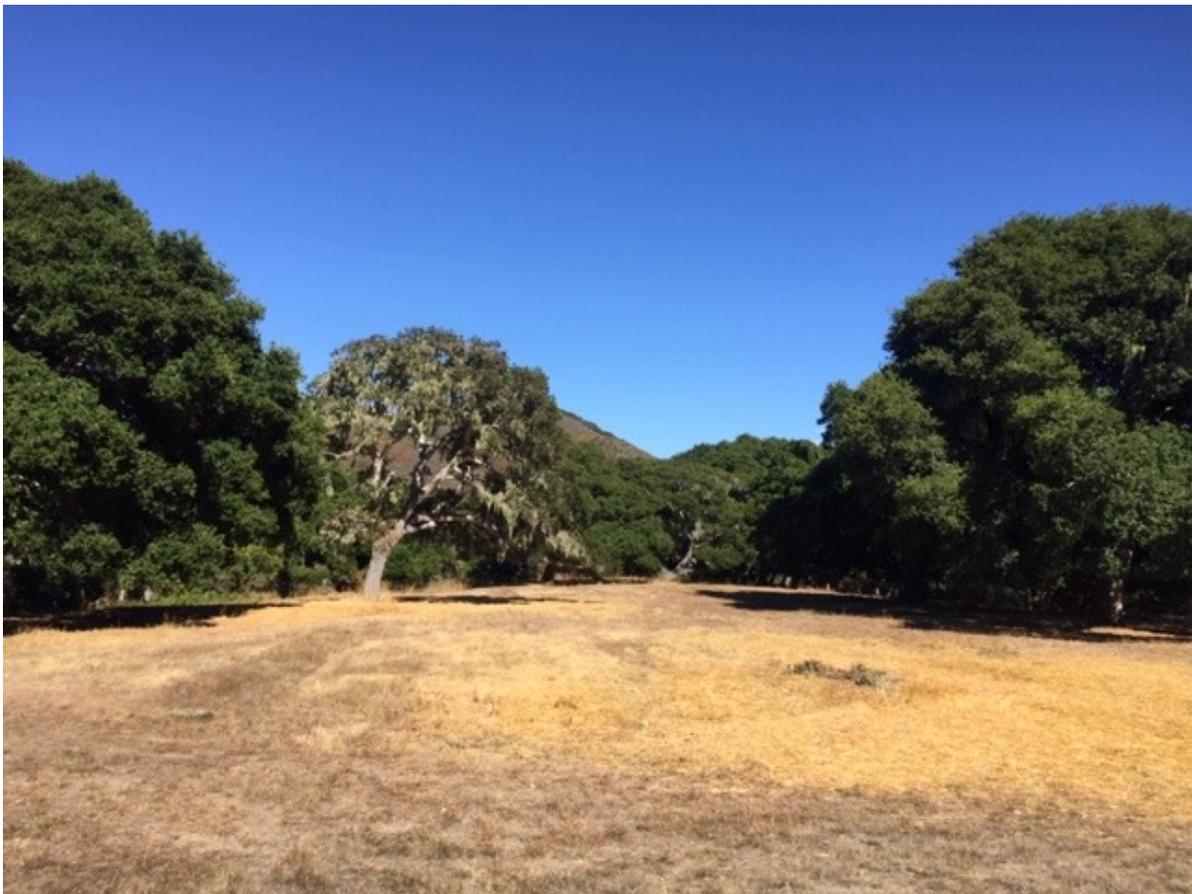
Figure 1. View of lot from Wild Boar Run. Proposed homesite is located in rear part of Homeland.

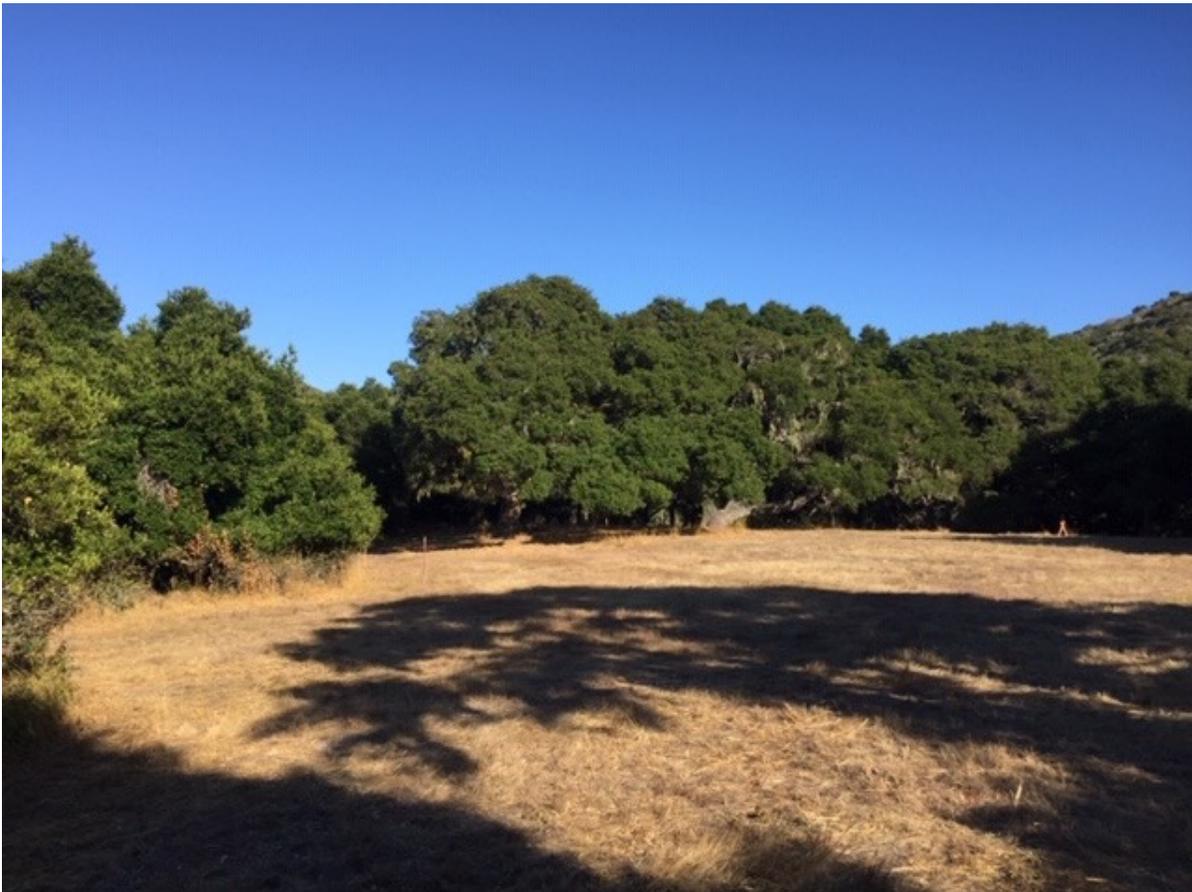
Figure 2. Portion of proposed homesite in annual grass dominated clearing.

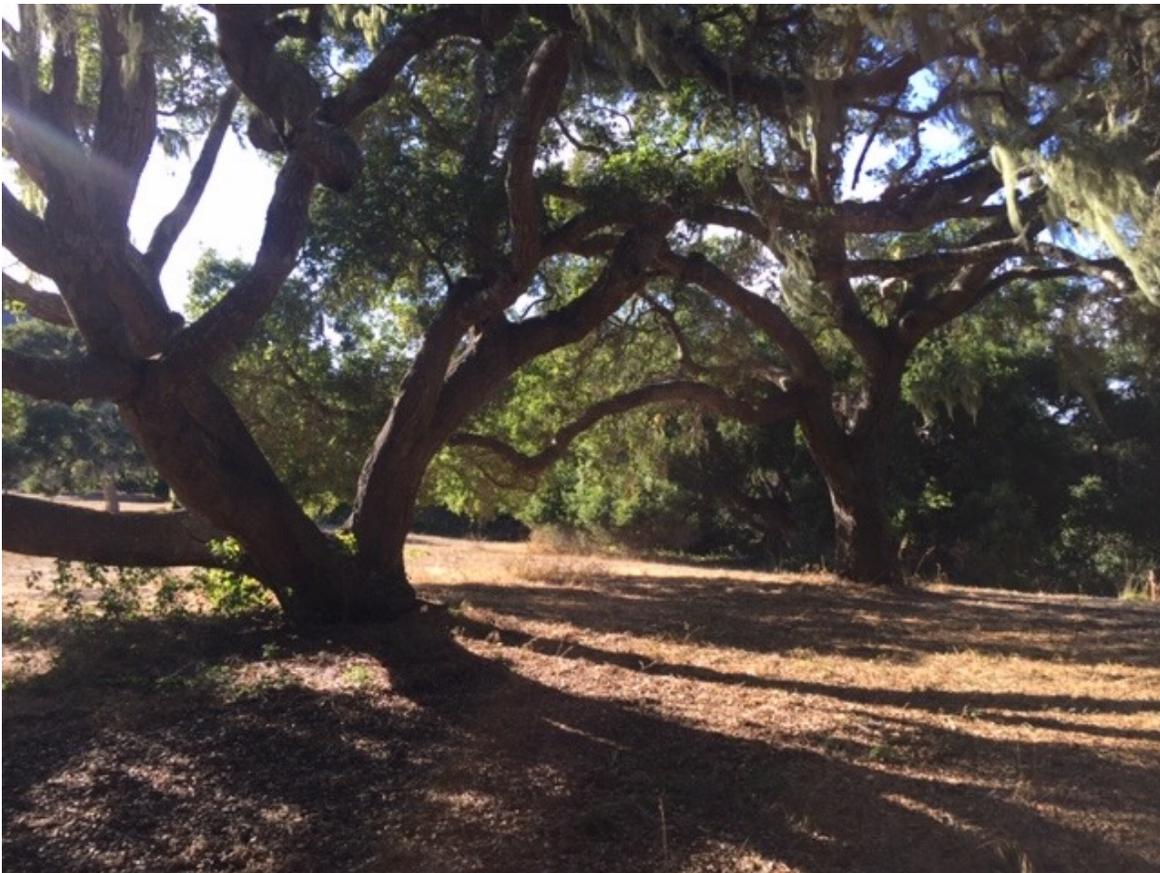
Figure 3. Two prominent landmark status trees (*Tree#89* is right of center in background & *Tree#90* is left of center in foreground) will be retained and protected during planned construction operations, and impacts are expected to be minimal and insignificant.

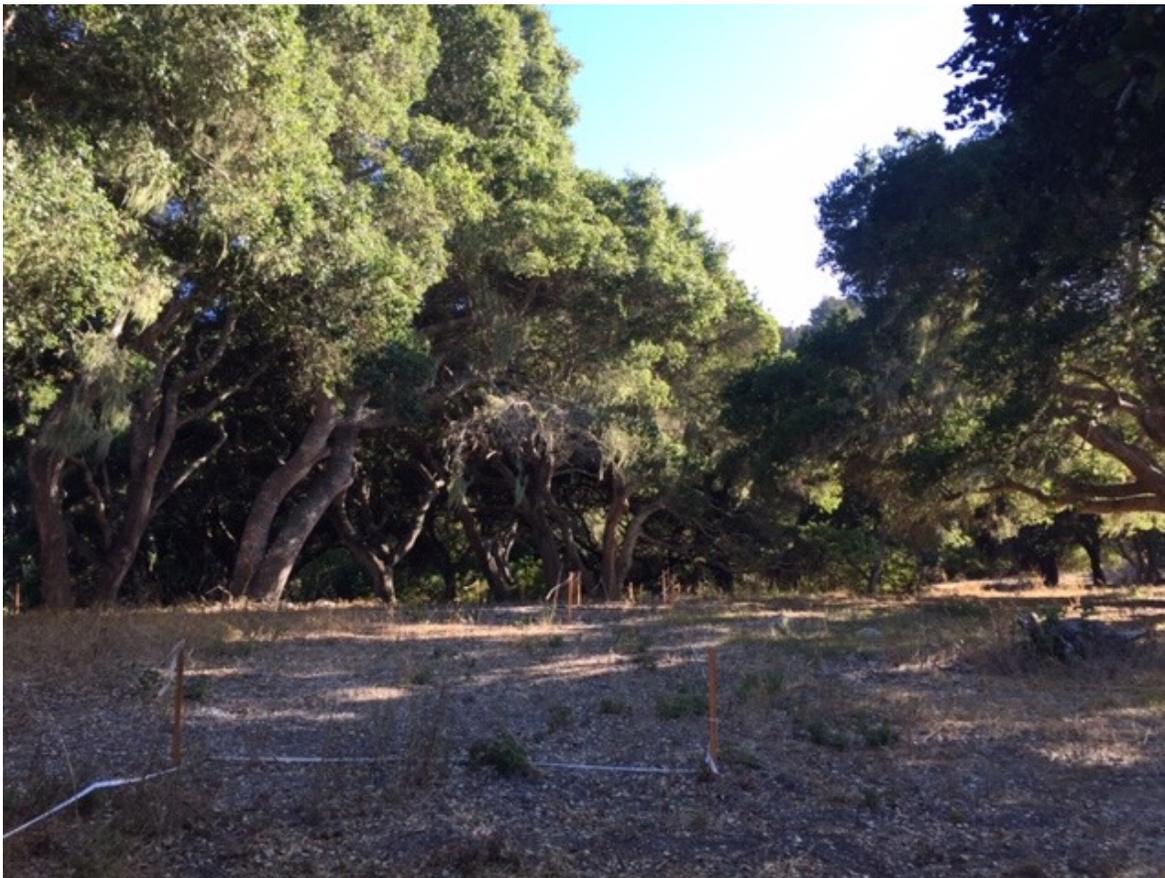
Figure 4. Proposed building location in oak woodland clearing. Surrounding trees will be retained and protected, and impacts are expected to be minimal and insignificant.

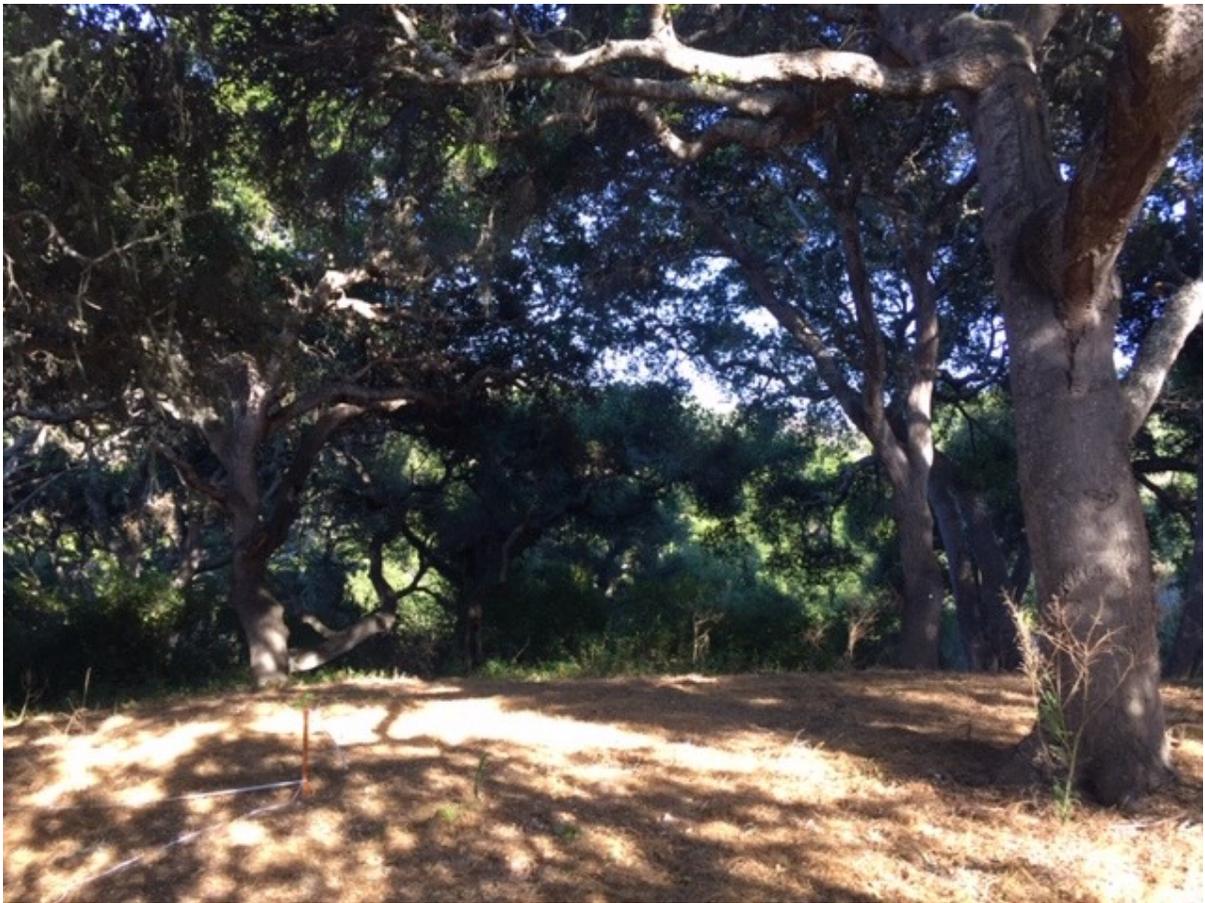
Figure 5. Proposed building site within portion of canopy dripline of a few oak trees is not expected adversely affect tree health.

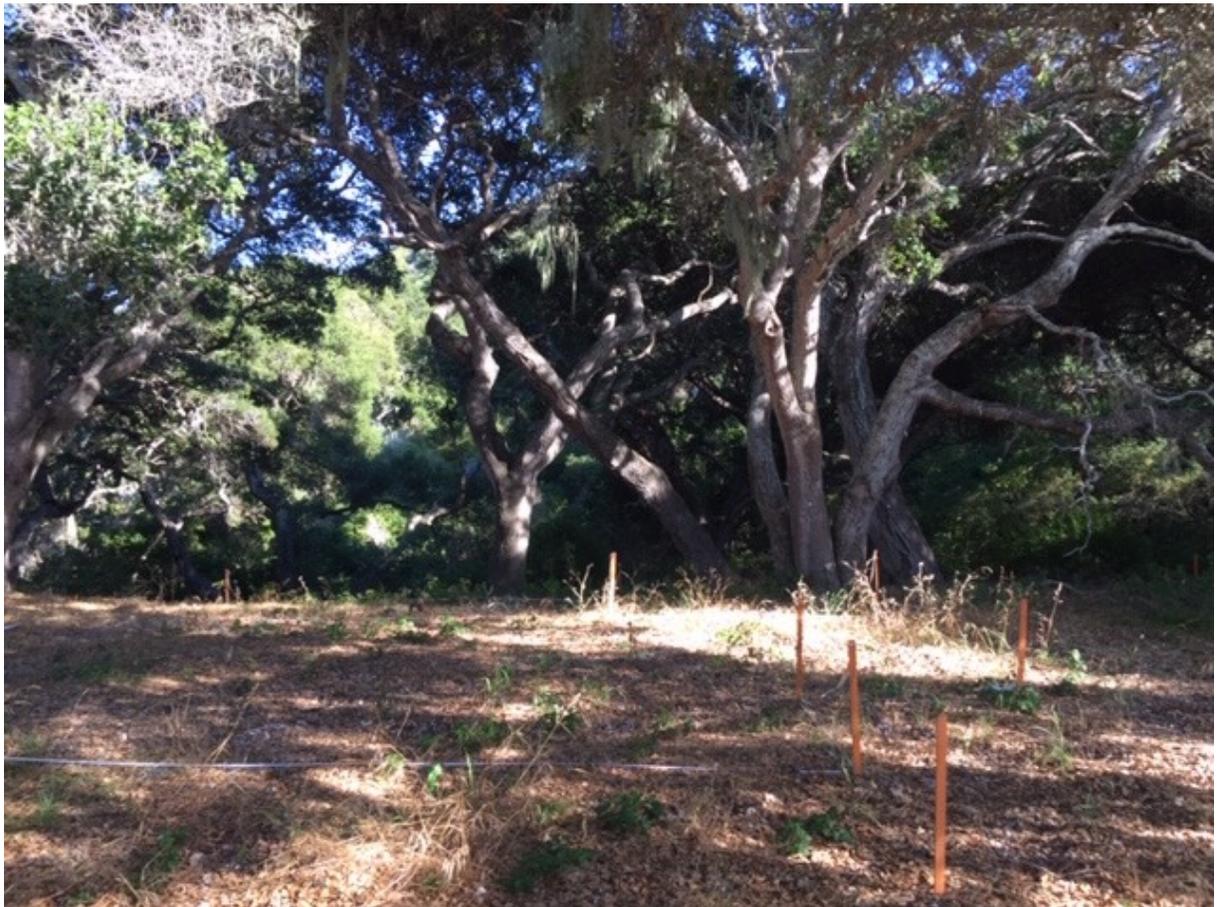
Figure 6. Another view of proposed building site occurring within canopy dripline of a few oaks.

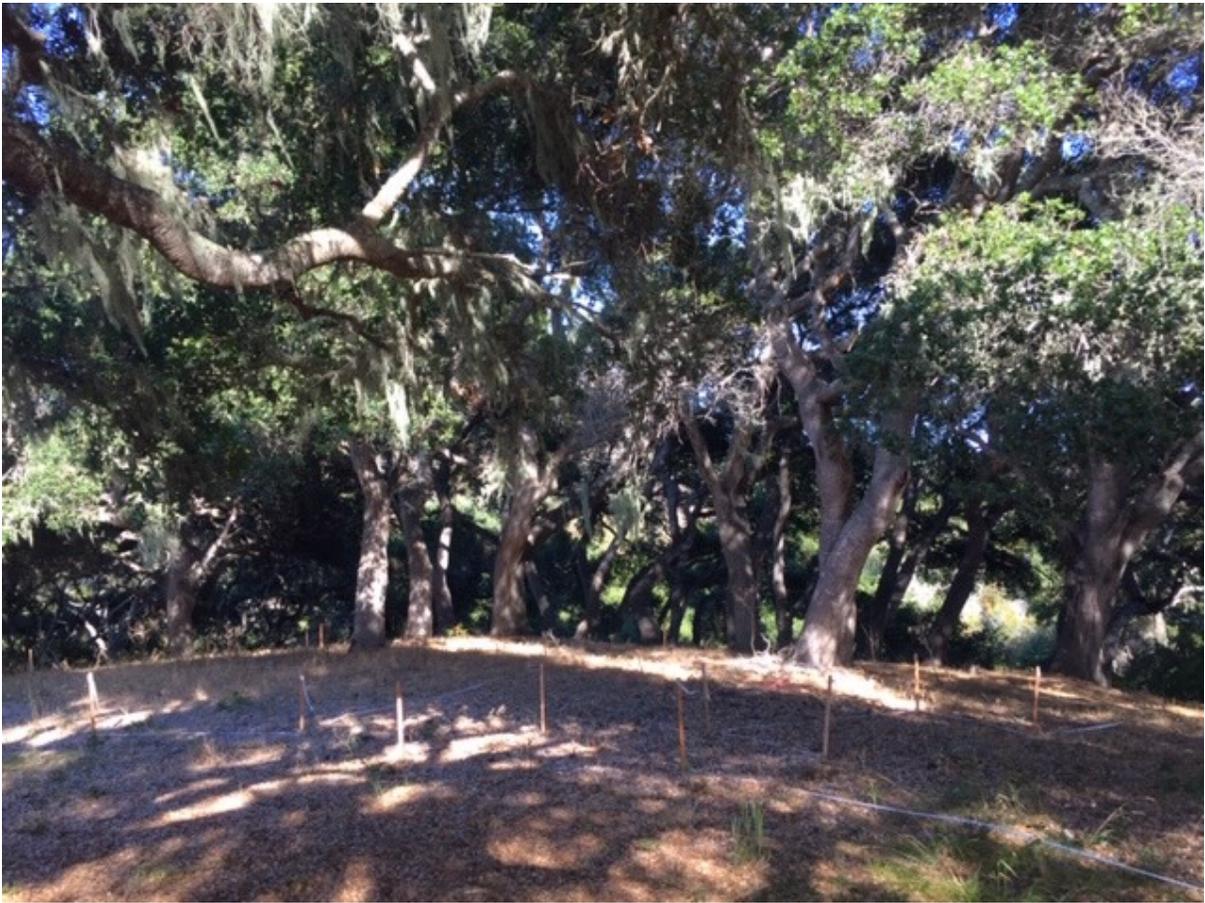
Figure 7. Another view of proposed building site located in smaller gap in woodland canopy.

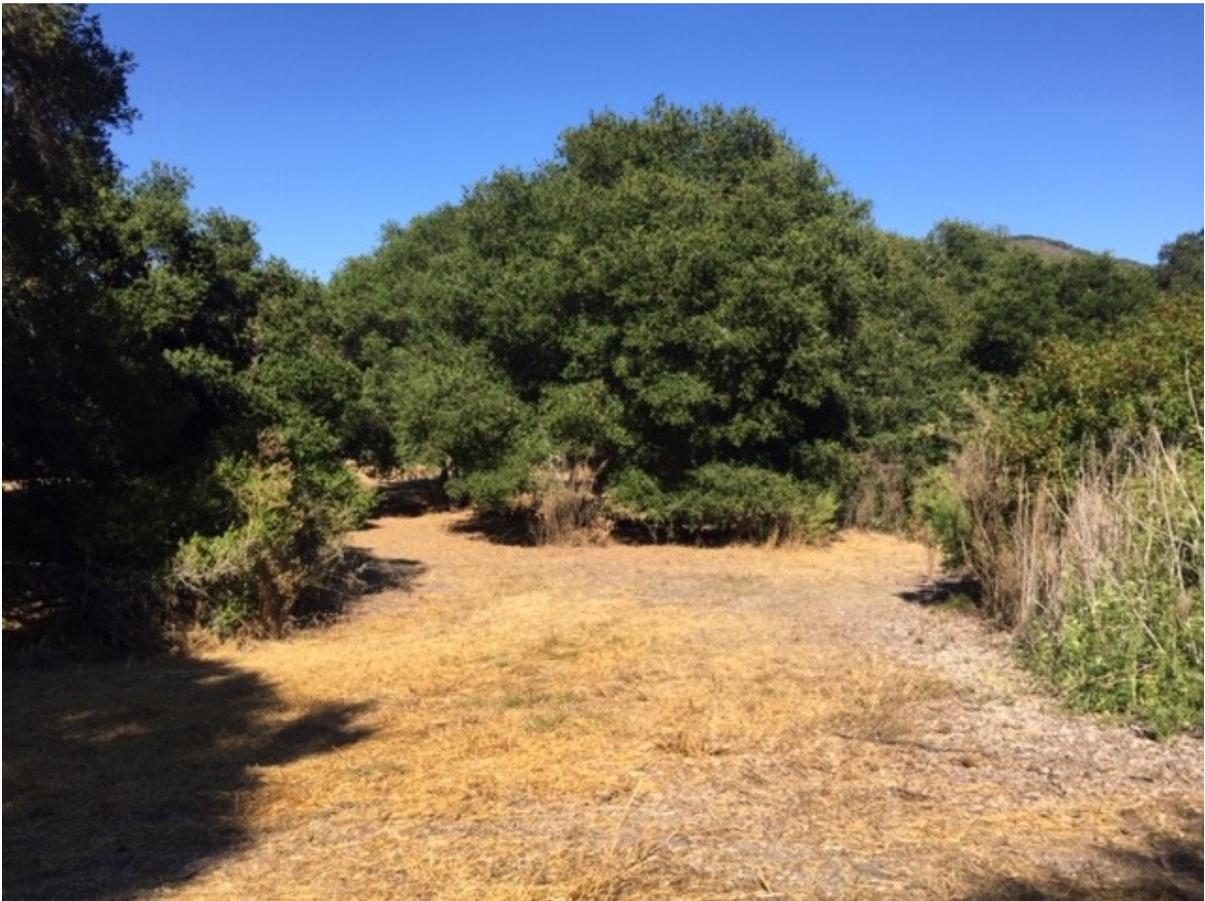
Figure 8. Proposed driveway turn around area.

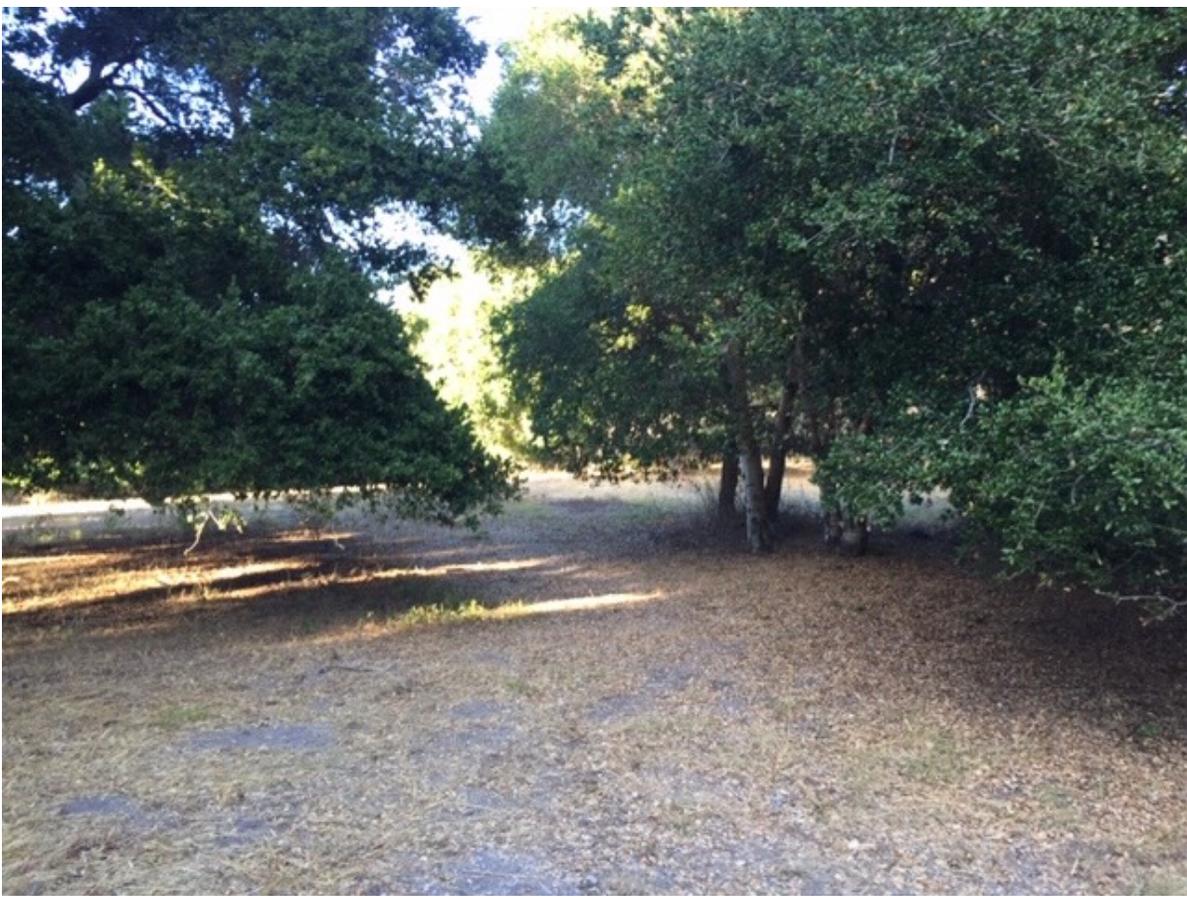
Figure 9. Oak grouping seen in previous photo is right of center. Driveway passing through gap in oak canopy is expected to have minimal impacts.

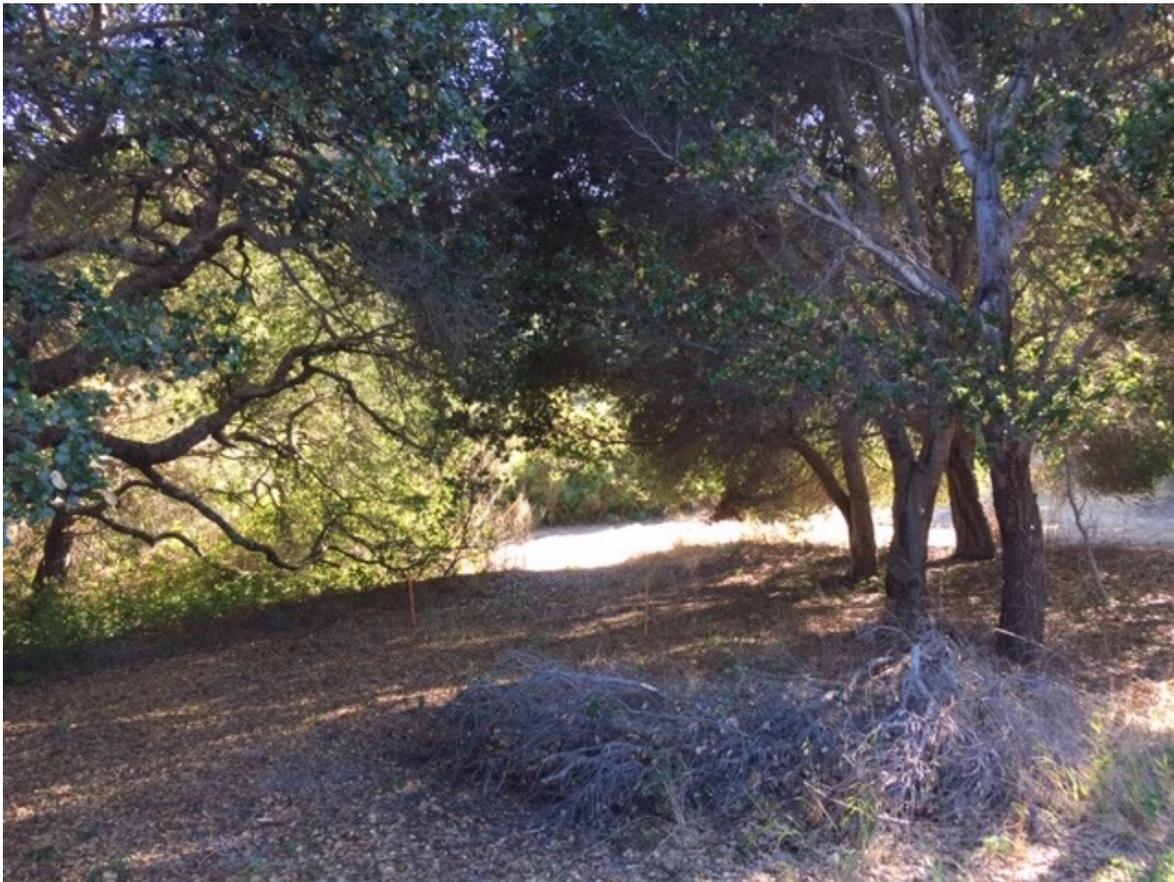
- 1) *Tree#61* is a 16 inch DBH coast live oak that is located directly adjacent to the proposed garage (refer to *Figures 10 & 11*). This semi-mature tree is currently in overall fair health and condition, but has a notable co-dominant stem with included bark in the lower to mid stem section that may compromise structural integrity as the tree ages and gets heavier in the canopy. If tree removal is approved plant three (3) replacement oak trees to support and sustain woodland health and character and to satisfy County tree removal permit requirements.

- 2) *Tree#62* is a 13 inch DBH coast live oak that is located within the proposed construction footprint for the garage (refer to *Figures 10 & 11*). This semi-mature tree is currently in overall fair physiological health and structural condition. If tree removal is approved plant three (3) replacement oak trees to support and sustain woodland health and character and to satisfy County tree removal permit requirements.

Figure 10. Proposed garage location. *Tree#s 61 & 62* proposed for removal are at right edge of photo in foreground.

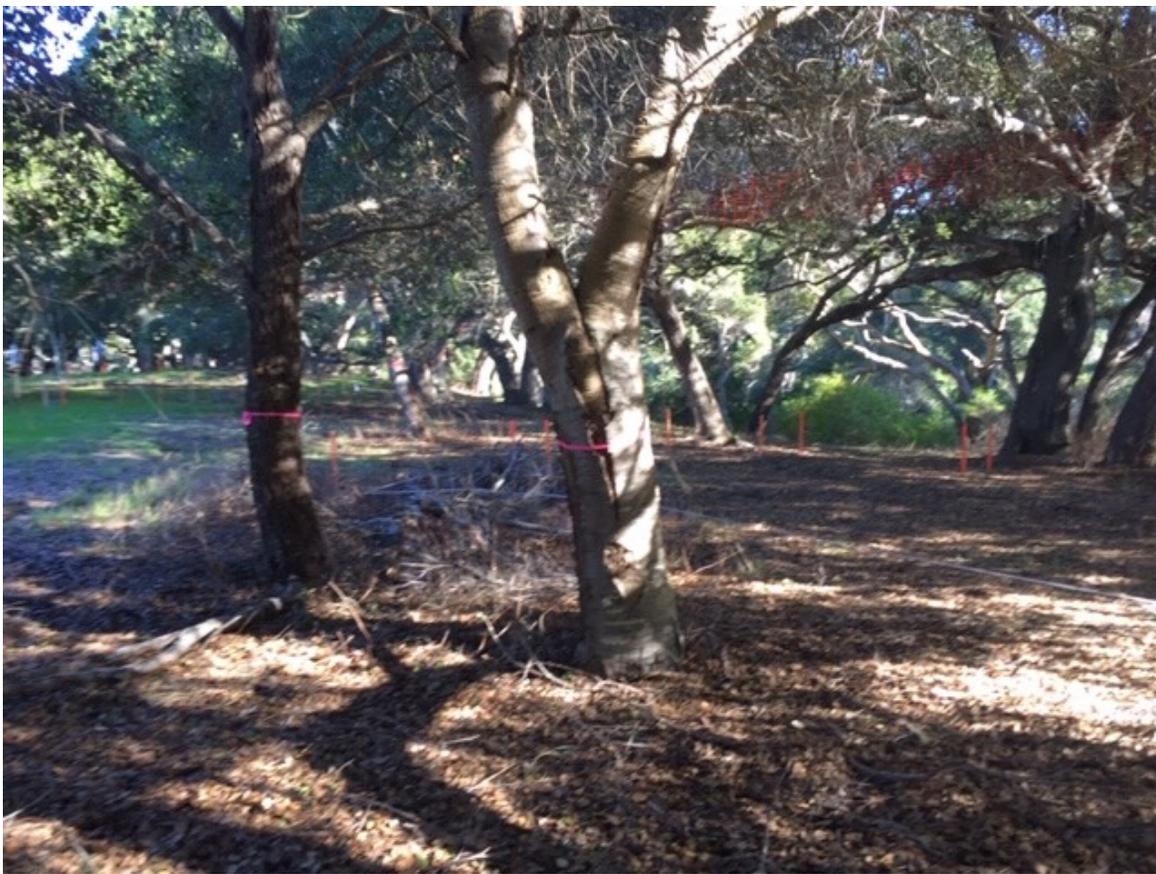
Figure 11. Coast live oaks identified as *Tree#61* (center of photo) and *Tree#62* (left of center) are planned for removal due to proposed garage location.

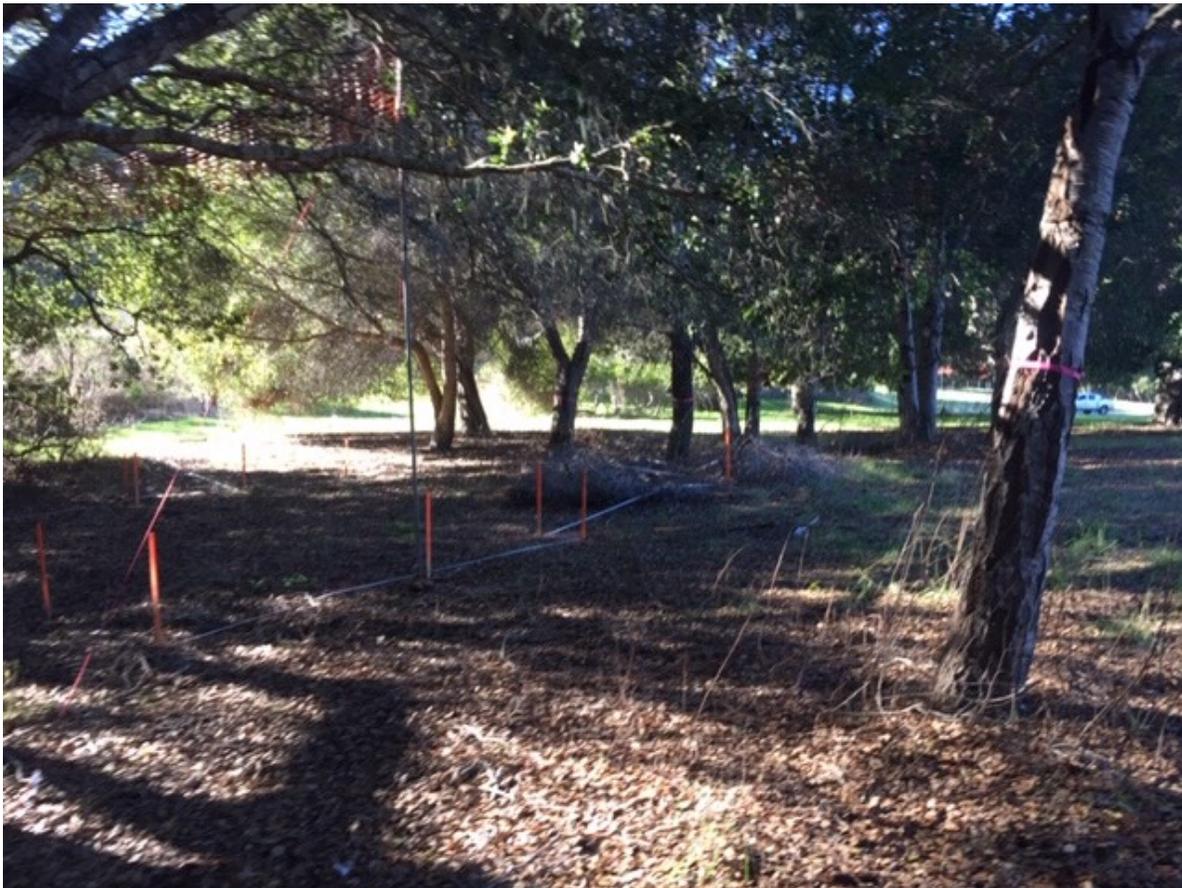
- 3) *Tree#63* is a 12 inch DBH coast live oak that is located within the proposed construction footprint for the gravel driveway (refer to *Figures 12 & 13*). This semi-mature tree is currently in overall fair health and condition, but has a notable lean and poor canopy balance and symmetry due to more dominant nearby oaks. If tree removal is approved plant three (3) replacement oak trees to support and sustain woodland health and character and to satisfy County tree removal permit requirements.

Figure 12. Oak identified as *Tree#63* (right edge of photo) is proposed for removal due to driveway location. *Tree#s 61 & 62* are in center background.

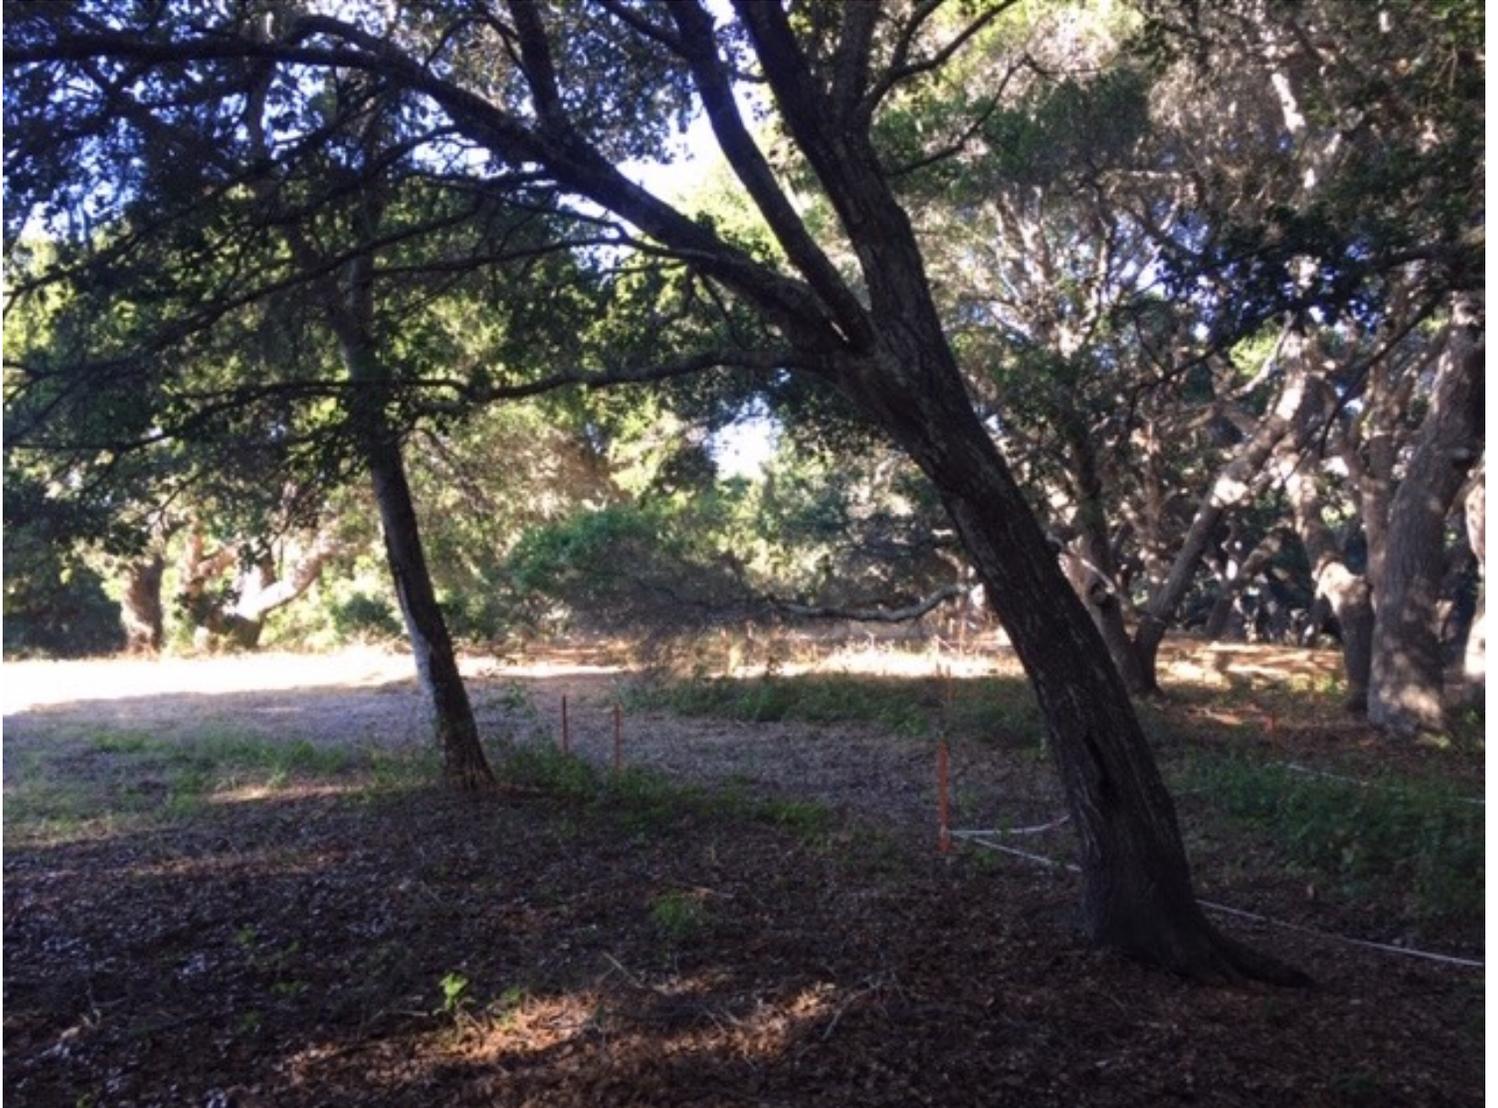
Figure 13. Oaks identified as *Tree#63* (left of center) is planned for removal due to location within driveway. *Tree#64* (right of center in foreground) will be retained and protected.
