4161 Sunridge Road
Tree Assessment
Arborist report

Prepared for:

Steven Rivera

August 10, 2023

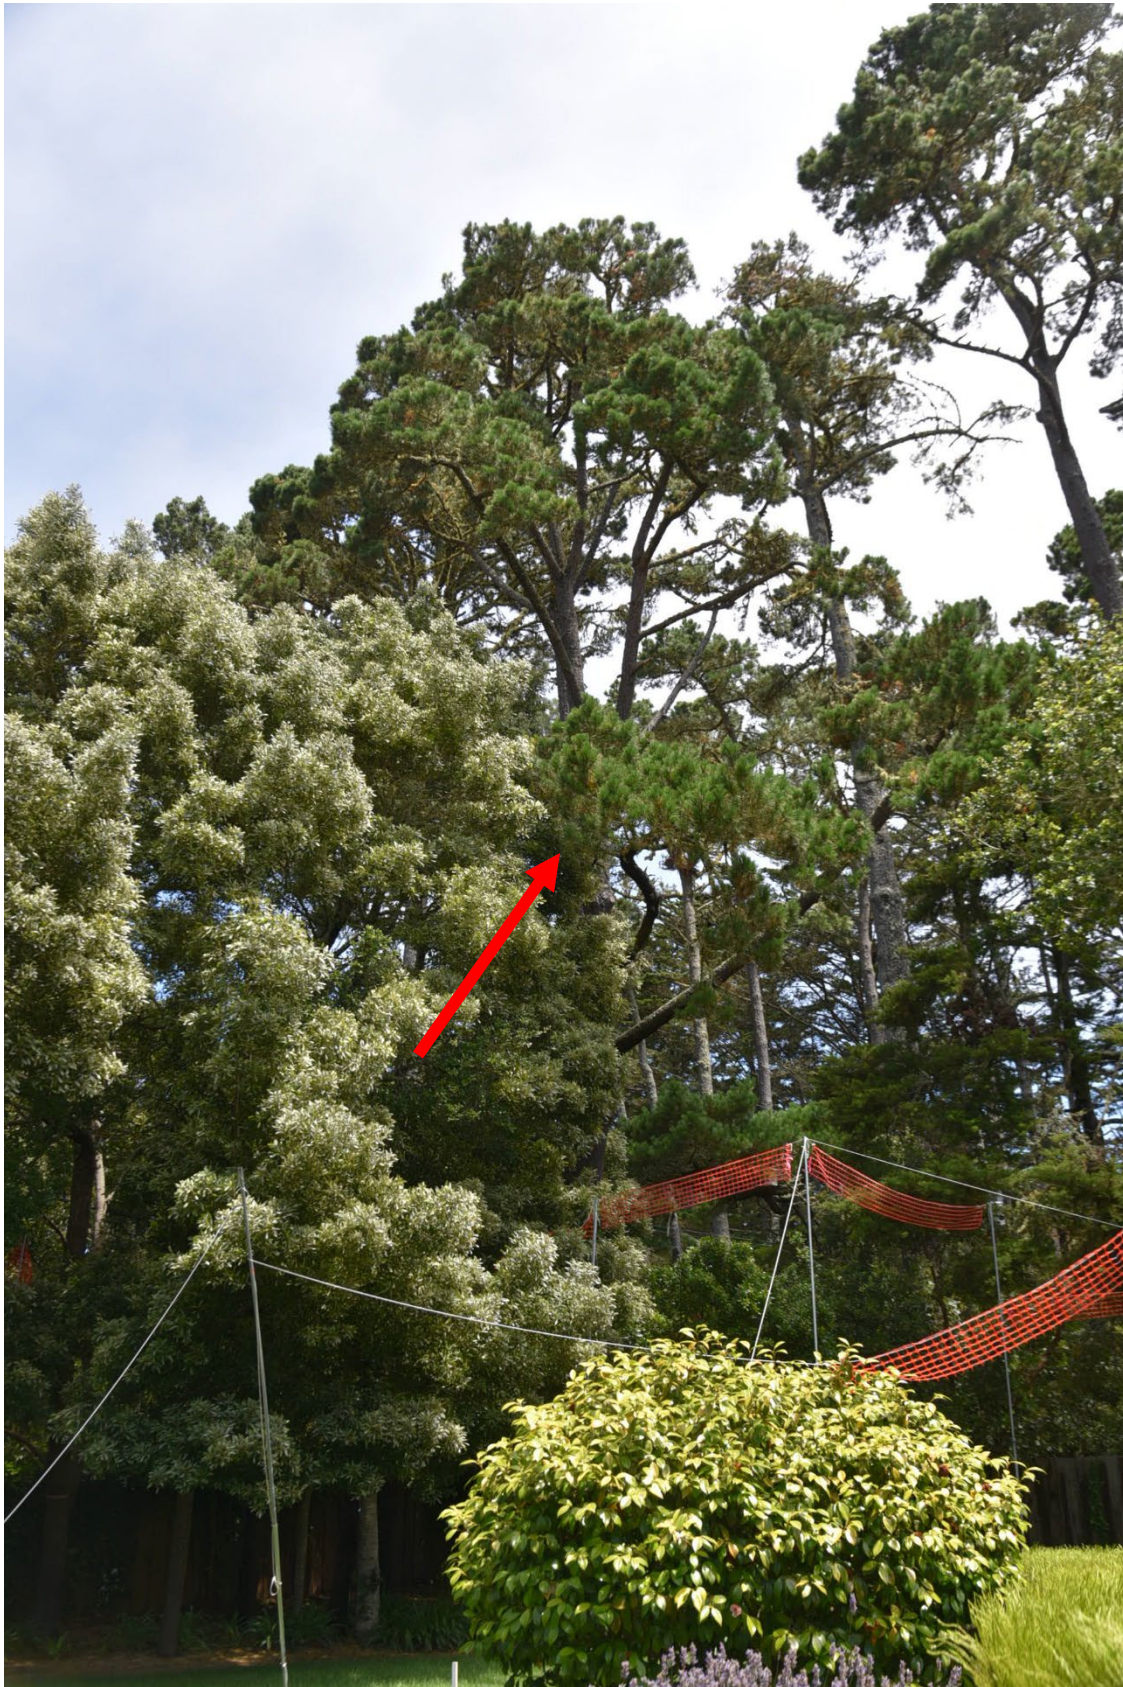
- #766 – 10" Coast live oak is within the building footprint.
 - #763 – 36" Monterey pine will require root loss, (approximately 24% or more); thus, its stability will be questionable.

Tree #763 is a large-diameter pine that will become impacted by grading

Two county-protected trees are proposed for removal on this project; a 10” diameter oak and a 33” diameter Monterey pine. The pine should be replaced at a minimum with two 5-gallon size Monterey pines to sustain the forested environment and the oak should be replaced by a five-gallon size or larger oak. All other County-protected trees are to remain and be protected from construction effects when closer than 25 feet from construction.

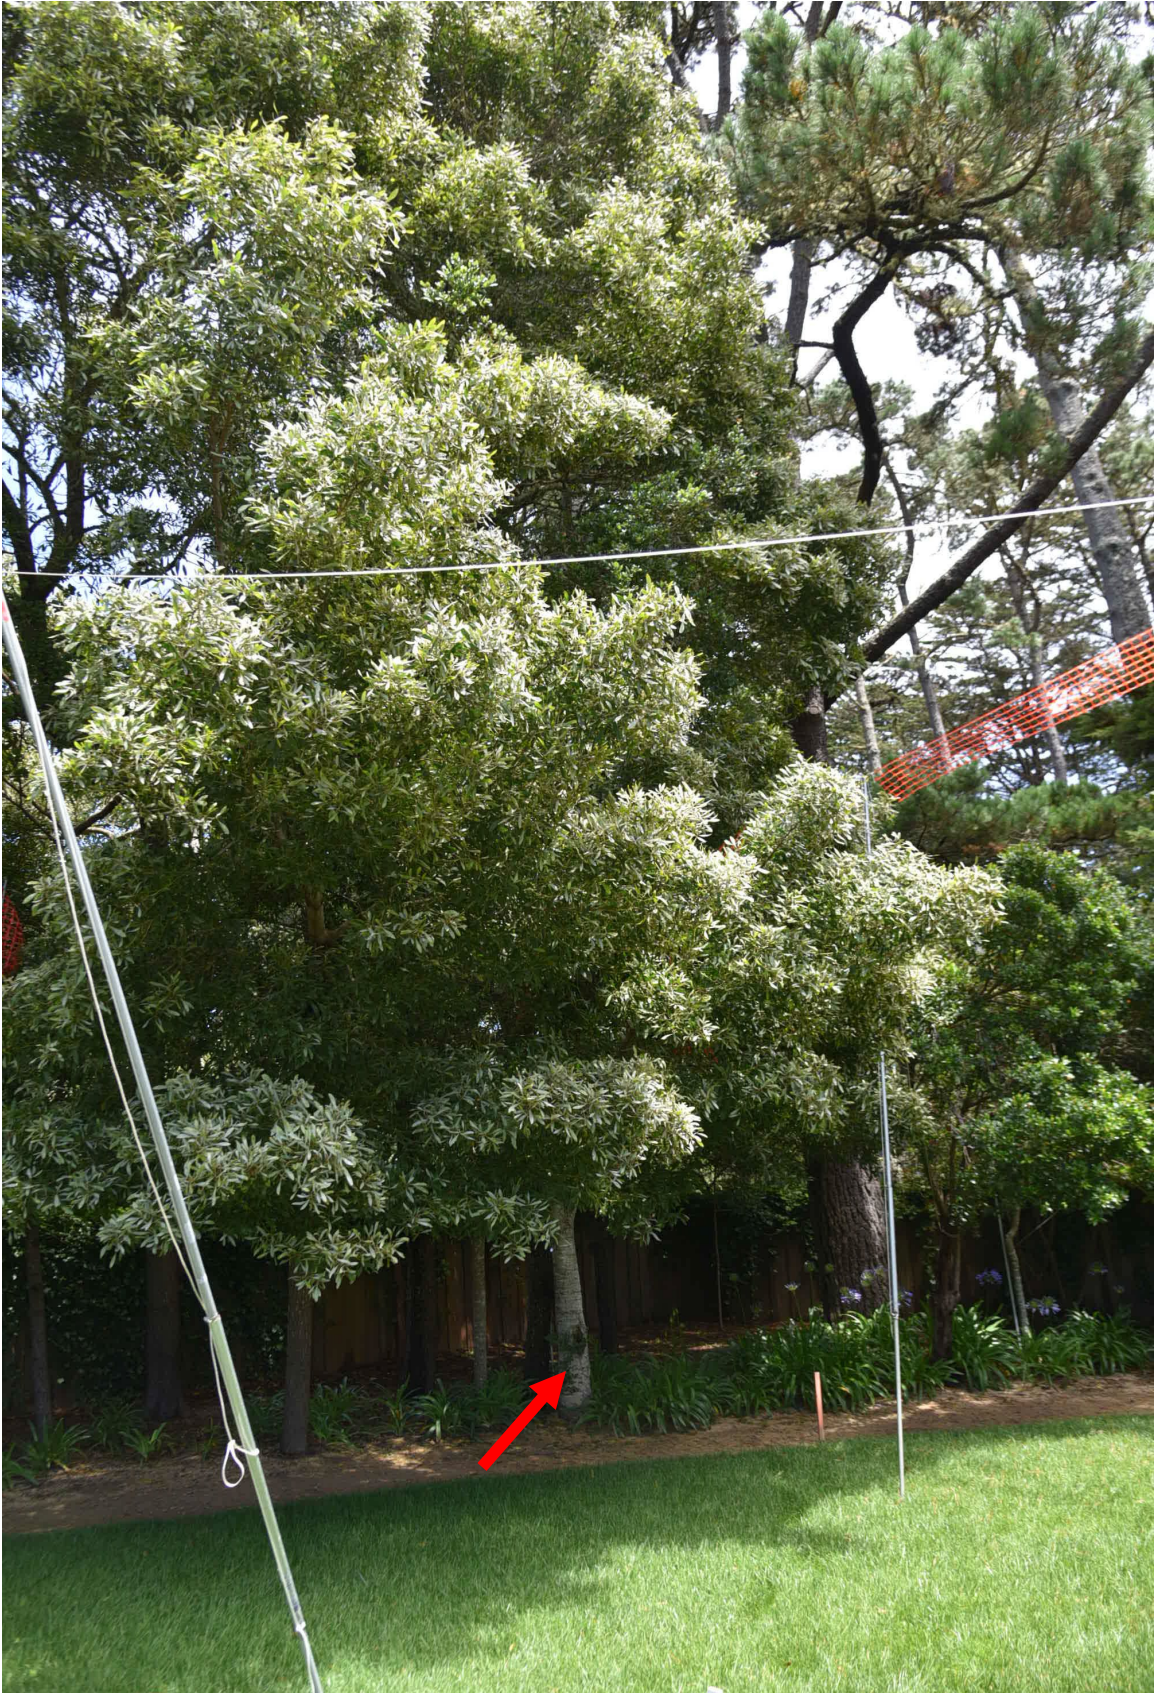
Oak #766 is hidden by Black acacia that must be removed.
