# 4161 Sunridge Road Tree Assessment Arborist report

Frank Ono Forester Society of American Foresters I.D. # 48004 Certified Arborist #536 1213 Miles Avenue Pacific Grove, CA 93950

August 10, 2023

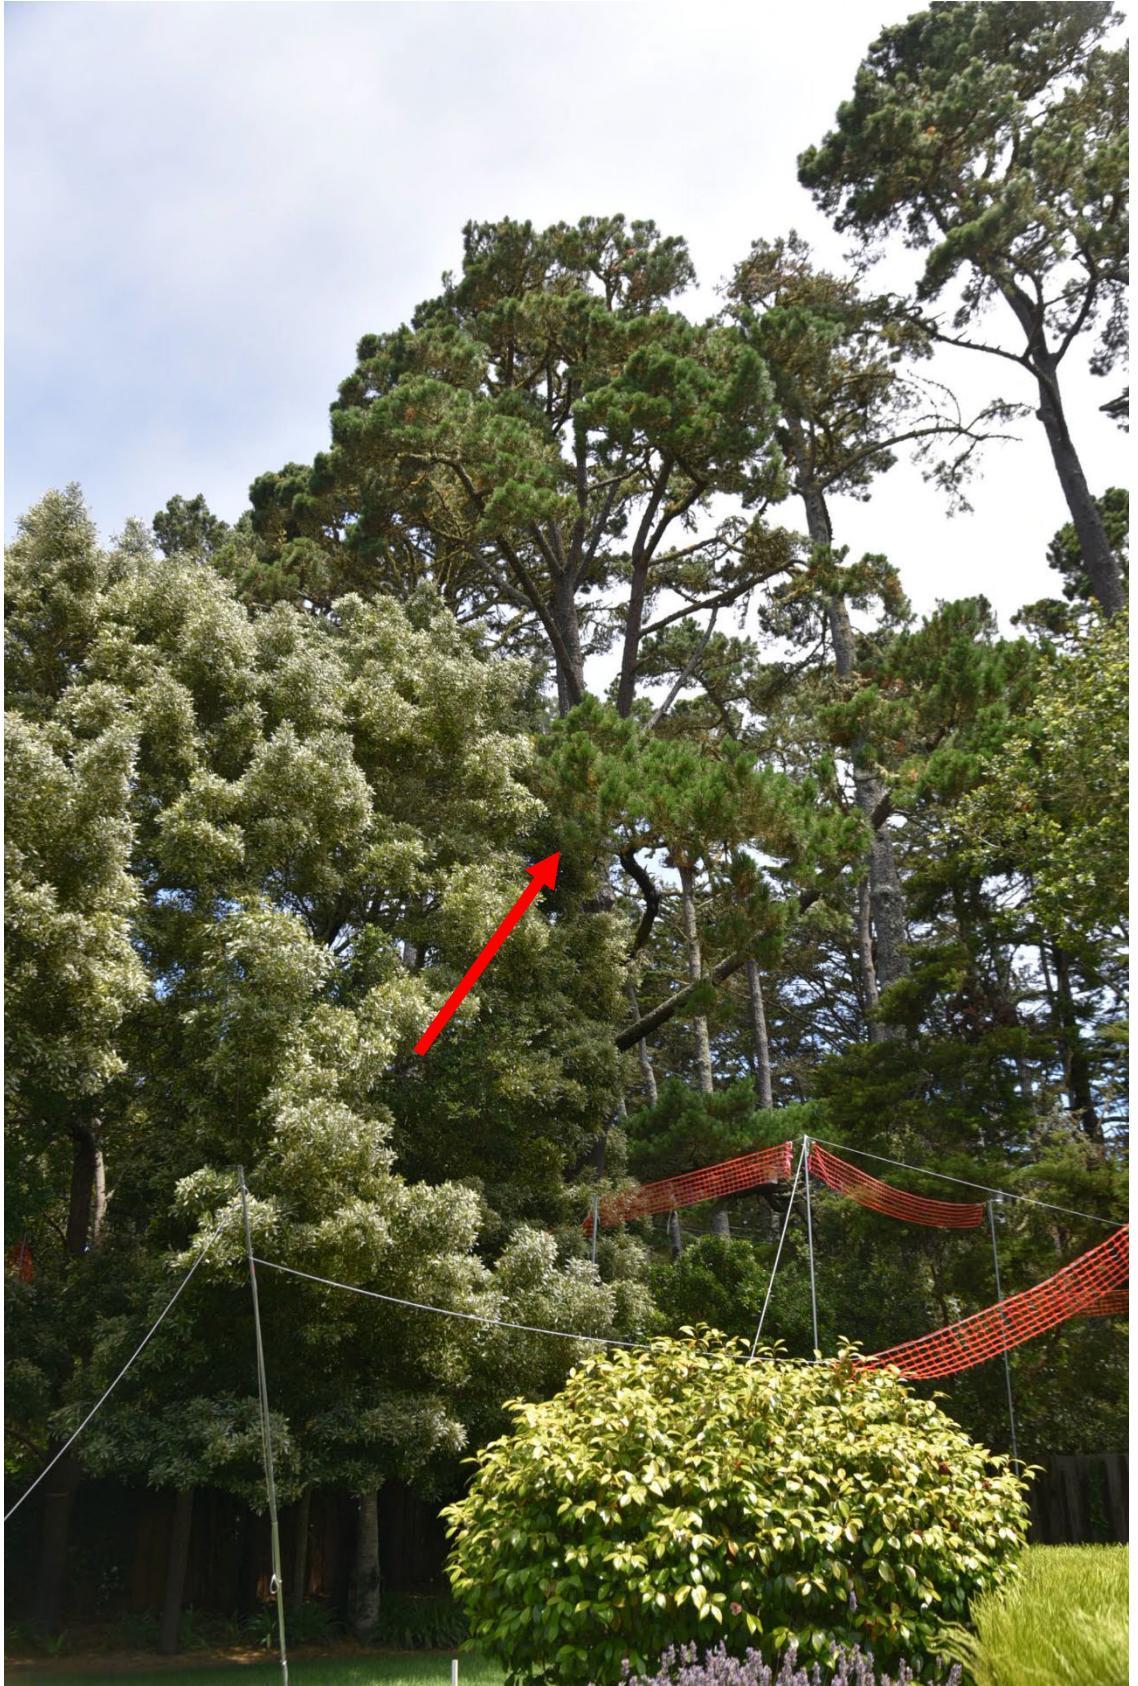
- #766 10" Coast live oak is within the building footprint.
  - #763 36" Monterey pine will require root loss, (approximately 24% or more); thus, its stability will be questionable.

Tree #763 is a large-diameter pine that will become impacted by grading

Two county-protected trees are proposed for removal on this project; a 10" diameter oak and a 33" diameter Monterey pine. The pine should be replaced at a minimum with two 5-gallon size Monterey pines to sustain the forested environment and the oak should be replaced by a five-gallon size or larger oak. All other County-protected trees are to remain and be protected from construction effects when closer than 25 feet from construction.

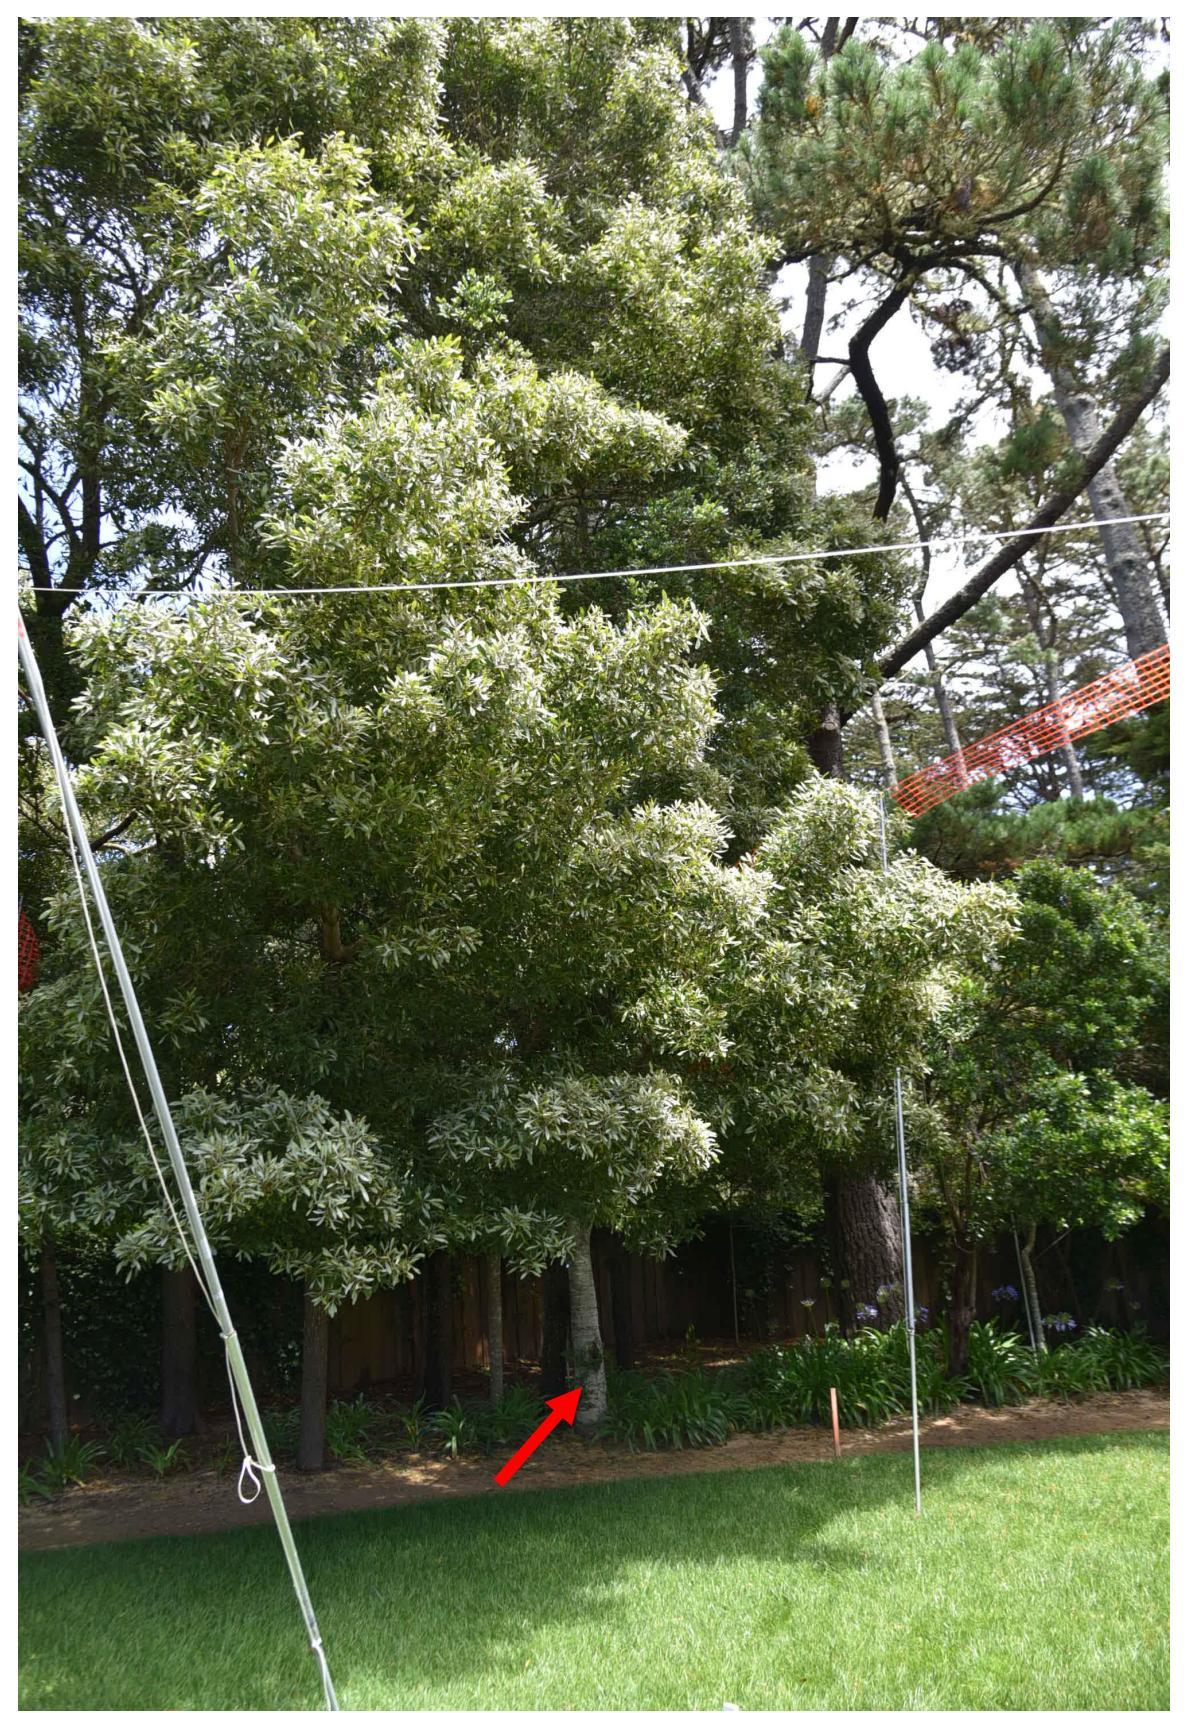
Oak #766 is hidden by Black acacia that must be removed.
