LOT-SPECIFIC FUEL MANAGEMENT PLAN

DECEMBER 5, 2022

LOT 119 FUEL MANAGEMENT PLAN

21 EAST PRONGHORN RUN; APN 239-091-044

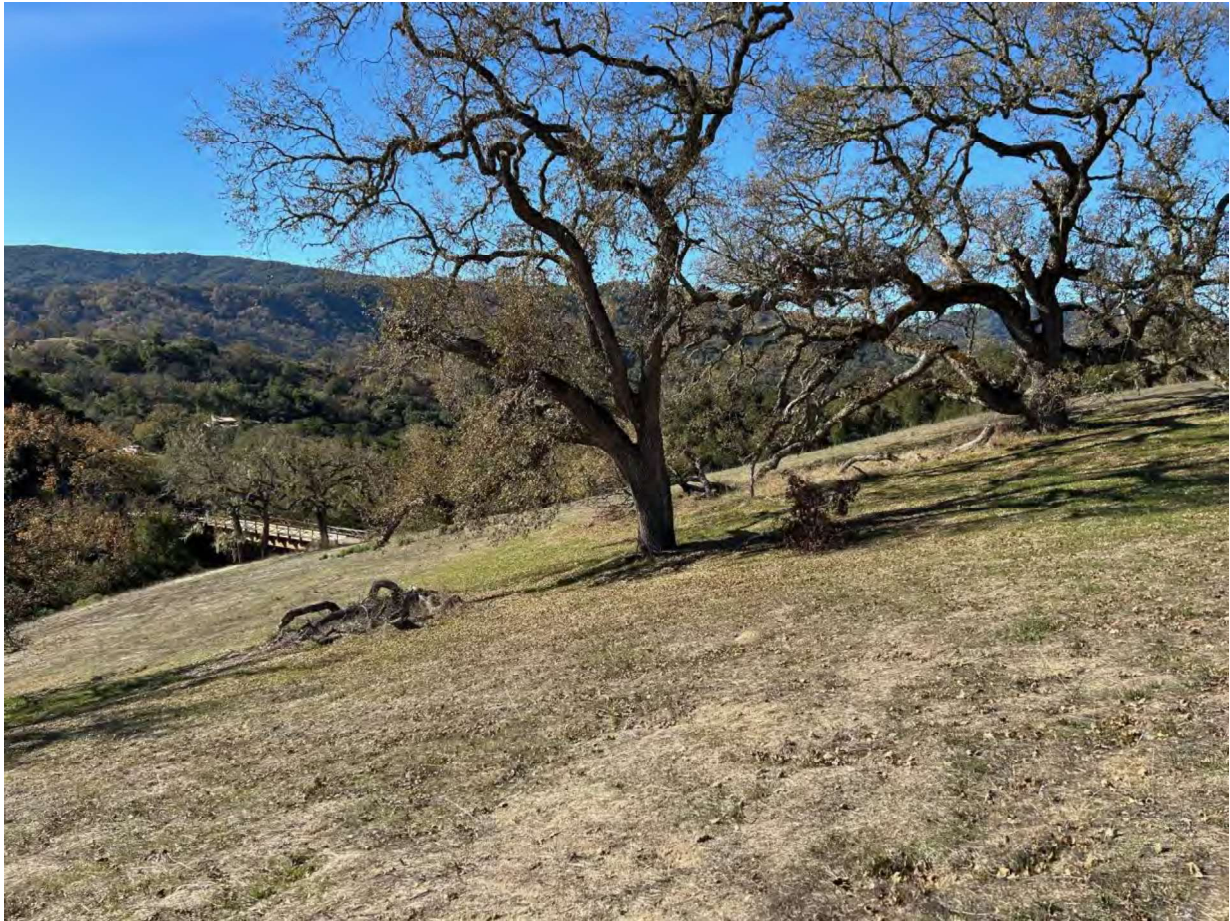
FIGURE 1. PHOTO OF LOT 119 TYPICAL VEGETATION.

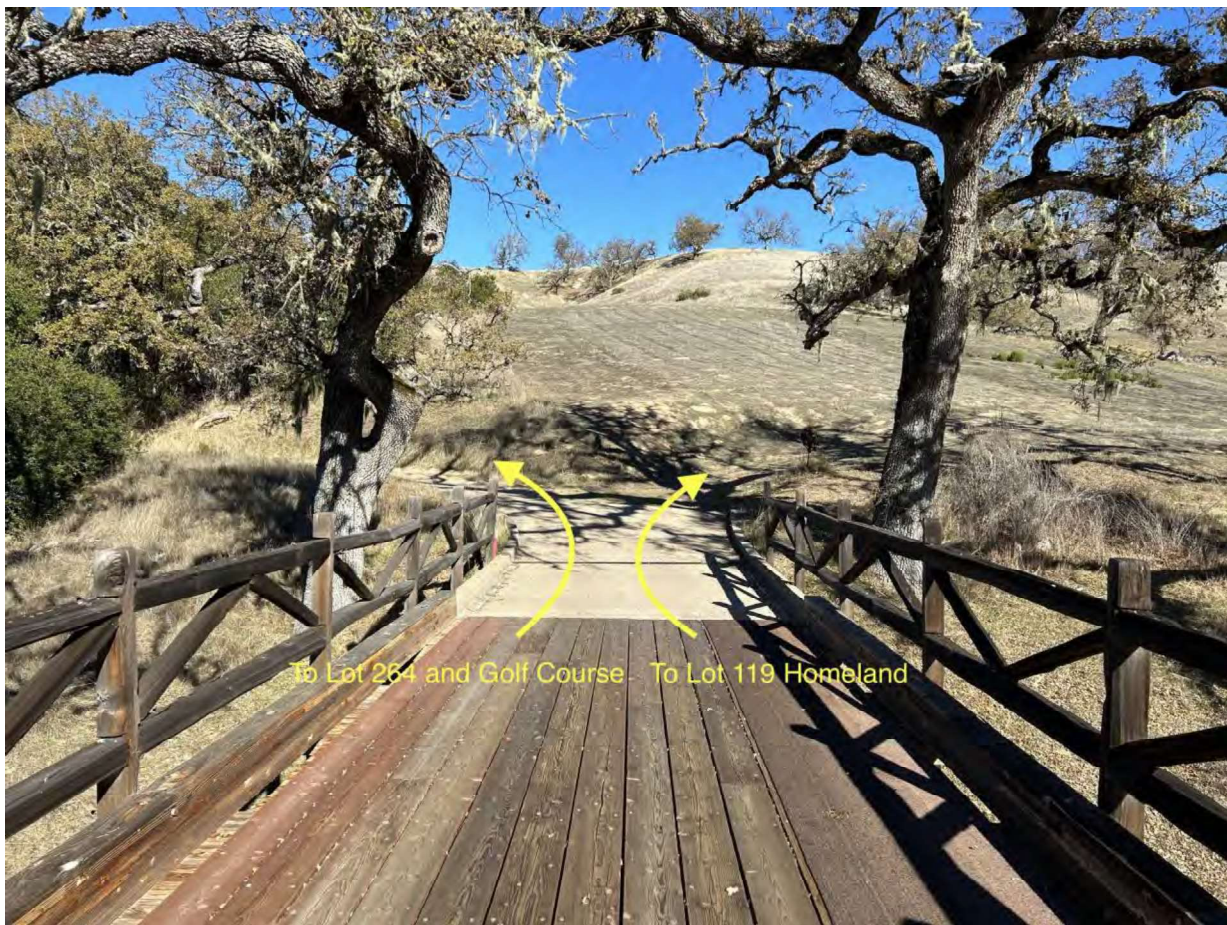
Lot 119 is accessed from East Pronghorn Run, as described above. The driveway to the residence from the named road is narrow, shared with the Preserve Golf Course, and is approximately 1,140 feet in length. The driveway traverses a moderate grade, containing multiple turns and a long, wood-framed bridge. The driveway does not pose a hindrance to access or maintenance. The majority of the driveway is shared with the Golf Course (Lot 264). A short segment of the golf course access road passes through Lot 119 immediately southwest of Lot 119's Homeland.

FIGURE 3. PHOTO OF LOT 119'S ACCESS ROUTE.

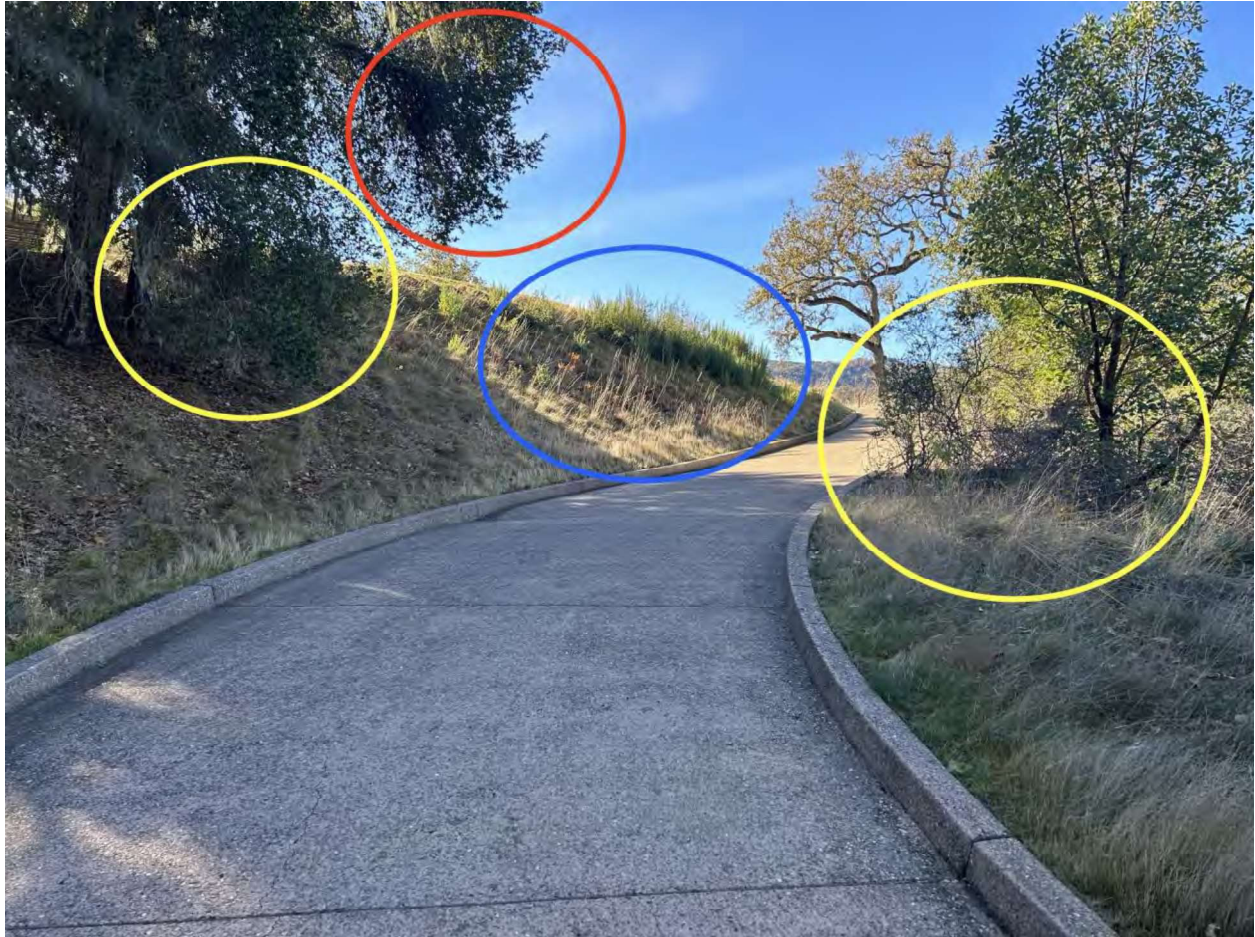
FIGURE 12. TYPICAL DRIVEWAY CONDITIONS FOUND ON LOT 119. SUGGEST REMOVING LOW HANGING BRANCHES (EX. AREA CIRCLED IN RED), REMOVE LADDER FUELS NEAREST ROAD SURFACE (EX. AREAS CIRCLED IN YELLOW), MOWING TO 15FT ON EITHER SIDE OF ROADWAY ONCE NATIVE GRASSES HAVE SET SEED (EX. AREA INDICATED IN BLUE)

- a. Grassland, and the understory of all Oak Savanna, and Oak Woodland vegetation should be mowed within 15 feet from the pavement edges, according to the recommendations in the Grassland Zone.
- b. All Chaparral, Coastal Scrub, and Oak/Shrub Woodland vegetation should be treated to 30 feet from the pavement edge, according to their respective recommendations.
- c. All tree branches extending over driveway surfaces should be pruned to ensure 15 feet of vertical clearance. Whenever possible, healthy overhanging branches higher than 15 feet should be left in place to shade driveway areas and thereby reduce weed and understory growth.
- d. Every residential structure shall have a dedicated fire hydrant and a hammerhead or other safe turnaround for fire equipment access as detailed in the Santa Lucia Preserve Design Guidelines.

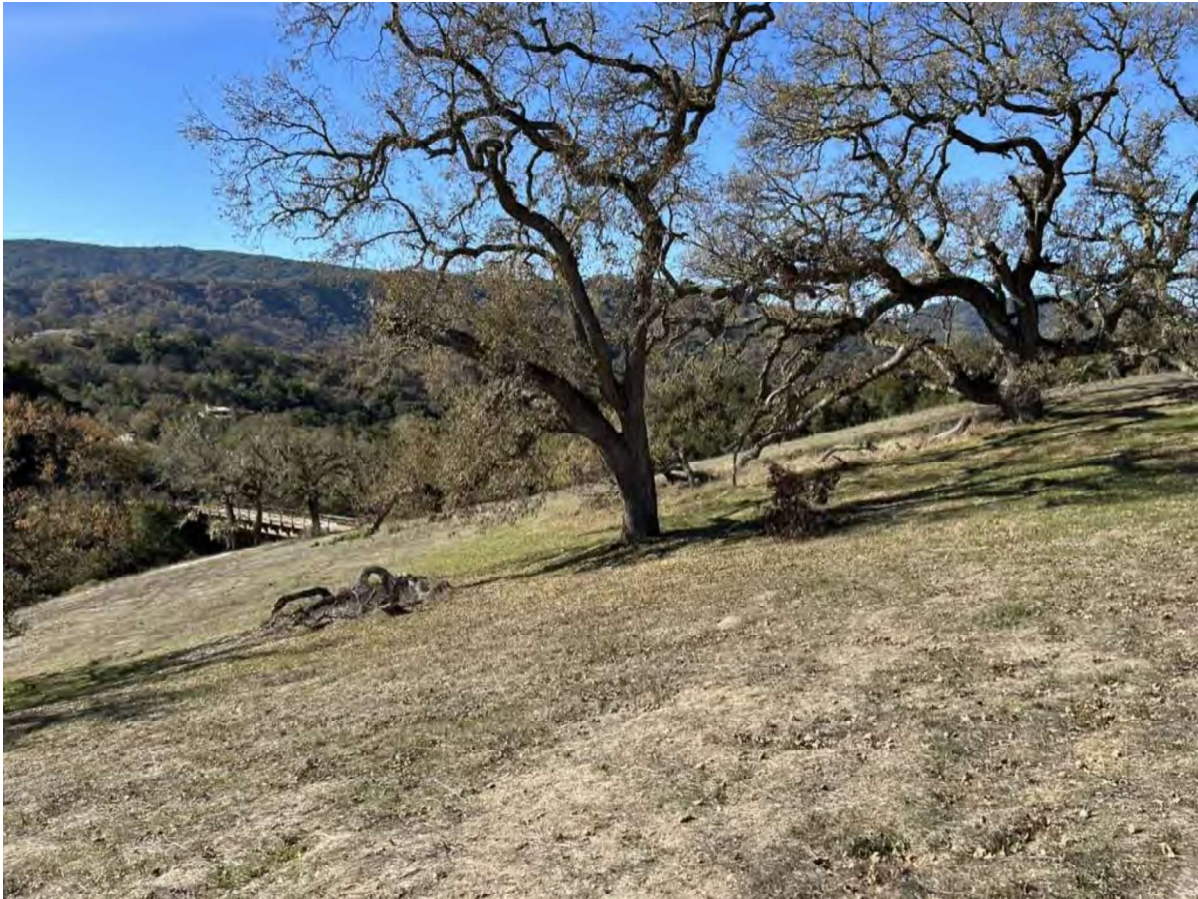
FIGURE 13. TYPICAL OAK SAVANNAH CONDITIONS FOUND ON LOT 119.

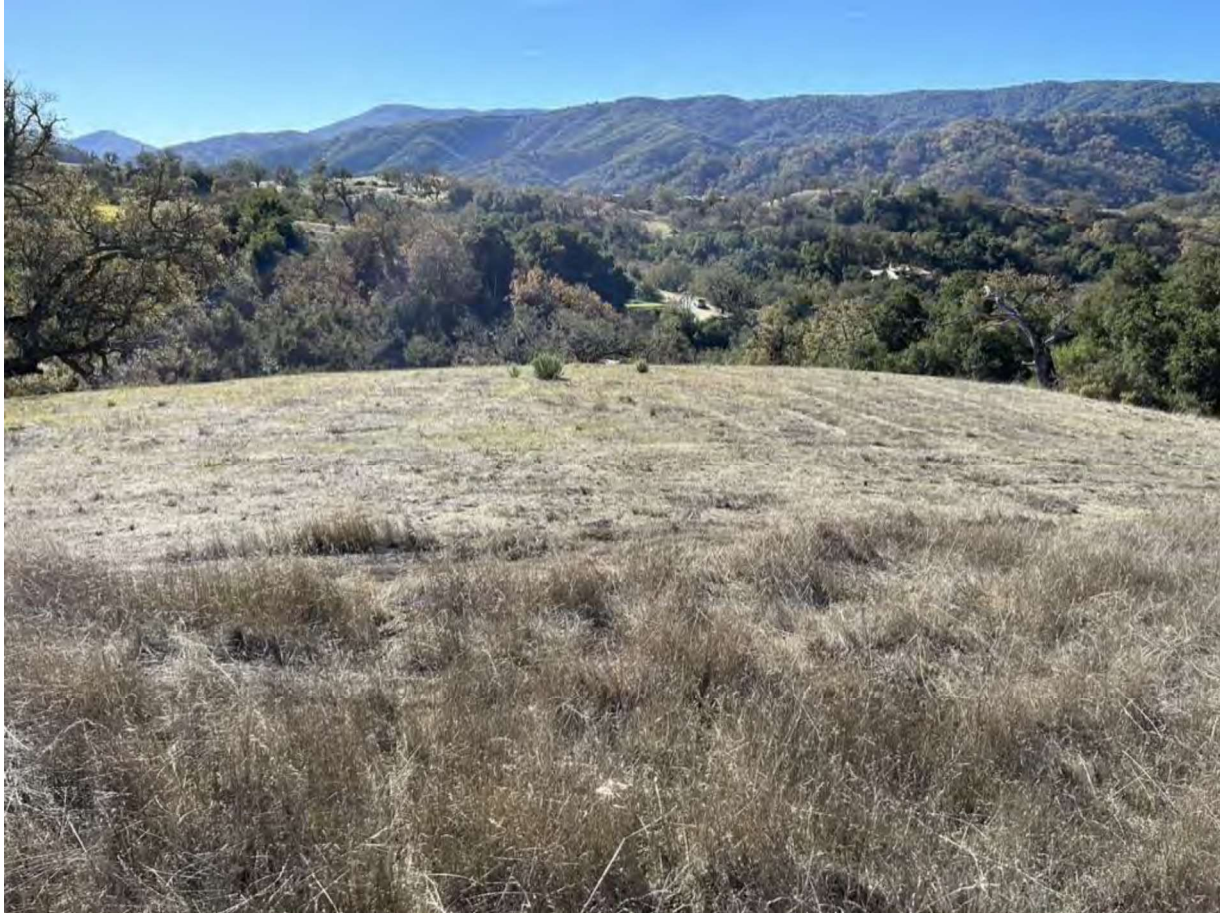
FIGURE 14. GRASS HEIGHT AND EXTENT WITHIN THE OAK SAVANNAH TREATMENT ZONE. RECOMMEND MOWING UNDER TREE CANOPIES, REMOVING DEAD MATERIAL, REMOVING LEAF LITTER AND LOW HANGING LIMBS, ACCORDING TO PRESCRIPTIONS.

- a. Within 30 feet of structures, all grassland areas should be mowed in early summer to a height of four inches, according to the recommendations in the Grassland Zone.
- b. Within 100 feet of structures, all grass growing under trees, out to 6 feet beyond the driplines of trees, should be mowed in early summer to a height of four inches.

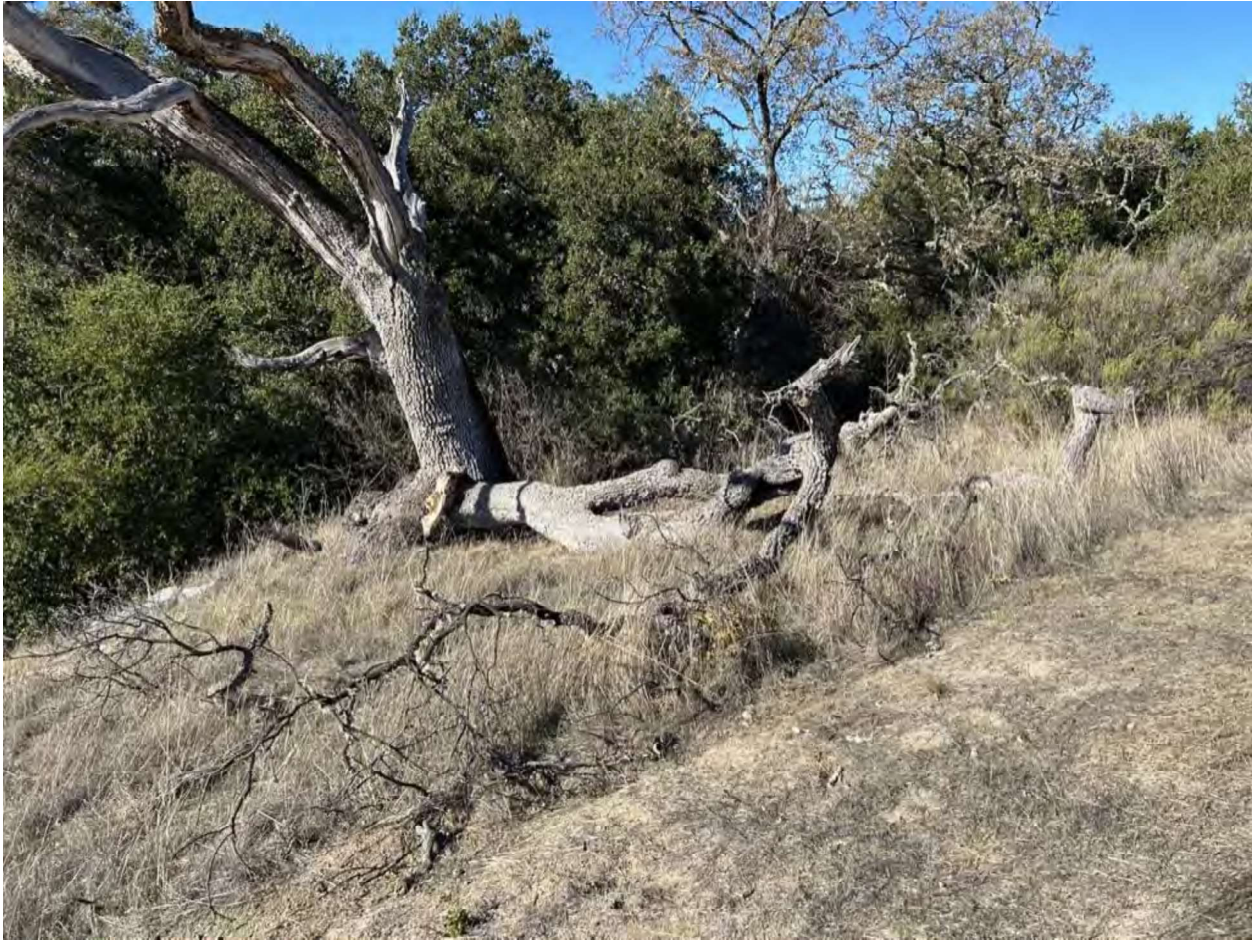
FIGURE 15. LARGE DEAD LOGS MAY REMAIN WITHIN THE OAK SAVANNA TREATMENT ZONE UNTIL THEY BECOME ROTTED OR FRIABLE.

- a. Throughout the Fuel Management Zones, remove all dead branches on the ground smaller than 6-inch diameter.
- b. Large dead material located within the fuel management zone may be removed or relocated as recommended by a Lot-Specific Plan. Dead limbs larger than 8 inches in diameter, in the Fuel Management Zones within the Openlands, should remain on the site if isolated from dead material that is smaller than 4-inches in diameter, if not under a tree canopy, or if moved at least 100 feet from the structure. Large woody material by itself does not ignite readily and does not produce long flames. Retaining these features in open areas serves a beneficial purpose of retaining soil moisture and supports important wildlife, including native pollinators. Once dead logs become rotted through and friable, they should be removed or scattered in the general area to avoid a concentration of lighter fuels. **Note: some dead branches and larger logs were observed in this zone during the November 29, 2022 site visit.**

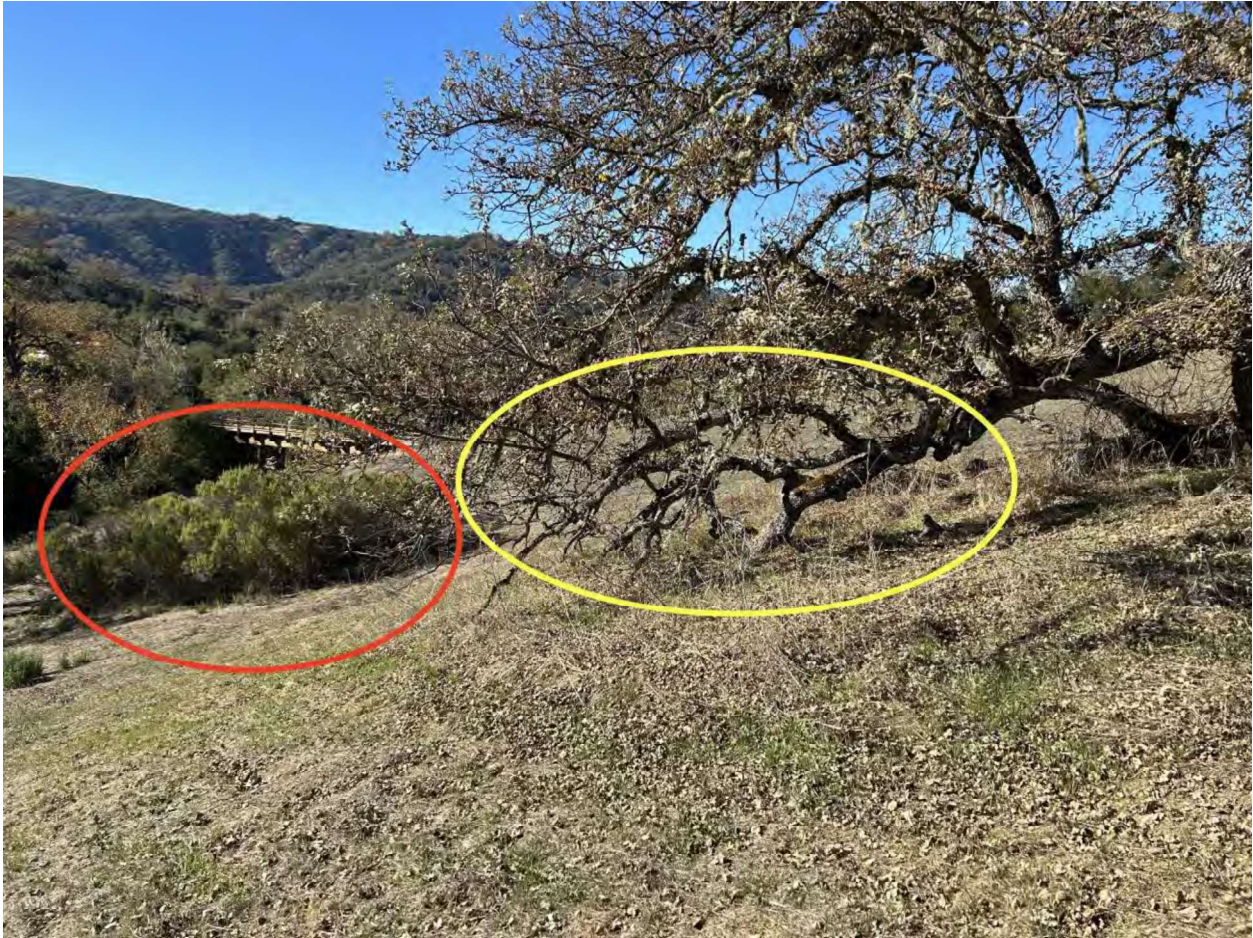
FIGURE 17. CARE SHOULD BE TAKEN TO REMOVE ONLY BRANCHES SMALLER THAN 3 INCHES IN DIAMETER (SEE AREA CIRCLED IN YELLOW ABOVE). IF RETAINING BRANCHES FOR SCREENING OR AESTHETIC PURPOSES, UNDERSTORY MUST BE CLEARED TO BARE MINERAL SOIL BELOW LOW HANGING BRANCHES. NOTE COYOTE BUSH STAND IN THE OAK SAVANNAH ZONE (CIRCLED IN RED), WHICH SHOULD BE REMOVED.

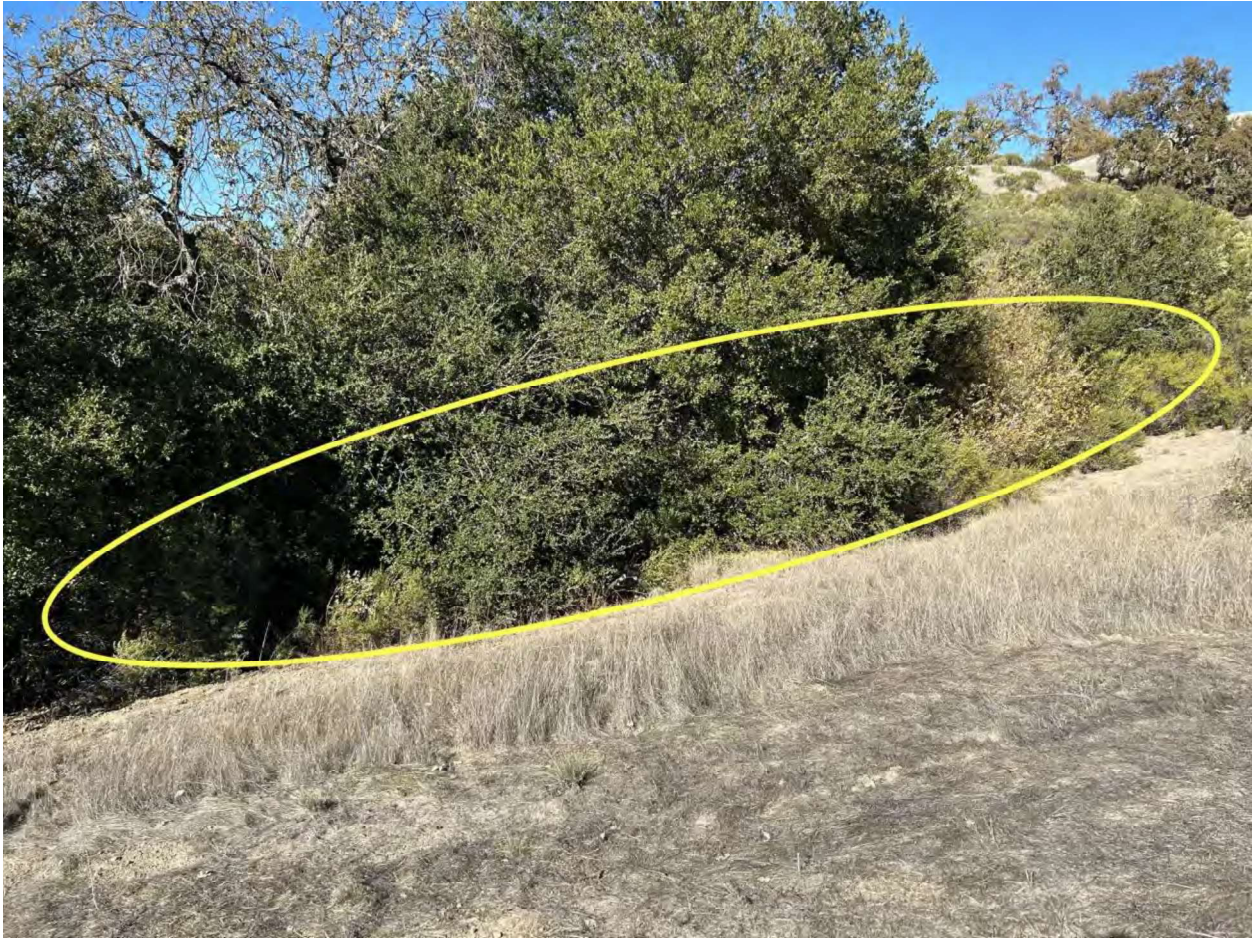
As indicated above, the ladder fuels in the Valley oak/Coast live oak area to the west of the planned structures are also in need of treatment as fire approaching from the Lot 264 (or the Golf Course) is a possible scenario where there are various potential sources of ignition (ex. Equipment or vehicle fire, cigarette butt, etc.). See Figure 8 Fuel Treatment Zones map for more details. Fuels may be treated in a "mosaic" pattern to allow for maximum ecological benefit and in order to keep desired visual screening for privacy.

FIGURE 18. DENSE LADDER FUELS GROWING IN THE VALLEY OAK / COAST LIVE OAK (VOCL) ZONE IN THE OPENLANDS, WITHIN THE 150 FOOT TREATMENT RADIUS, DUE WEST OF THE PLANNED STRUCTURES ON LOT 119.

- a. All branches, living or dead, less than 3 inches diameter in width and less than either 8 feet from the ground or three times the height of any understory shrubs whichever is greater, shall be removed (Figure 16).

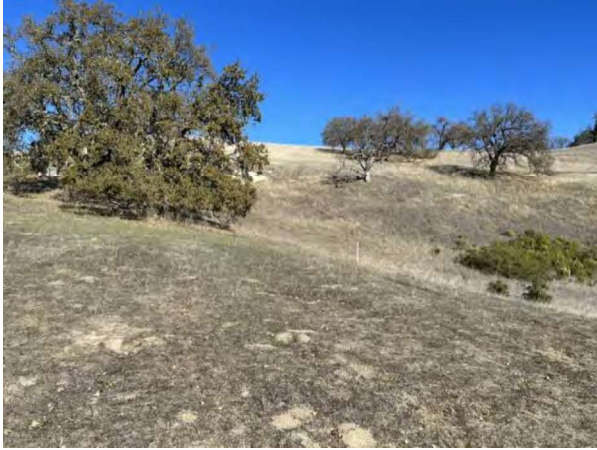
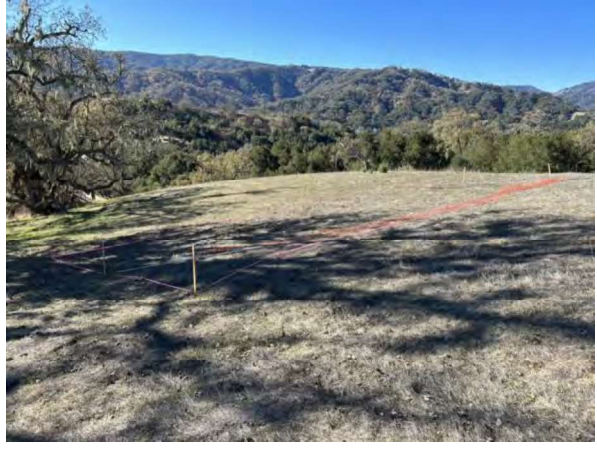
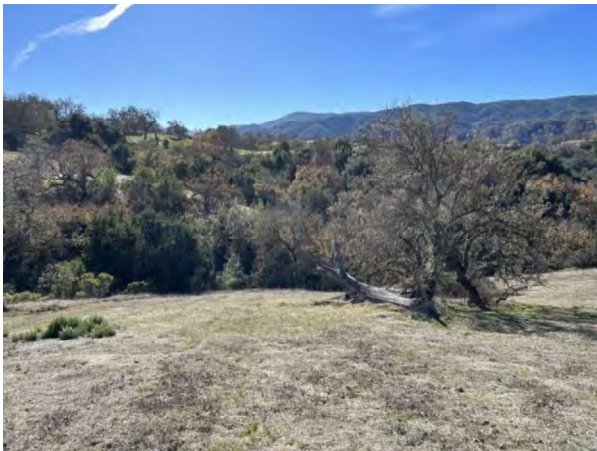
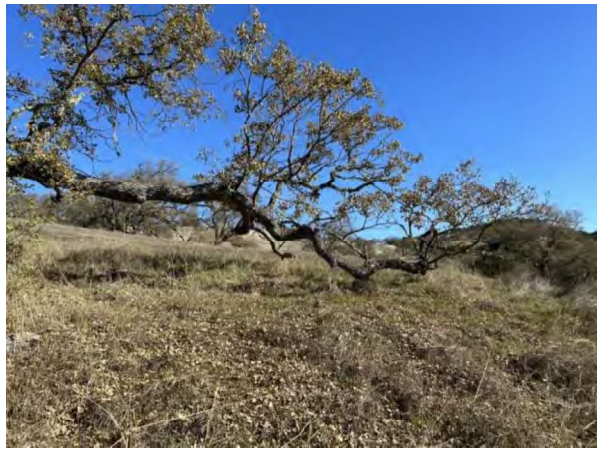
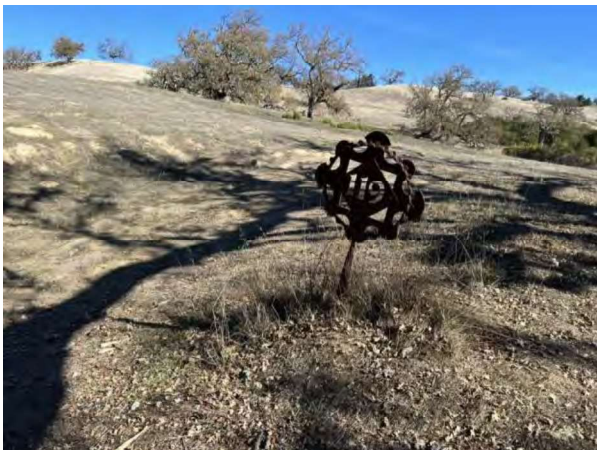
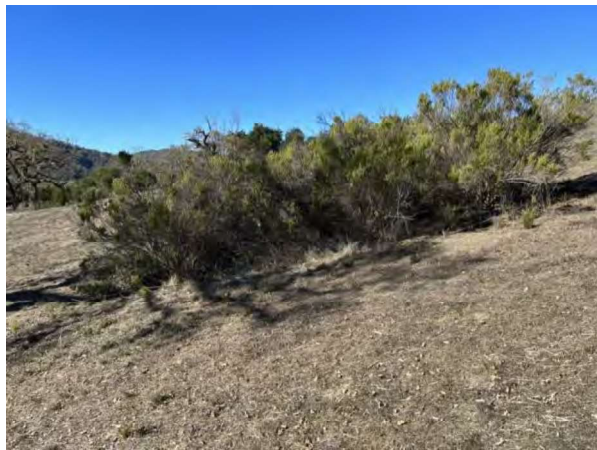
Valley oak (VaOa) Zones adjacent to and surrounding building site on Lot 119.

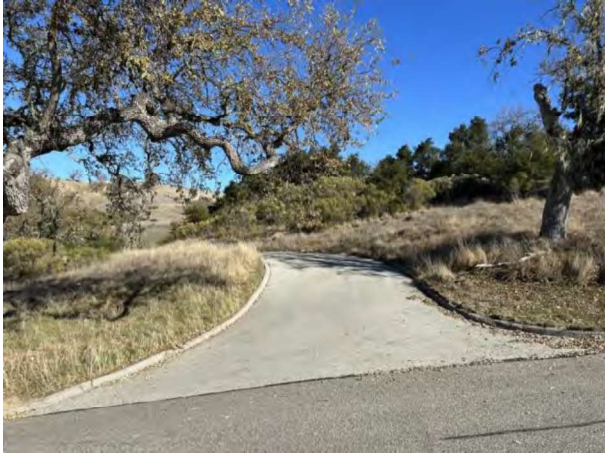
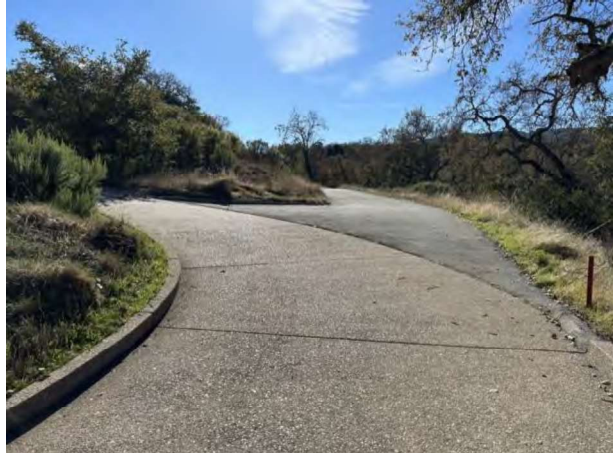
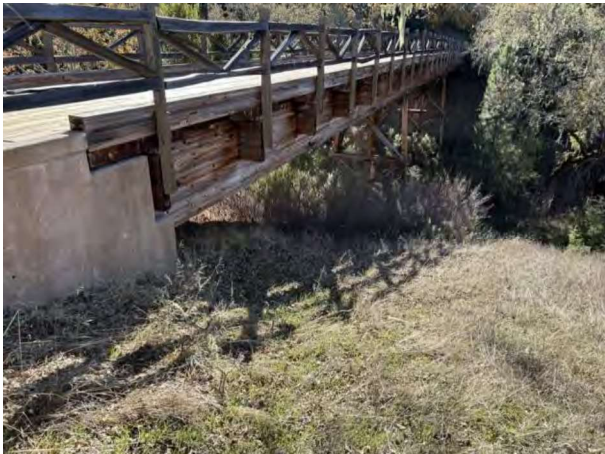
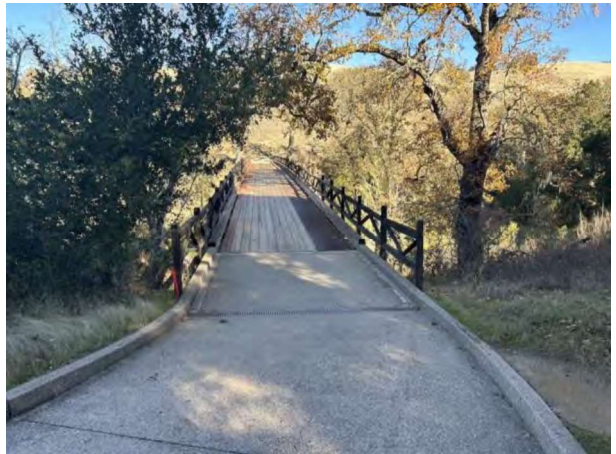
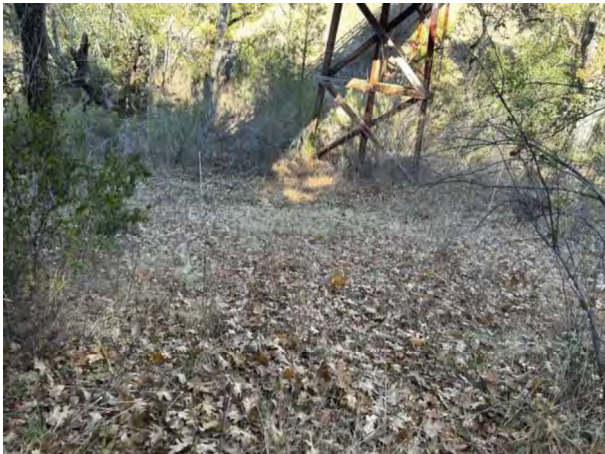
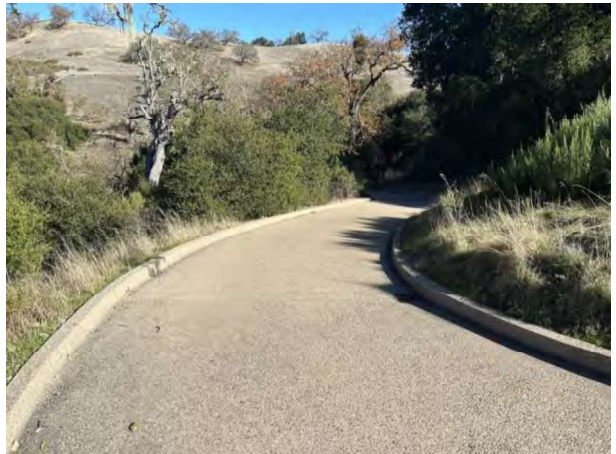
Shared Driveway and Wooden Bridge.
