RE: Oak Restoration and Forest Management Plan – 146 Vega Road APNs: 117-471-003-000, 117-471-004-000, 117-471-006-000. 117-471-007-000, and 117-471-016-000

Oak Restoration/ Forest Management Plan 146 Vega Road

Prepared by Ono Consulting 311 Forest Ave, Box 14 Pacific Grove, CA 93950

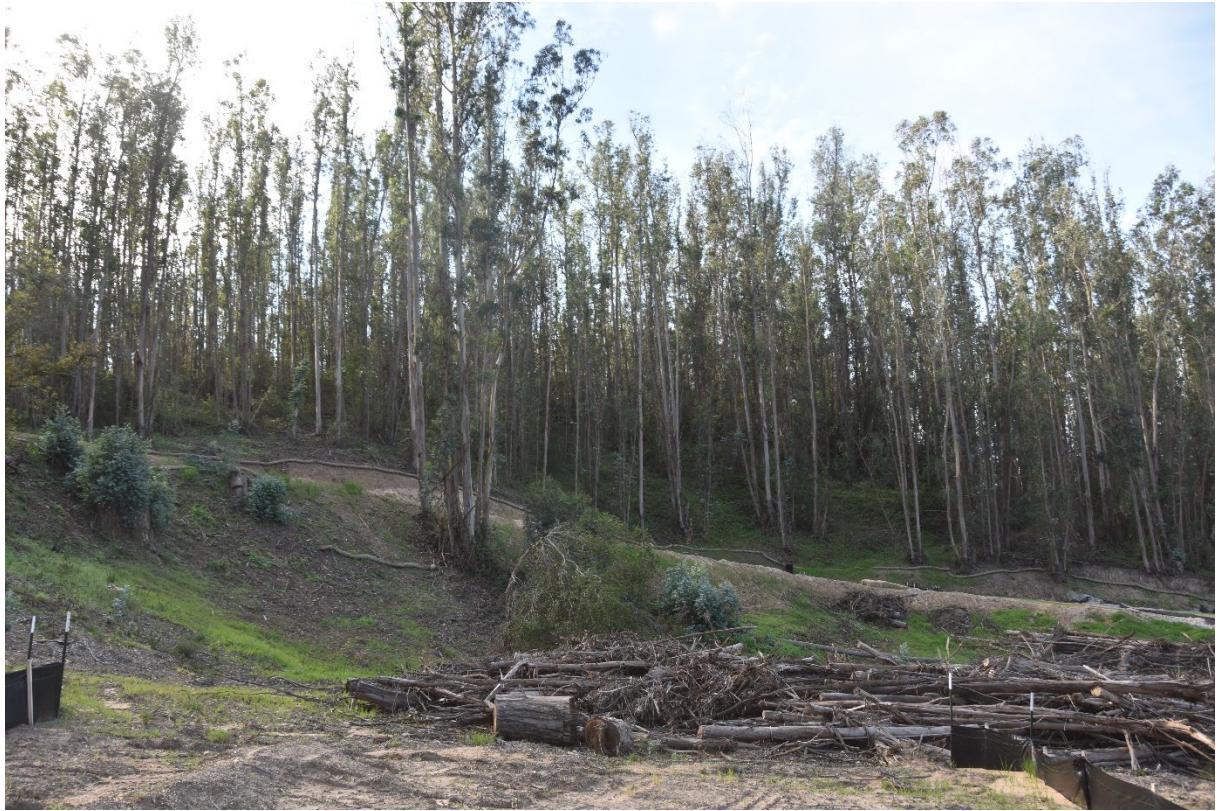
Evenly spaced Eucalyptus stumps adjacent to roadwork.

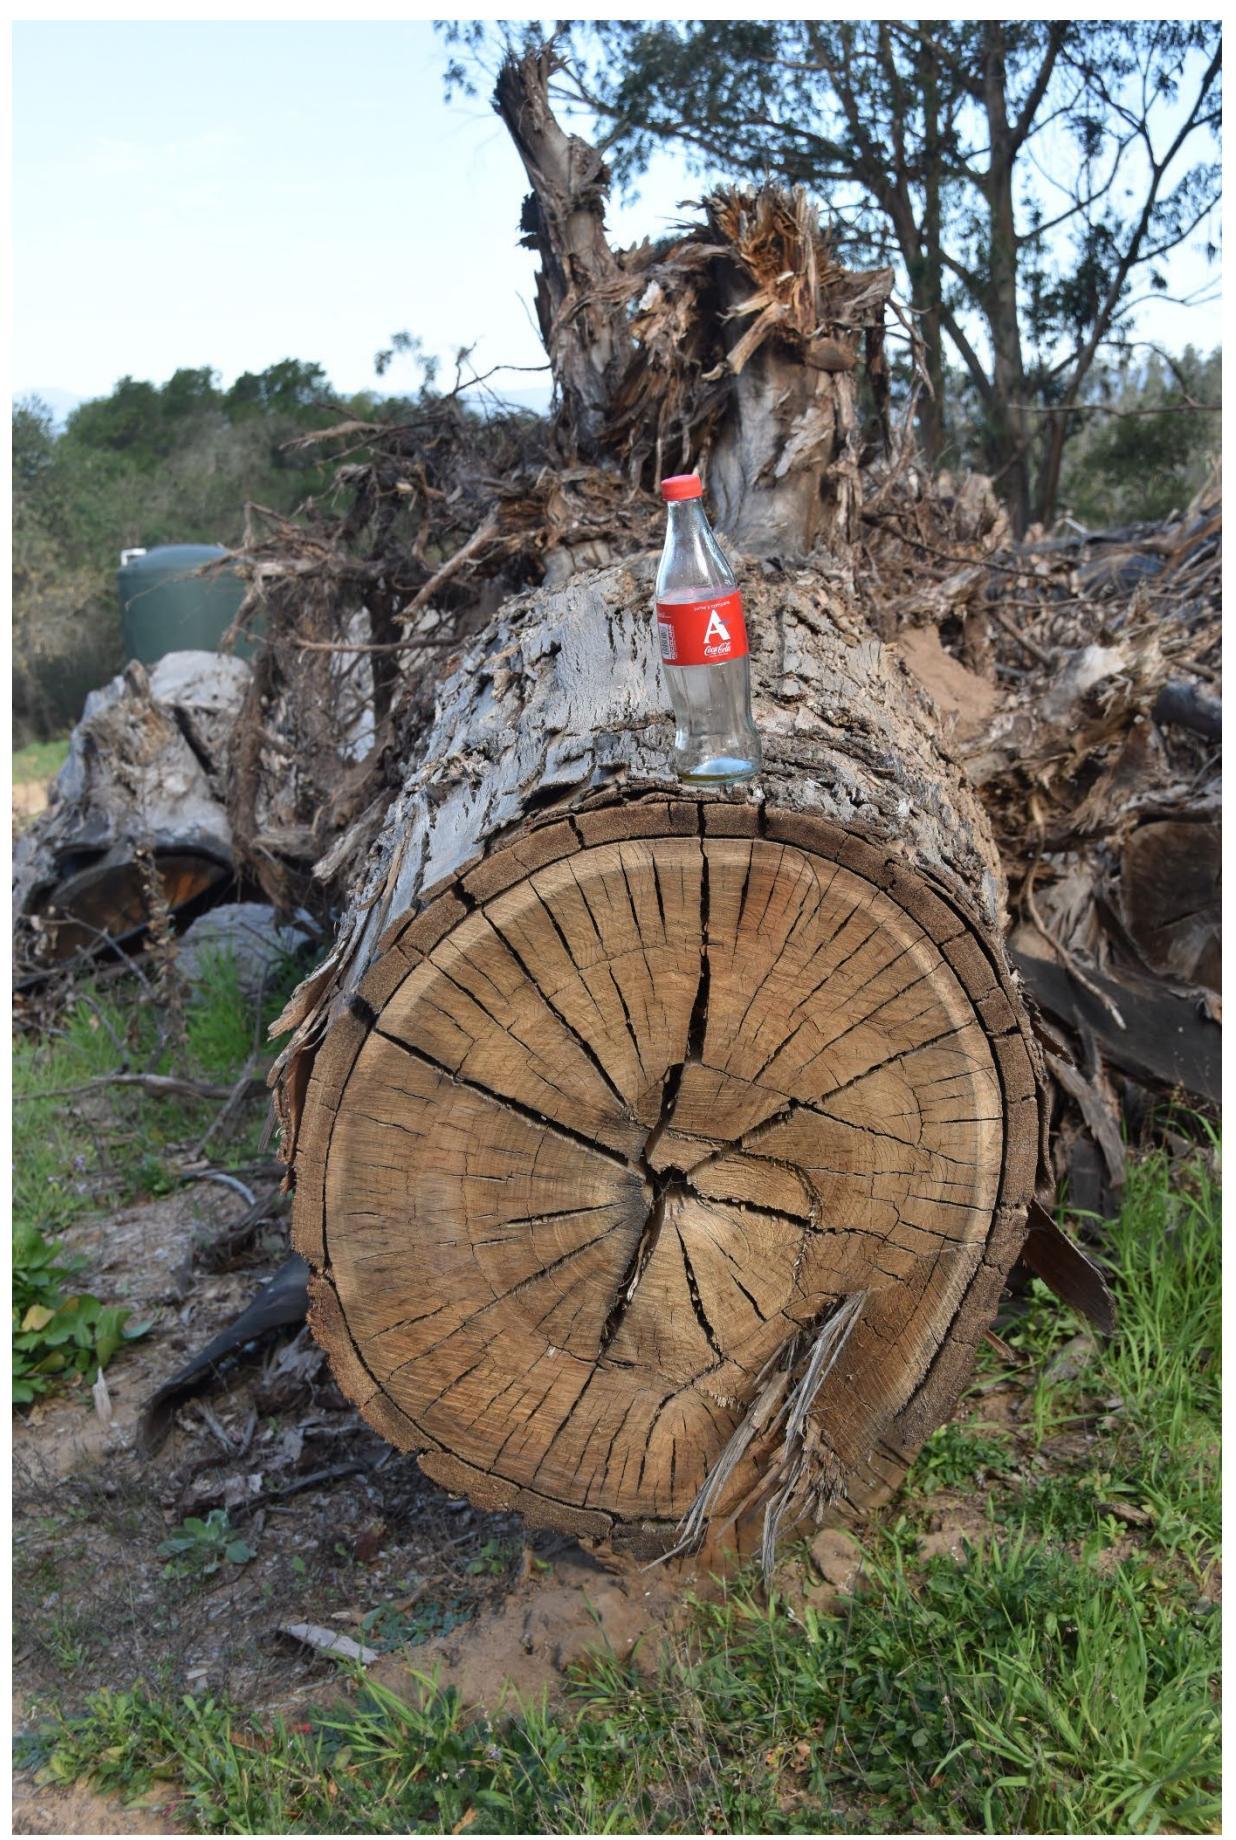
- The existing Eucalyptus trees appear to have been harvested two to three times with multi-clustered stems ranging from 10-24-inches in diameter.
- Trees removed for roadway construction are all Eucalyptus under 30-inches in diameter.

One of the larger stems observed removed. Approximately 22-inches.

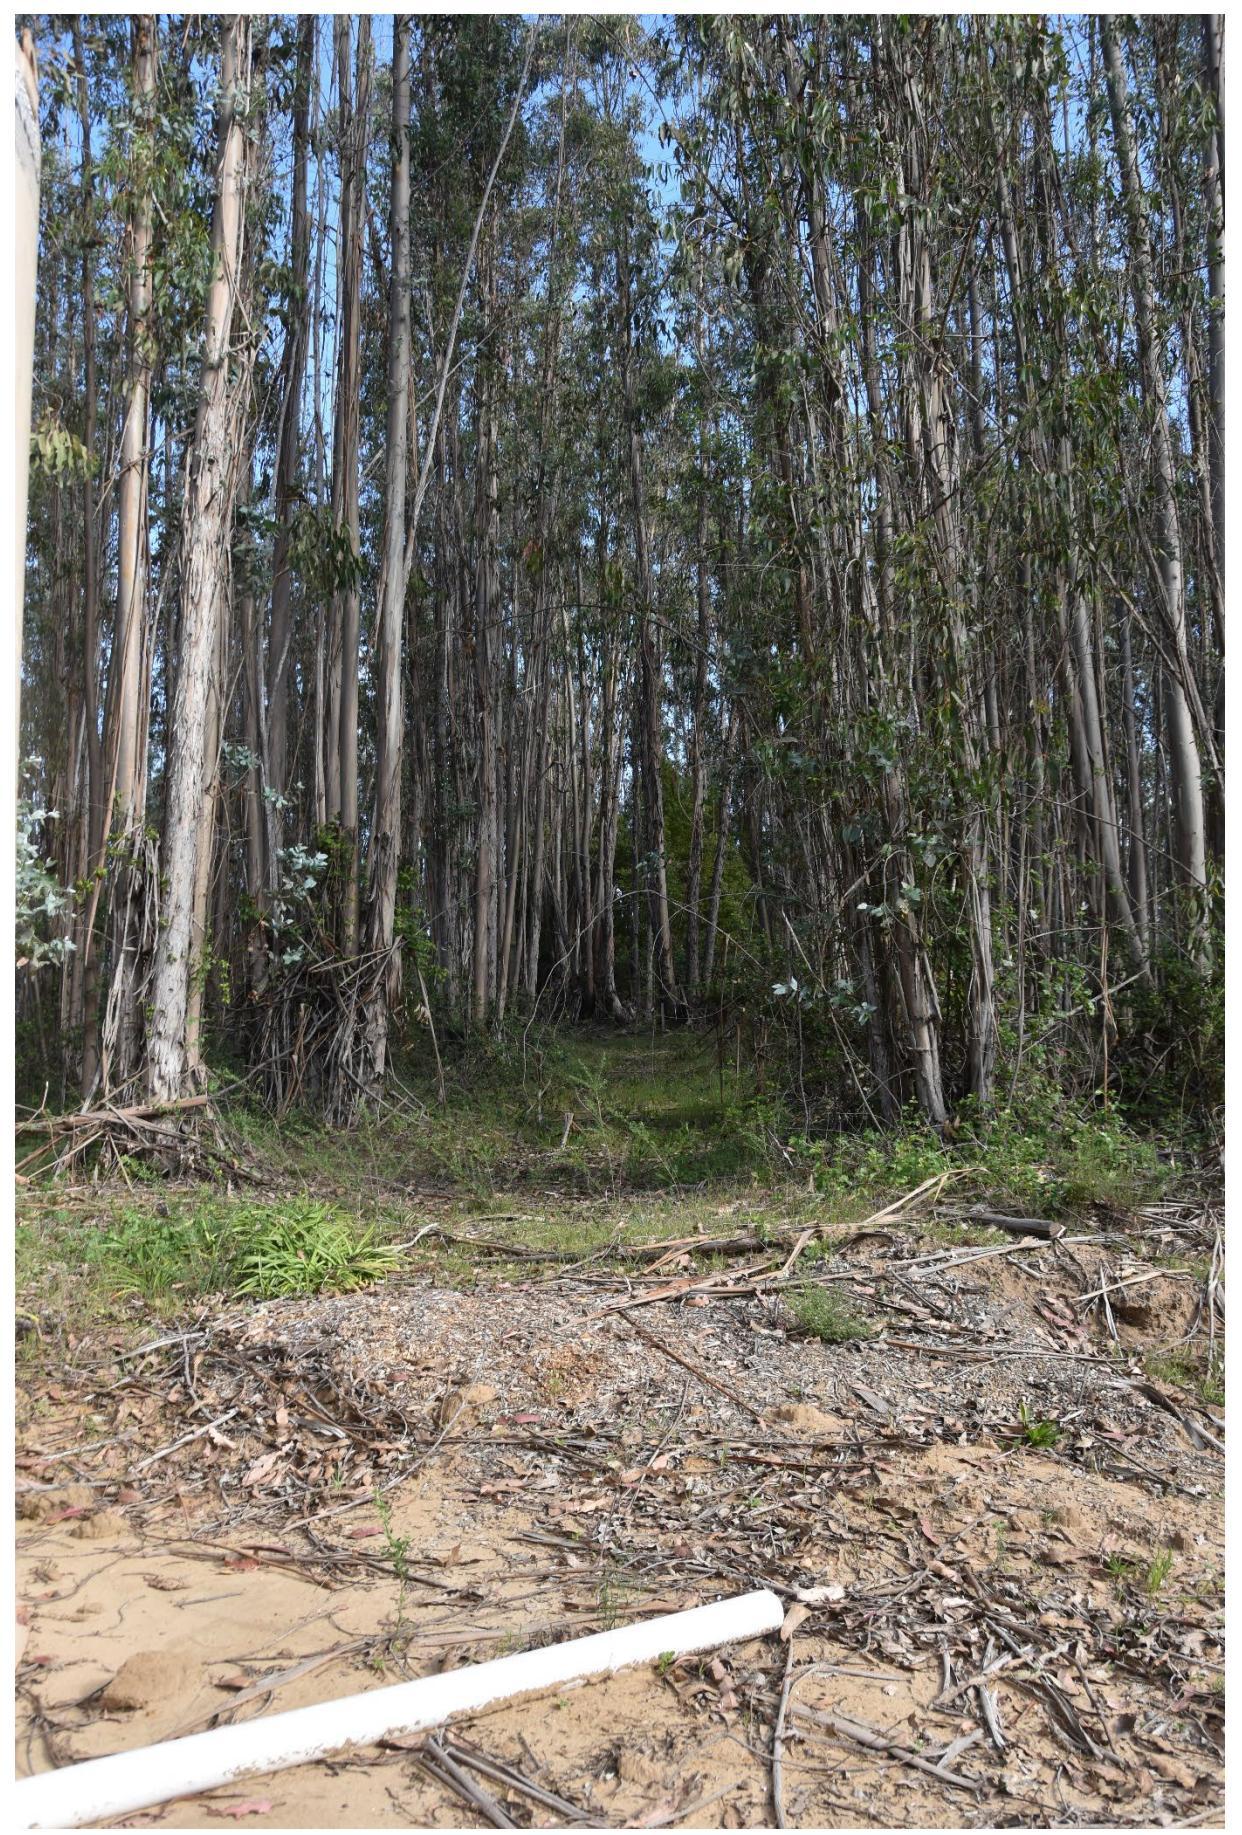
- The site was planted as a Eucalyptus plantation as was evidenced by uniform row crop planting 10 to 20-feet on center. Over 60% of the parcels' acreage is taken up by eucalyptus planting. In the densest areas, 200-400 trees per acre were calculated.

Eucalyptus trees were planted in rows 10-feet on center.

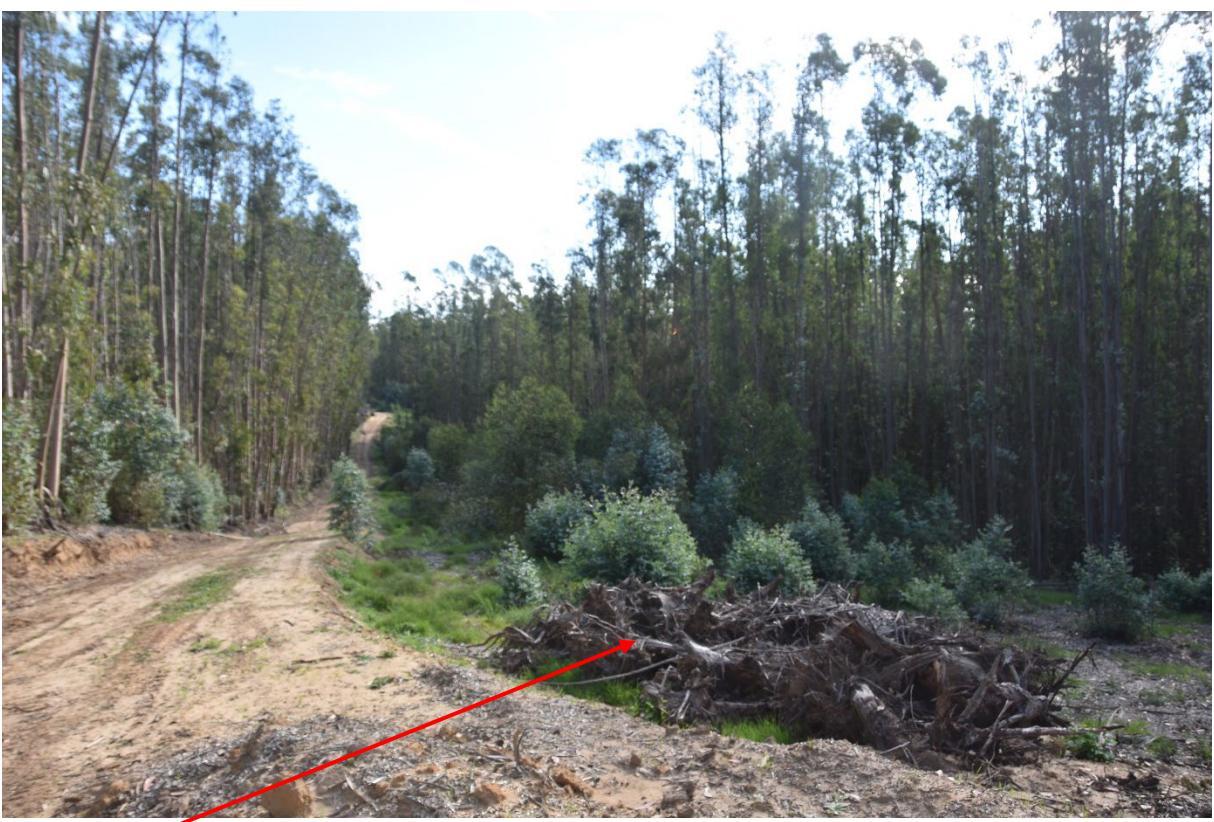
Previous stumps have been dug up and masticated.

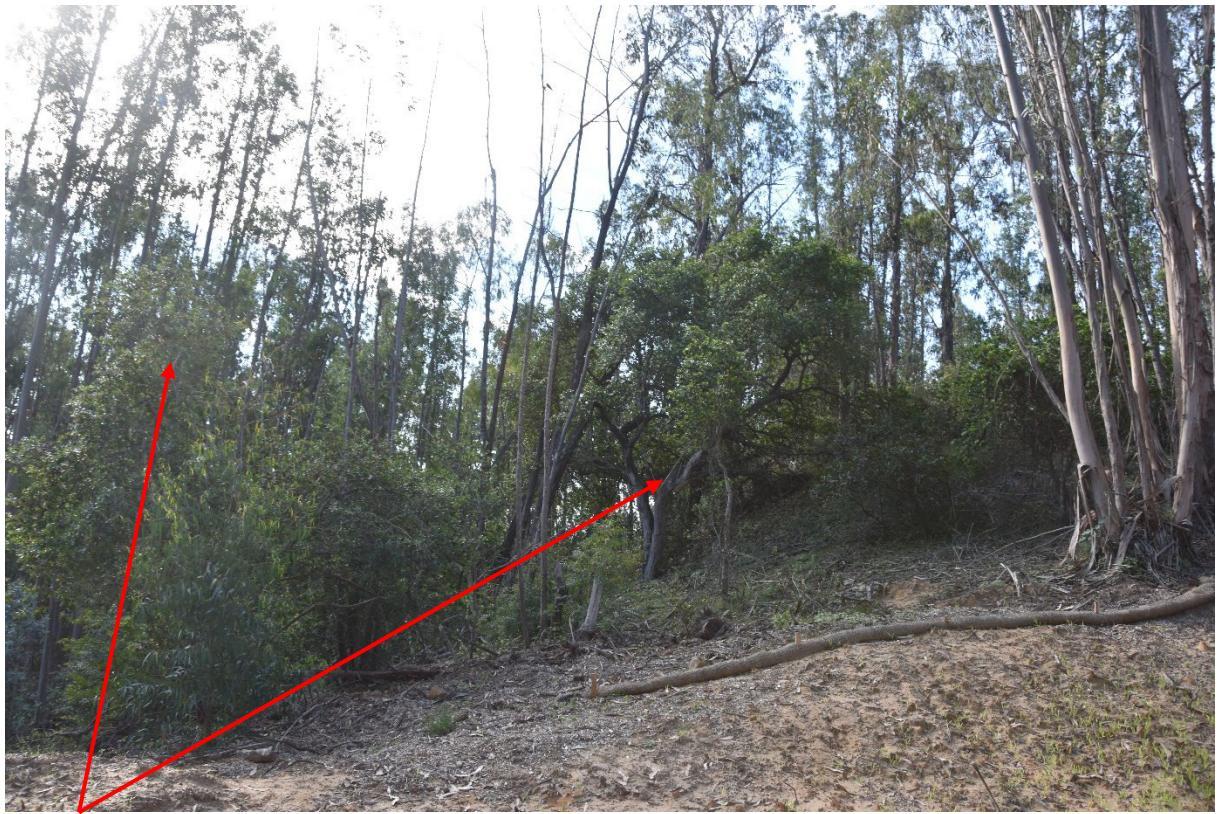
- Very little native vegetation was observed around the planted eucalyptus trees due to Allelopathy.
- Along the road, in parcel 117-471-003-000 there is a small stand of Coast live oak trees in poor condition.

A small number of existing oaks are growing in a small island next to the road in parcels 007 and 003.

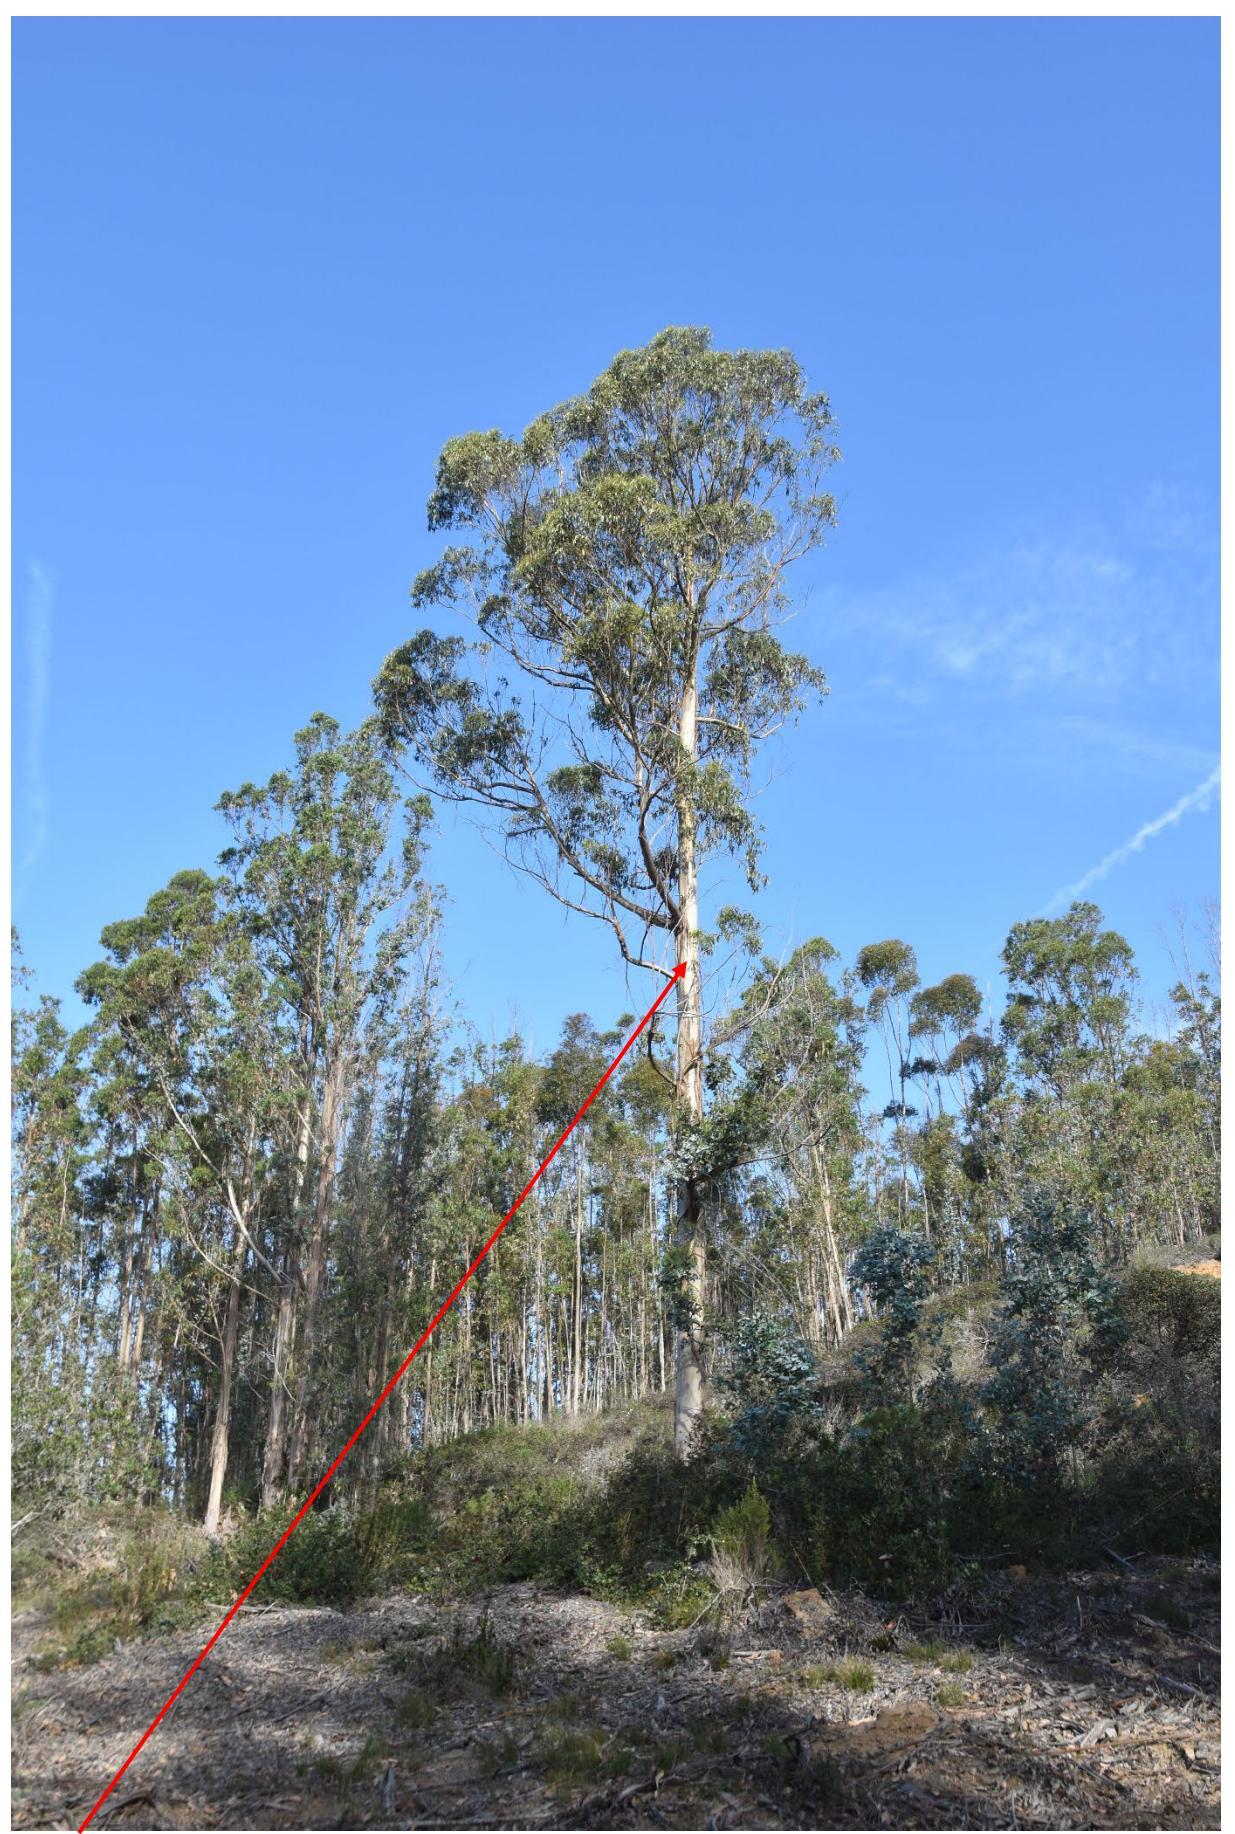
- Eucalyptus logs, both large and small cut pieces were left on site in piles.
- Only two (2) heritage Eucalyptus trees (greater than 36-inches in diameter) were observed on the sites. One in the clearing in parcel 117-471-003-000 upslope from the declining oak stand, and one off the road in parcel 117-471-004-000 where the landscape transitions from eucalyptus to more native plantings.

Large Landmark Eucalyptus can be left on site or removed if warranted by new development.

- 3. If Eucalyptus stumps are to be mechanically removed, a soil or grading erosion specialist will need to be consulted to avoid the risk of erosion.
- 4. The small number of landmark Eucalyptus trees observed can remain on site as they are outside of development areas. If the trees are proposed to be removed later, oak reforestation efforts will mitigate the removal of the landmark Eucalyptus.

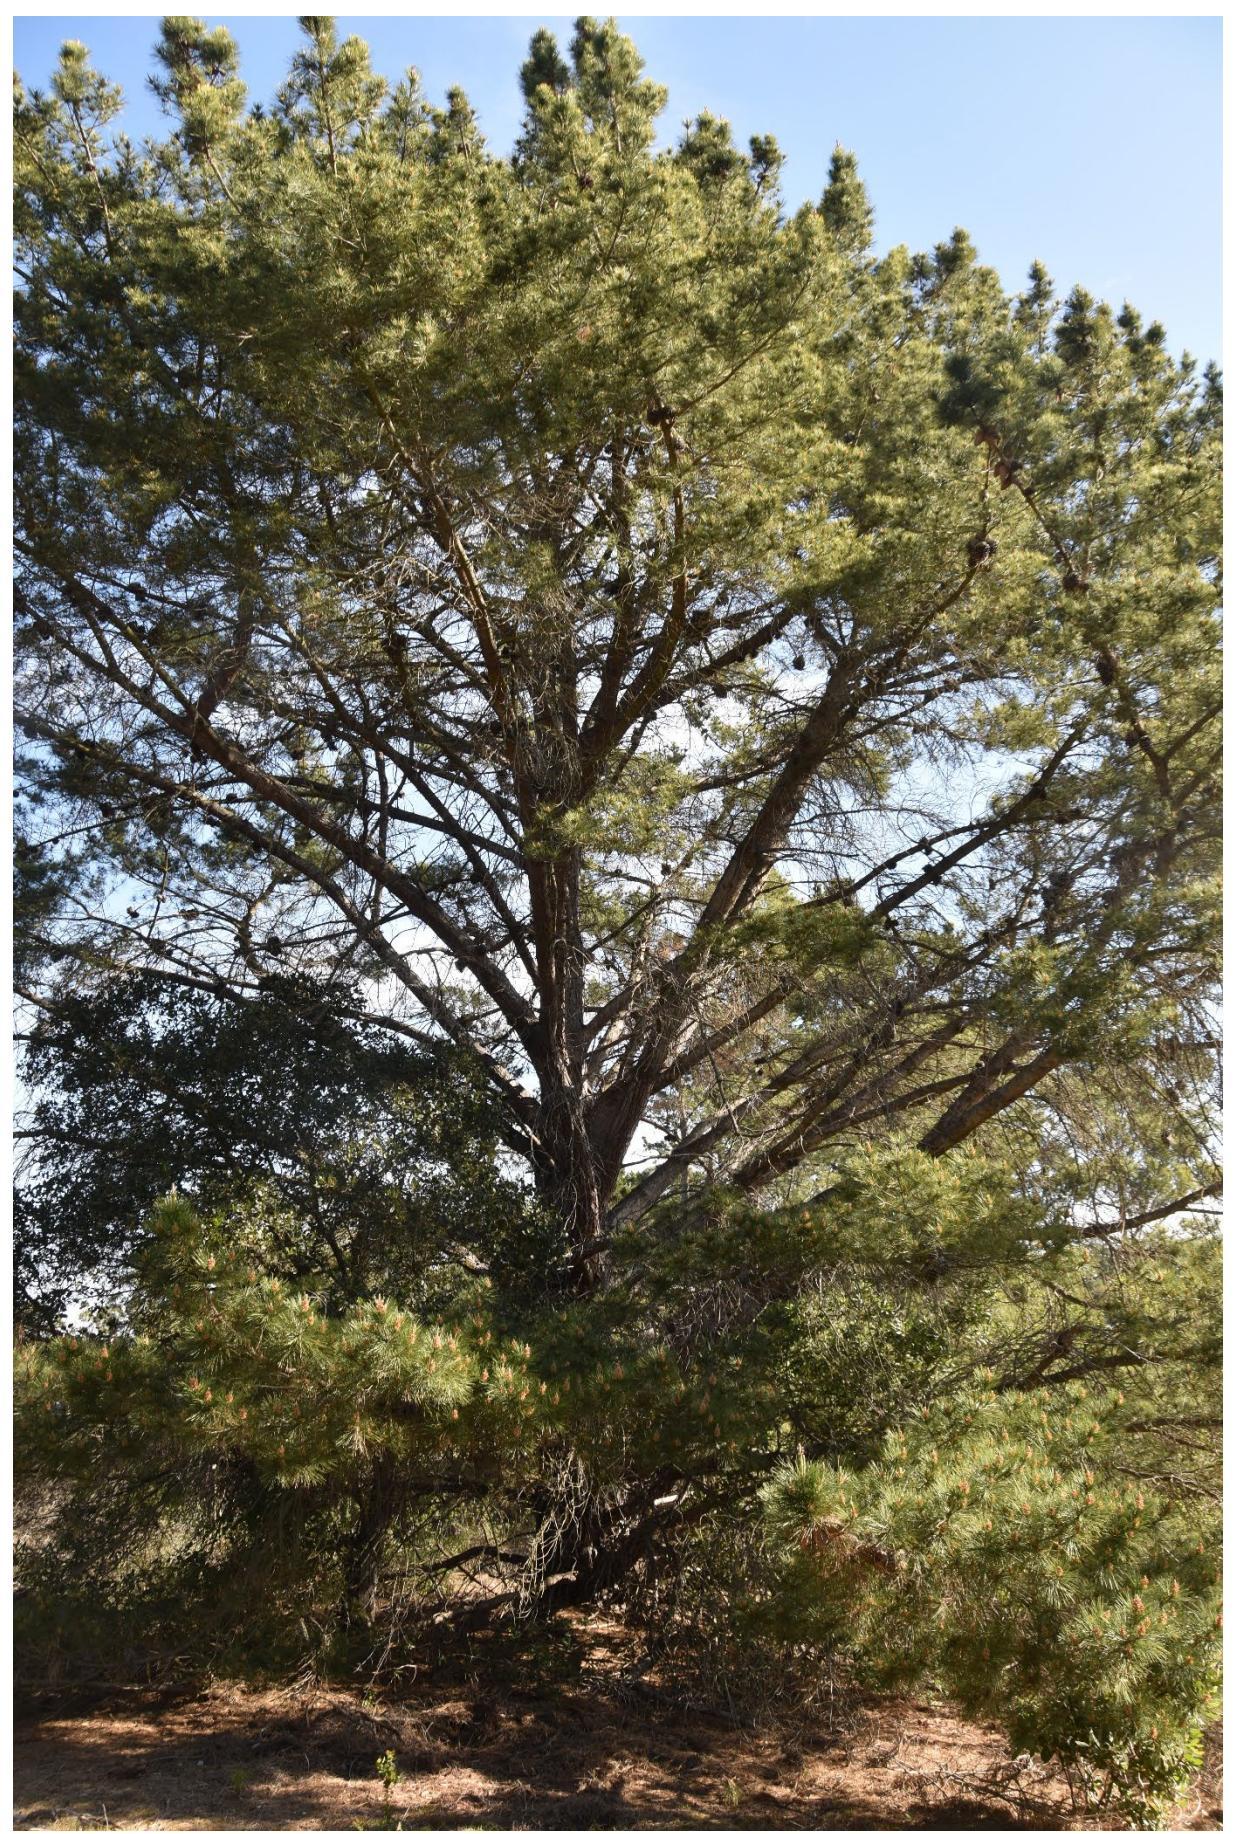
There are several smaller (< 36") Monterey pine trees in the eastern section of the lots.
