# Tree Assessment Robinson Residence

September 1, 2022

(Revised July 18, 2023)

**ROBINSON RESIDENCE**

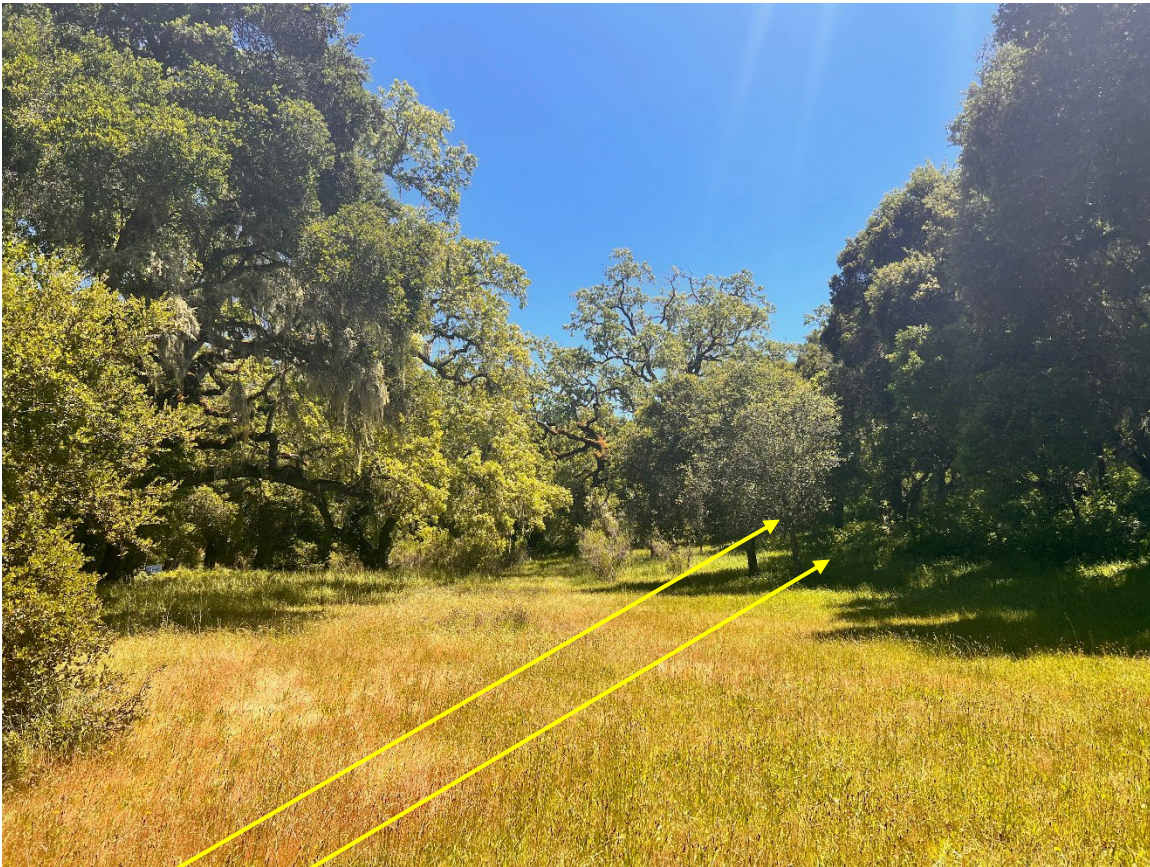
- Tree #125.1 is an 8-inch diameter Coast live oak in fair condition located within the proposed house footprint.
  - Tree #125.2 is a 14-inch diameter Coast live oak in fair condition located within the proposed house footprint.

Trees #125.2 and #125.1 are located within the proposed building.

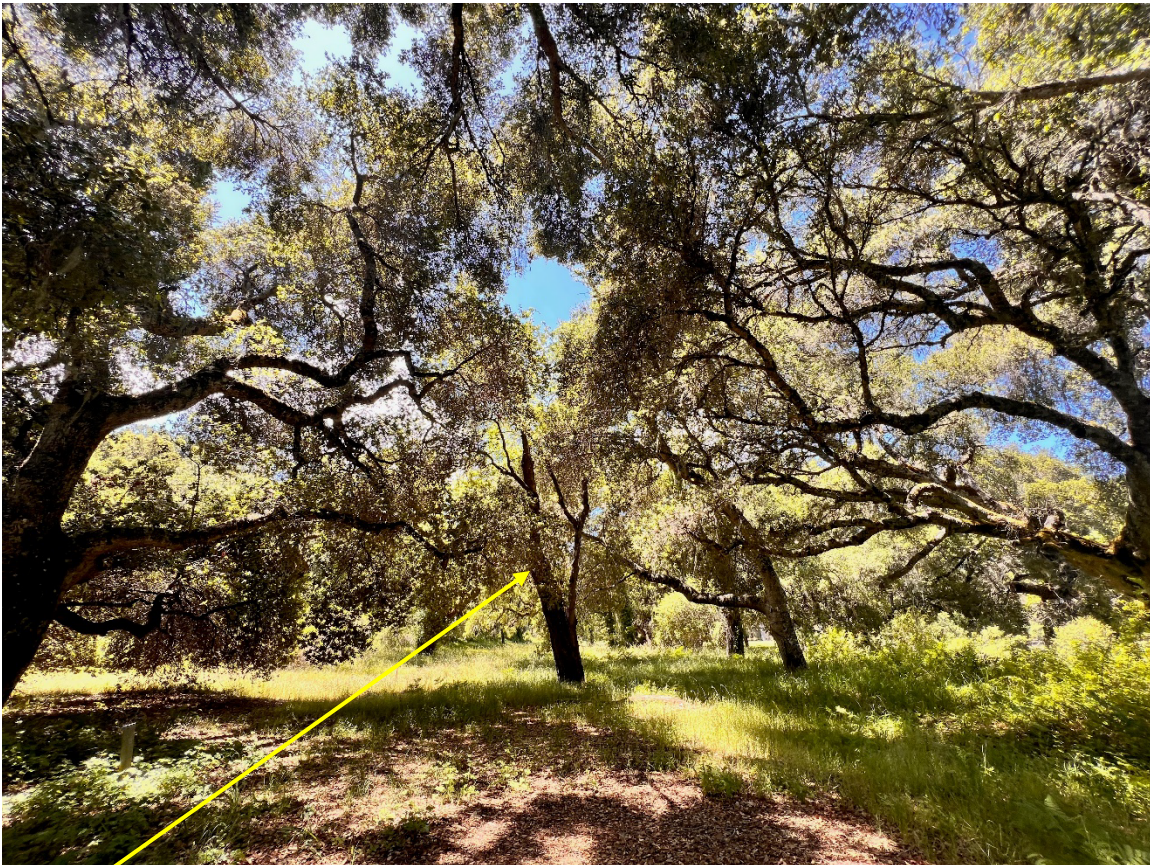
- The site is forested mainly with Valley oak and Coast live oak trees.
- Three (3) trees are proposed for removal with the current design.
  - Tree #103 is a 40-inch diameter Valley oak in poor condition located in the proposed driveway. The tree is in decline and is fragmenting apart, the tree was proposed for removal before plans were submitted to us.

Tree #103 is in very poor condition and is located within the proposed driveway.

- No alternate designs were considered as reworking the driveway would force development closer to healthy trees and tree #103 would need to be removed anyways.

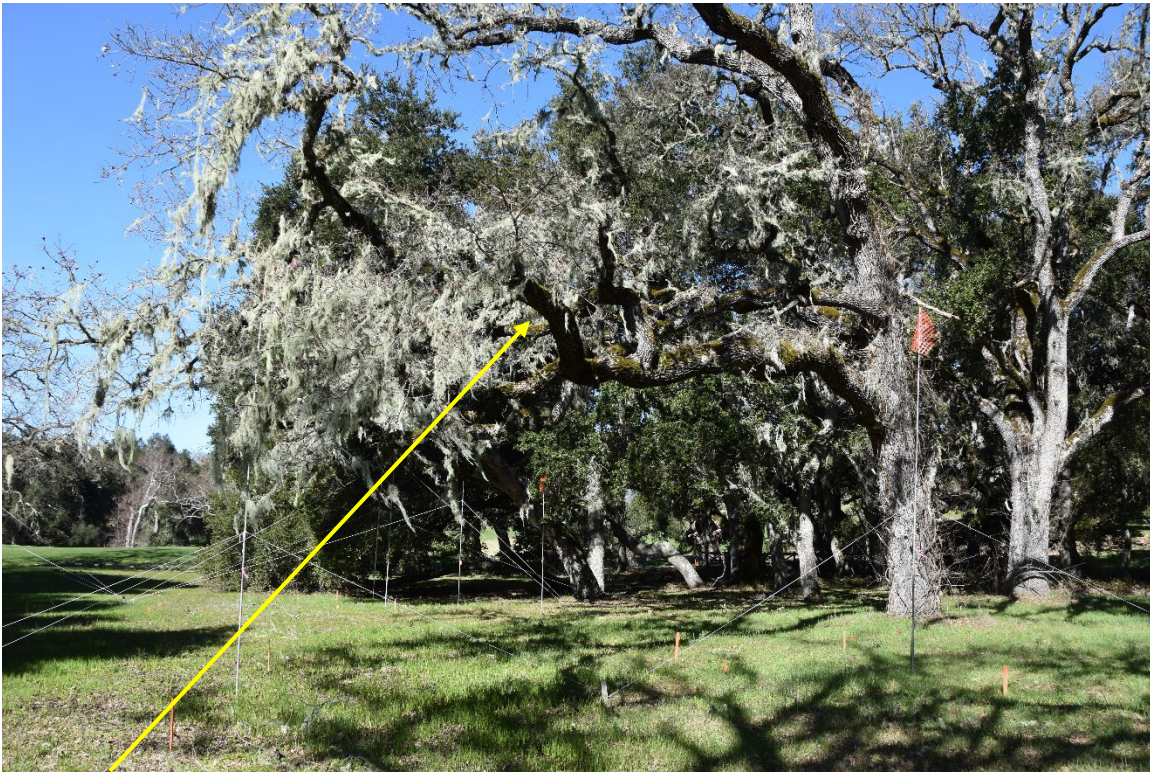
- Trees #107 will need clearance pruning to accommodate the proposed roof eaves. The trees are in fair condition and no long-term damage is expected.
- Trees #104, #105, #107, #115, #122, #124, #137, and #147 are adjacent to proposed drainage swales. Excavation will need to be dug by hand to locate roots before construction.

Tree #107 will need clearance pruning for the proposed structure.
