Forest Management Plan  
for the  
Jack Rabbit Ranch (Knoop) Property  
Project – Driveway Phase

**July 2025**

Denise Duffy and Associates, Inc  
Patric Krabacher, ISA Certified Arborist 11759  
TRAQ Certified / Registered Consulting Arborist #887  
947 Cass Street, Suite 5  
Monterey, California 93940

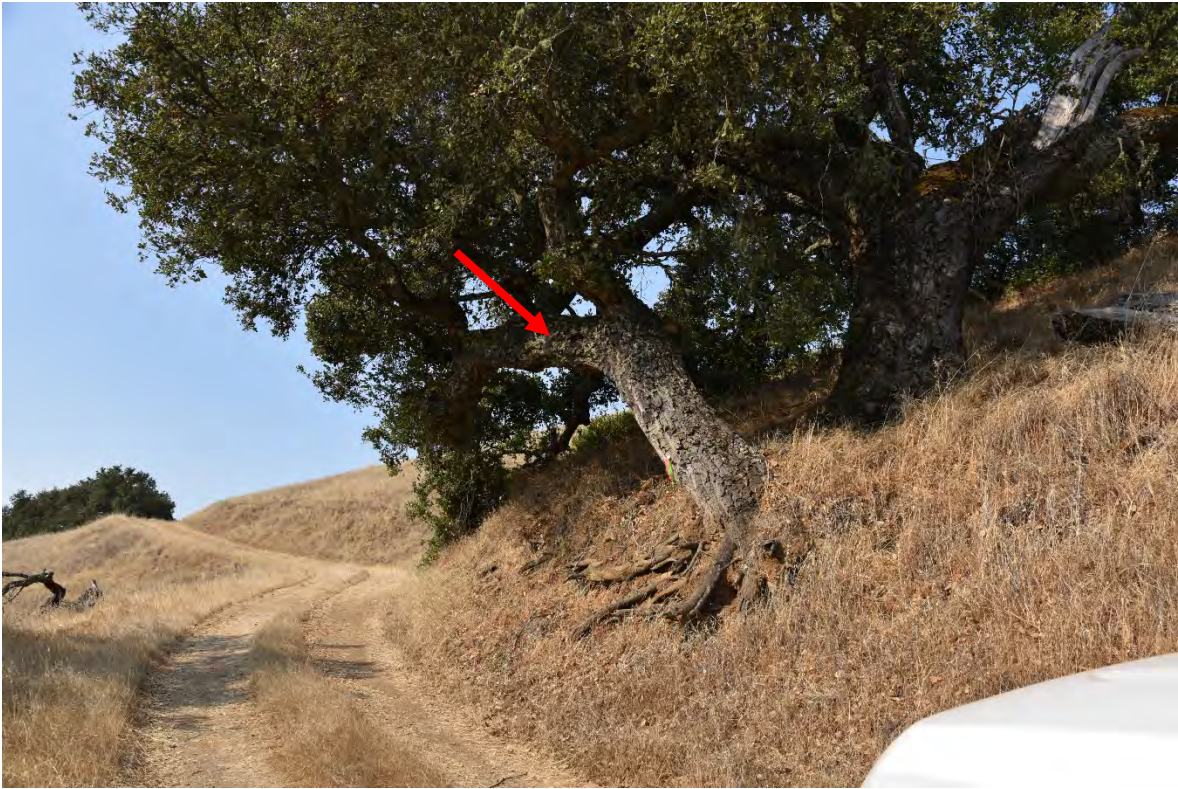
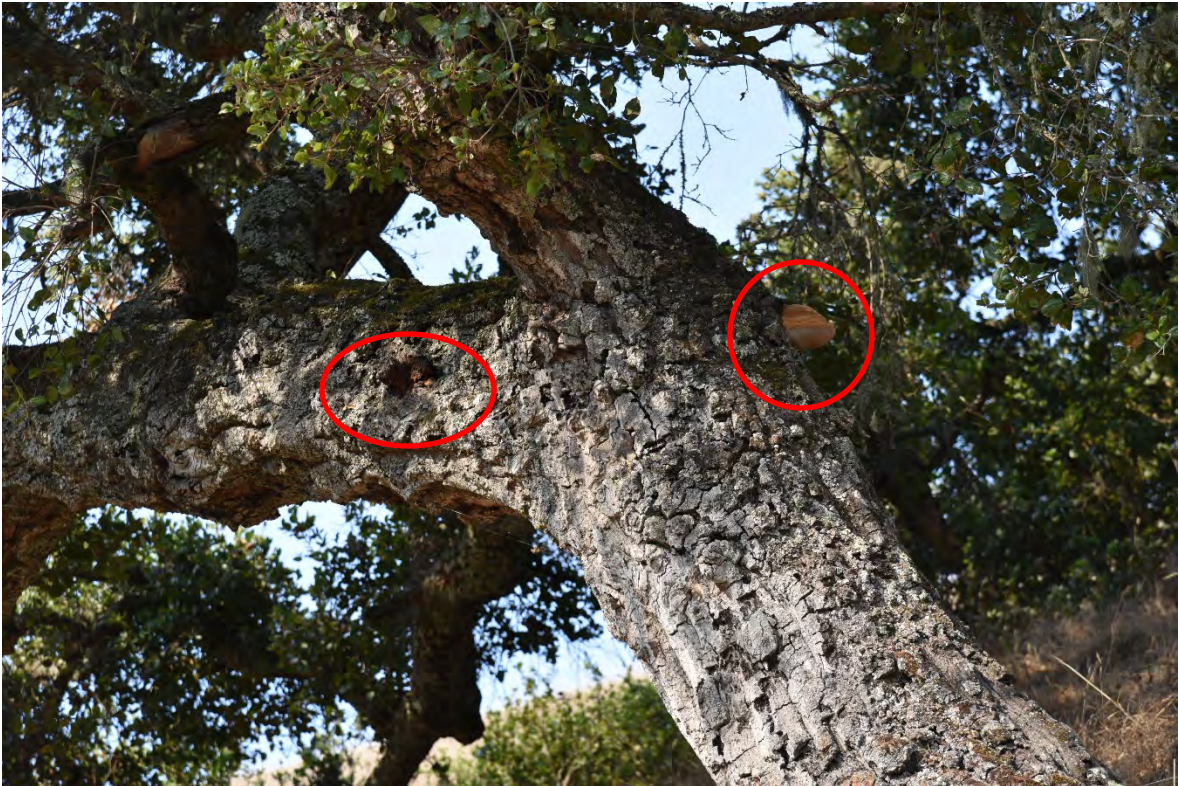
- Tree #13 is a 24” diameter Tree also in poor condition. It will be impacted by the inclusion of a retaining wall for the roadway. This tree is seriously decaying as evidenced with fungal conks emerging on its trunk.

| ID# | Diameter | Species | Health | Structure | Remove | Comments |
|---|---|---|---|---|---|---|
| 13 | 24 | Coast Live Oak | Poor | Poor | x | Decay in the stem, fungal conks |

Fungal conks on stem

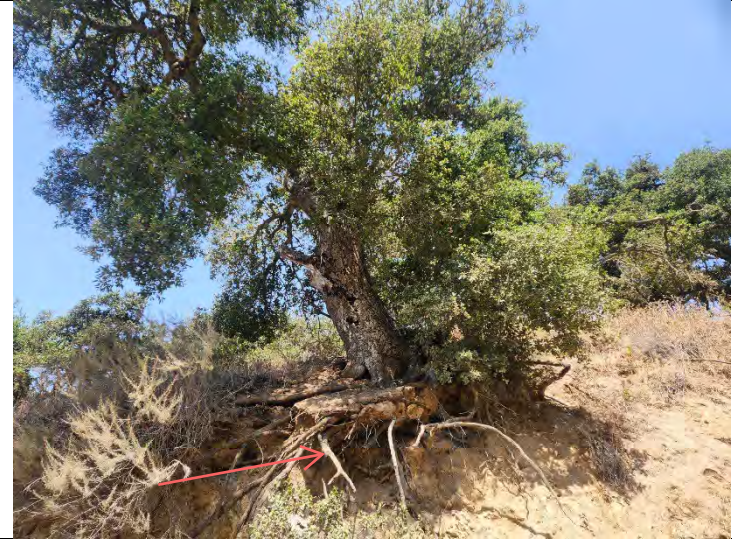
Tree #15; Recommended for removal, soil eroding under tree.

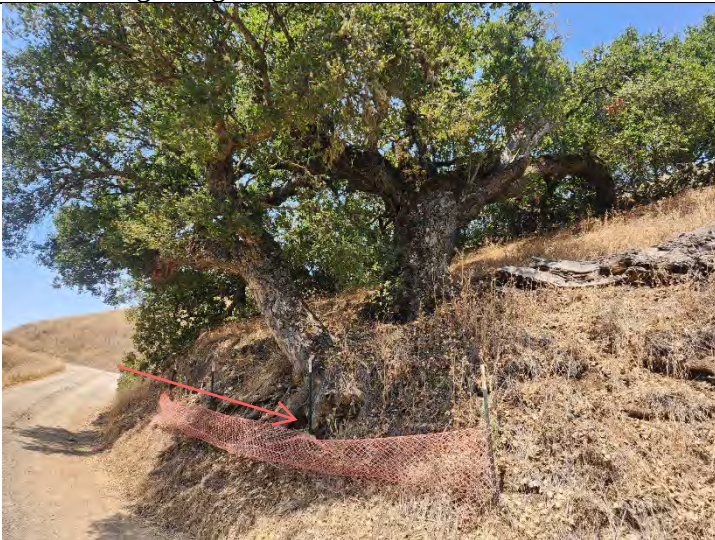
Tree #13 (left); Recommended for removal, soil eroding under tree.  
Tree #36 (right); Within grading limits for retaining wall footprint.

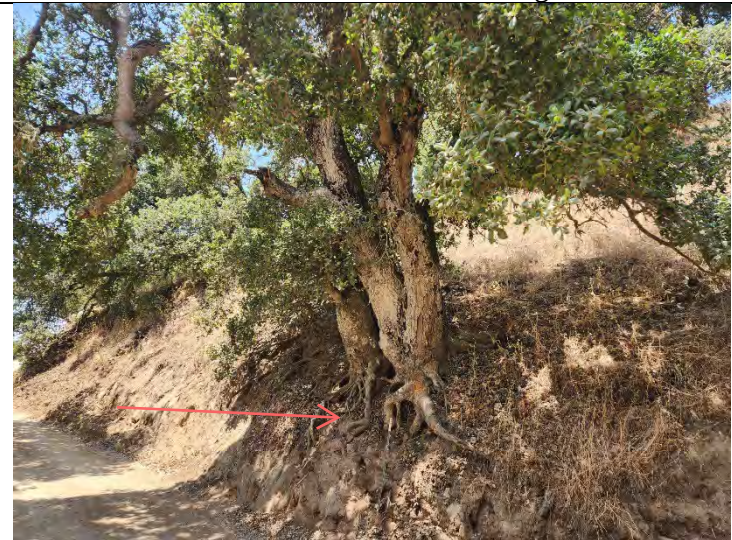
Tree #34; Recommended for removal, soil eroding under tree.
