Tree Resource Assessment
15360 Plaza Serena
Prunedale, CA

September 5, 2017

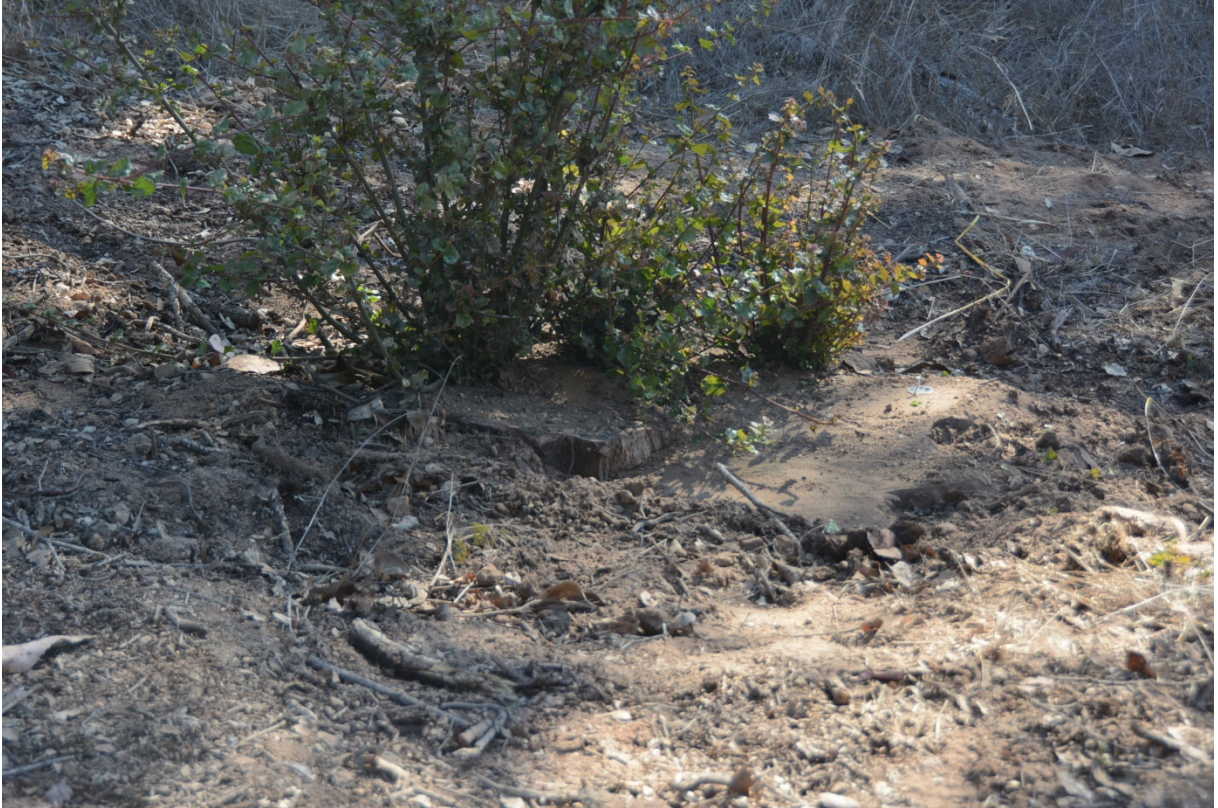
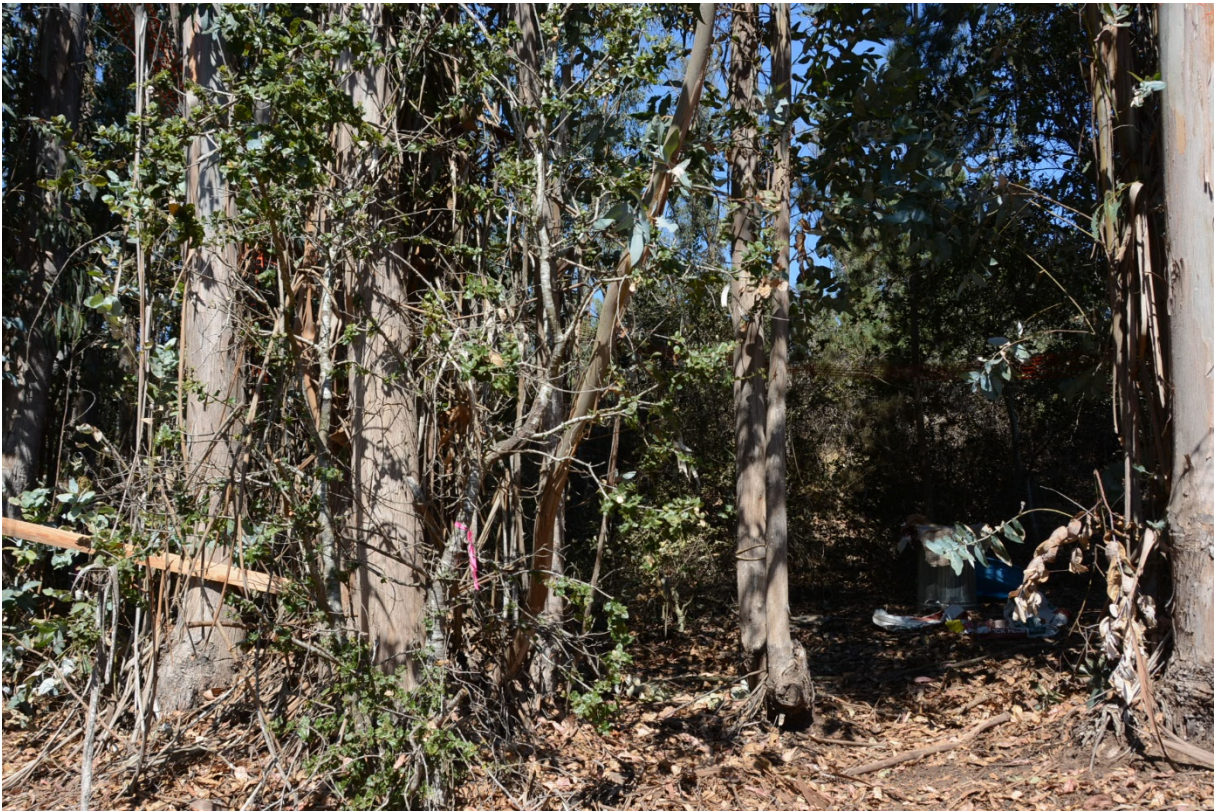
Stump #333

- One stump is found where a 24" diameter Oak tree (#333) was removed without a permit, which will be added to the tree removal count. The tree stump is located within the building foot print. The tree, judging by its stump measurement, is classified as a landmark oak. The oak has larger remaining trees which are between it and the adjacent property to the east and the public roadway. It would not have been visually significant or have historical value or more than 1000 years old. The removal would have been recommended with this site plan due to the configuration of the lot, which has a scenic easement that makes designing a house difficult on this property.

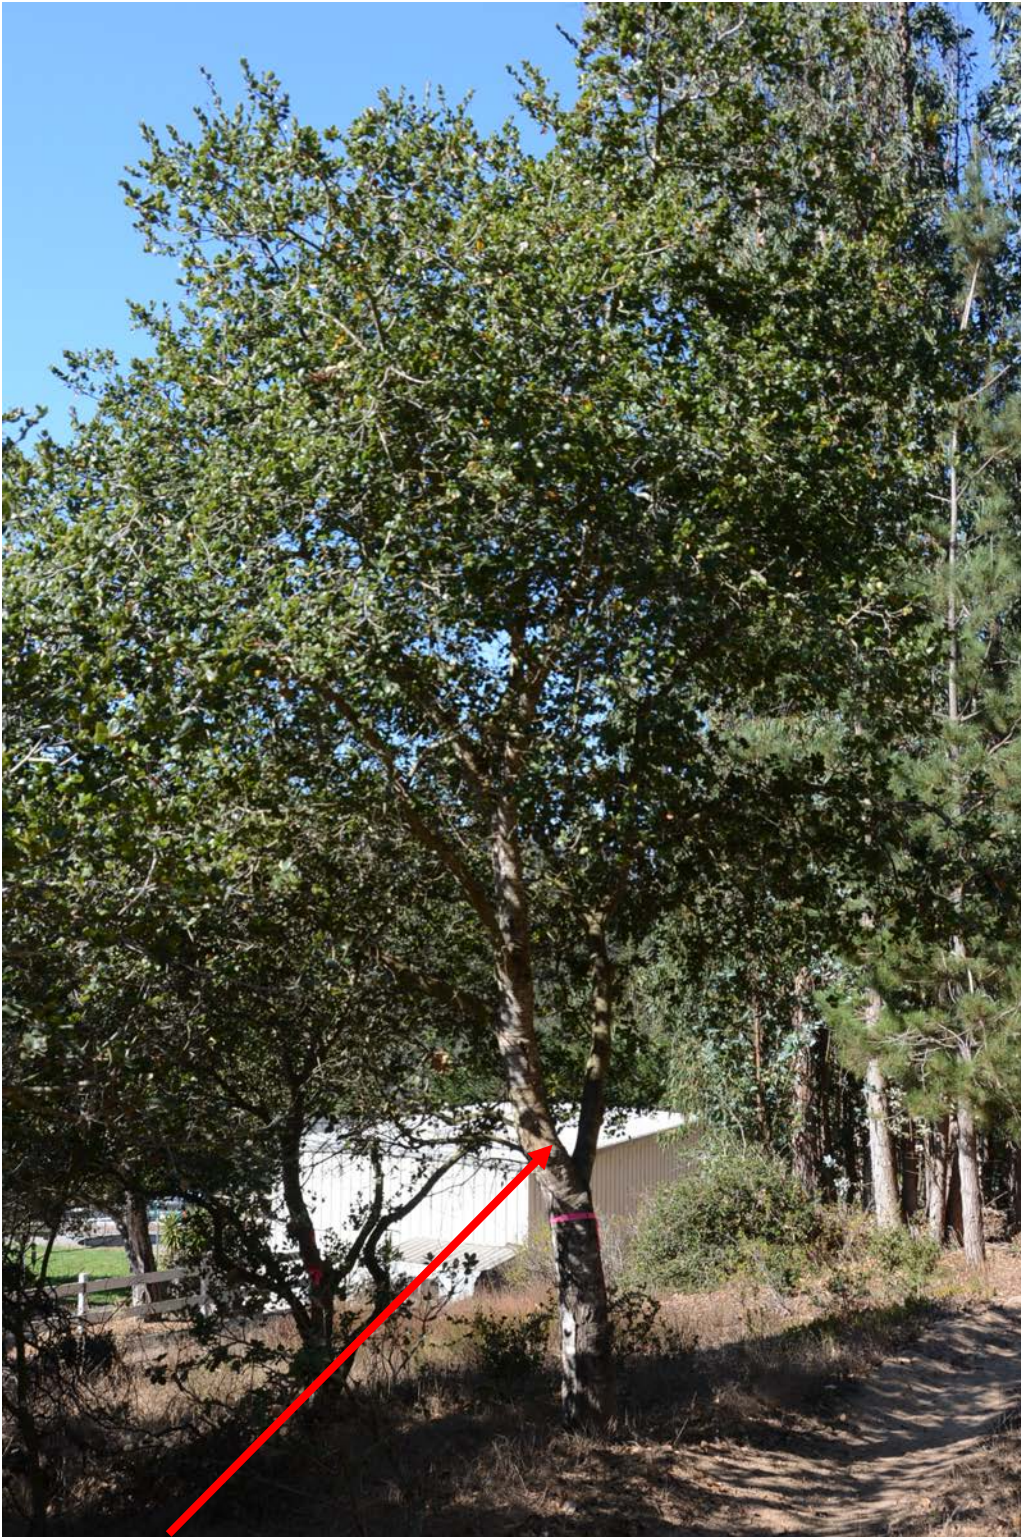
Tree #326 and #325

- The proposed leach fields will require removal of three small oaks.
 - #325- 6" oak in fair condition
 - #326- 10" oak in fair condition
 - #327 – 10" oak in fair condition

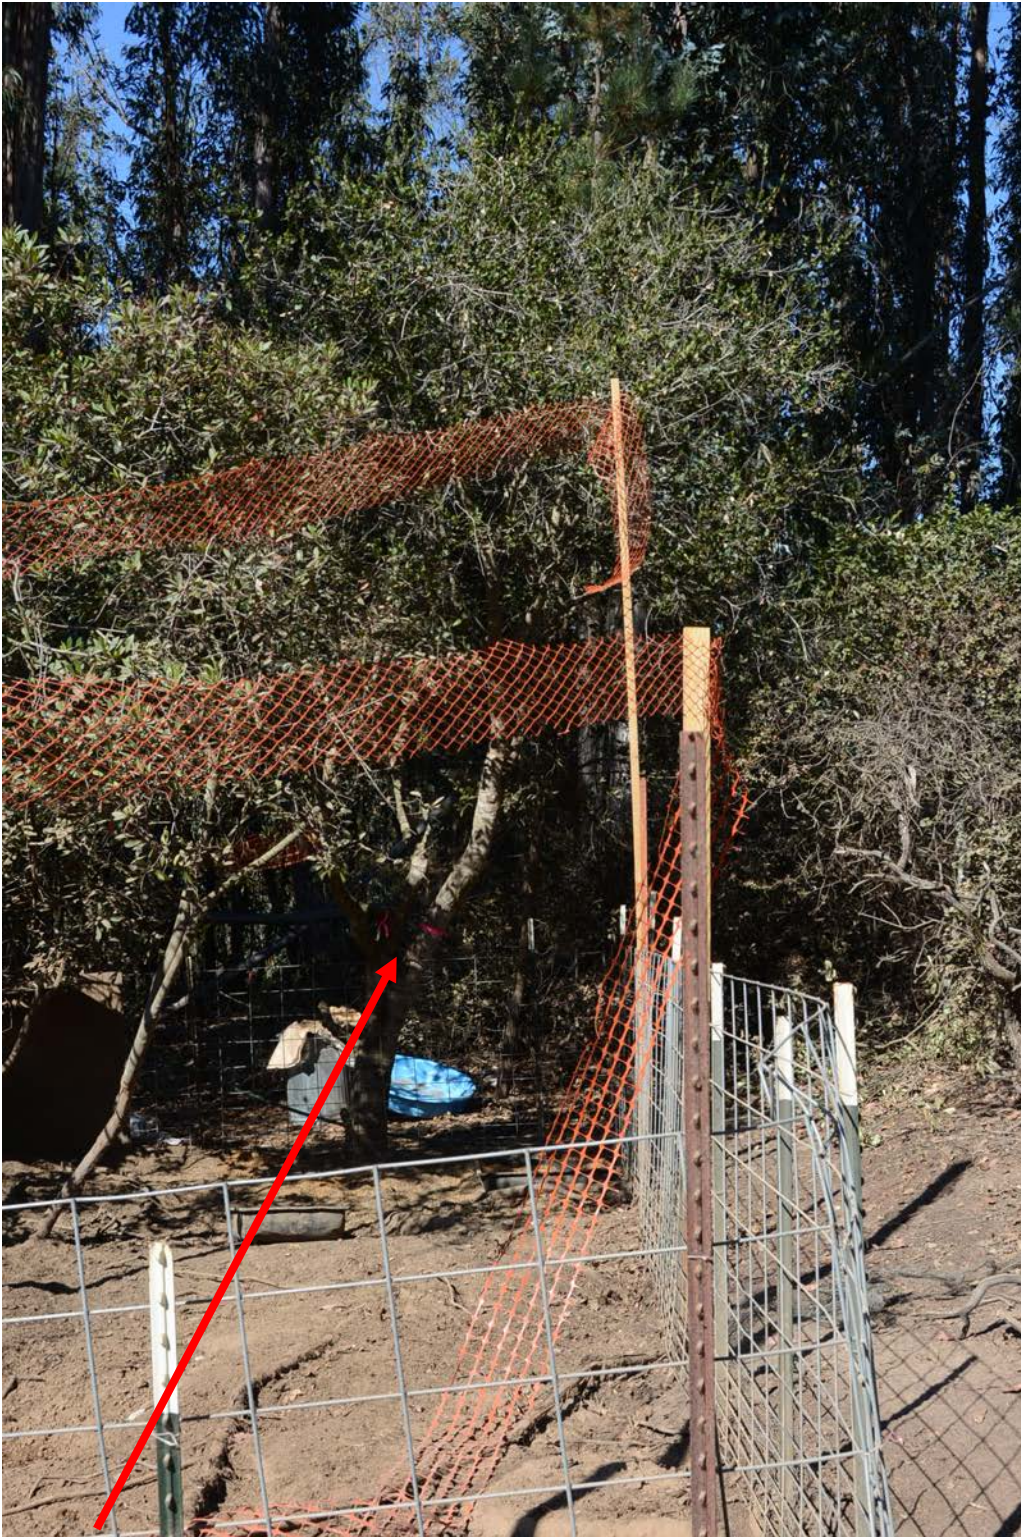
Tree #328

- Two Oaks are located near and within the building footprint which are to be removed.
 - #328 is a small but mature 6" diameter Oak in fair condition.
 - #329 is a 9" diameter oak in fair condition and is within building footprint which must be removed.
