Subject: Biological assessment for 26346 Valley View Avenue in Carmel

Project No. M11382
18 December 2017

Proposed Residence at
26346 Valley View Avenue
Carmel-By-The-Sea, California

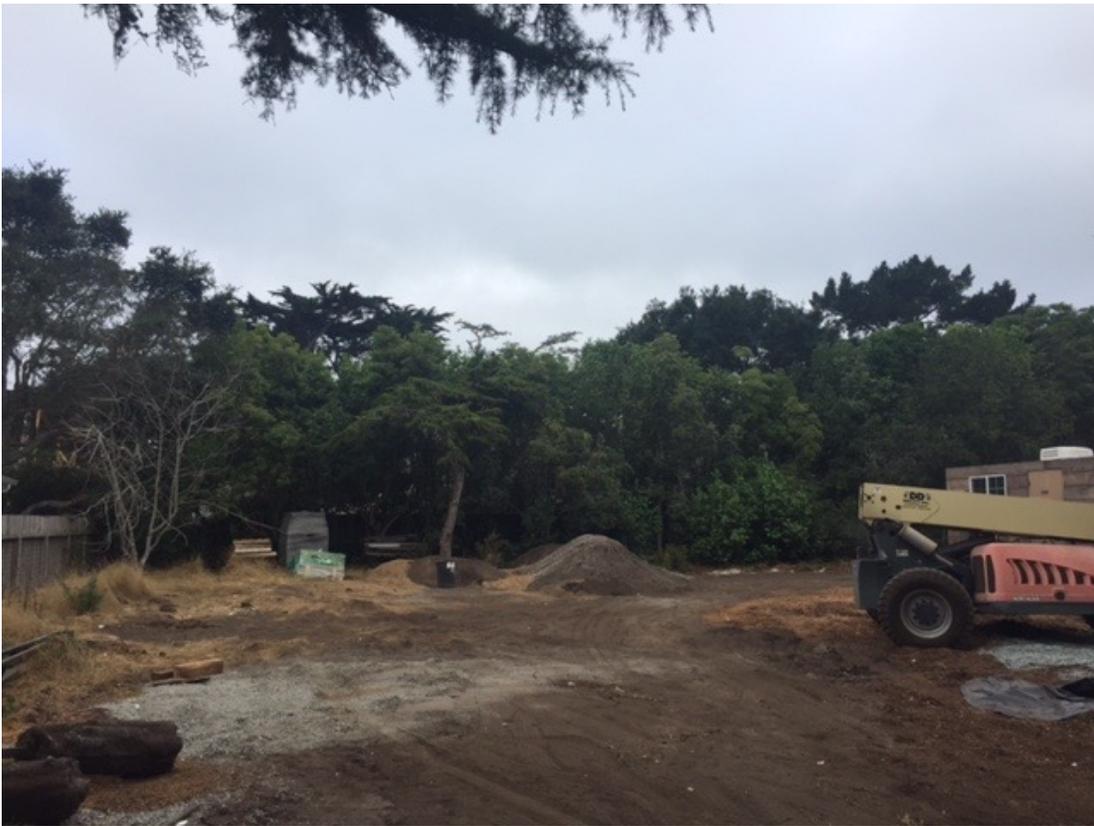
Figure 1. Sensitive and protected biological resources are not occurring on previously disturbed and impacted property located at 26346 Valley View Ave in Carmel. Resources are limited to a few native tree and plant species, as well as some non-native introduced plant species.

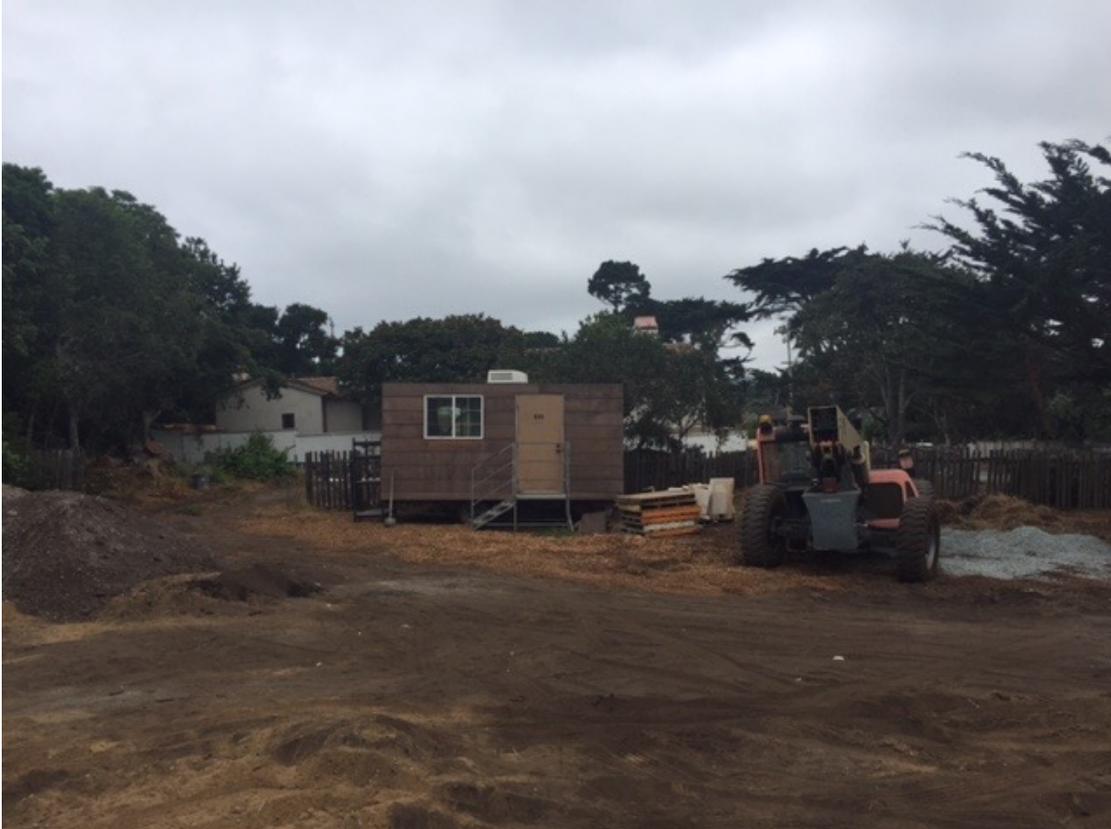
Figure 2. Another view of disturbed and impacted property. The neighboring property at 26338 Valley View is located on other side of trailer and small fence

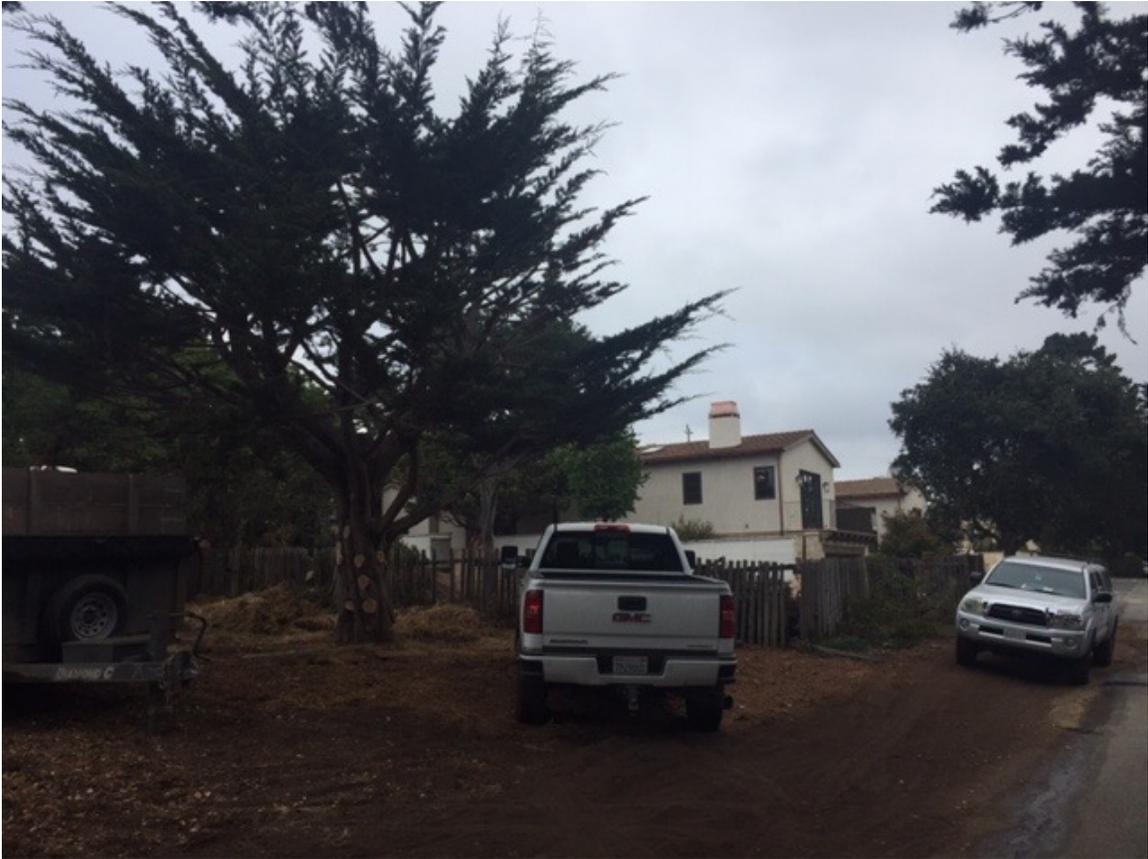
Figure 3. Mature cypress tree with a relatively compact form due to past pruning operations is located on subject property.
