Askar/Zohori
Tree Resource Assessment
2972 Colton Road
Pebble Beach CA

April 16, 2025

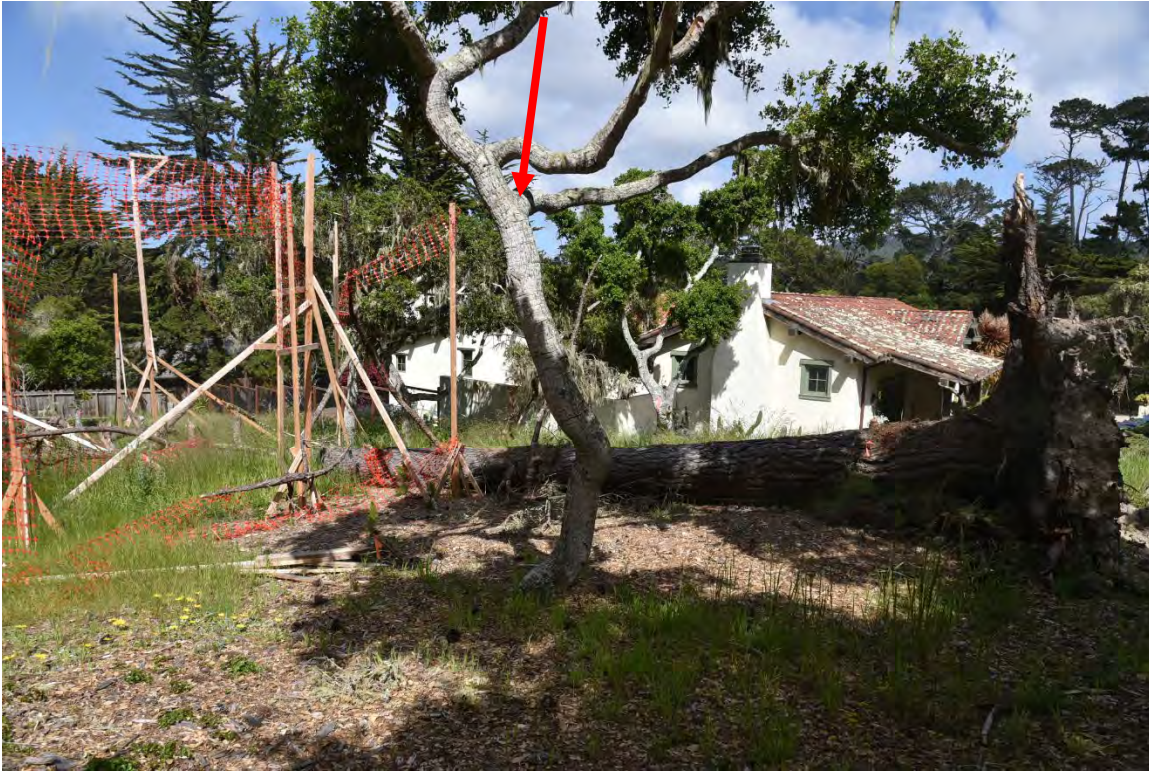
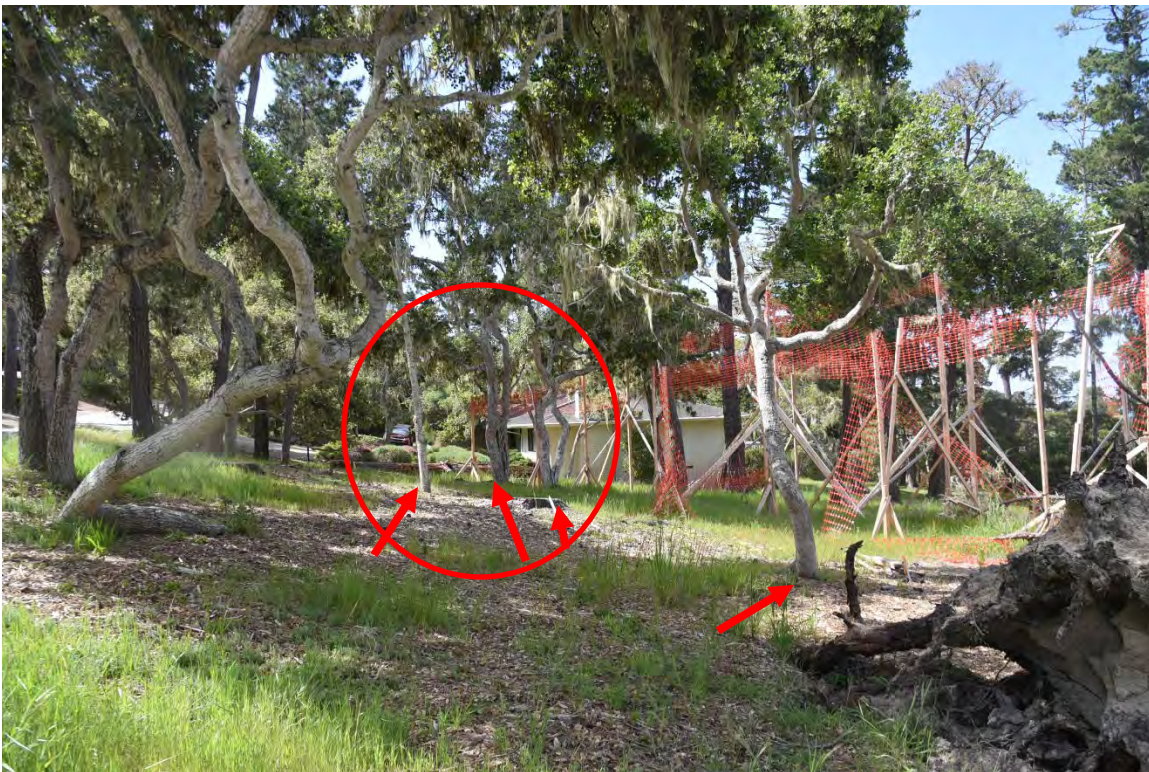
- Two oaks were found that were not indicated for removal on the site map but are affected by the design:
 - #377 is a 10" diameter oak that is located in the front yard where a concrete walk is to be installed. The tree is in fair or better condition.

- There is a 30" diameter Monterey pine (#97) on the property that has been uprooted and will need to be removed. Judging by the tree's trunk, the tree appears to have been in poor condition before its failure.

Tree #97 has uprooted and fallen, tree #377 is in the concrete walk

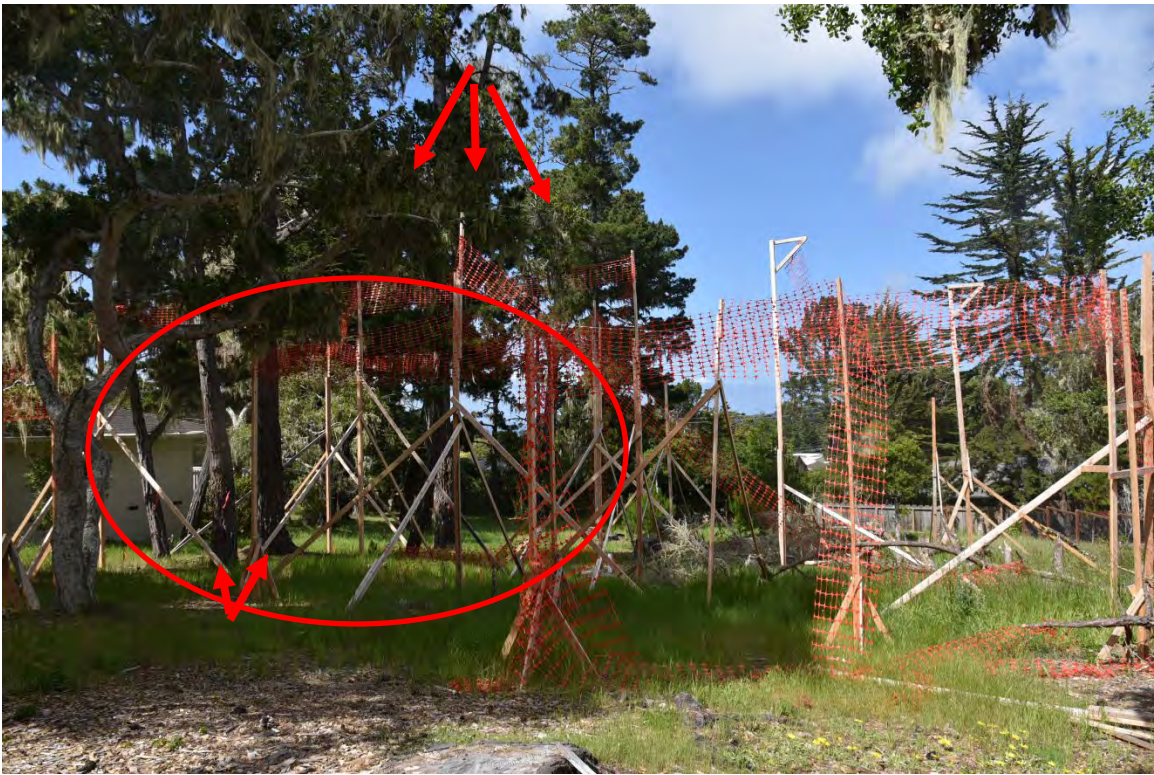
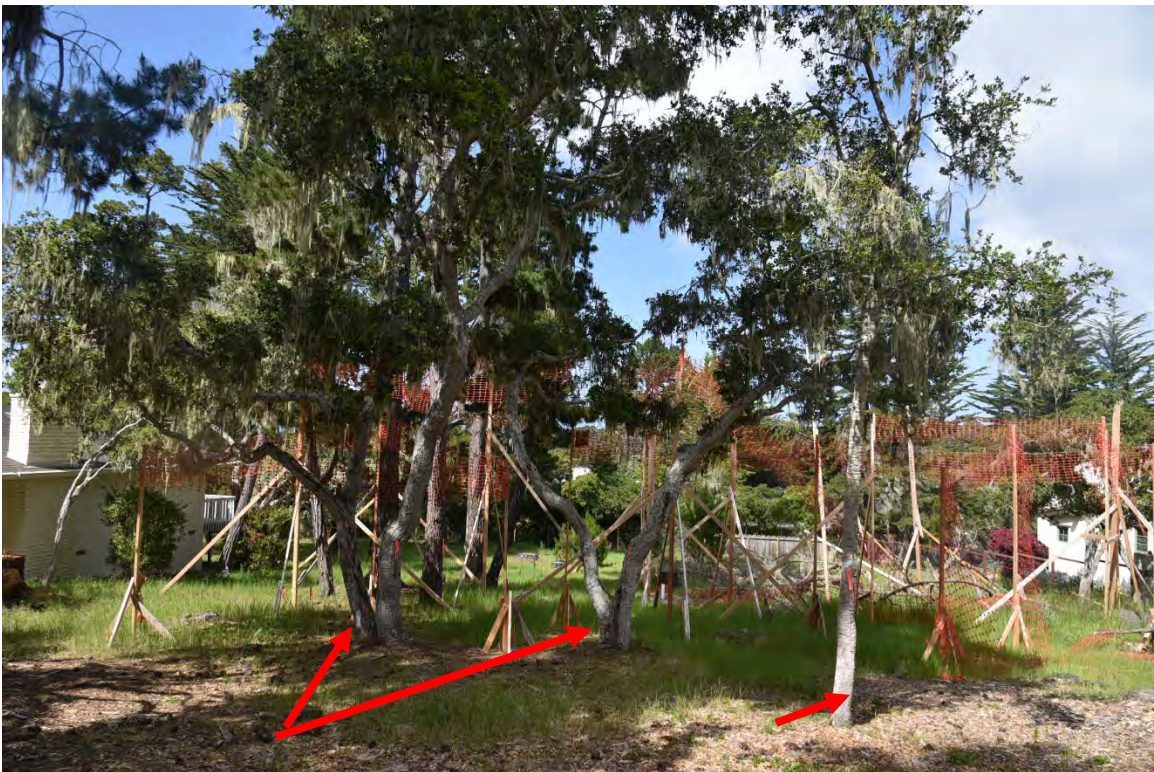
- The main structure and patio area require that trees #384 (patio area) and # 386-#389 will require removal due to the trees being located within the building footprint.

Trees to be removed , #390, #391, #392, and 377

Pines #384-#389 will need removal

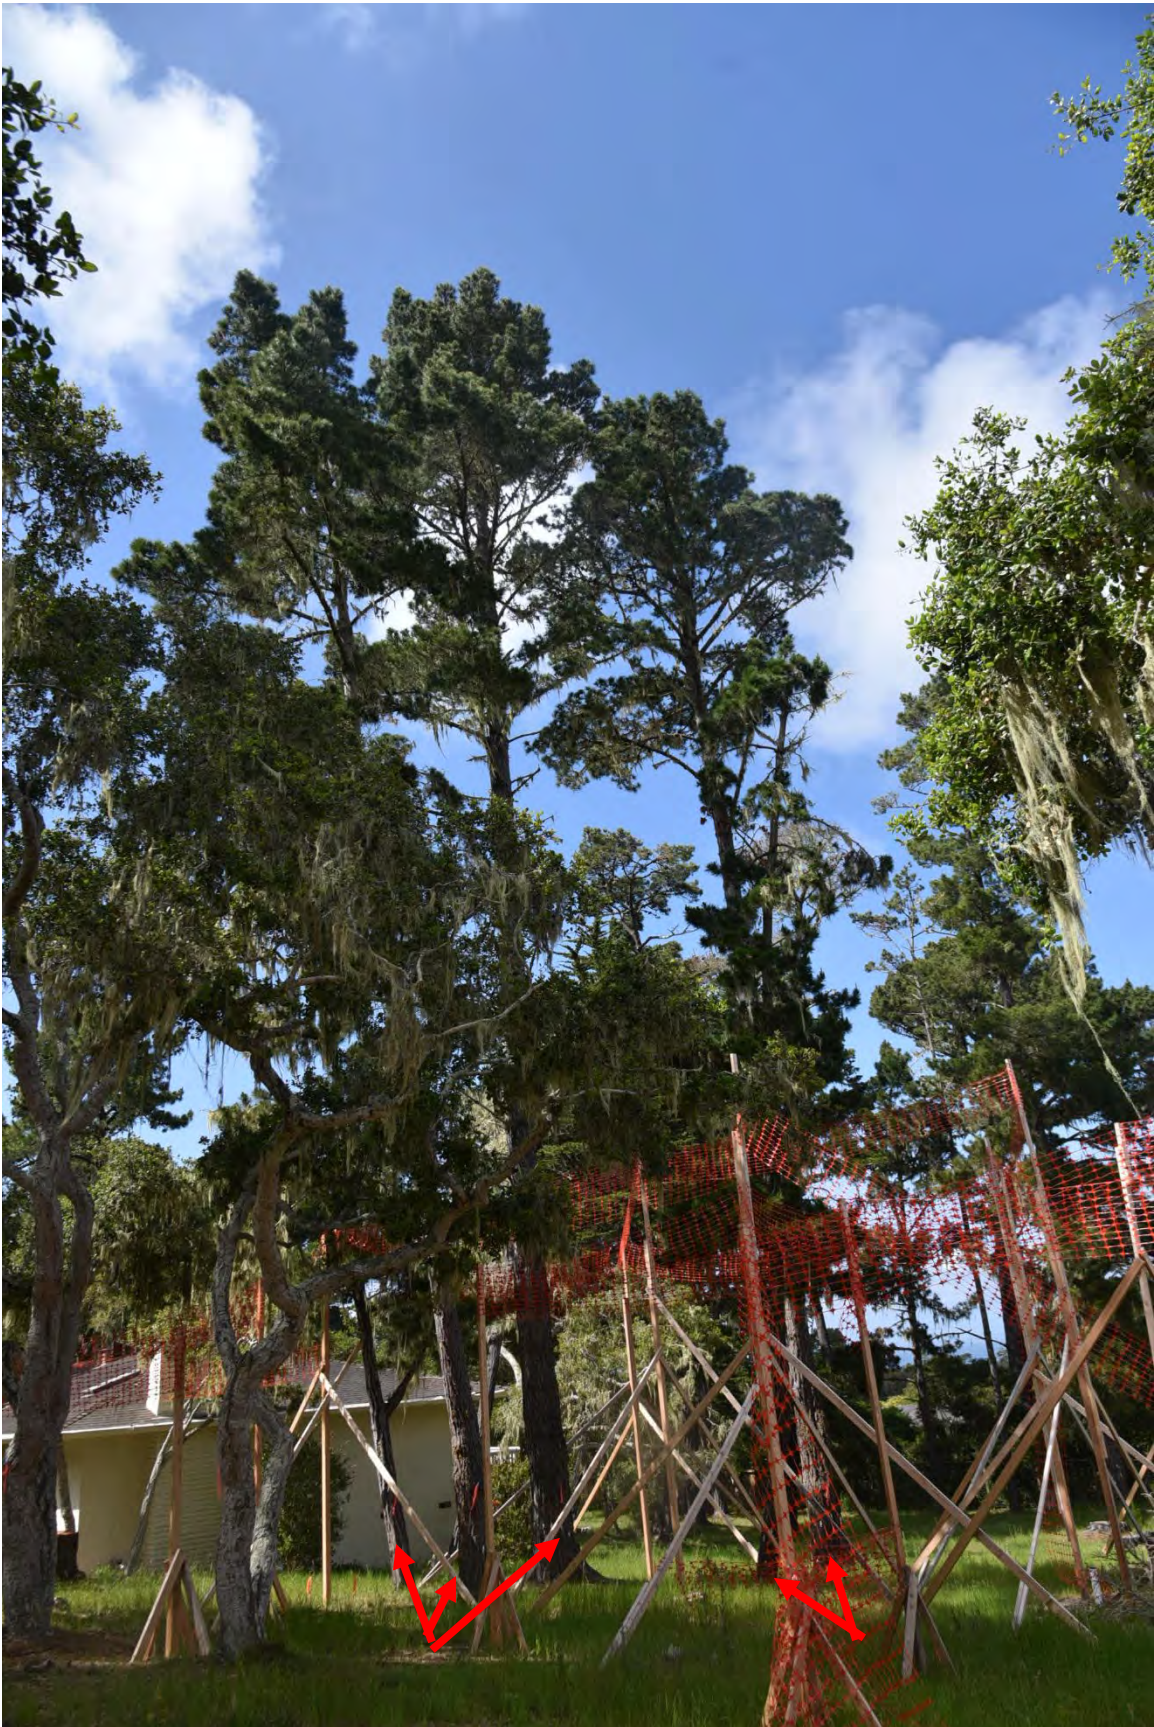
- #392 is a small 6" diameter oak located in the front yard where a series of steps are proposed. This tree appears to be in fair or better condition.

Trees #390, #391, and #392

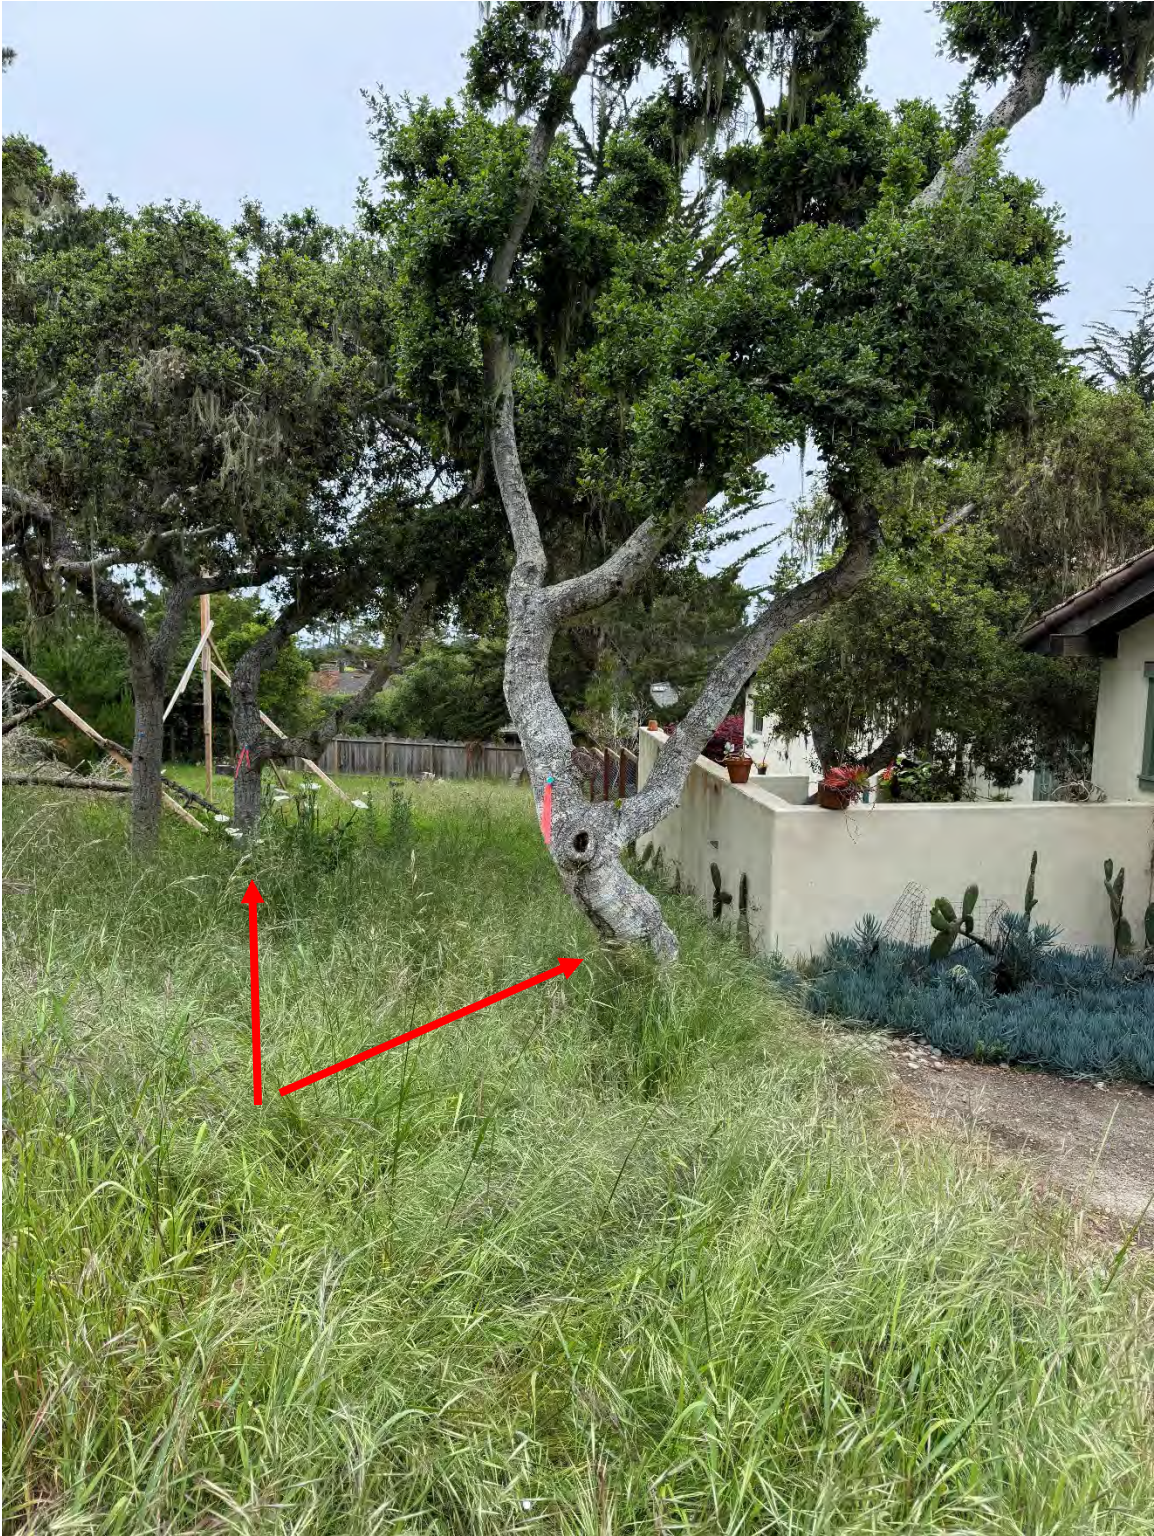
Five tall pines to be removed #384, #386-#389.

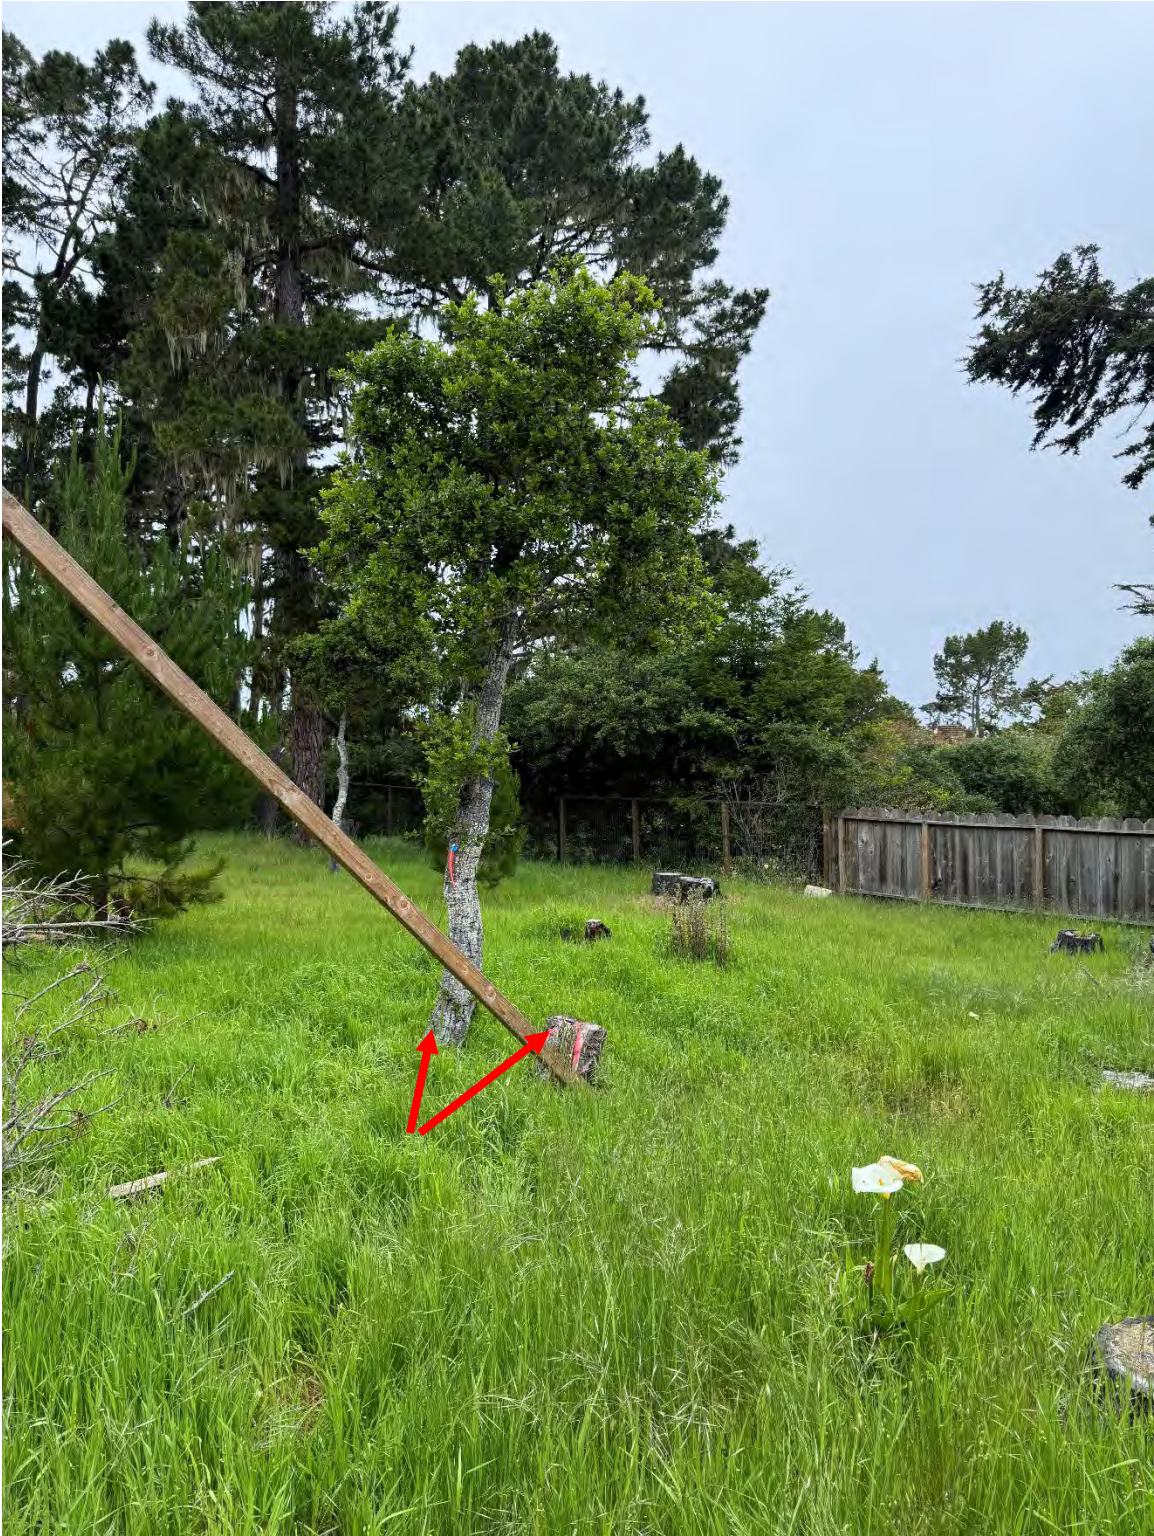
- The project will construct the main structure and install a driveway to the rear yard. The driveway travels along the eastern portion of the lot and will affect trees #378, #379, #381 (now a stump), and #382. Oak tree #380 is shown to be retained, however, excavation may encroach into the tree's critical root zone, but it does not appear that many roots will be encountered; therefore, the tree is expected to survive construction, provided work near the tree is monitored and the tree is protected.

Trees #379 and #378 need removal; they are in the driveway.
