- Background on Pajaro Levee
- Update following the 2022/2023 Storm Events
- Overview of recent emergency flood control activities

BACKGROUND OF LEVEE AND FUTURE IMPROVEMENTS BY PRFMA

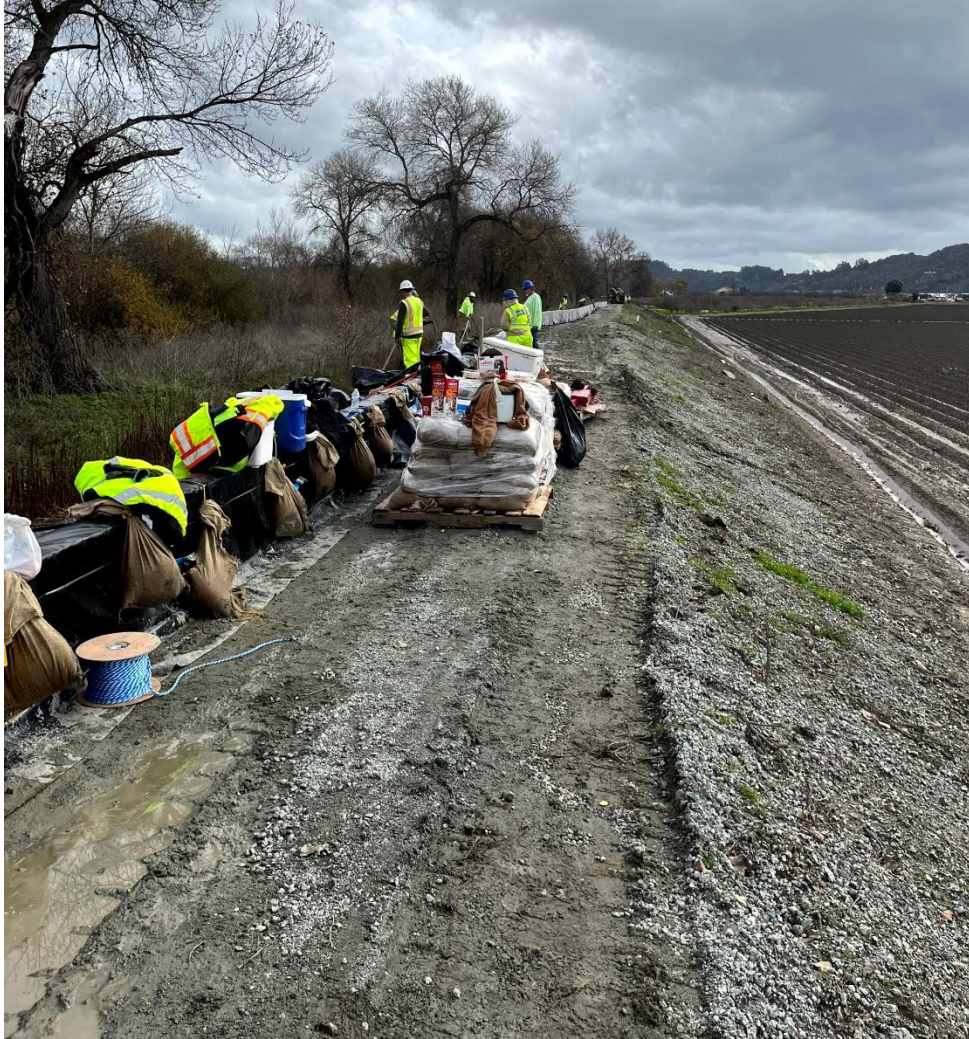
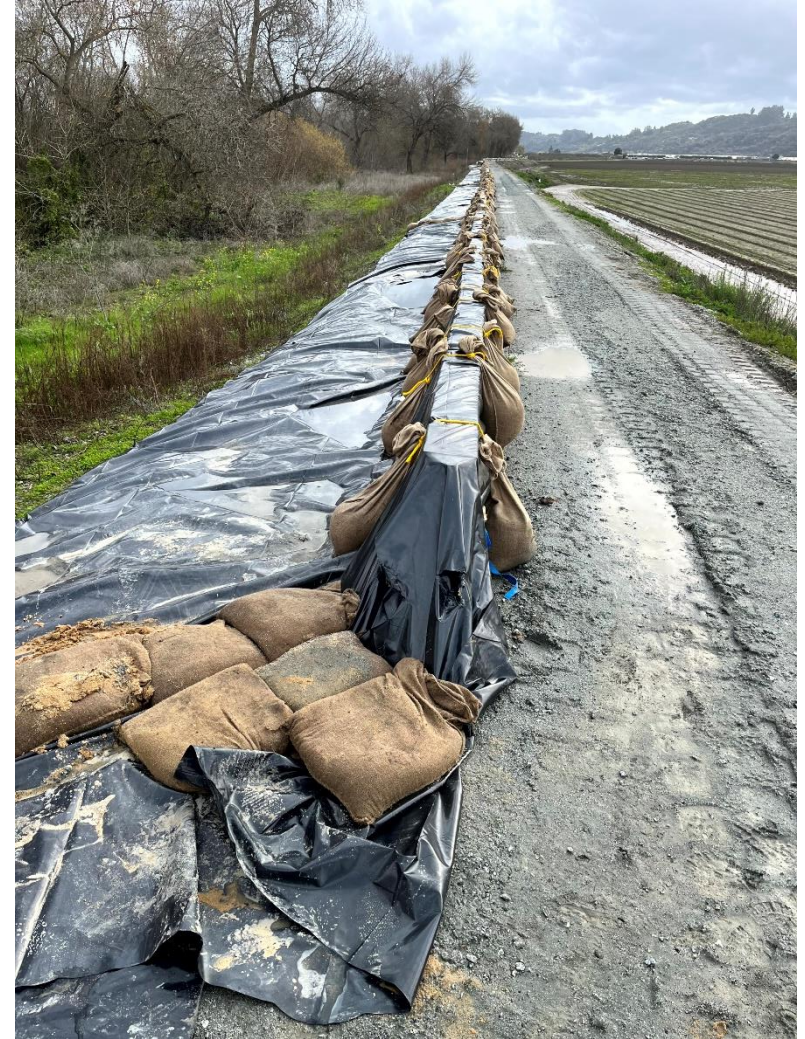
Pajaro Levee Preventative Measures

- Pajaro flood preparations based on forecasts include:
 - Installed 3,000 linear feet of floodwall
 - Repairs to levee road and banks
 - Stockpiled materials for storm response
 - Improved all-weather access to the levee
 - Identified key areas for monitoring river height during peak flows

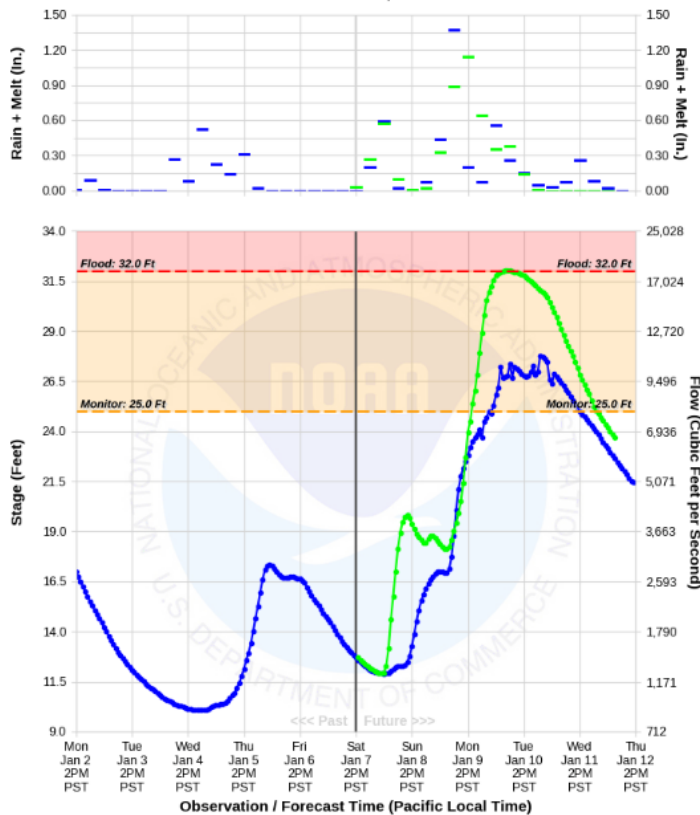
Pajaro River Forecast Jan 8-12

- Forecasts (green line) above flood stage were predicted
- Actual river flows (blue line) peaked below the forecast
- MCWRA staff and consultants patrolled levees 24/7 to observe actual conditions
- Flows within the levee channel were at the top of the levee in some areas, during this peak event

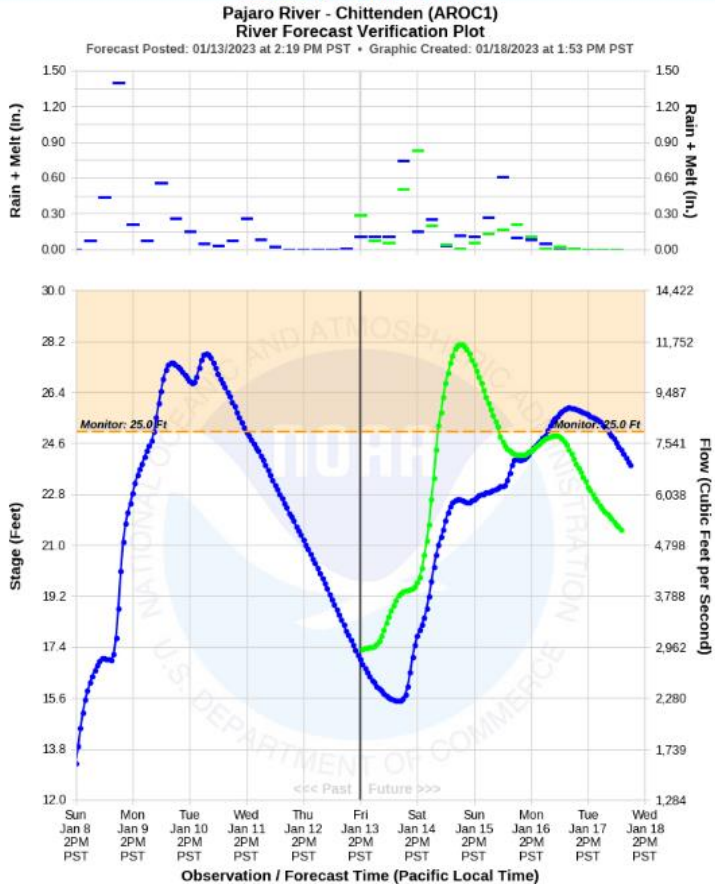
Pajaro River Forecast Jan 14-18

- Forecasts (green line) were predicted to be higher than previous actual flows
- Actual river flows (blue line) peaked below the forecast
- MCWRA staff and consultants continued to patrol levees 24/7 to observe actual conditions
- Flows within the levee channel were below the top of the levee in all areas during this event
