**GEOTECHNICAL INVESTIGATION
For
Proposed Residential Construction
180 Walker Valley Road
APN 131-101-033
Monterey County, California**

**Prepared By
HARO, KASUNICH AND ASSOCIATES, INC.
Geotechnical & Coastal Engineers
Project No. M11108
November 2017**

Subject: Geotechnical Investigation

Reference: Proposed Residential Construction
APN 131-101-033
180 Walker Valley Road
Monterey County, California

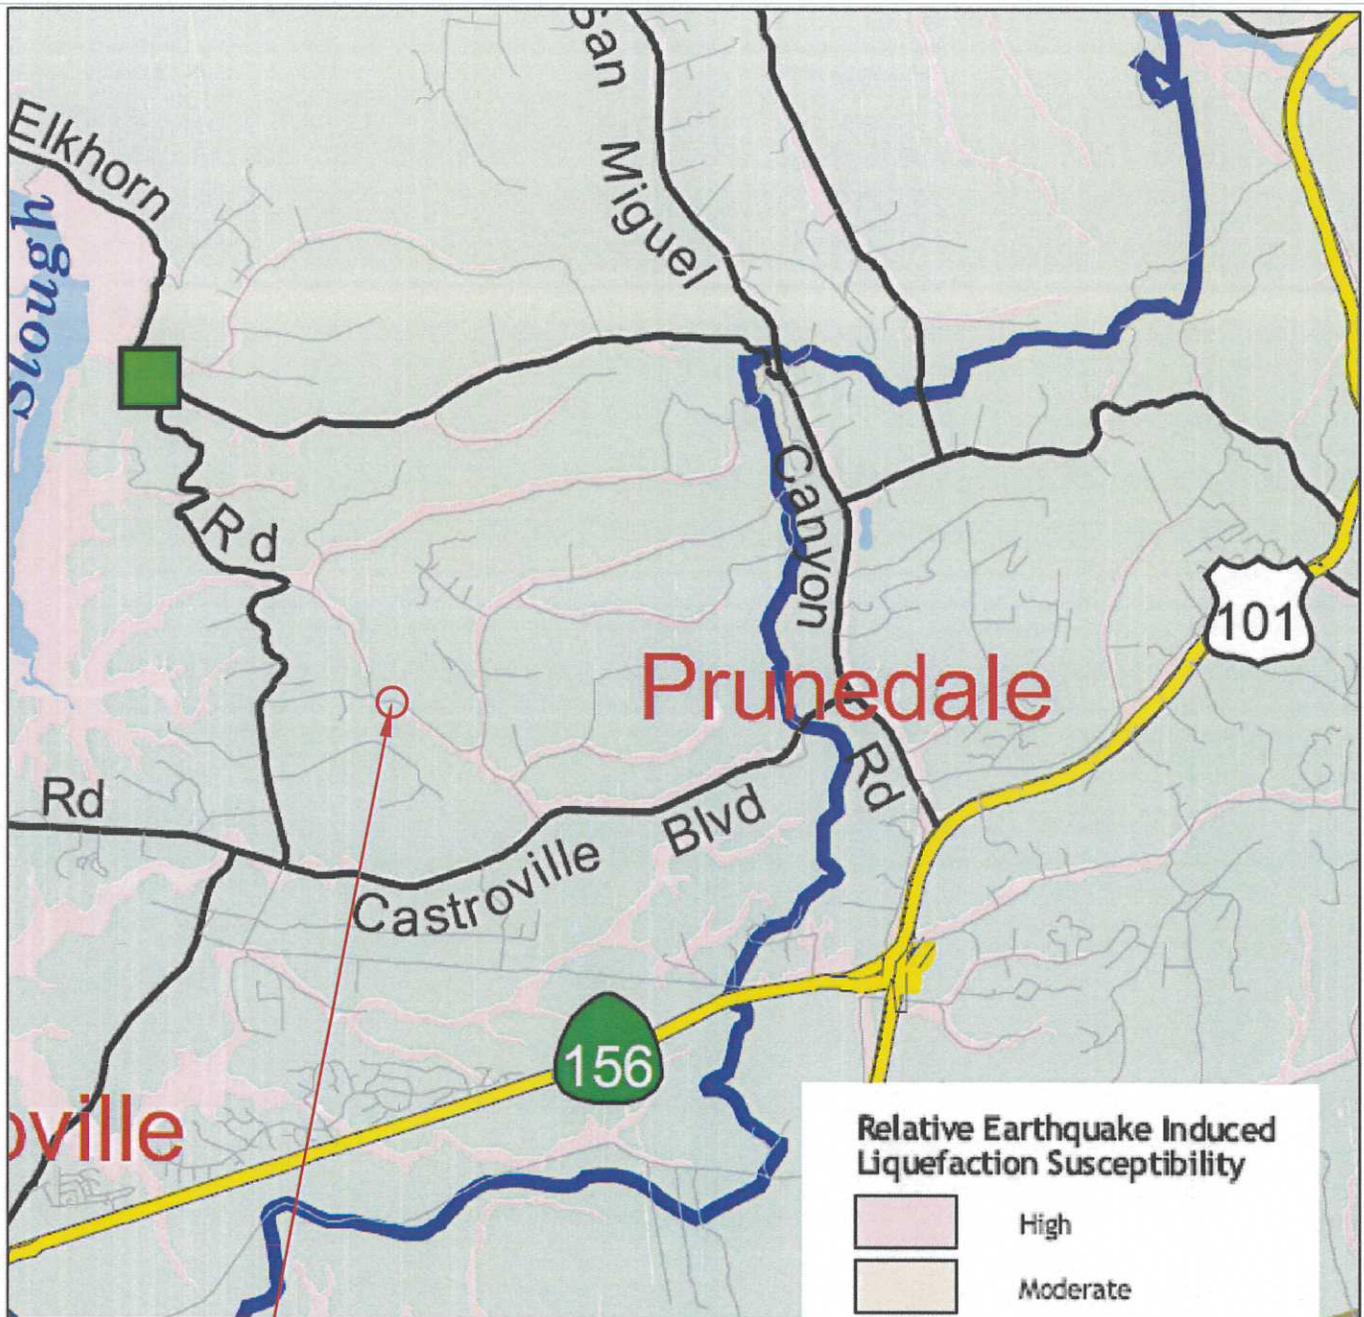
FIGURE NO. 3

The Monterey County Liquefaction Map (See Appendix, Figure 3) shows the site located near areas mapped as having high liquefaction susceptibility. During HKA's site reconnaissance perched shallow groundwater was observed at the site. To mitigate the potential for liquefaction, the top two feet of loose soil within the building pad should be sub excavated and recompacted. Additionally, a 5 foot (\pm) thick mat of engineered fill should be constructed atop the two feet of recompacted soil.
