**PRELIMINARY
GEOTECHNICAL ENGINEERING AND
GEOLOGIC INVESTIGATION
PROPOSED RANCHO EL POTRERO
TEN (10) LOT RESIDENTIAL SUBDIVISION, PLN060603
APN 157-181-006, 007, AND 008
CARMEL, MONTEREY COUNTY, CALIFORNIA**

Project Number: D69201.01-01

January 16, 2008

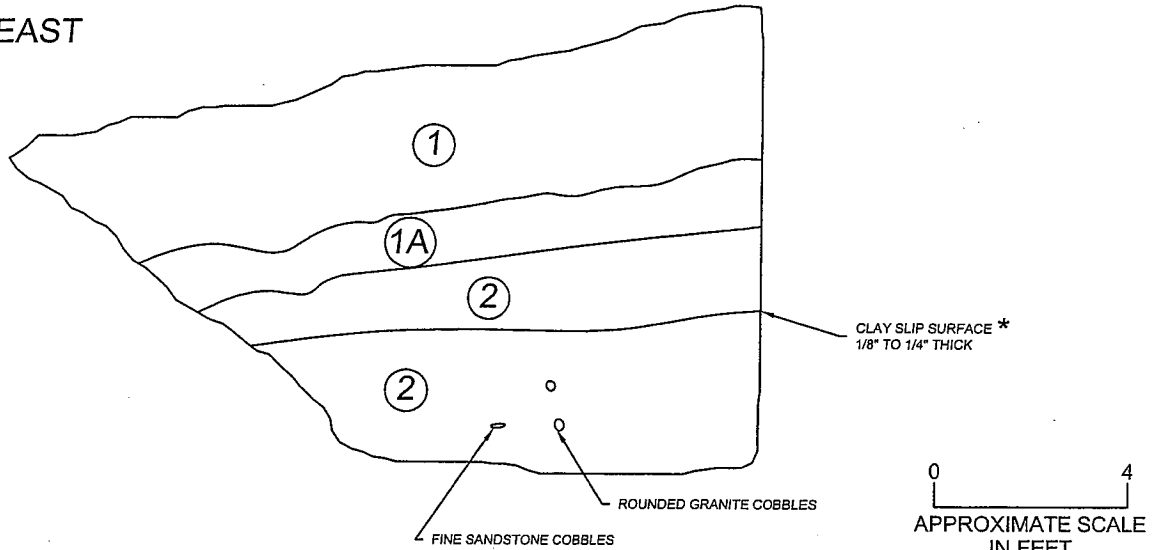
SLIP SURFACE STRIKE AT ABOUT PIT ORIENTATION DIP TO WEST ABOUT 20 DEGREES

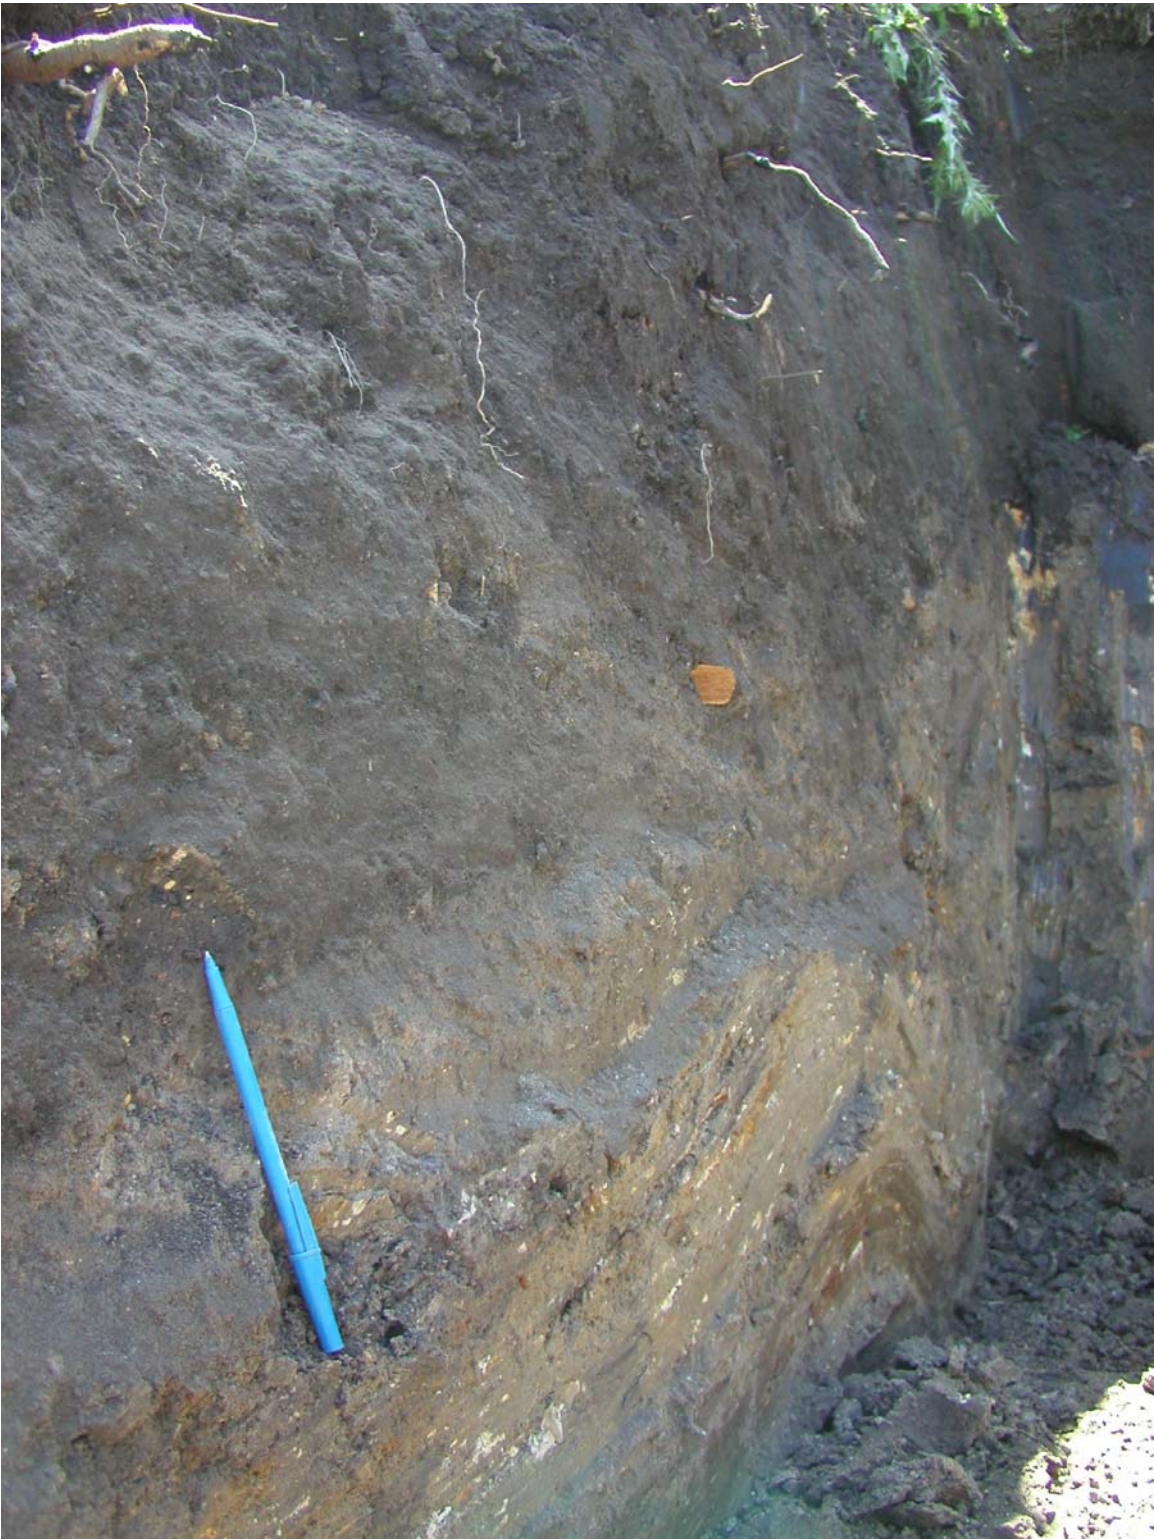
Photograph No. 4: Test pit 4, Lot 4. A horizon soil underlain by E horizon soils, underlain by lean clay with abundant siltstone and porcelanite fragments.

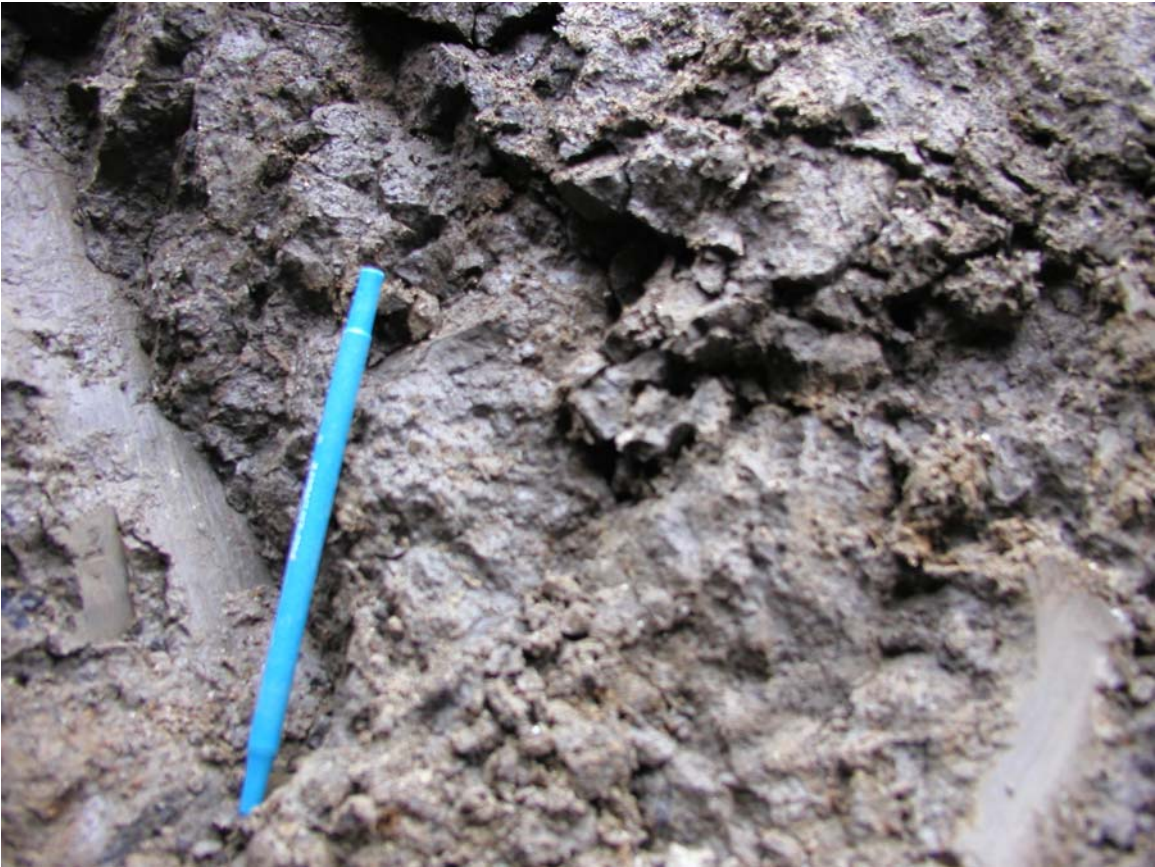
Photograph No. 5: Test pit 12, Lot 1. Slickensides in blocky clay at about 4 feet below site grade.

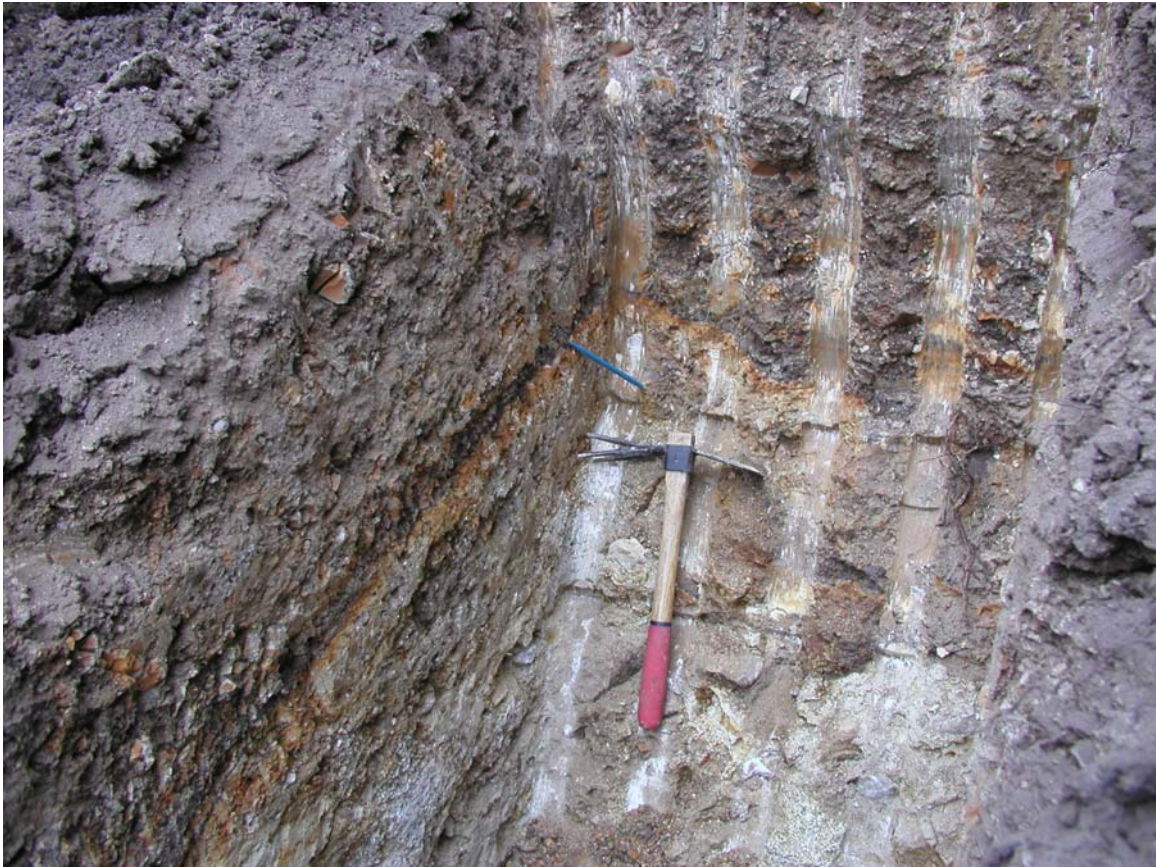
Photograph No. 7: Test pit 13, Lot 9. Pen at clay slip surface.

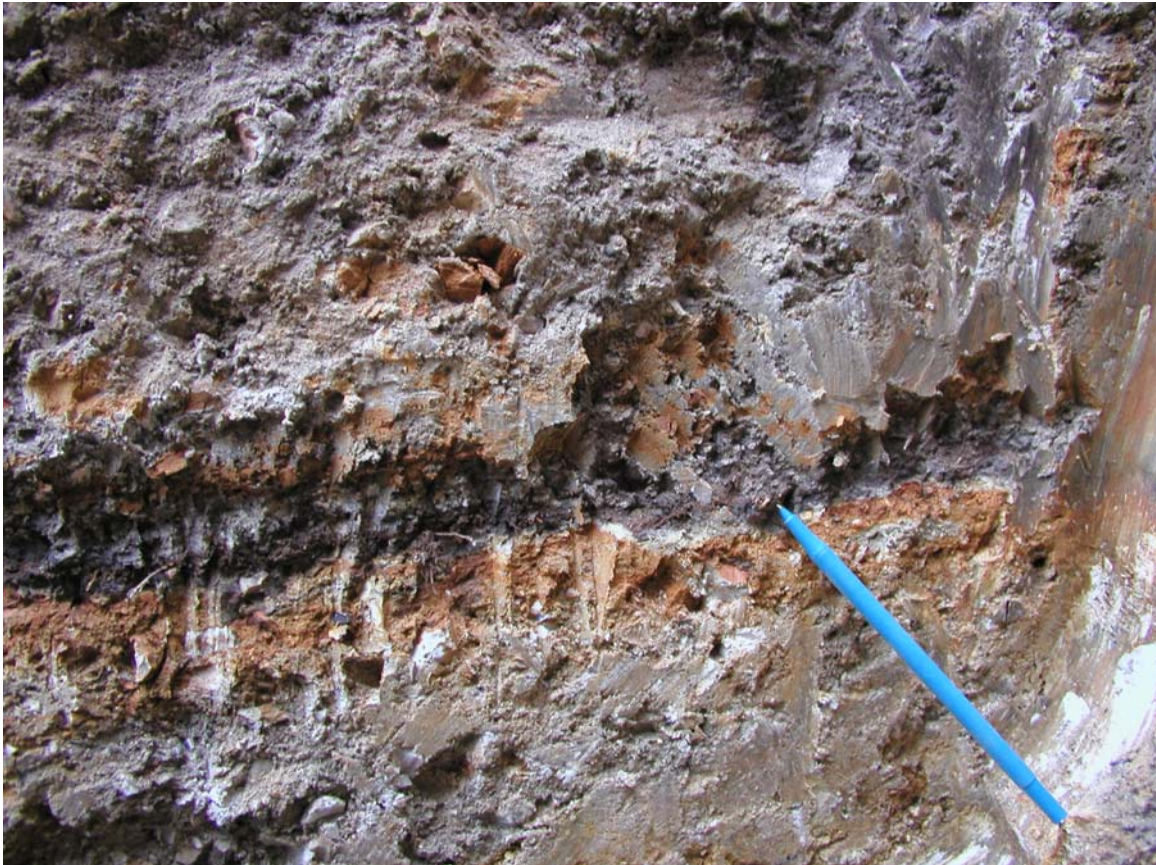
Photograph No. 8: Test pit 13, Lot 9. Head of pen on clay slip surface.

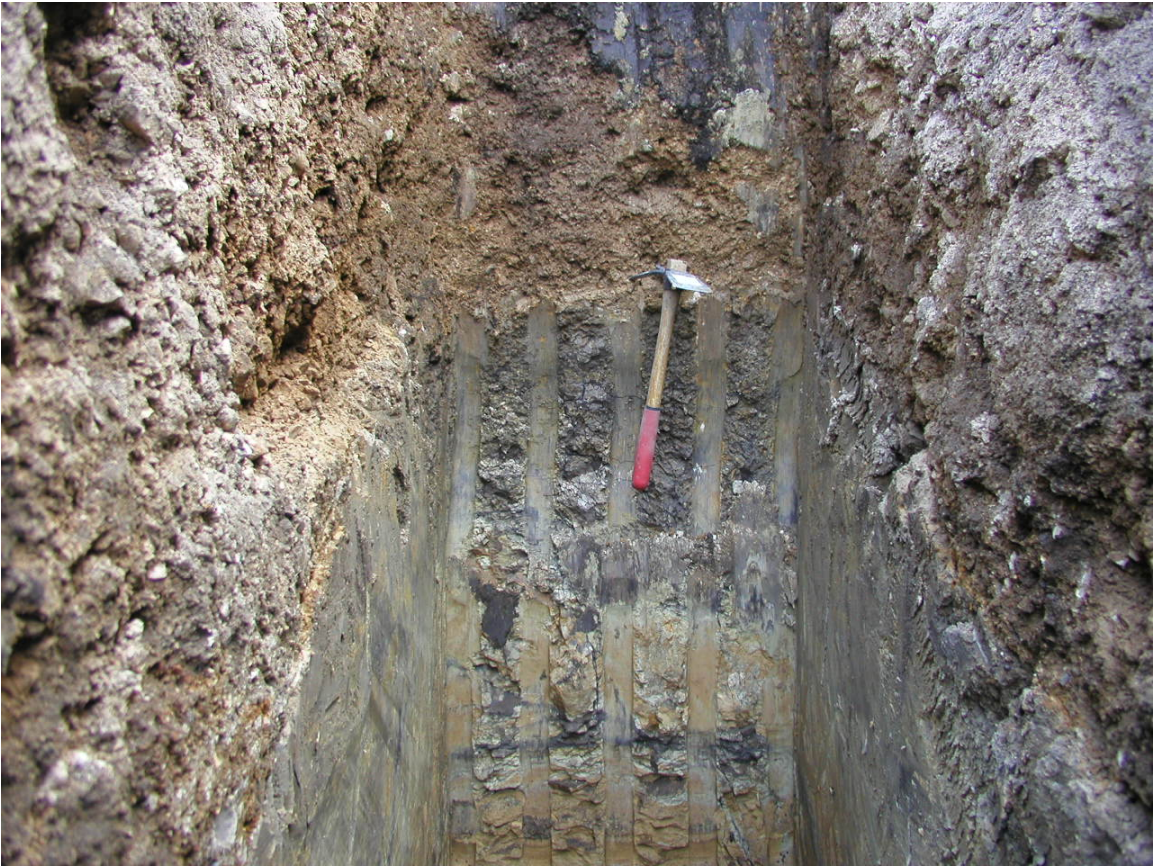
Photograph No. 9: Test pit TP-1, Lot 5. Pick head at bottom of grayish tan slit with abundant siltstone and porcelanite fragments. Silt is underlain by lean clay with siltstone and porcelanite fragments and intensely fractured and sheared siltstone below the pick handle.

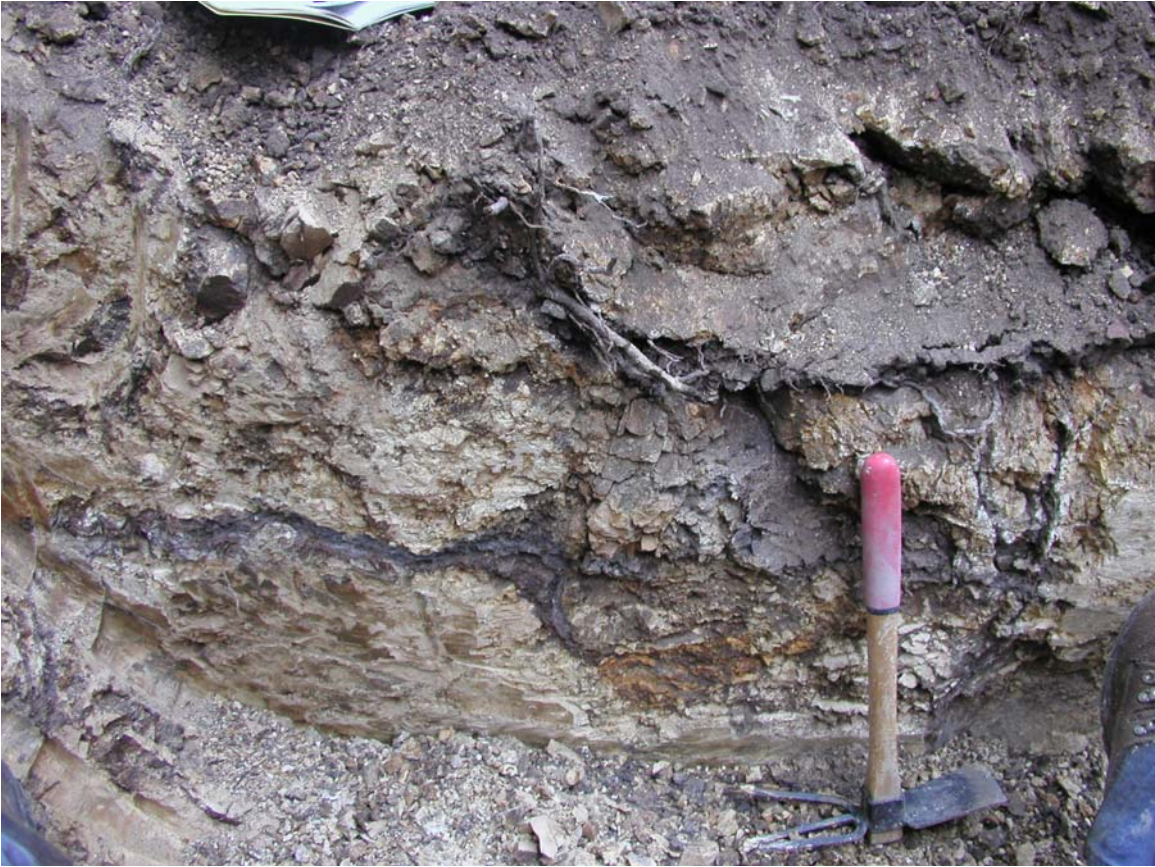
Photograph No. 10: Sheared Monterey Formation siltstone, Test Pit 11, Lot 7. Ground surface at top of photograph.

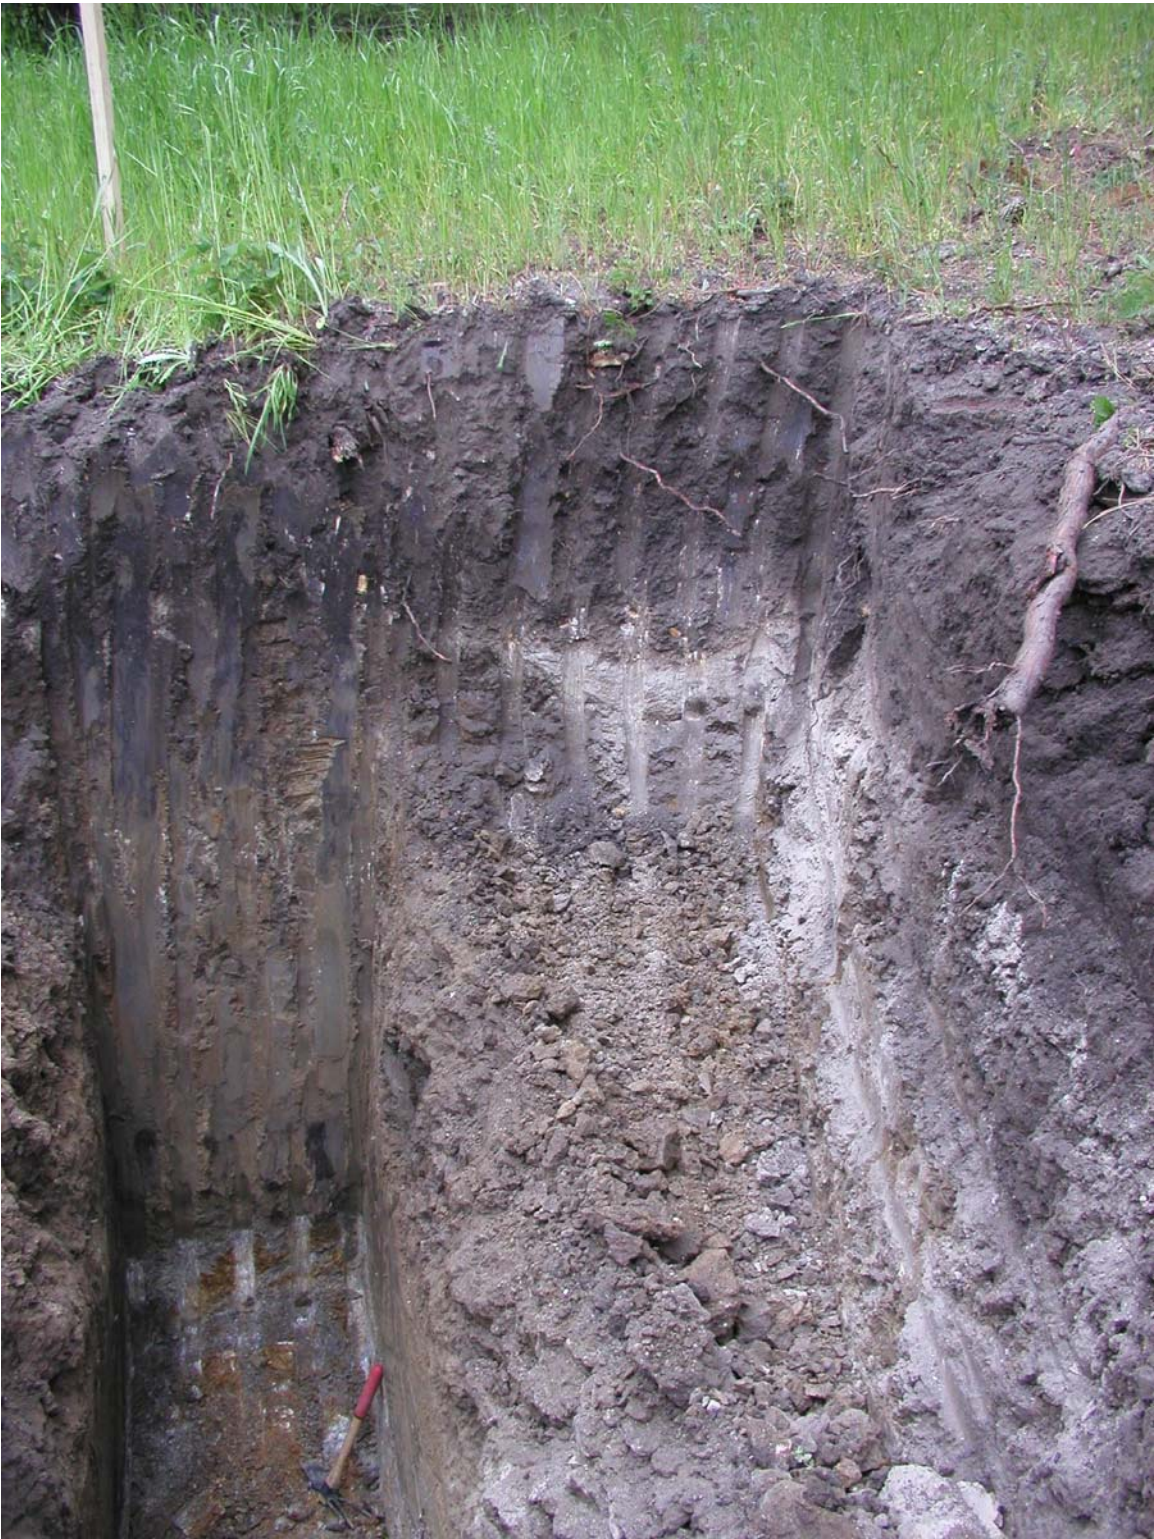
Photograph No. 11: Test pit 12, Lot 1. Approximately 2 to 3 foot thick A horizon top soil exposed at top of trench. Note granodiorite exposed near bottom of test pit.

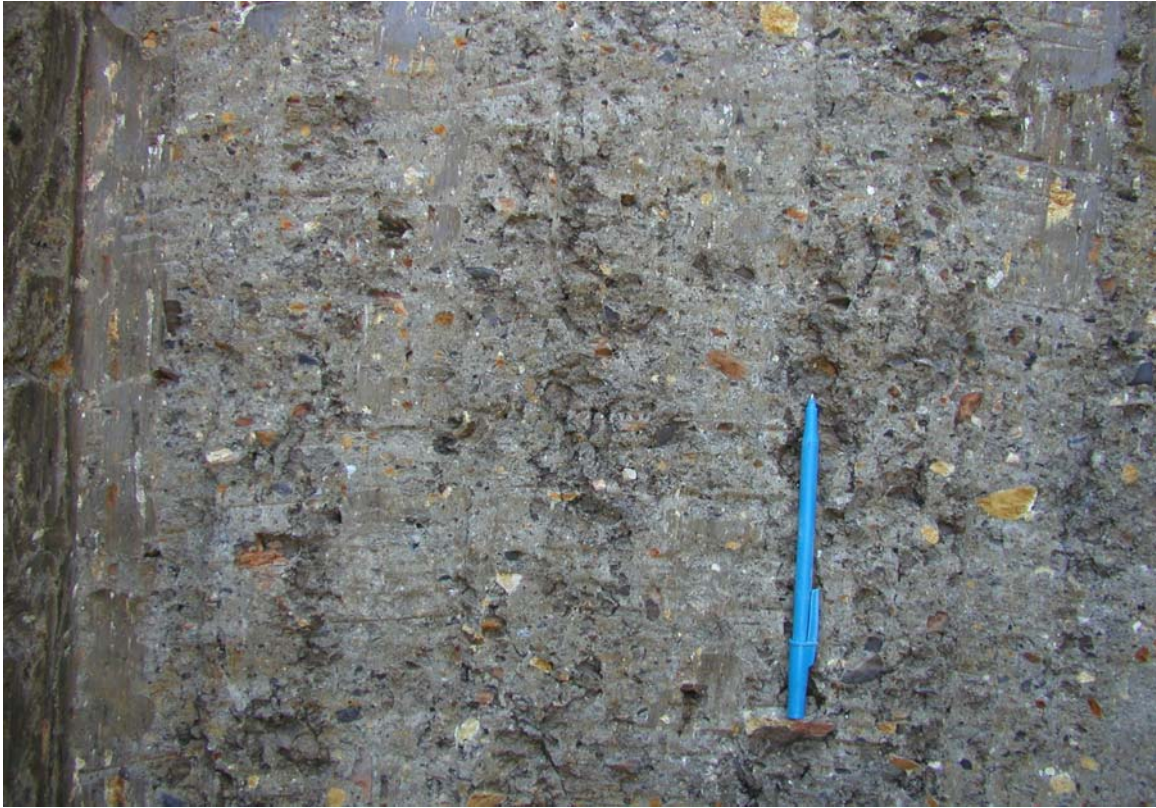
Photograph No. 12: Test pit 4, Lot 4. Lean clay with abundant siltstone and porcelanite fragments.

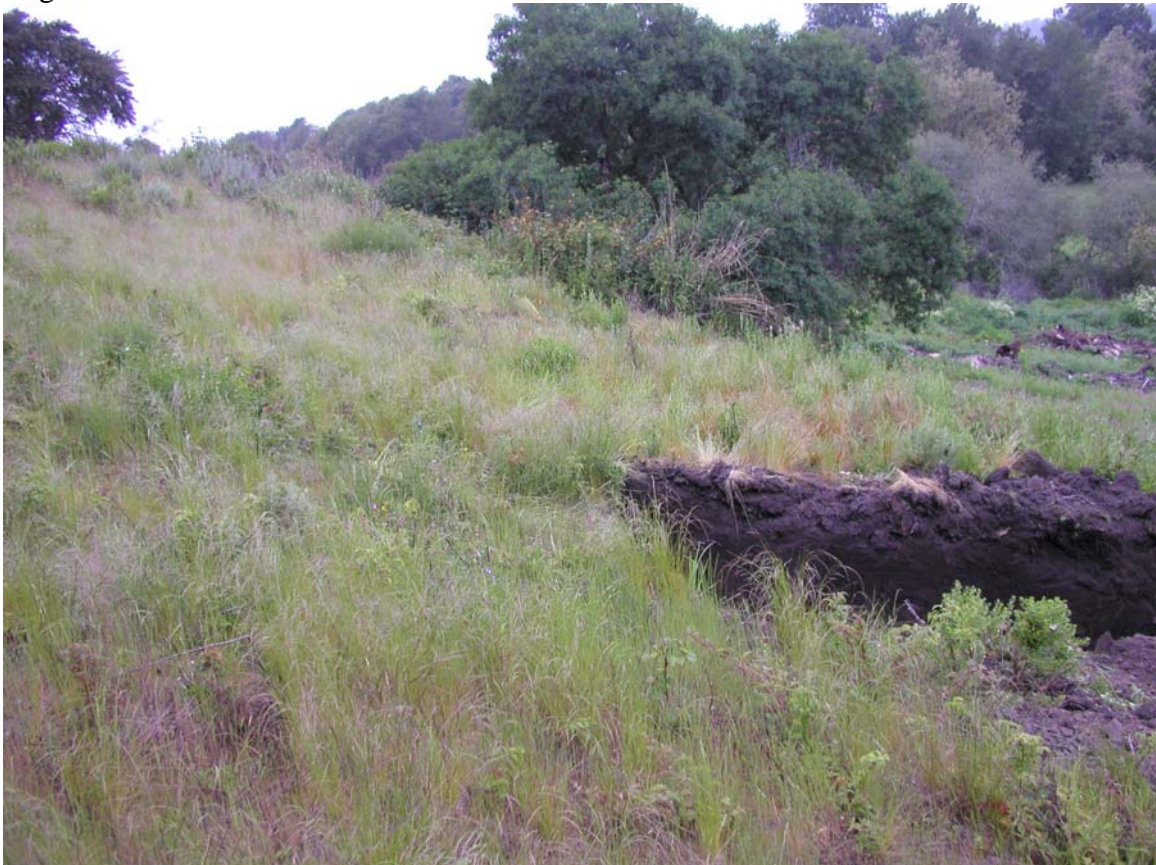
The presence of the relatively shallow dormant landslide feature noted on Lot 3 underscores the potential that other such features may be present on the development site, or may develop in the future. Based on the limited scope of this feasibility level investigation, and the existing ground cover which obscures, additional relatively shallow dormant or active slides may be present that were not identified. Future design level geotechnical/geologic investigations (conducted for each of the proposed home sites/residences) should assess the potential presence of slides and the potential for reactivation of these slides. Mitigation of landslide risk typically includes such measures as removal and recompaction of, or buttressing of the slide and installation of drainage controls. General recommendations for shallow slide repair are provided in subsection 10.7 of this report.

Photograph No. 13: Surface condition near headscarp of small slide Lot 3.

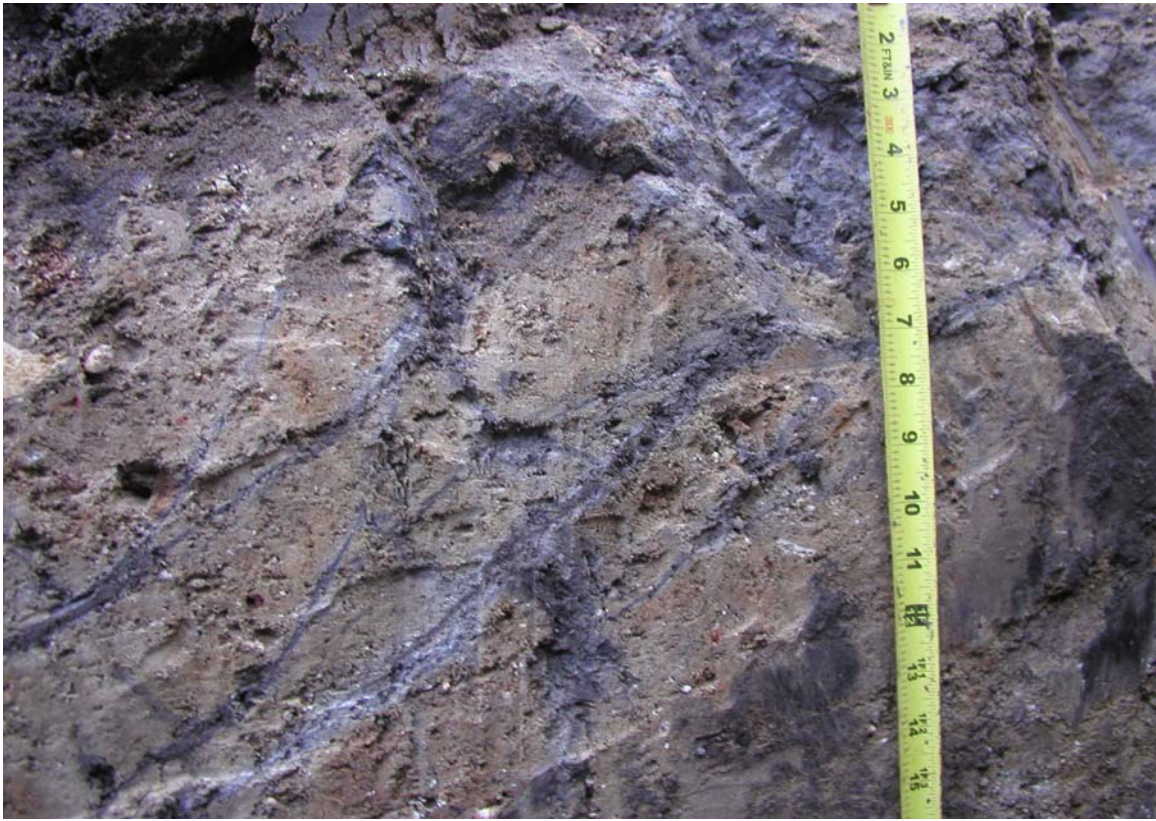
Photograph No. 14: Clay shear surfaces exposed in TP-5, Lot 3.

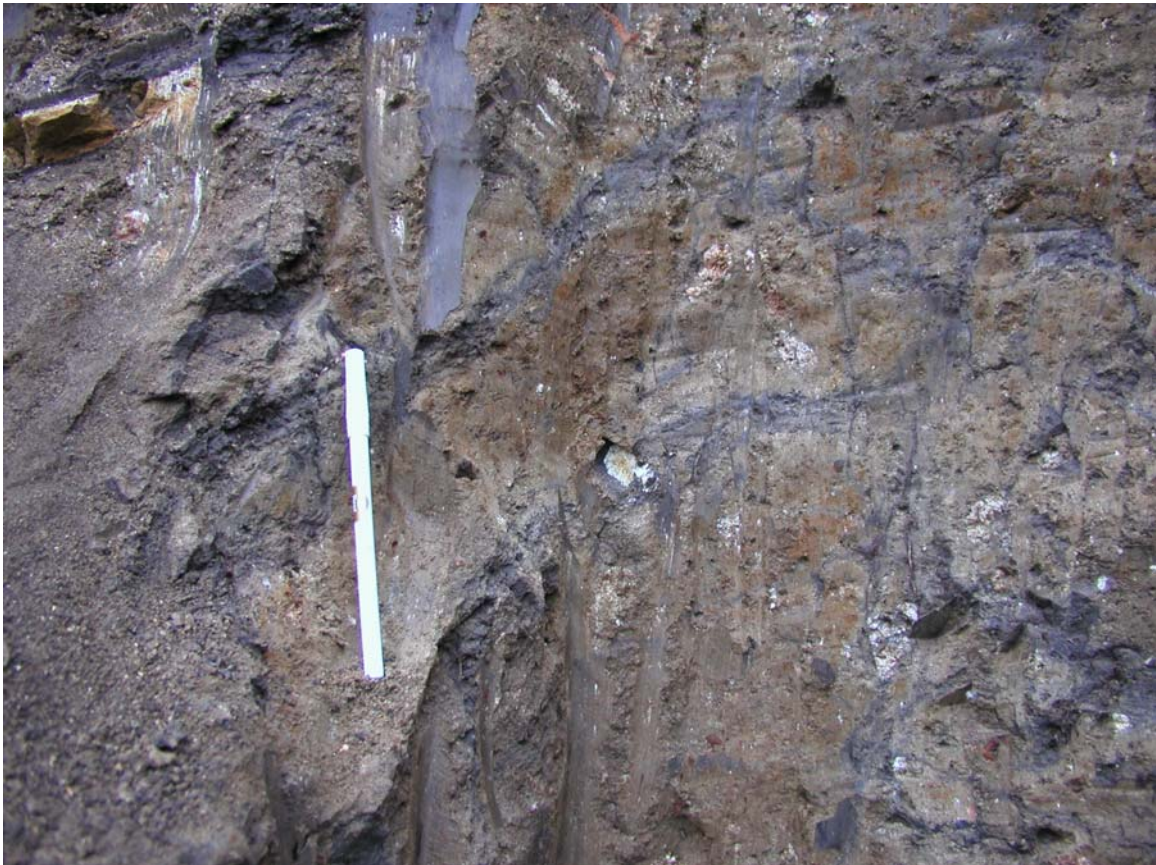
Photograph No. 15: Clay shear surfaces exposed in TP-5, Lot 3.
